**Environmental Impact Report: The
Development of a Photovoltaic (PV) Plant
up to 100MWp generation capacity
associated with the Tubatse Ferrochrome
(TFC) Smelter, Fetakgomo Tubatse Local
Municipality
DFFE Ref: 14/12/16/3/3/2/2079**

Final Environmental Impact Report

Client: Samancor Chrome Pty Ltd

Reference: MD5462-RHD-ZZ-XX-RP-Z-0002

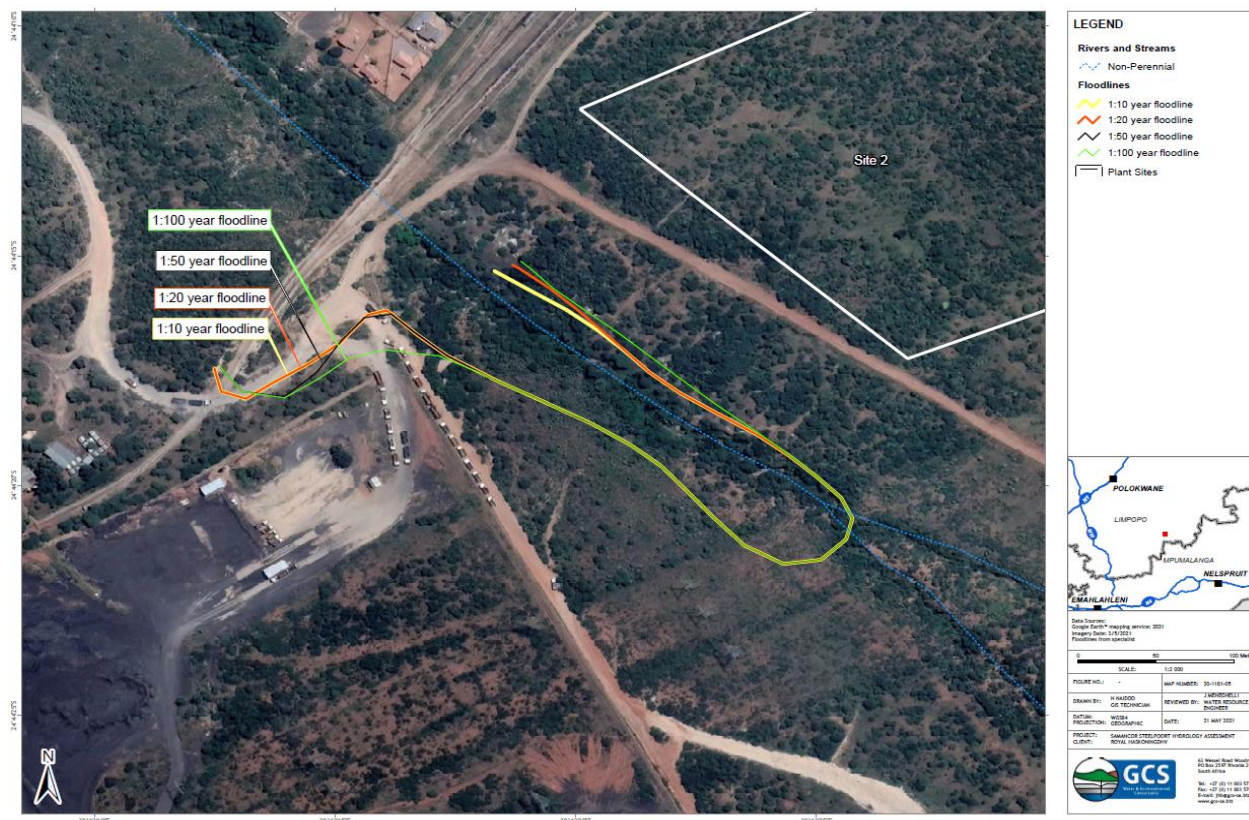
Invert Elevation: 800.51mamsl

Figure 8-3: Tributary 2 floodline
