ROOM NO. SOUTH WING CORRIDOR P.O.BOX 37188 OVERPORT DURBAN 4067 TELE : 2097245/6 FAX : 2097247 E-MAIL : seedat@ion.co.za AHMED.SEEDAT-ARCHITECT REG no :3140(S.A.C.A.P)	ROOM NAME - PROJECT: NATAL COMMAND -DILAPIDATION REPORT	SCALE: 1/50	DRWG.No: 21126
	DRAWING TITLE: ROOM AND OFFICE DATA SHEETS	DATE: DEC 2022	PAGE.No: 1

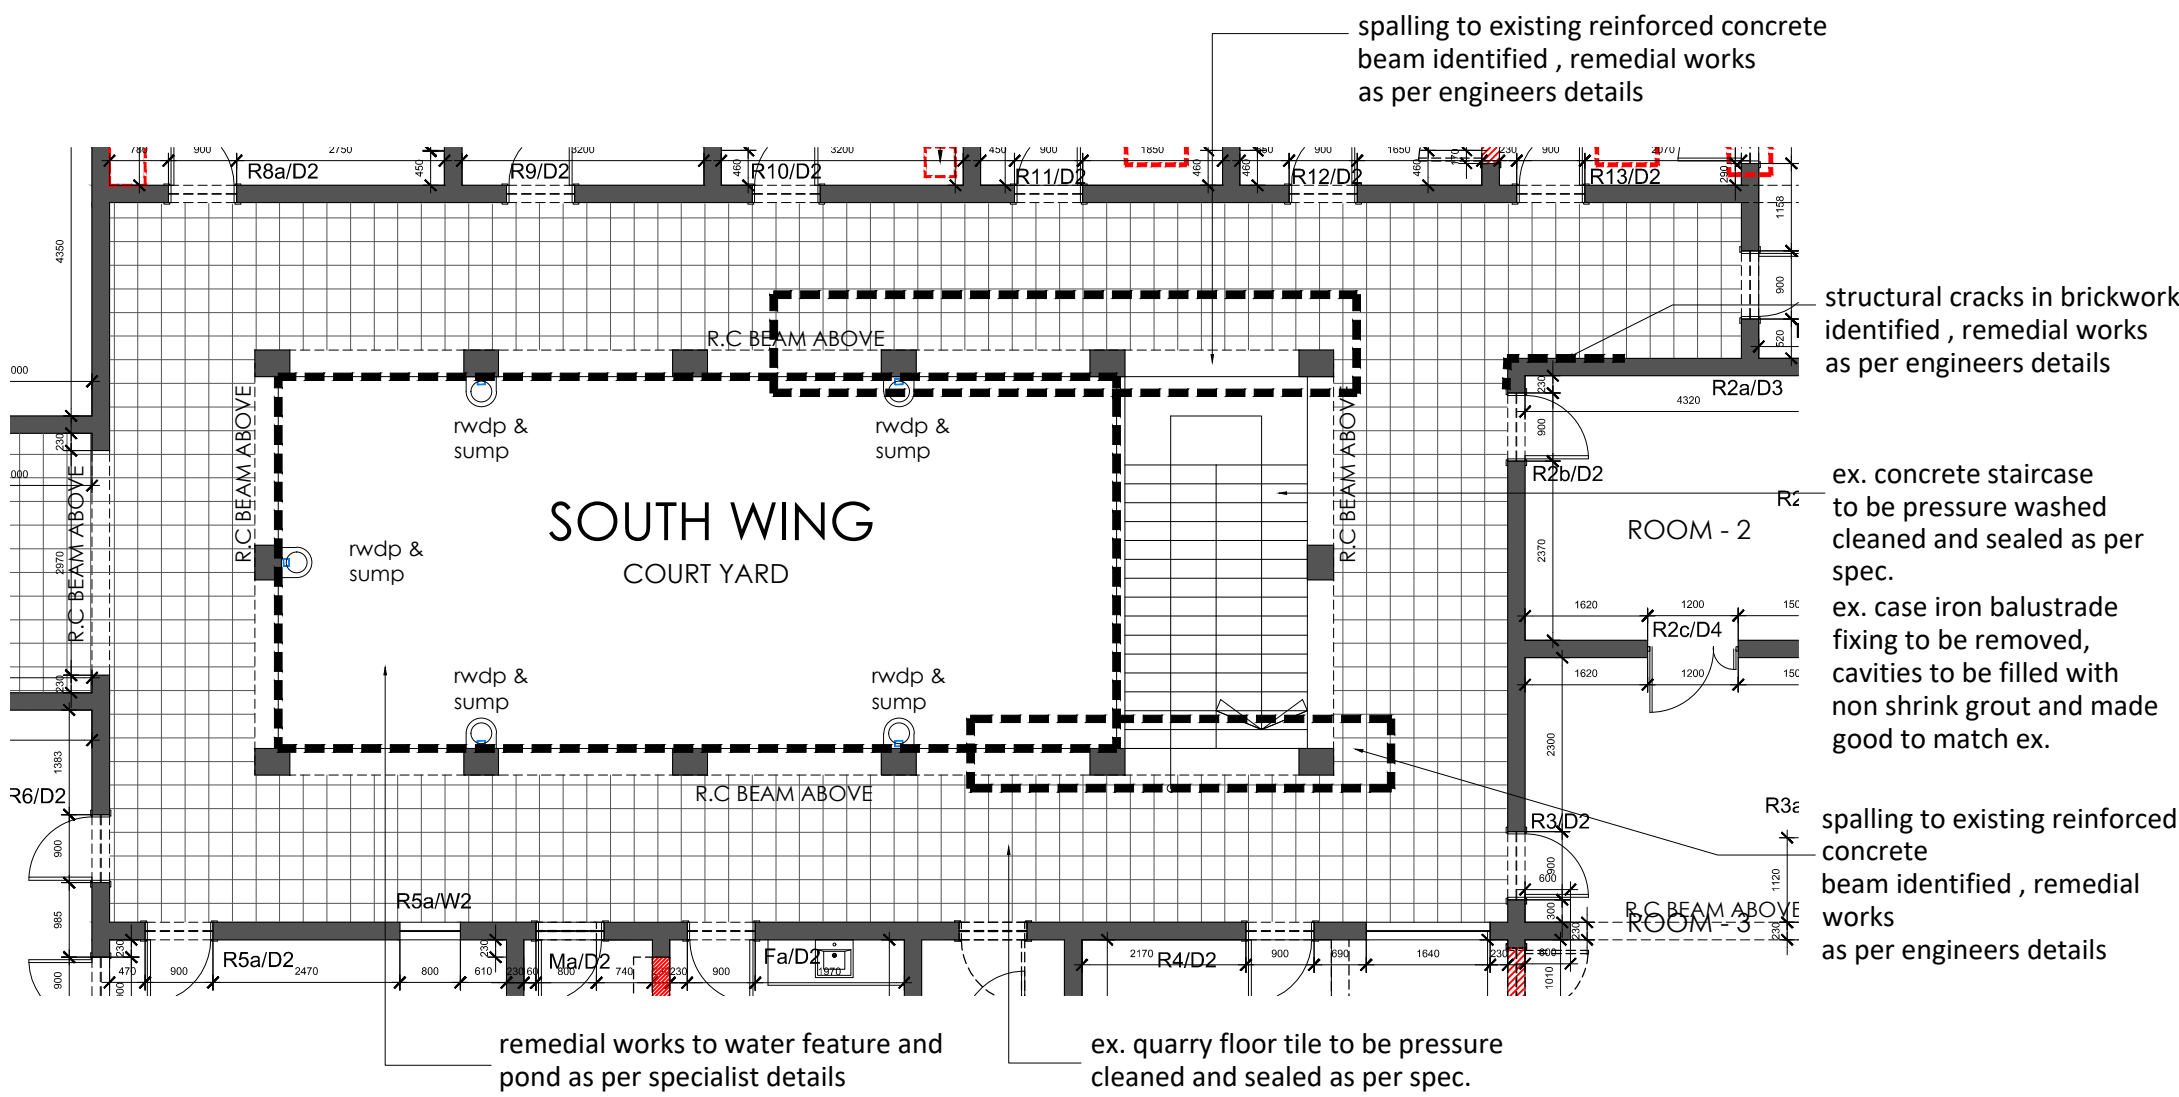
FLOOR FINISH	• ex. quarry floor tile to be pressure cleaned and sealed as per spec. - 115.44m <sup>2</sup>
WALL FINISH	• Existing red satin face brick 1.4m above f.f.l to be pressure washed , mortar joints to be filled were required and sealed as per specifications  Existing plaster & paint above red satin face brick - Walls to be scraped, treated, fill all imperfections. - Walls to receive new finish as per specifications
CEILING	• - scrape off existing flaking paint , treat and fill all imperfections to receive new finish as per spec.
