**ADDENDUM TO ENGINEERING GEOLOGICAL
INVESTIGATION**

**AALWYNDAL HOUSING DEVELOPMENT
ERF 21244 - MOSSEL BAY
WESTERN CAPE – SOUTH AFRICA**

Title:	Addendum to Aalwyndal Housing Development – Erf 21244
Project No:	GT-19-104- Addendum

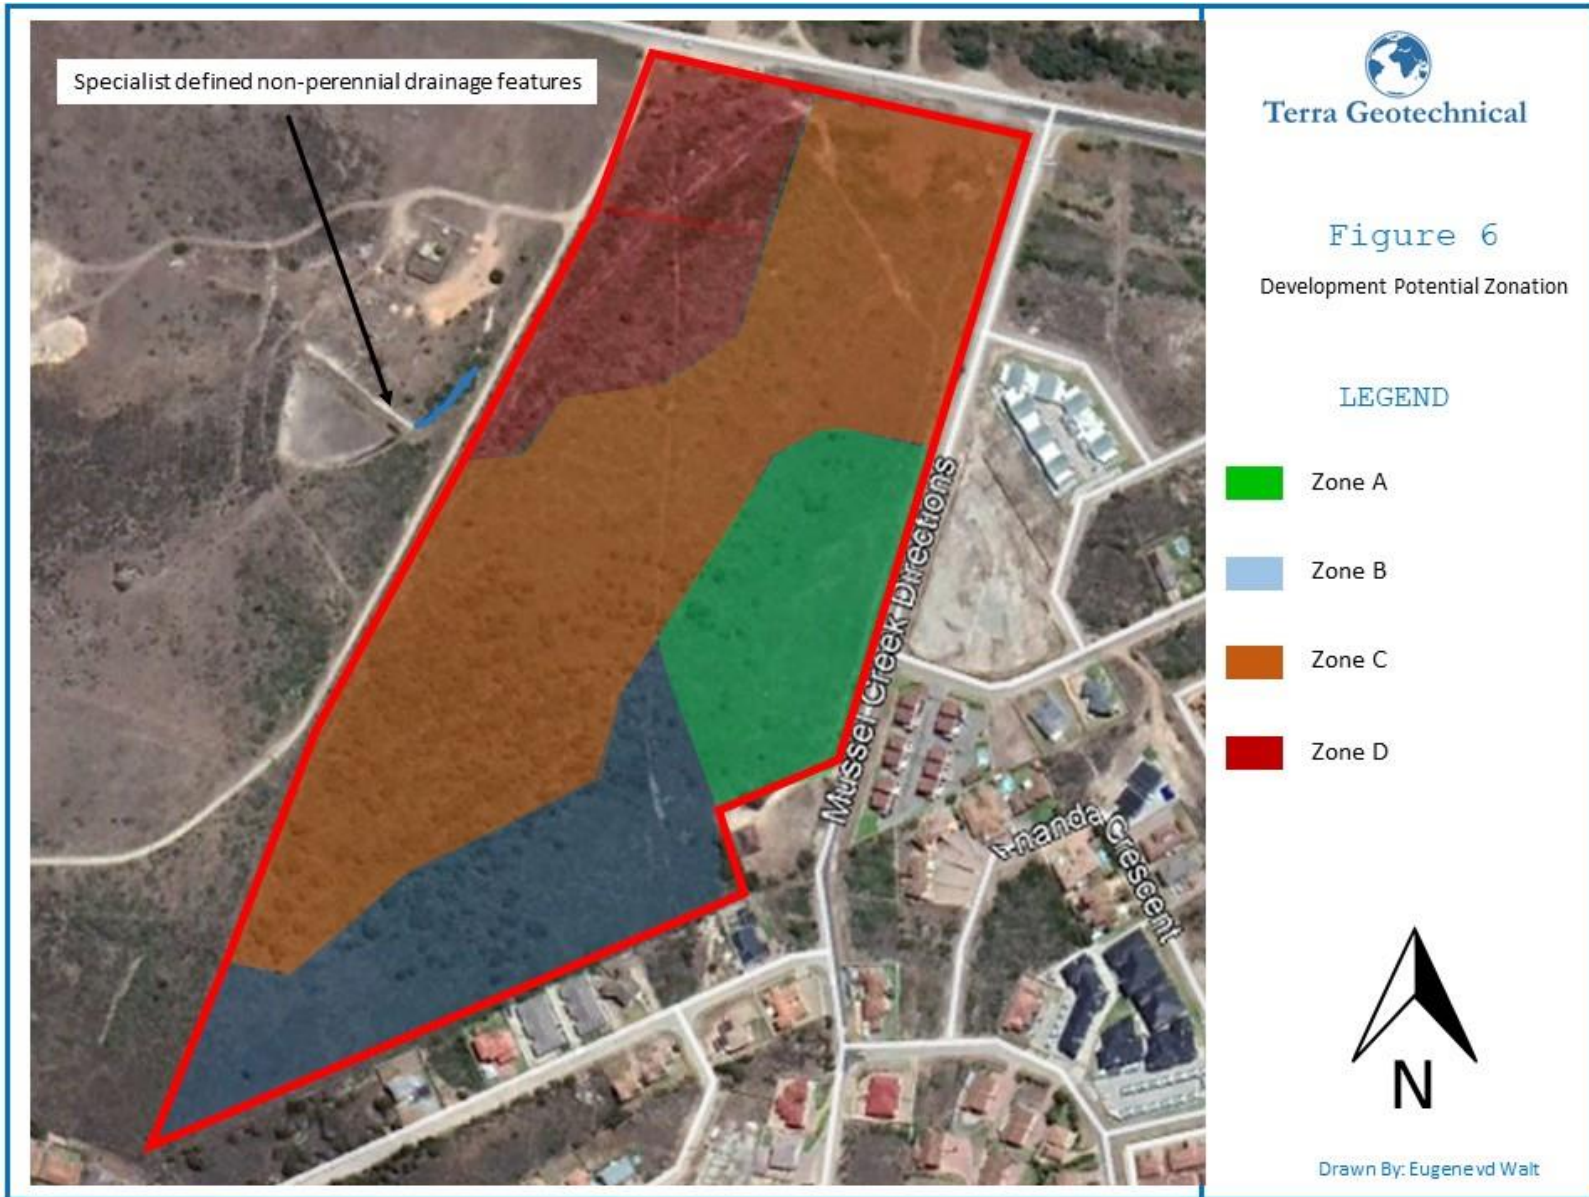
The major change that these findings bring to the geotechnical report is the shifting of the indicated non-perennial drainage feature. Through the evidence provided it can now be assumed that this drainage does not intersect or have any influence on the investigated area. The minor depression in the north western corner will lead to ponding of surface water during high rainfall. Surface drainage measures needs to be implemented as described in the original report.

Please refer to the updated table 5 and Figure 6 below, for the updated geotechnical zoning of the site.

During the investigation and subsequent report, it was depicted by available topographic maps, that a non-perennial stream intersects the north western portion of the site. The site was zoned accordingly during the zonation phase of the project, with a large segment of the north western portion, deemed to be potentially affected by the drainage channel. This area Zone D, was graphically depicted in Figure 6 and indicates the inferred location of the channel.

These specialist studies have clearly defined the extent of the flood lines and marshy areas, proving that the inferred non-perennial stream indicated on Figure 6 of the Geotechnical report, does not intersect the site as previously indicated and as such the **investigated site does not pose any risk of being exposed to elevated volumes of surface water runoff, that could lead to localized flooding**. There is however a localized depression in the north western corner, that could lead to ponding of surface water.

Due to these specialist studies, changes to the zoning of the site (specifically Zone D) will occur. The following changes are deemed to more accurately define the on-site conditions and should be accepted as correct.
