Distribution environmental screening document (DESD) **Reticulation Powerlines and Ancillary Services**

Project name/Survey

Area **Jacobsdal**.....

Voltage: **22Kv**.....

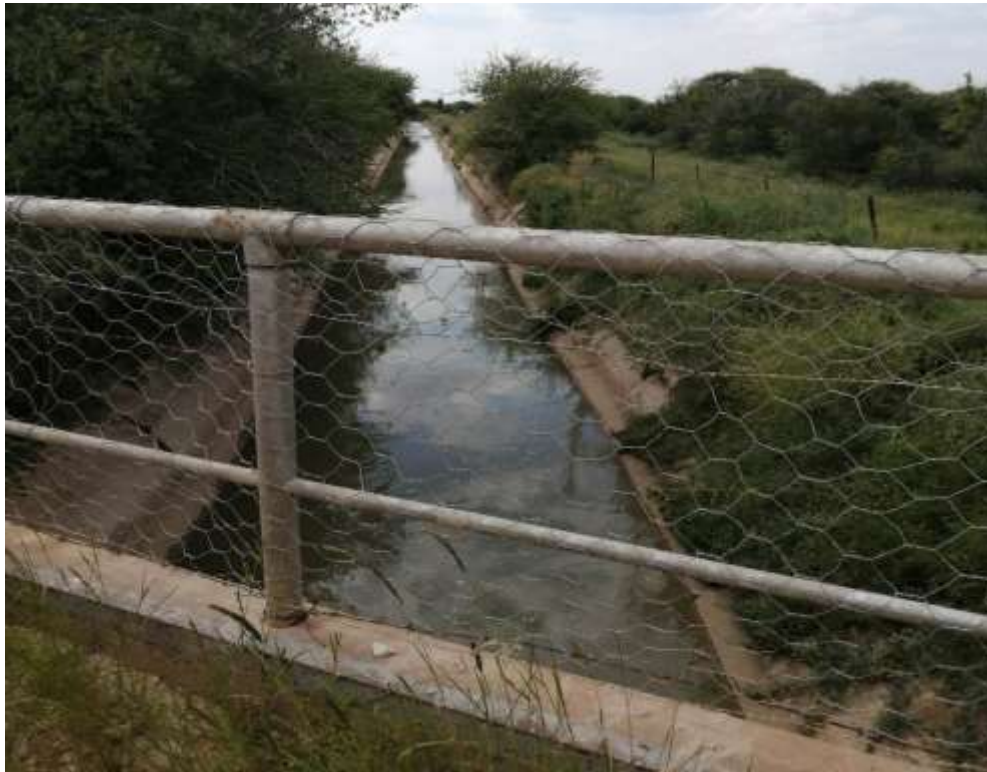
Figure 1: Cemented furrow

The area is characterized with vegetation growth, surface and subwater systems related to the nama-karoo vegetation region. The proposed site falls under the Upper Orange water management area within the Riet-Modder River catchment. There is a farm reservoir on farm Uitijk 231 and a cemented furrow on farm Pramberg 15 (See figure 1).

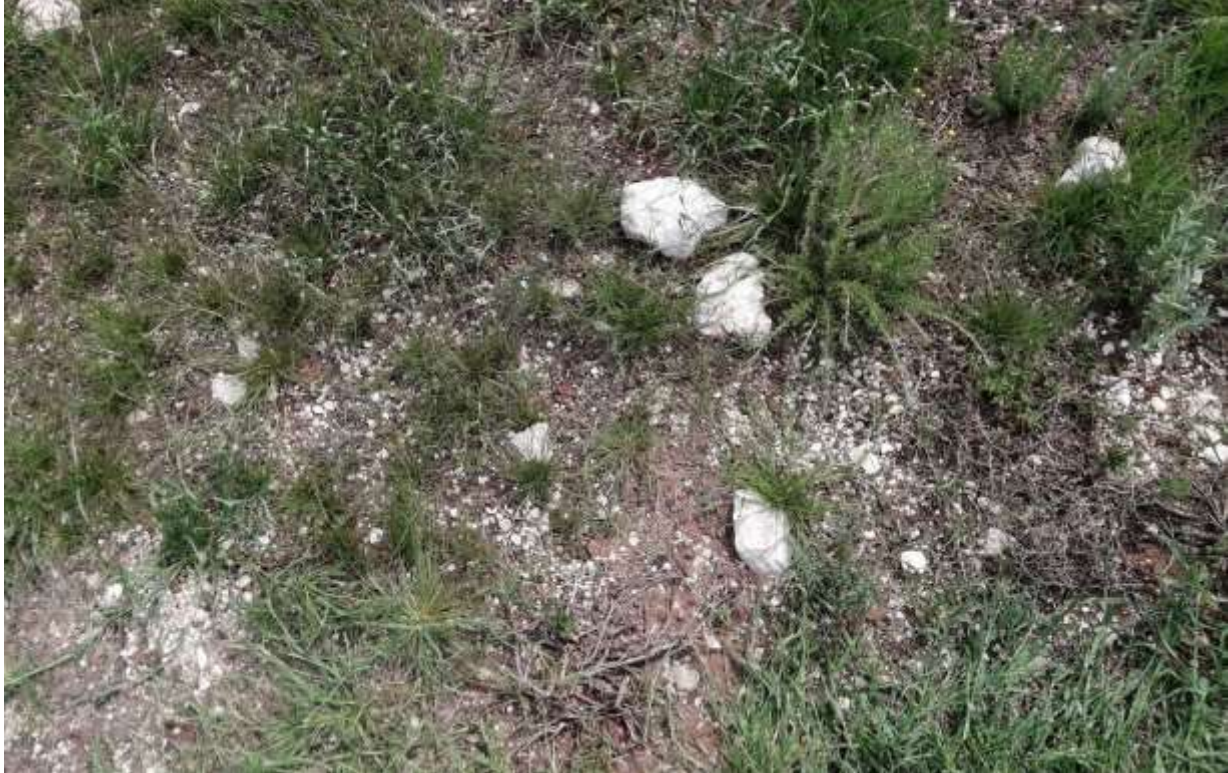
Figure 4: Limestone prevalent on the surface

There are soils with minimal development that are usually shallow and lay on hard or weathering rock. The landscape is generally underlain with limestone and other sedimentary rock which is covered with red soils that has a high base status (See figure 4). The plain is rocky with a medium clay content that has a low potential for swelling and shrinking. The area is mainly covered with Upper Nama Karoo and Eastern Kalahari bushveld vegetation growth which is supported.

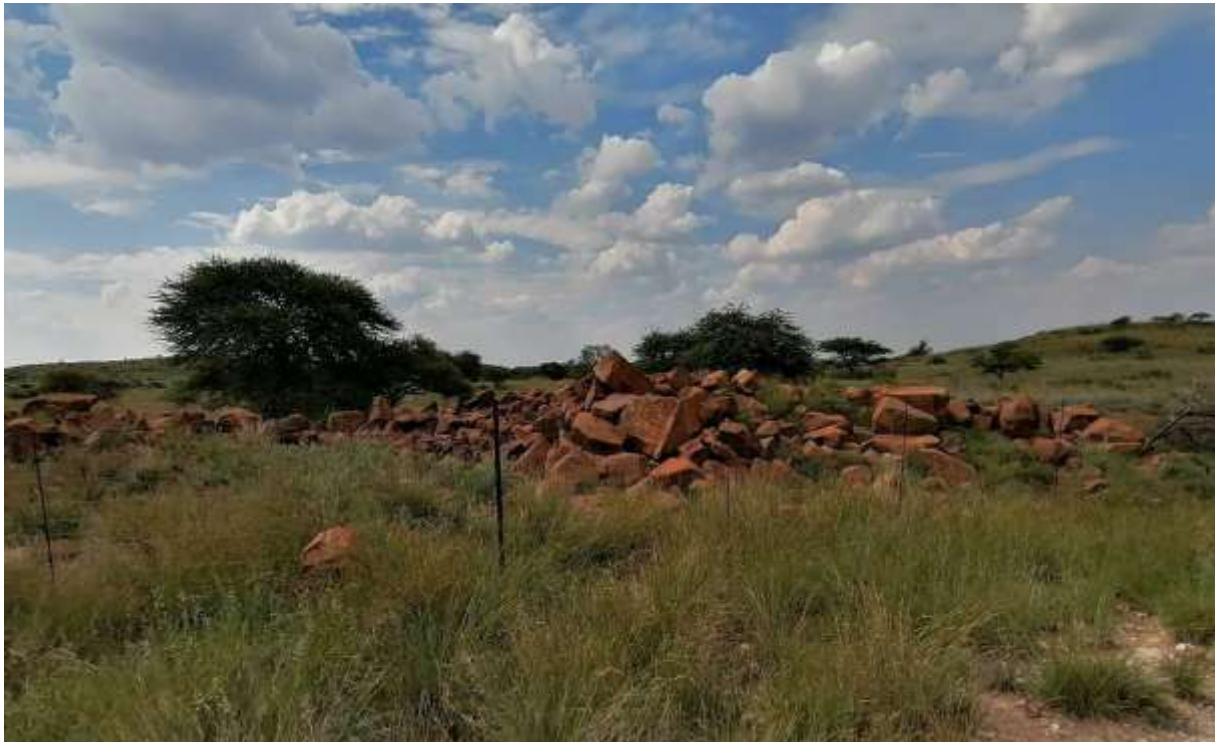
Figure 5: Boulders laying in the veld along the proposed route

Soils are vary between shallow and deep, red-yellow, apedal and are freely drained to very shallow. There are rocky outcrops present on the undulating to sloping plains and boulders on low hills in the area (See figure 5)

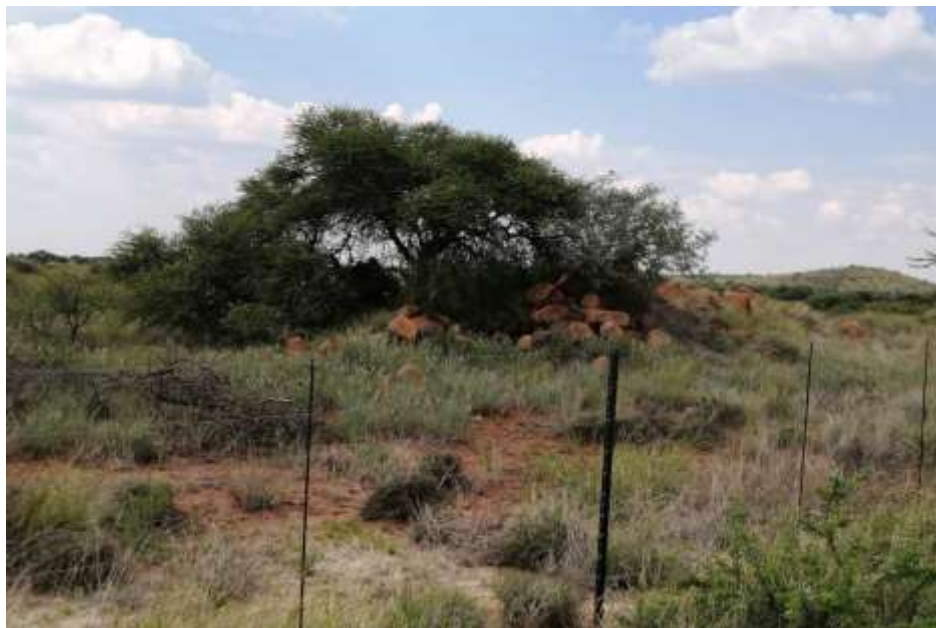
Figure 6: Rocky koppies

The proposed site is on a slightly undulating plain, which is slightly sloping. The small hills and koppies are highly rocky with boulders present on the surface (See figure 6).

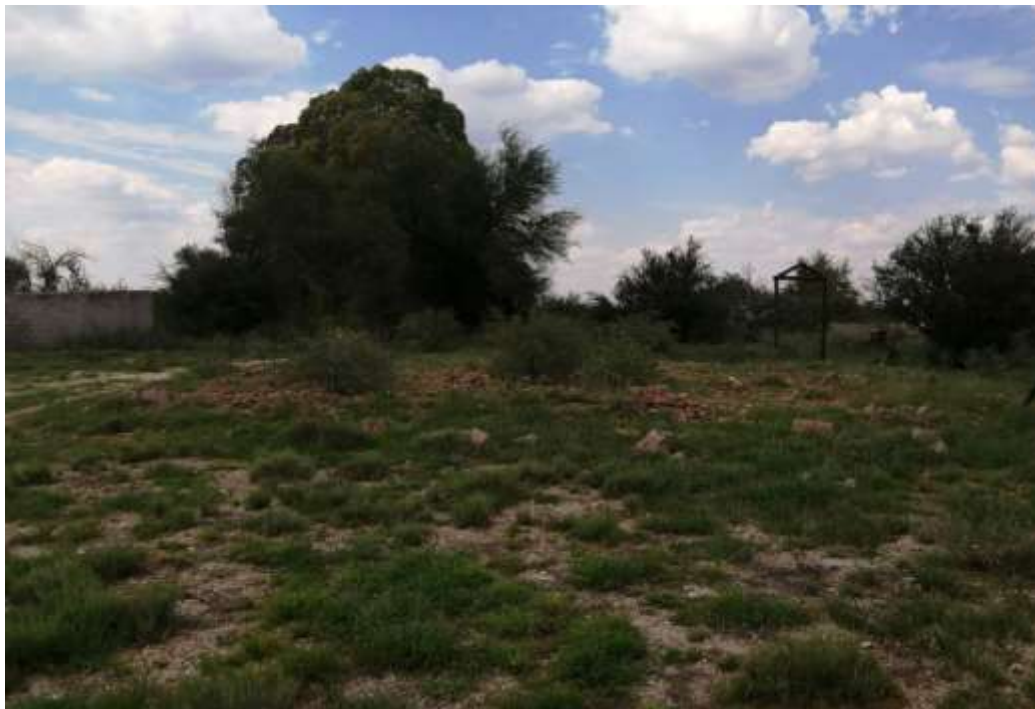
Figure 7: Nama Karoo vegetation

The proposed project is located in the Nama Karoo and Eastern Kalahari bushveld vegetation area with karoo grasses, succulent plants and shrubs (See figure 7). The plains are mainly covered with different grasses, low shrubs and small trees (Mucina and Rutherford, 2006). The trees mainly seen along the route of the proposed line are the **sweet thorn tree (Acacia Karoo)** (See figure 8). Various species of **candelabra plants** were observed to be present during the site visit close to the areas of a high water table. There are also alien trees present in the grassland biome like bluegum-, poplar trees and indigenous trees like karee and pepper trees (See figure 9).

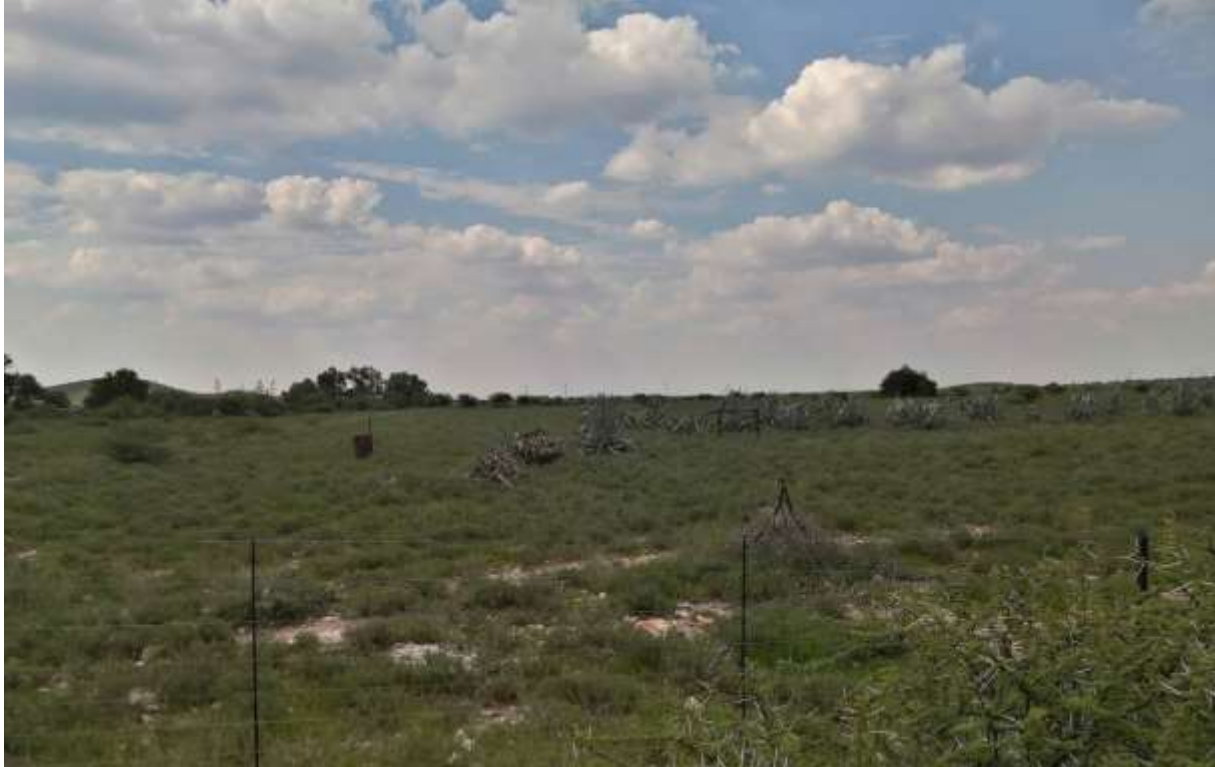
Figure 10: Aloe plants in the veld

The **Aloe plants prevalent** on farm Uitijk 231 can provide an important ecosystem service to the surrounding communities in the form of medicinal provisions (See figure 10).

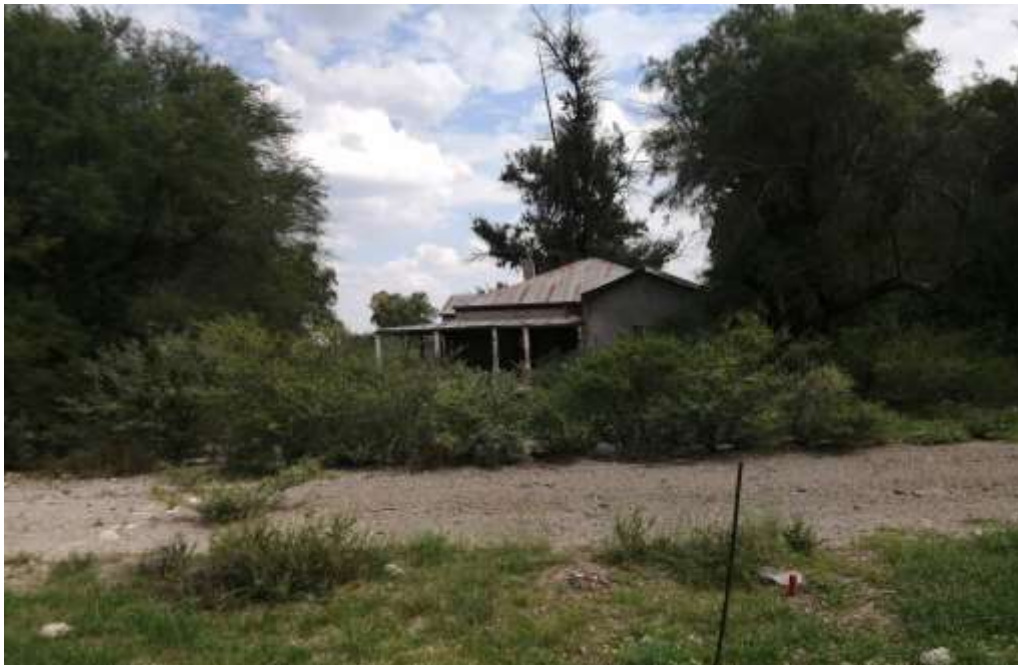
Figure 13: Old farm house on farm Uikijk 231

The proposed site is located on farm Ultijk 231 where farm worker houses and a main farm house is standing (See figure 13). No one occupied the farmhouse at the time of the site visit. It was evident that there are still farm workers present on the farm and in farm worker houses.

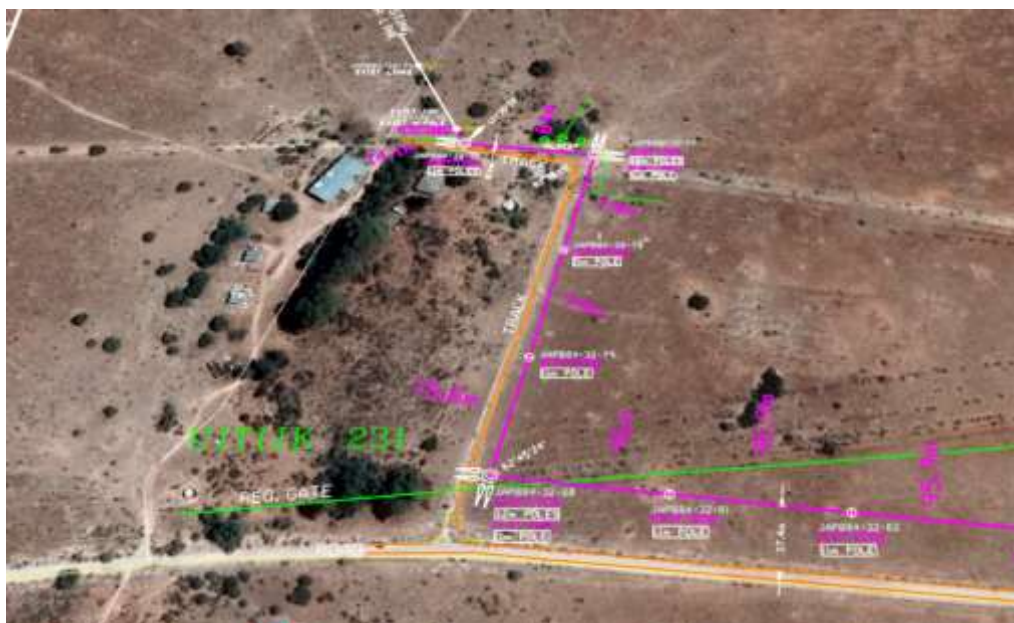
Figure 14: Visual impact from farmworker houses

The proposed power line will be seen from the main gravel road. The power line will also be seen from the farmhouse (See figure 14).

The new line might have a minimal impact as the farm house has no occupants but farmworker houses are still occupied on farm Ultijk 231. The proposed line is not visible from farmworker houses and there is an existing power line already on the farm which minimize the impact of the proposed power line.

- ❖ Make use of wooden poles on the project.
- ❖ Line should be kept behind trees where it is hidden
- ❖ The power line should preferably be aligned in the valley and not on top of the hills.
- ❖ The proposed power line should as far as possible be aligned next to or close to existing infrastructure and already disturbed environments

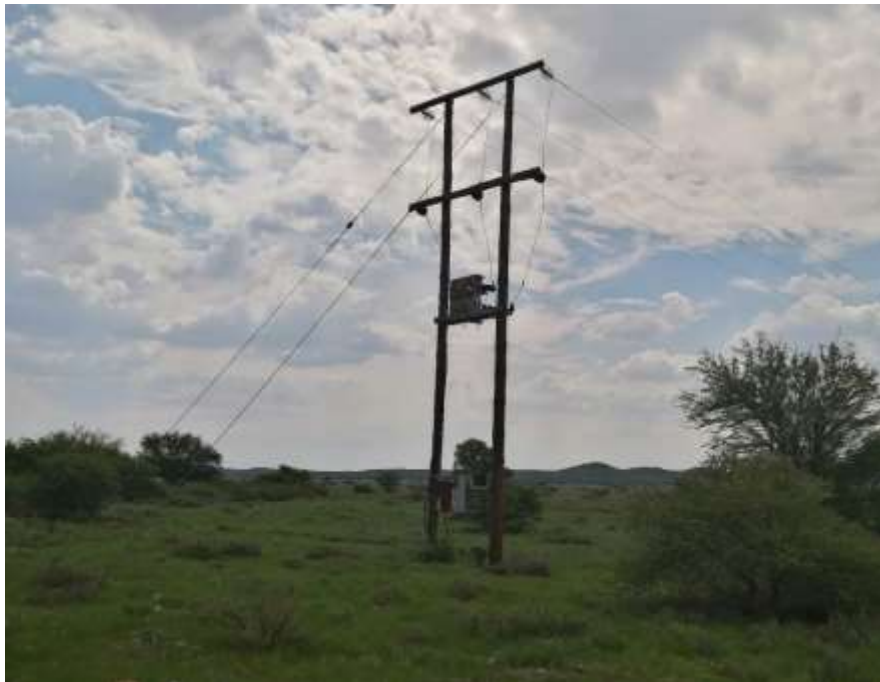
Figure 14: Existing transformer pole

- ❖ Gravel roads might deteriorate due to erosion caused by the traffic increase on it.
- ❖ The gravel road serves as an easy access medium to the proposed line.
- ❖ The existing power lines might be damaged due to construction activities.
