The VIA is based on the currently provided layout for the proposed Kudu PV 9 facility. Mitigation measures have been recommended in Tables 9 to 12 above. These have been included where possible in the project layout. A photomontage has been attached to depict the current layout.

CHAPTER II: Heritage Impact Assessment (Archaeology and Cultural Heritage)

ASHA Consulting (Pty) Ltd was appointed by the Council for Scientific and Industrial Research (CSIR) to assess the potential impacts to heritage resources that might occur through the proposed development of a suite of twelve photovoltaic (PV) solar energy facilities (SEFs) to be located between 50 km and 66 km northeast of De Aar, Northern Cape. They will be named Kudu PV1 SEF, Kudu PV2 SEF, etc. The present report pertains to the Kudu PV9 SEF which has a centre point at S30° 11' 16.7" E24° 21' 16.8".

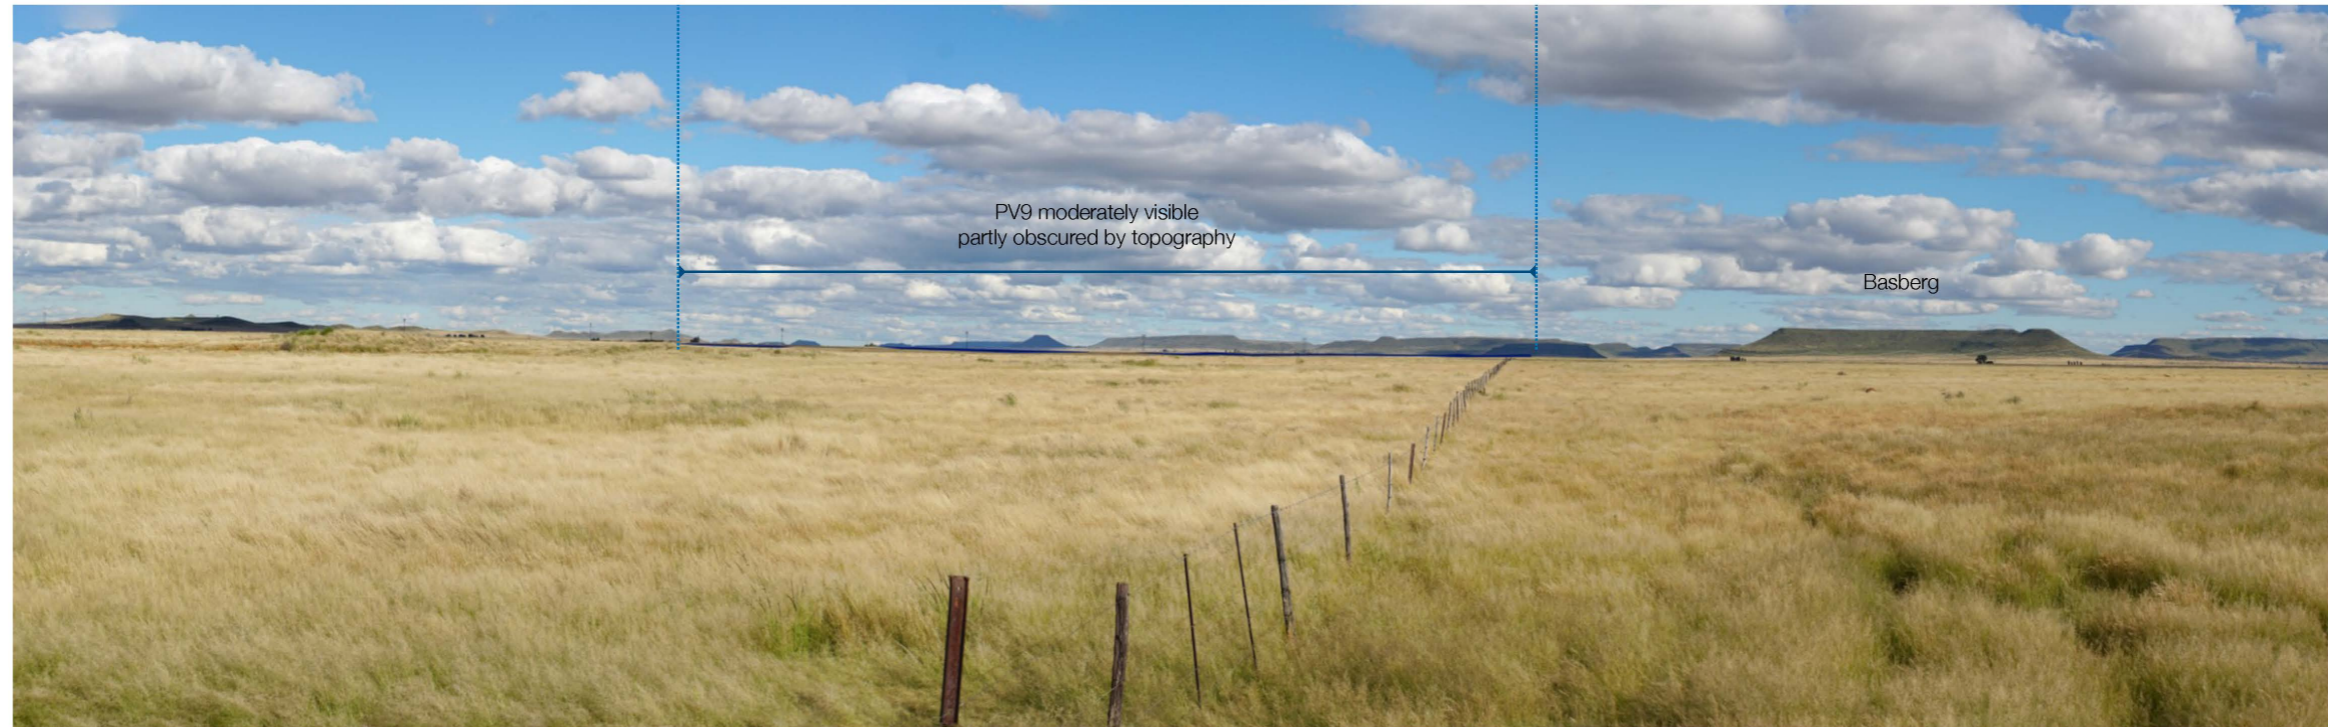
vp9 : Looking East from farm road near Jakobsrus

30.161906S 24.328036E Distance 2.52km

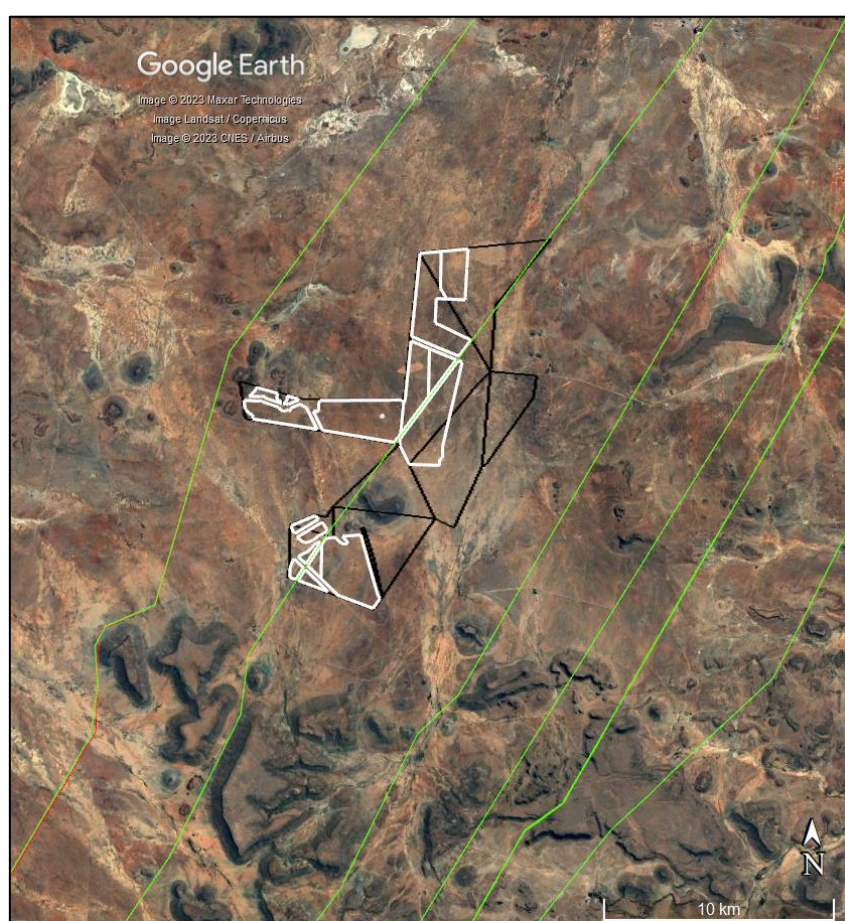
Figure 5: Map showing the project location in relation to existing HV powerlines (green lines).

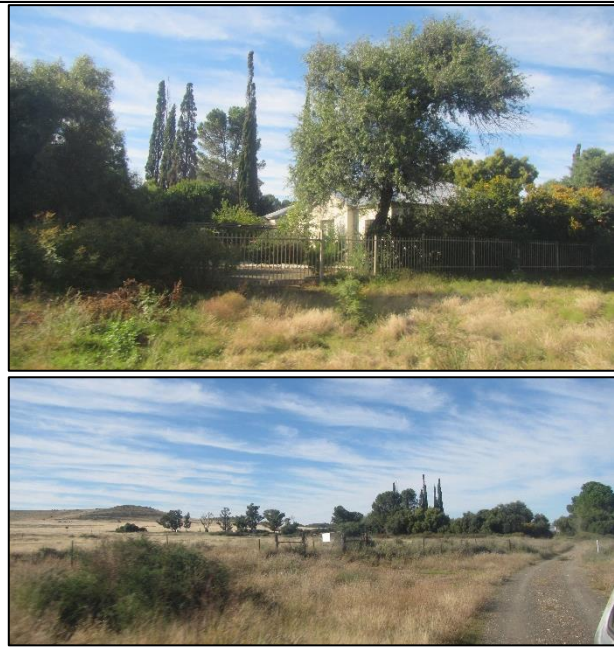
Waypoint	Location	Description		Significance Grade
947	S30 11 13.0 E24 23 45.3	Farm complex on Wolwe Kuilen 42/rem. The house is early 20 th century and it is in good condition (including inside). There are various outbuildings. The main house is surrounded by trees.

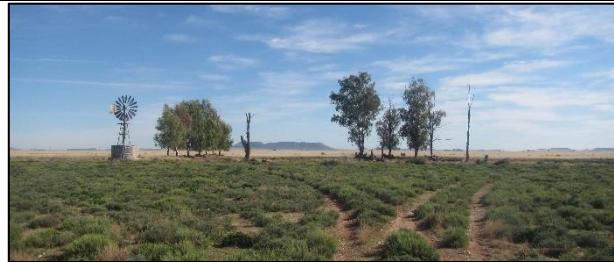
High
948	S30 09 40.1 E24 21 50.3	Gum trees, wind pump and reservoir – part of the cultural landscape

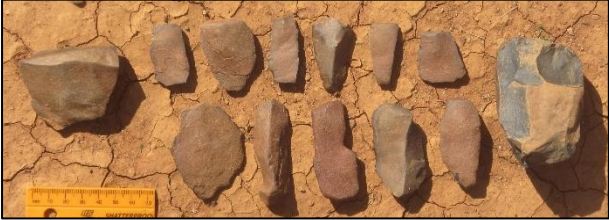
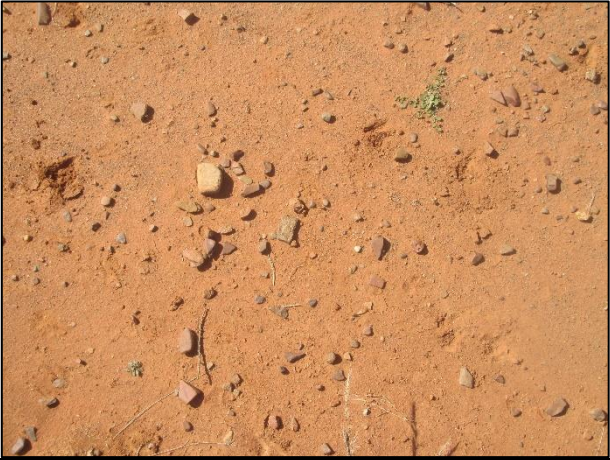
<p>949</p>	<p>S30 08 21.5 E24 22 20.5</p>	<p>Light scatter of well-patinated hornfels MSA flakes and blades and also one less patinated core located in an eroded area.</p>

<p>Very low GPC</p>
<p>950</p>	<p>S30 09 01.2 E24 21 30.2</p>	<p>Light scatter of well-patinated hornfels MSA flakes located in an eroded area.</p>

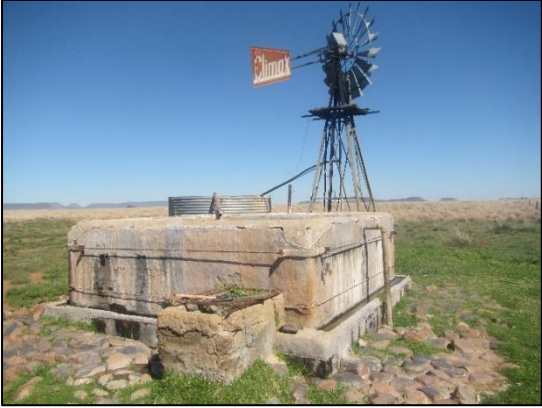
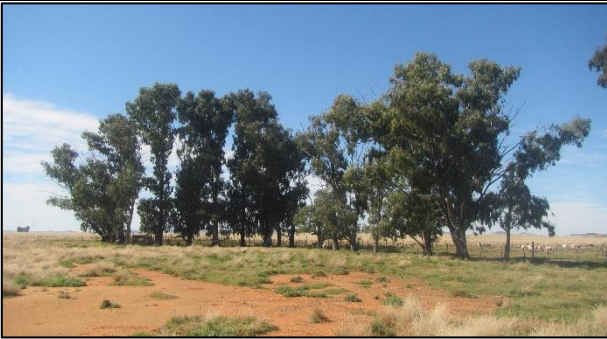
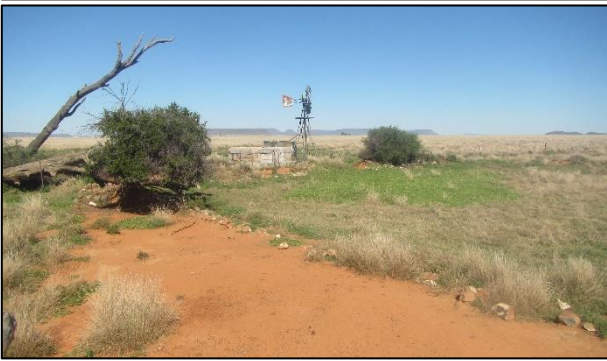
<p>951</p>	<p>S30 08 34.6 E24 22 39.0</p>	<p>Line of gum trees, a wind pump, an old stone-lined low reservoir (derelict), a square plastered and white-washed reservoir and a newer corrugated iron and cement reservoir – heritage resources forming part of the cultural landscape.</p>

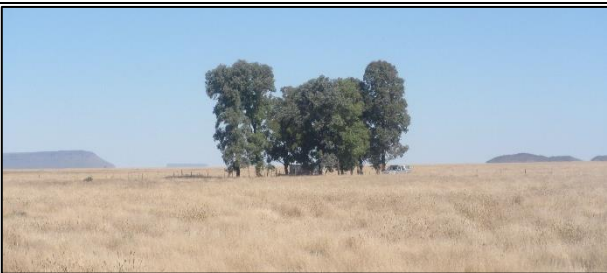
<p>Low</p>
<p>952</p>	<p>S30 08 22.9 E24 23 33.5</p>	<p>A cluster of gum trees with a corrugated iron reservoir under them – part of the cultural landscape.</p>

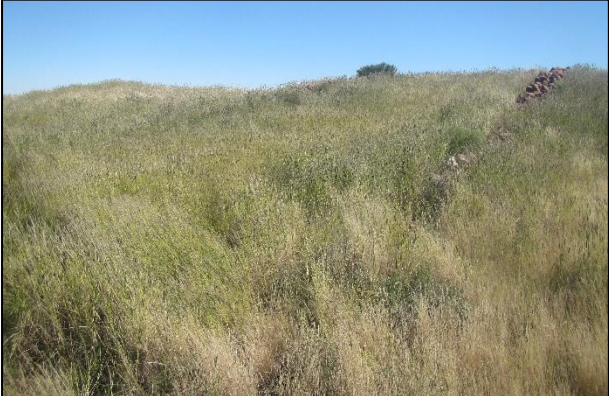
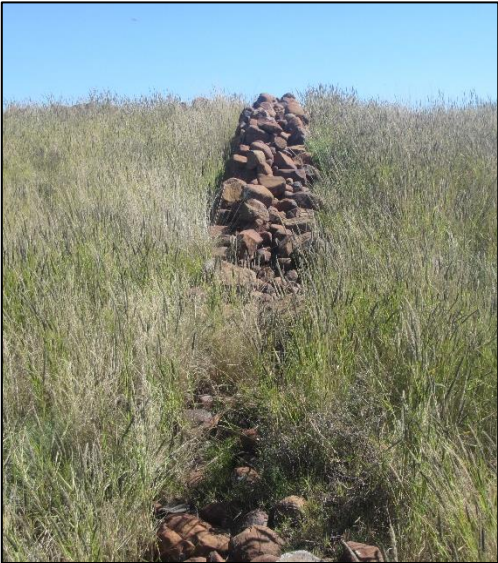
<p>953</p>	<p>S30 08 03.5 E24 24 26.0</p>	<p>A small circular feature made of dolerite rocks and about 1.5 m in diameter. Very close by is a small cairn of dolerite rocks. Both are very overgrown with grass. Also seen here were a few fragments of dark bottle glass, the neck of a small cobalt blue bottle, two fragments of red-painted refined white earthenware and some wire. The site is presumably related to farming activity.</p>  	 	<p>Medium GPA</p>
<p>954</p>	<p>S30 08 06.6 E24 24 32.1</p>	<p>A circular stone-walled feature of dolerite rocks and located on a low dolerite hill. The feature is about 2 m in diameter. It lies very close to the kraal at waypoint 955 (visible in the background).</p>	 	<p>Medium GPA</p>

955	S30 08 07.1 E24 24 31.9	<p>A rectangular stone-walled measuring about 9 m by 20 m. It is heavily overgrown with grass. It is very close to the circular feature at waypoint 954.</p>

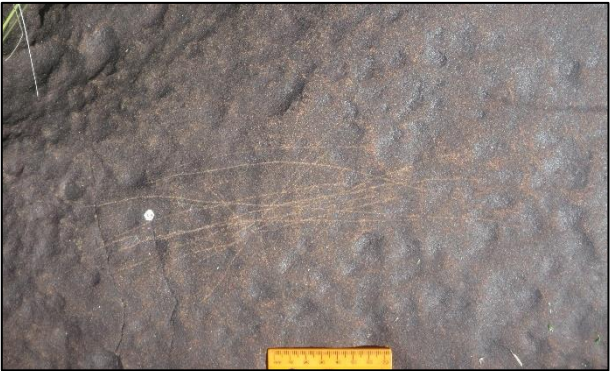
Medium GPA
956	S30 08 07.3 E24 24 31.7	A dolerite rock with a scratched motif on it.

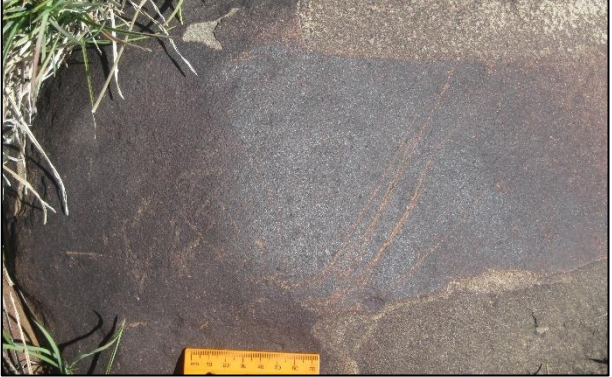
959	S30 07 53.1 E24 24 52.6	This point is at the northern end of the wall recorded under waypoint 957.		High IIIB
960	S30 07 53.3 E24 24 52.0	A dolerite rock with some scratches on it.

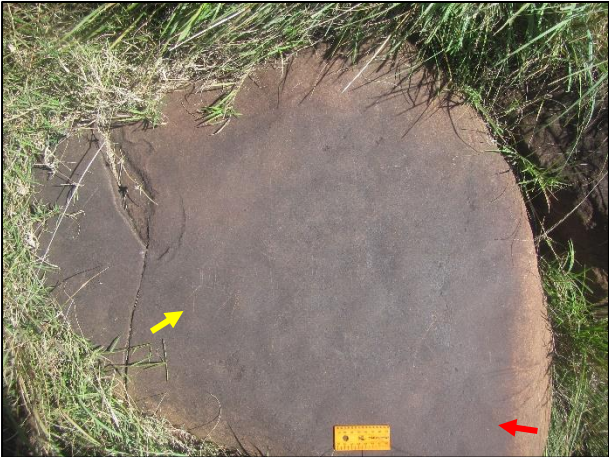
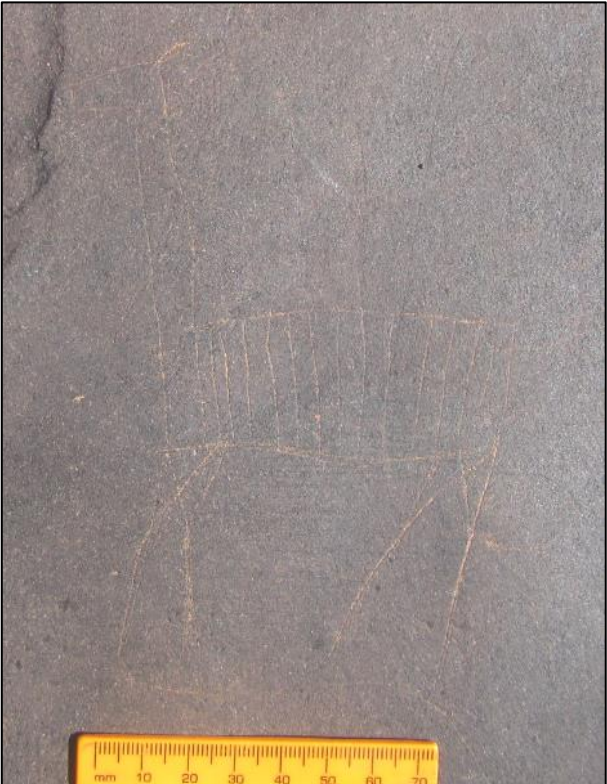
961	S30 07 53.4 E24 24 51.9	<p>Two historical scratched horse engravings and a few other images. The horses are identical in design, but the one is far smaller (and clearer) than the other. The large one is above the scale in the photograph below, while the smaller is indicated by the yellow arrowed. There is also a patch of multiple parallel lines that is very well patinated and must be far older (red arrow).</p>

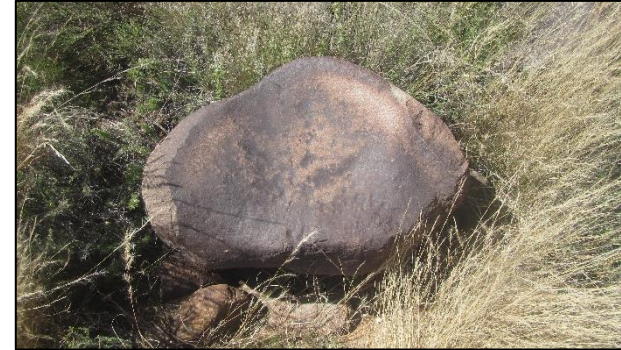
962	S30 08 23.9 E24 24 12.8	An isolated dolerite rock that looks like it has been used as a lower grindstone. The surface is lightly concave which presumably invited this use.

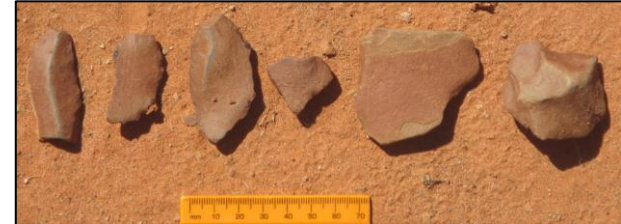
Very low GPC
963	S30 09 03.6 E24 23 16.6	Light scatter of well-patinated hornfels MSA flakes located in an eroded area.

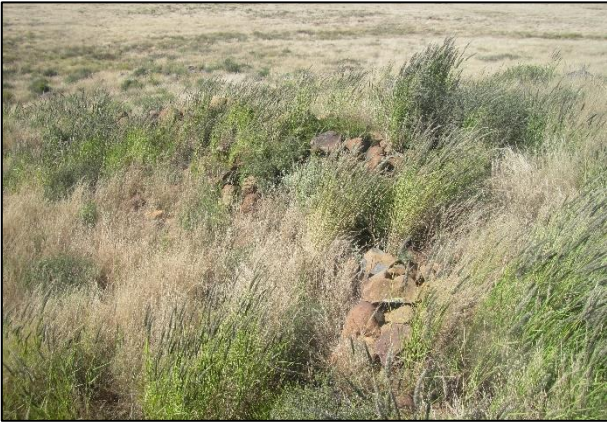
964B	S30 09 14.9 E24 23 25.6	<p>These waypoints are the four corners of a U-shaped kraal located on the northern foot of a prominent hill. The open side of the kraal faces downhill and the entire structure is 33 m by 33 m. It is heavily overgrown with grass.</p>
