Soil, Land Use, Land Capability and Agricultural Potential Assessment for the Proposed Masetjaba Reservoir, Elevated Tower and associated infrastructure, Gauteng Province

Submitted by TerraAfrica Consult cc Mariné Pienaar (MSc. Environmental Science) (SACNASP Agricultural and Soil Scientist)

January 2019

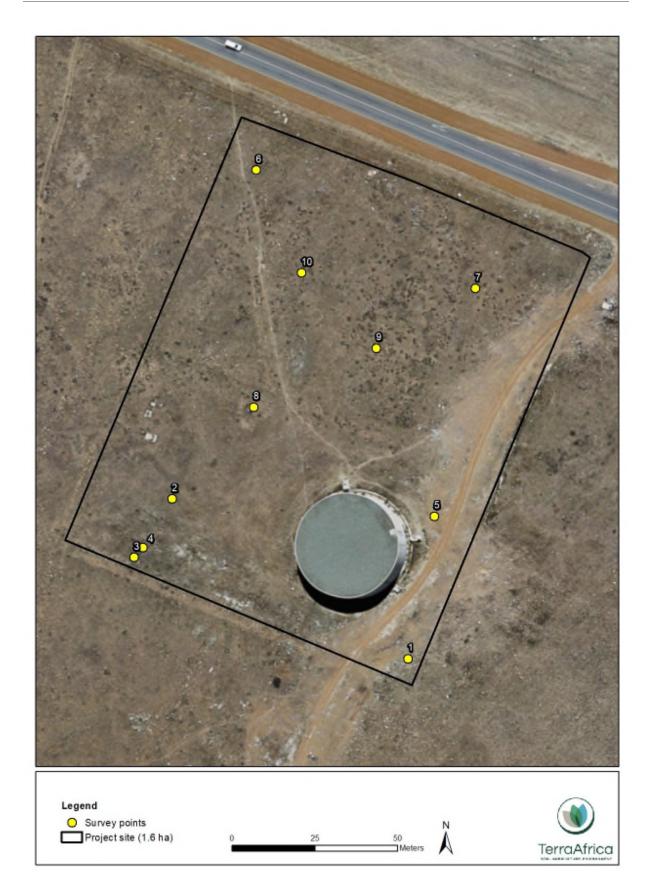
Figure 2 Survey points map of the project site of the Masetjaba Reservoir, Elevated Tower and associated infrastructure

A one-day systematic soil survey was undertaken on 19 November 2018. The season in which the site visit took place has no influence on the results of the survey. The soil profiles were examined to a maximum depth of 1.5m using a hand-held auger. Detailed soil surveys are usually conducted on a 1 ha survey grid but as a result of the small size of the site (1,6 ha), soil profiles were classified at much higher density and ten survey points were observed (Figure 2). Observations were made regarding soil texture, structure, colour and soil depth at each survey point. A cold 10% hydrochloric acid solution was used on site to test for the presence of carbonates in the soil. The soils are described using the South African Soil Classification: A Natural and Anthropogenic System for South Africa. For soil mapping, the soils were grouped into classes with relatively similar soil characteristics.

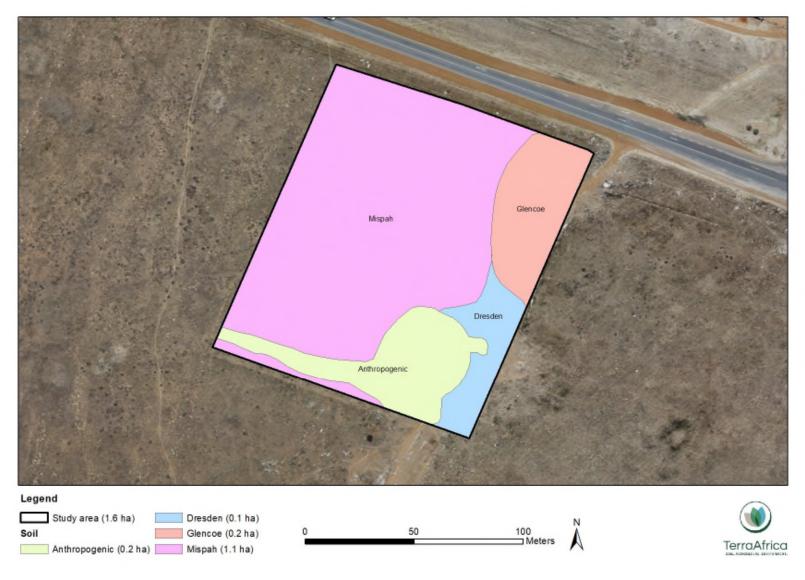
Figure 3: Soil map of the project site

Four different soil forms were identified within the project site. The soil depths of the ten profiles surveyed range between very shallow to shallow (the deepest Glencoe profile are 50cm deep).

Of the three in situ soil forms within the project site, the area is dominated by the rocky, shallow Mispah form (1,1 ha). This soil form has a bleached orthic A horizon of between 5 and 20 cm overlying solid rocky, parent material in combination with smaller loose stones.

The two remaining soil forms are the Dresden form (0,1 ha) and the Glencoe form (0,2 ha). For both these soil forms, the soil depth is limited by a hard plinthic B-horizon. While the Glencoe form consists of an orthic A horizon that overlies a yellow-brown apedal horizon (30cm in thickness) above the hard plinthite, the Dresden form consists of only an orthic A-horizon overlying the hard plinthite.
