PROGRESS REPORT 09: June 4, 2012

Towers 205, 167 & 141

PROPOSED 400KV TABOR-WITKOP TRANSMISSION LINE, LIMPOPO PROVINCE

For: Stefanutti Stocks Power

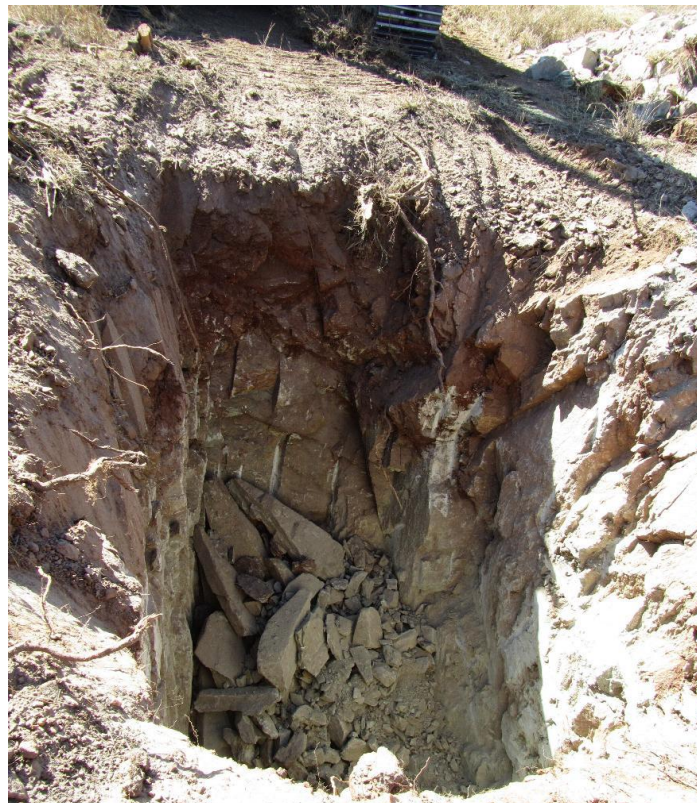
Leg A

Mr Reitz alerted the archaeologist that the excavation for this tower would be done on Monday, June 4, 2012. The archaeologist was in attendance on site for the duration of the excavation. No heritage structures had been damaged or removed and no cultural material is reported. No archaeological stratigraphy is visible in the images below.
