**Opencast mining of
Pit 62E at the Anglo
American Platinum
Amandelbult
Complex, Limpopo
Province**

Consultation Basic Assessment
Report

**Anglo American Platinum (Pty)
Ltd**

09 June 2017

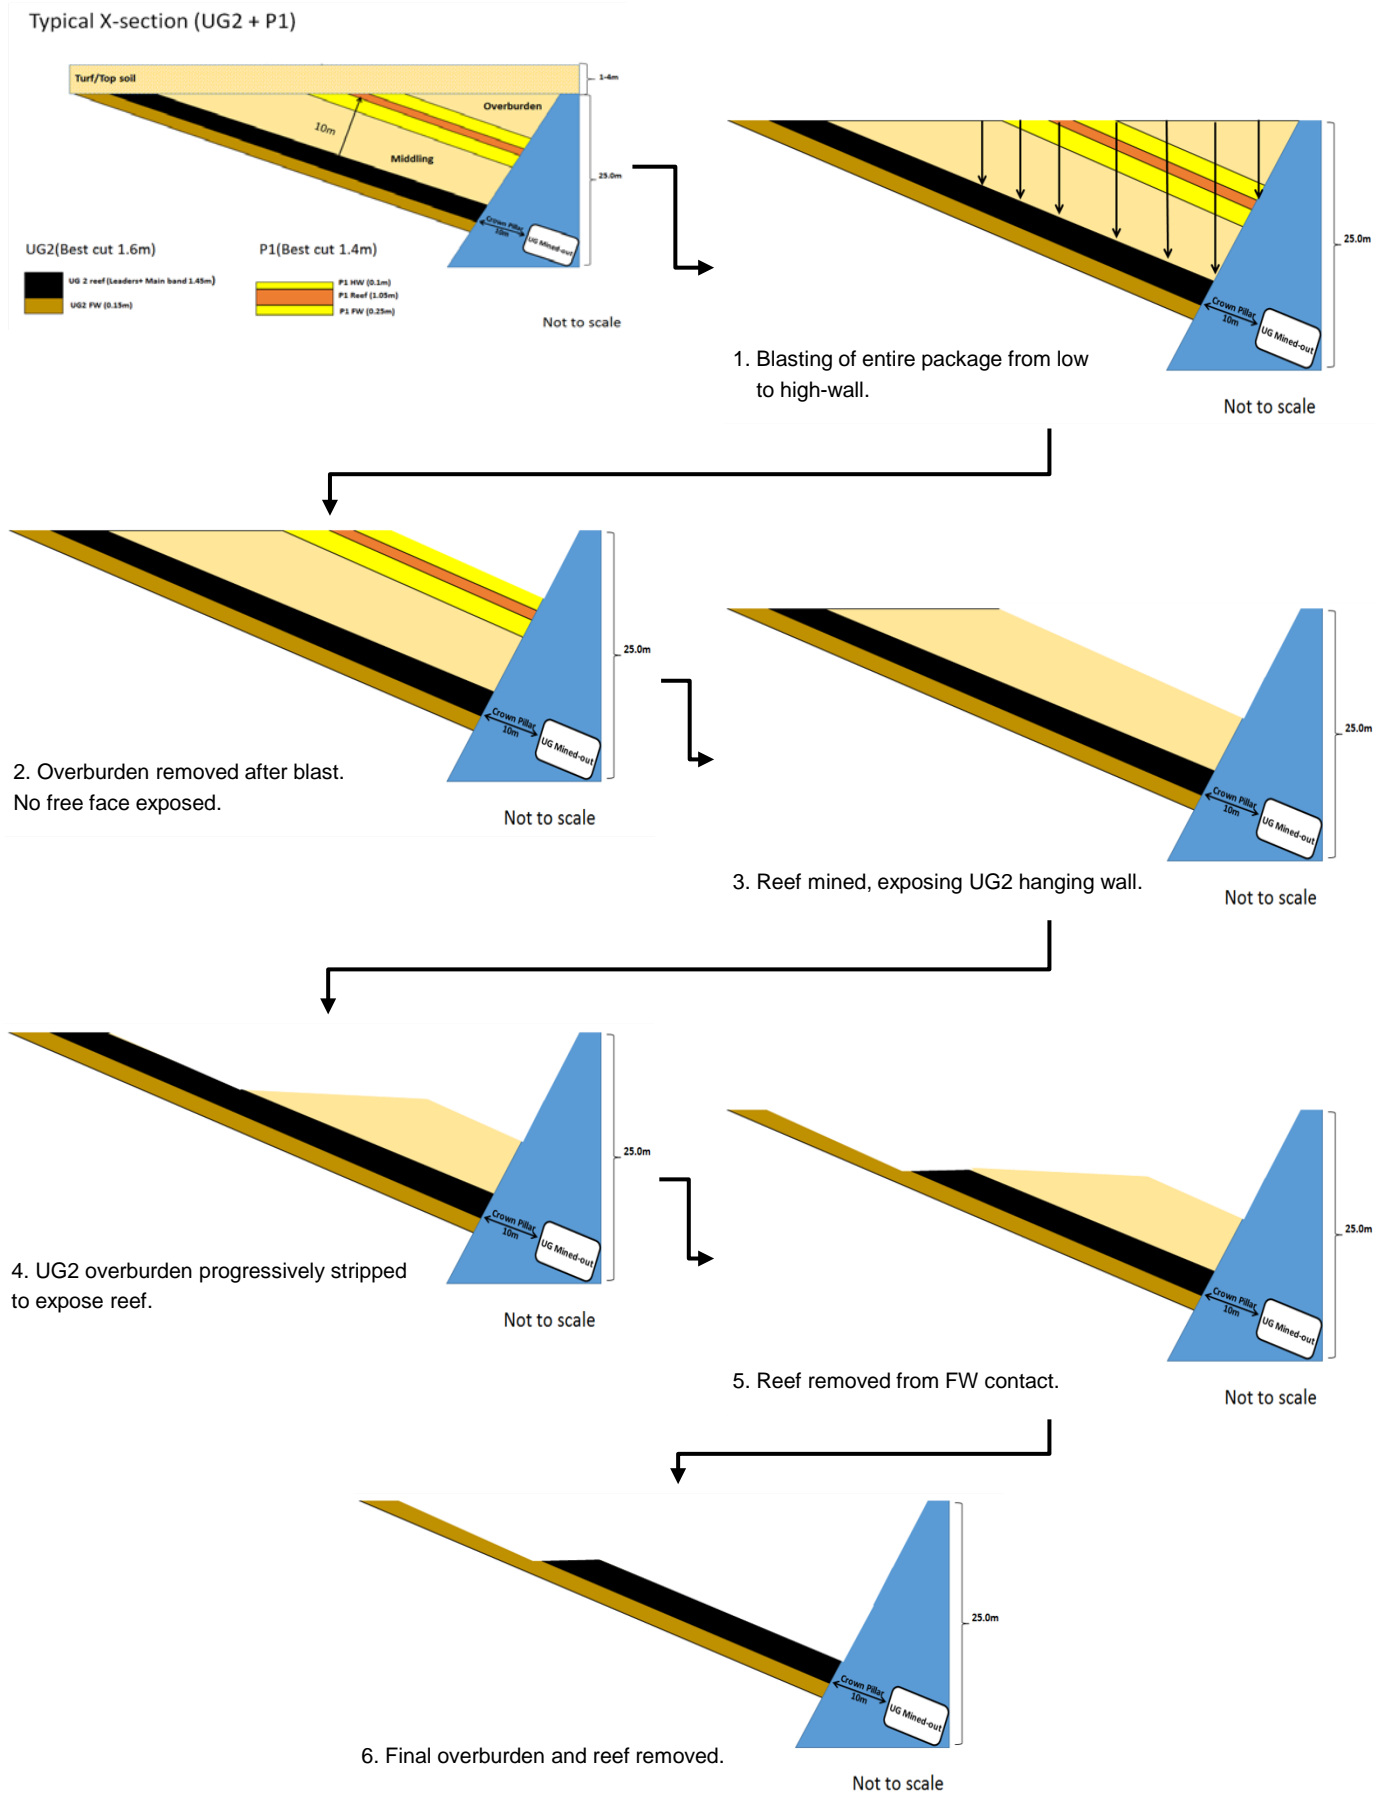
Figure 5 | Proposed opencast mining process

The loading conditions are expected to correspond closely to a small scale open pit site, with a maximum pit depth of 60 m envisaged. The pit is proposed at approximately 370 m in length, 93 m in width, and 60 m in depth. The pit surface area is approximately 3.1 ha. The regional topography in the project area is generally flat. The dip of the reef horizon ranges from 21° to 30°. Pit polygons have been adjusted to accommodate a 20-m crown pillar above underground workings.

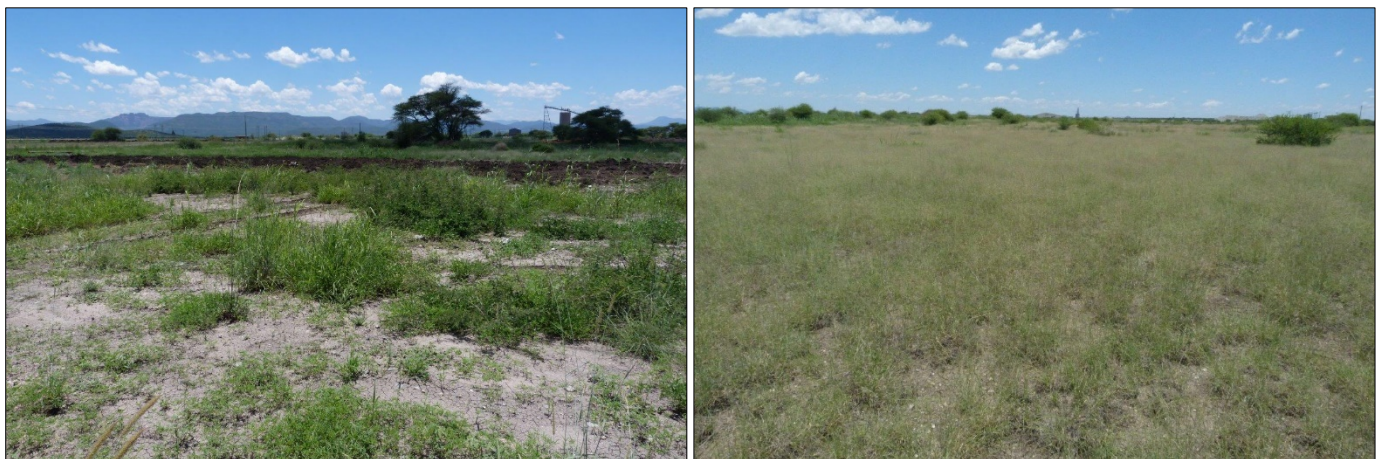
Figure 6 | Views of the site of Pit 62E, showing dark soils, severe disturbance, proximity to mining activities, and encroachment of mining activities.

The pit site is characterised by dark, heavy, vertic clay soils with marked shrink-swell properties, typical of soils overlying Andesite in an environment characterised by a hot dry climate and strongly seasonal rainfall (Figure 6).

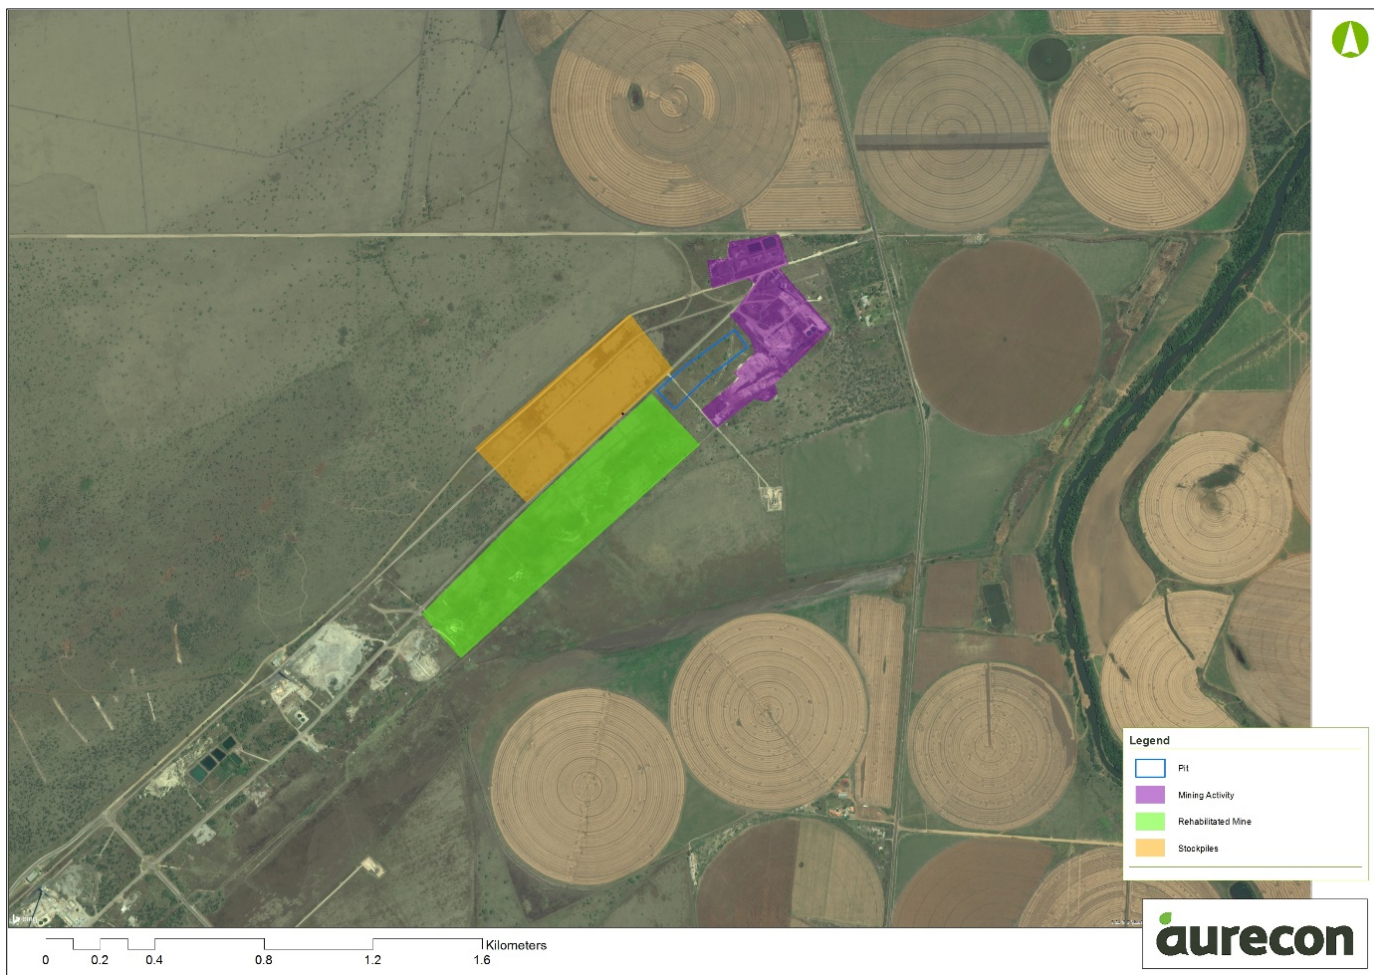
Figure 8 | Map of Pit 62E location, showing its position surrounded by a substantially transformed landscape

Pit 62E is bordered by recently closed and rehabilitated mine workings to the south; current mining to the east; and an area that has been used for mine stockpiles (and is hence completely transformed) to the north and west. Although there is porous connectivity to intact blocks of primary vegetation, in practice the area has been separated (albeit temporarily) by severe and ongoing disturbance from both mining and commercial crop agricultural activities (Figure 8).

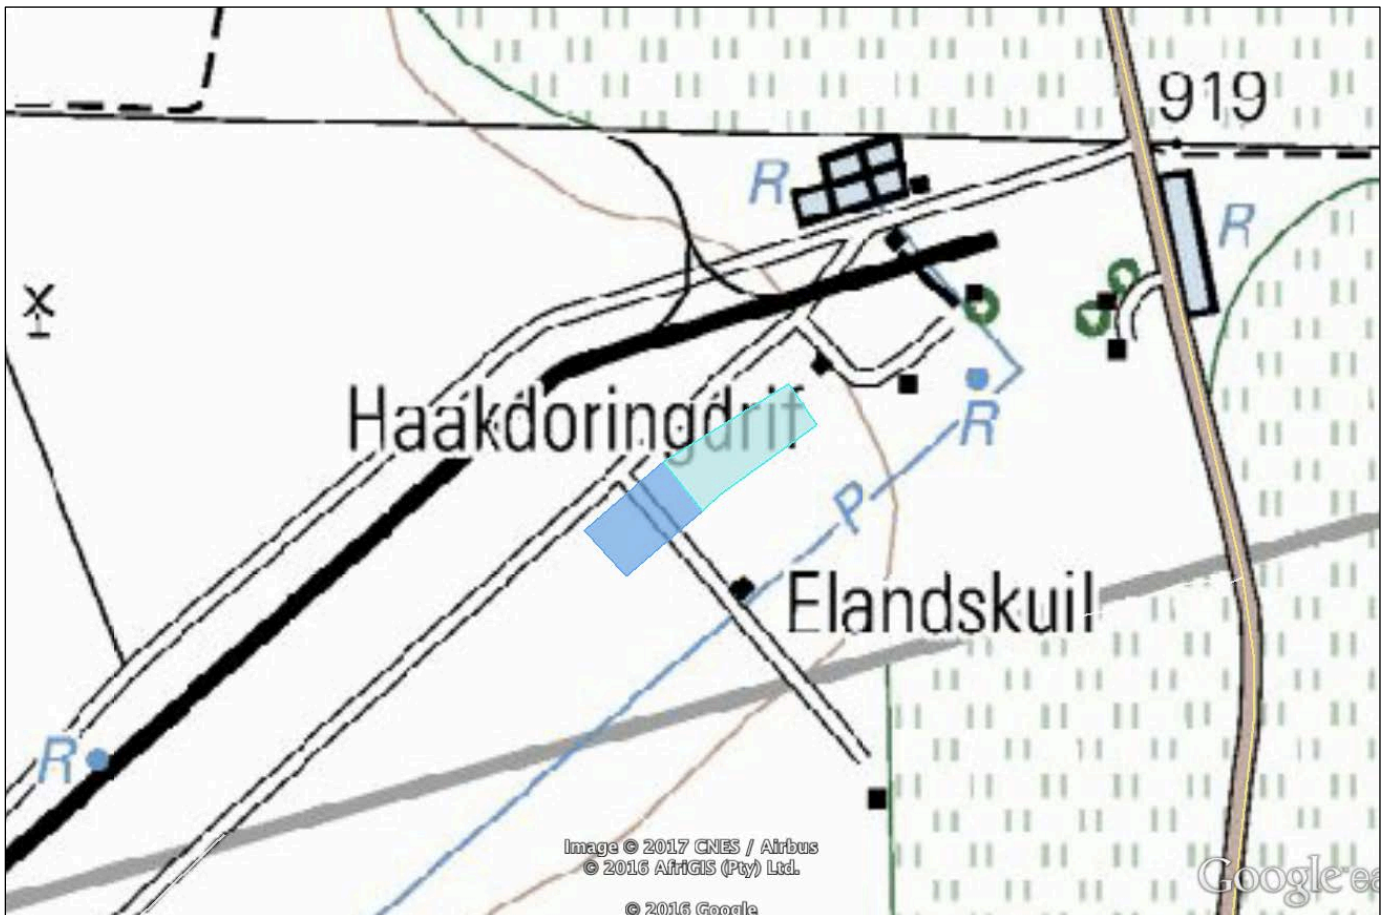
Figure 14 | A section of the Third Edition of the 2427CB Topographical Sheet that was surveyed in 2005.

Figure 14 depicts a section of the Third Edition of the 2427CB Topographical Sheet. This edition of the sheet was surveyed in 2005 and published by the Chief Directorate: National Geo-Spatial Information in 2009.

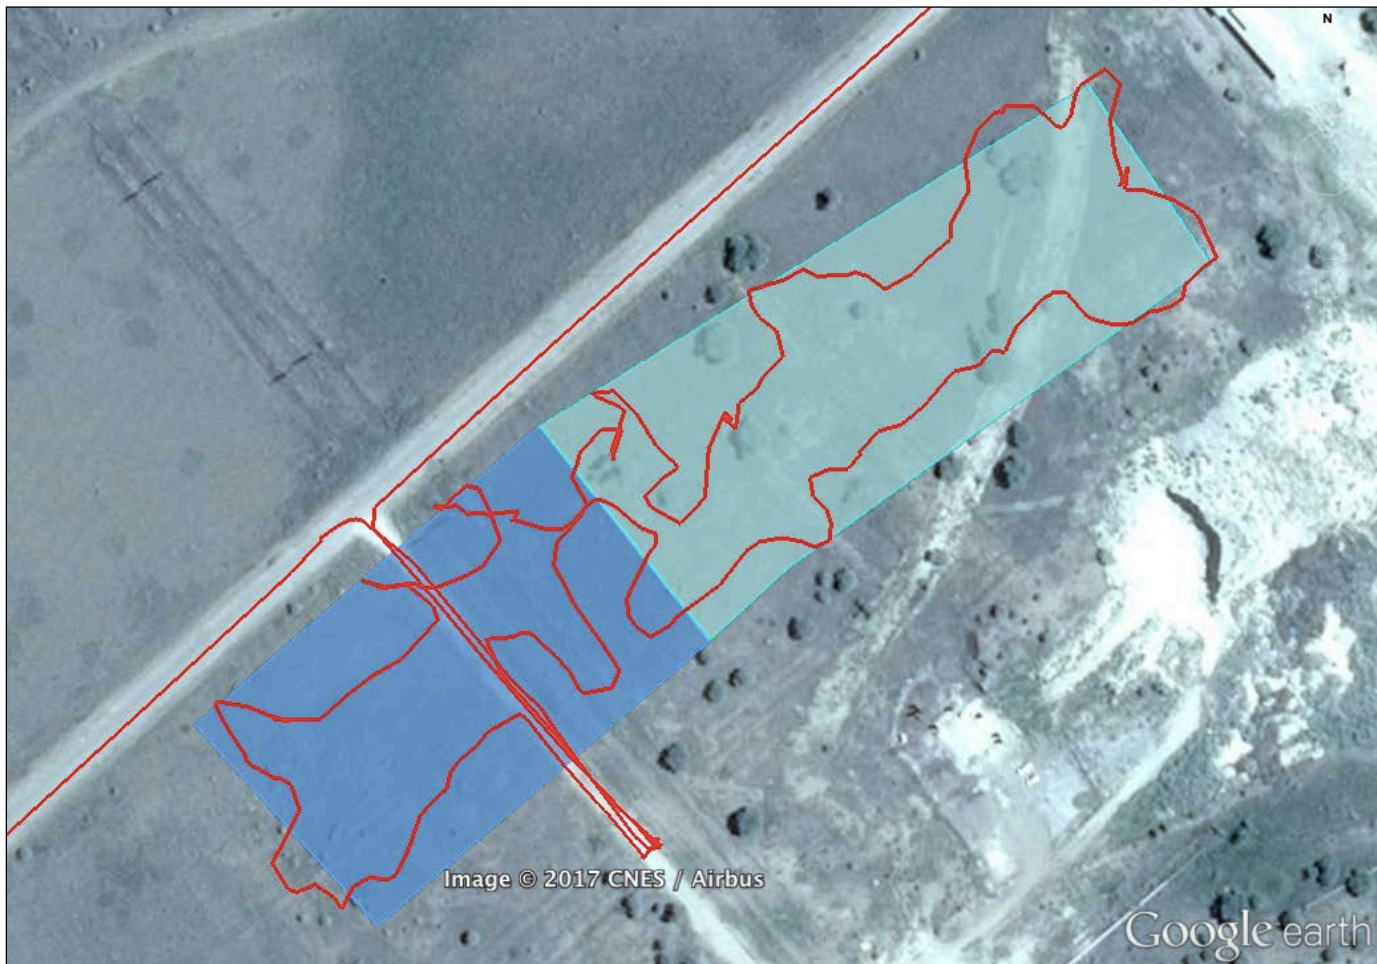
Figure 15 | Recorded track logs in red of the Pit 62E study area.

A walkthrough of the Pit 62E study area was conducted by PGS Heritage on 24 April 2017 as shown in Figure 15.

The study area had been disturbed by grading activities, with one section of the site also used for the storing of soil and rock. The immediate surroundings of the site are characterised by mining and mining infrastructure. The proposed open pit is located within turf thornveld some 1.5 km west of the Crocodile River. Several previous heritage studies had observed that the turf thornveld found in this landscape would have been avoided during prehistoric settlement.

No archaeological or heritage sites were identified within the proposed Pit 62E area.

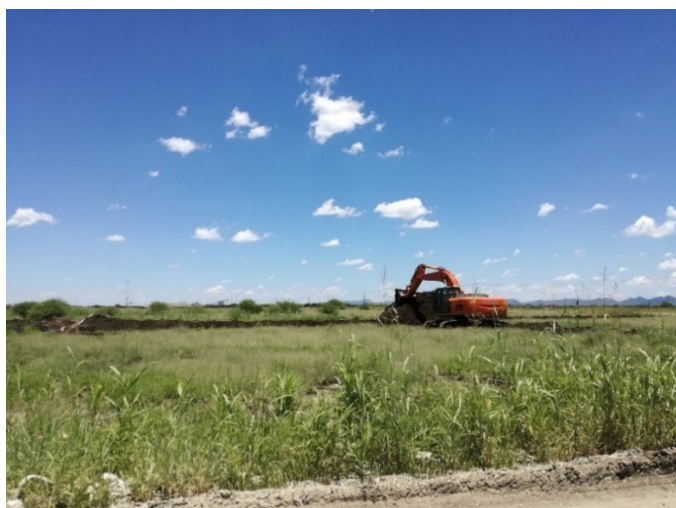
Figure 18 | View from within Pit 62E area, looking west

The site is located close to other mining activities, approximately 50 m to its east. To the west lies a rehabilitated open pit mine, and to the north, a gravel mining haul road of approximately 15m in width (Figure 18).

Infrastructure on site is limited to the 11-kV powerline and the gravel road crossing the pit and a further road running along the northern boundary of the pit.

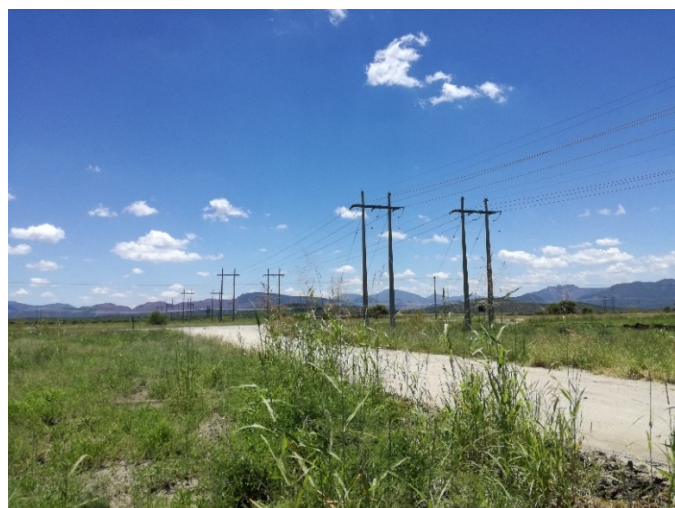
Figure 19 | View from within the Pit 62E area looking north-east, showing the 11kV line and north-south gravel road.

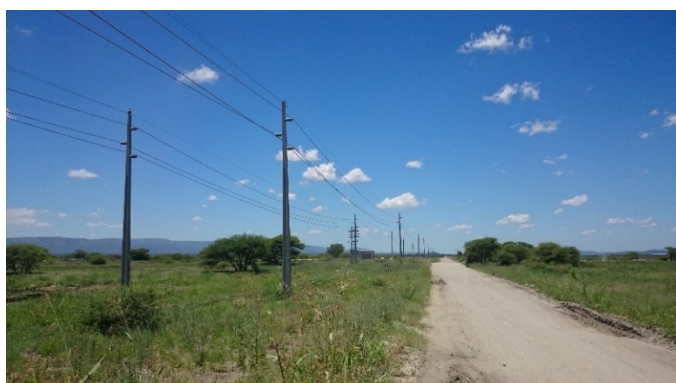
Figure 20 | View from within Pit 62E, looking south, showing the 11kV line and north-south gravel road.

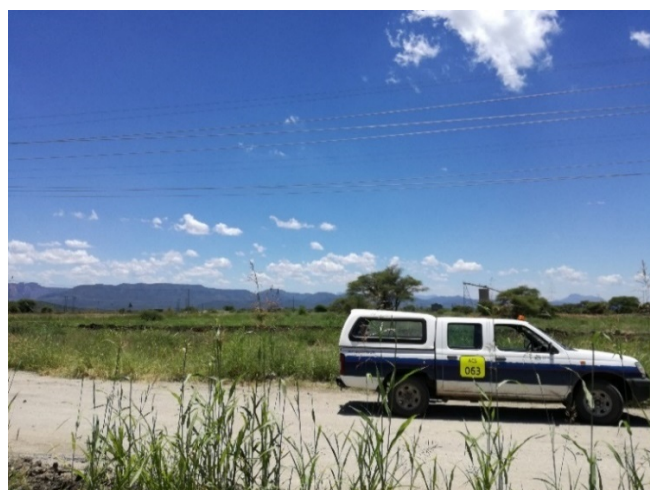
Figure 21 | View from within Pit 62E, looking east. The 62E Decline Shaft can be seen in the background.

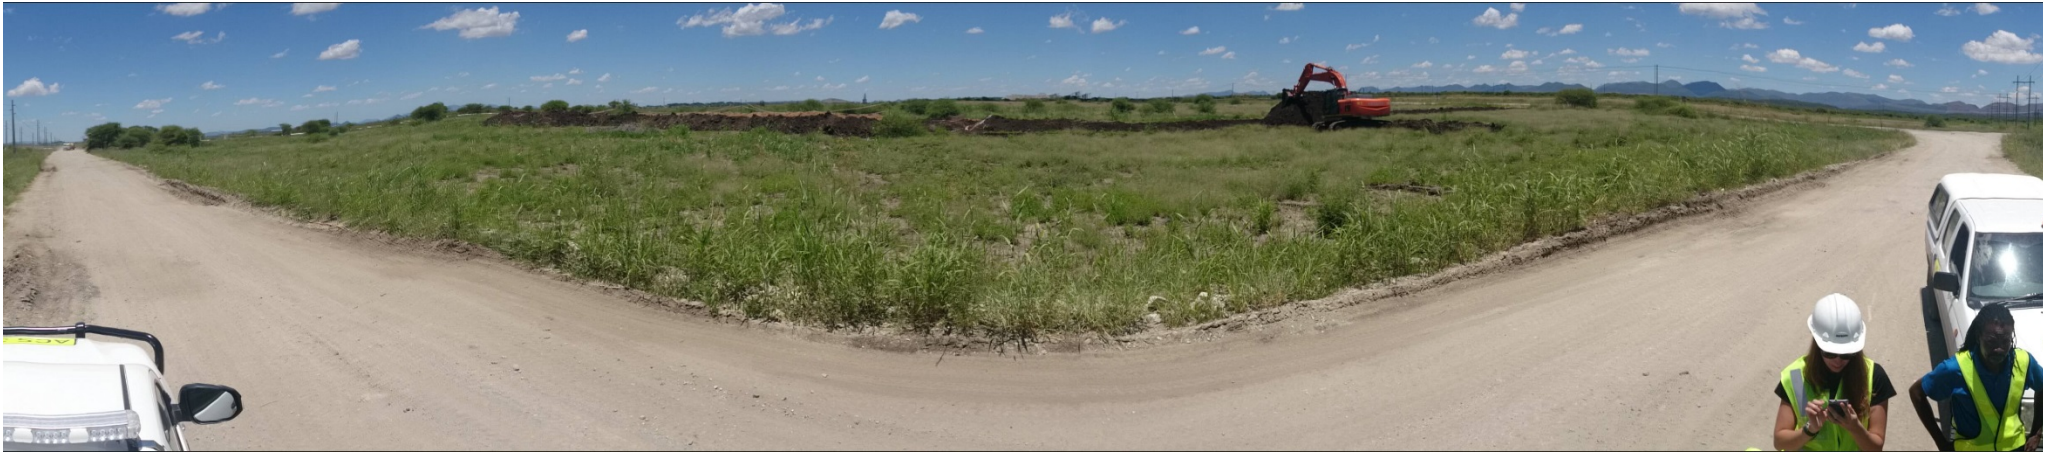
Figure 22 | Panoramic view of Pit 62E, looking west from the road that bisects it

Panoramic views of the western and eastern sides of the pit are shown in Figure 22 and Figure 23, respectively.
