S24G APPLICATION FOR THE UNLAWFUL STORAGE OF DANGEROUS GOODS BY PREMIER FMCG LOCATED AT 341 SYDNEY ROAD, CONGELA, DURBAN, ETHEKWINI MUNICIPALITY, KWAZULU-NATAL.

August 2022

As part of the development, a total of 97.35 m³ of dangerous goods (diesel and paraffin) is stored on site in six (4 x day tanks and 2 x aboveground storage tanks). The site is currently occupied and used for commercial purposes. The areas in the immediate vicinity of the proposed activity are primarily used for warehousing, automotive related stores, and clothing stores.

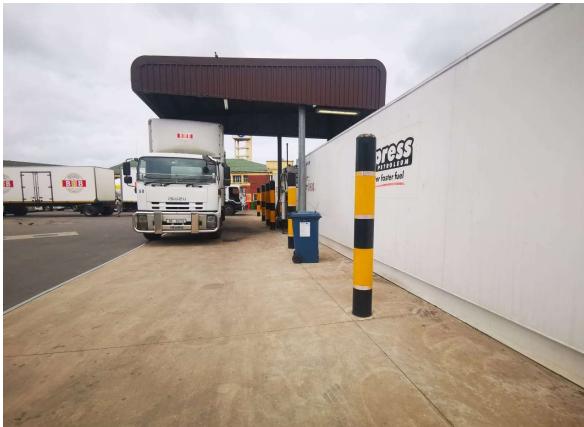
Plate 1: 64000 litre paraffin storage tanks and fuel filling station

The installation of above-ground storage tanks was the preferred design for the site. These tanks allow for much earlier detection of leaks than underground storage tanks, therefore significantly reducing the risk of contamination to the surrounding environments. Having the tanks placed above ground also allows for better access to the tanks. Ease of access allows repairs and maintenance of the tanks to be undertaken more rapidly and efficiently. As a result of more efficient maintenance, the lifespan of the aboveground tanks is increased substantially. Consequently, the fuel stored in the tanks is cleaner due to the frequency at which maintenance occurs.

The position of the storage tanks and filling station within the site were designed to ensure that suppliers can more easily access the storage tanks, to minimise the likeliness of spillages occurring when transferring the dangerous goods. As the filling station is located near the main access point of the site, Premiers trucking fleet access the fuel filling station, without causing additional traffic within the site. Further to the traffic impacts, because the filling station was constructed on site, delivery trucks no longer need to use the surrounding public roads to find different fuel filling stations to refuel. As a result of this, there is reduced traffic (often caused by the delivery trucks,) throughout the roads surrounding the premises.

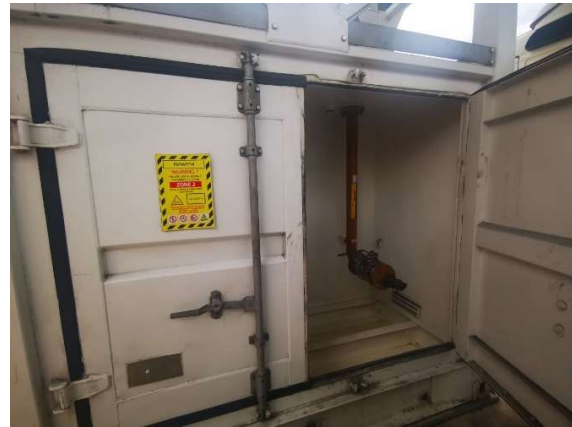
Plate 2: Opening of aboveground self-bunded paraffin storage tank

Self-bunded storage tanks allow for improved protection of the surrounding environment in the event of any spills or leaks. Storage tanks are completely contained within the bund ensuring that no leaks are exposed to the elements. The design of the self-bunded storage tanks is attached to Appendix C.

Unlike open bunded tanks, there is no air pollution as gases from the hazardous substances are completely prevented from interacting with the atmosphere. Furthermore, rainwater is unable to enter the bund, preventing the mixing of hazardous substances with water, as well as eliminating the transfer of any dangerous substances to stormwater drains. Safely collecting the spilled hazardous substances within the self-bunded tank, allows these substances to be reused by Premier and is therefore the preferred technology alternative.

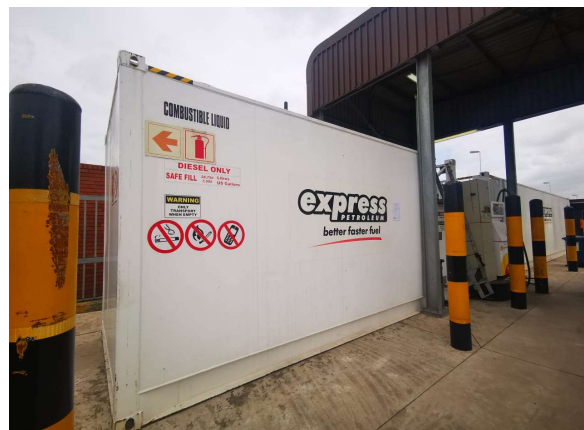
Plate 3: 28 750 litre diesel storage tank

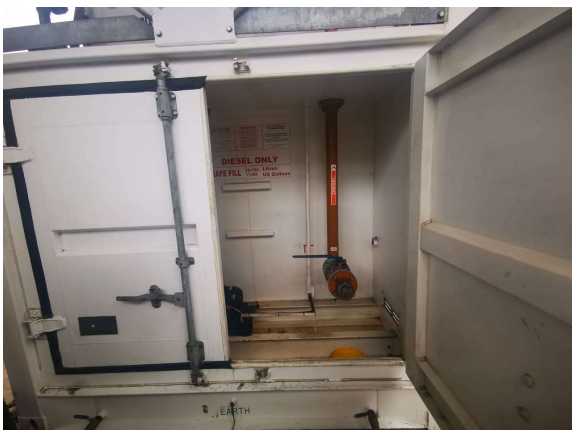
Plate 4: Opening of aboveground self-bunded diesel storage tank

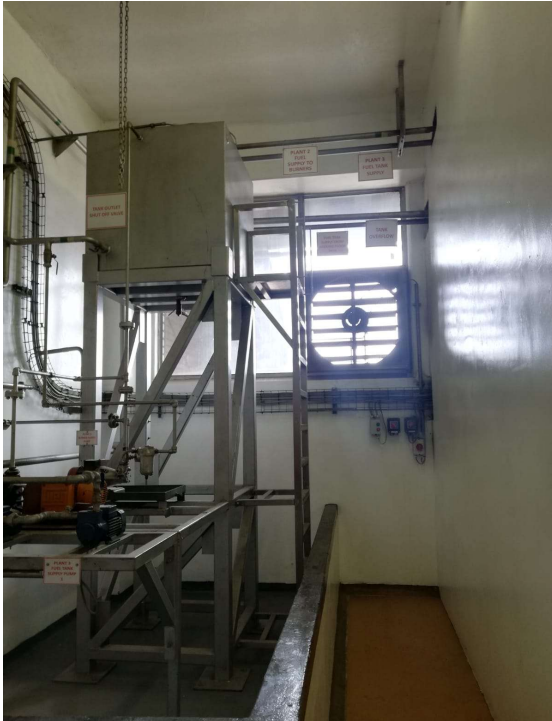
Plate 5: 1000 litre diesel day tank

Both paraffin and diesel are essential for the daily functioning of business operations - as such Premier had previously installed two paraffin day tanks, and two diesel day tanks, storing a combined total of four cubic metres of hazardous substances on the site. In 2019, Premier installed a further 64.6 m³ aboveground paraffin storage tank and a 28.75 m³ aboveground diesel storage tank on the premises, to meet their fuel demands more feasibly.

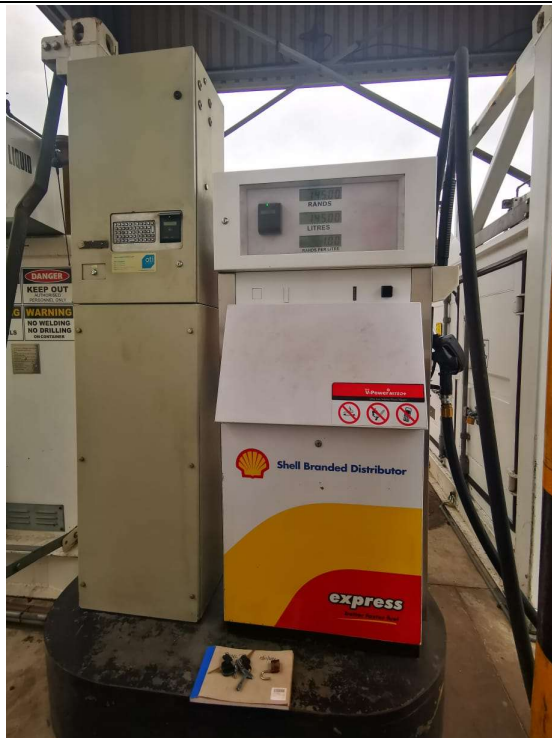
Plate 7: Fuel dispensing equipment
