Pep Clothing Store
184 Church Street
Pietermaritzburg
3201

Our Ref: Y2021-041
Date: 19 July 2021

RE: STRUCTURAL EVALUATION REPORT

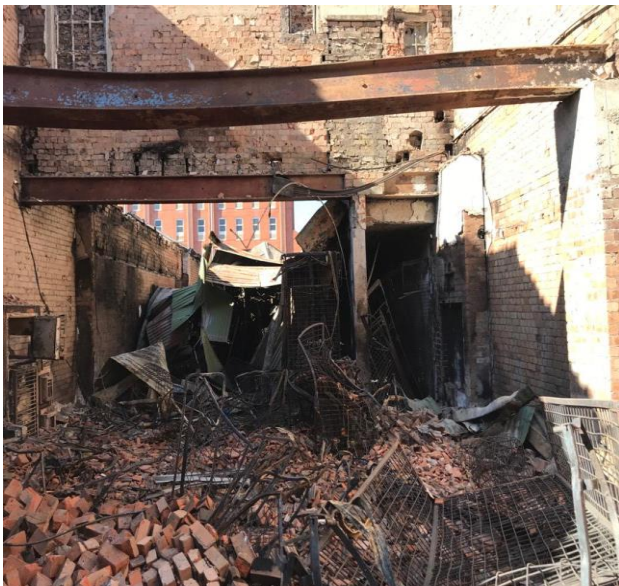
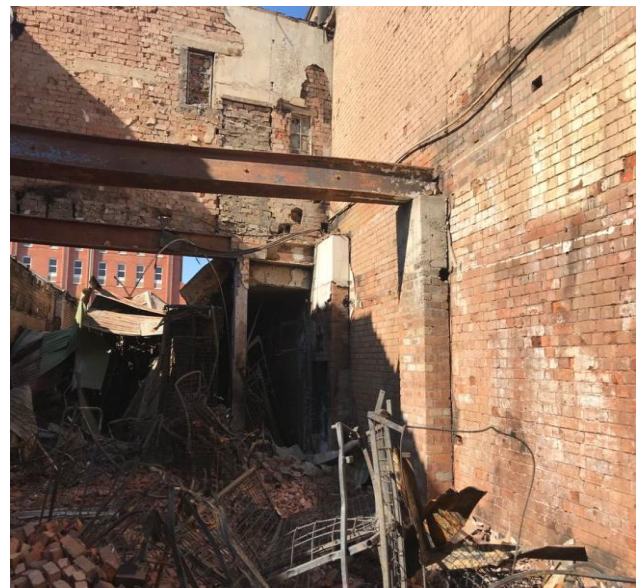
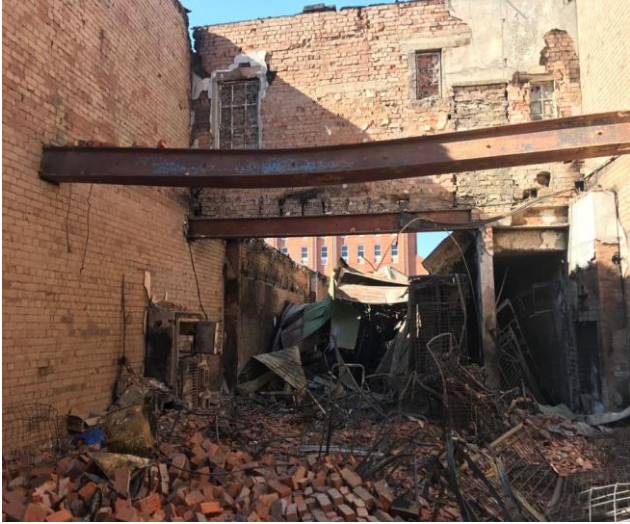
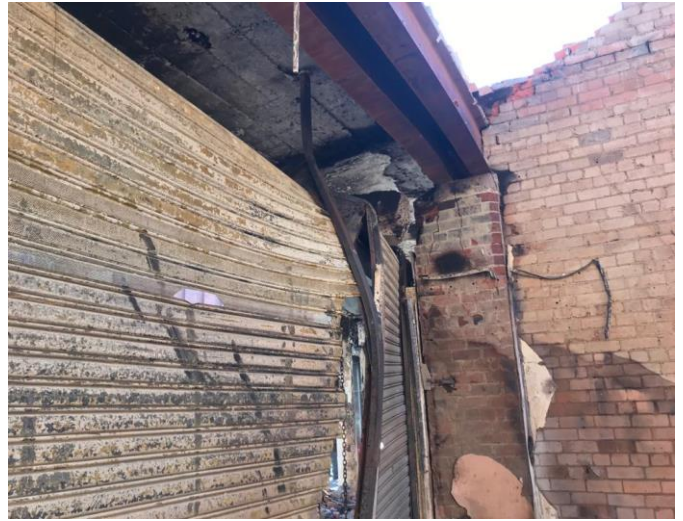
The extent of the fire was observed by conducting the general inspection on all structural members, notably the roof, beams, walls and floors. We carefully adjudicated all of these and none were found to be structurally sound, it is our opinion that to make the area safe, the entire building must be demolished and rebuilt.

1. The steel beam in this case is extremely sagging to be salvaged, floor completely damaged and there is a high risk of the walls to crumble if they are to be re-used as load bearing walls.
