Wimpy  
184 Church Street  
Pietermaritzburg  
3201

**Our Ref:** Y2021-042  
**Date:** 19 July 2021

**RE: STRUCTURAL EVALUATION REPORT**

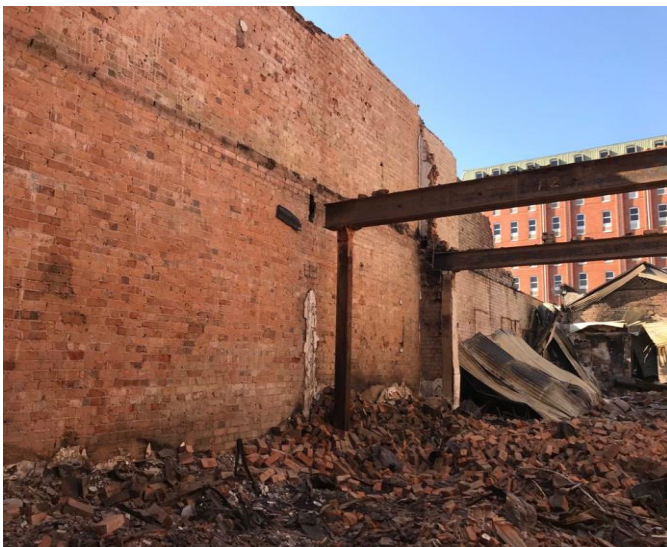
1. The roof collapsed and the brick rubbles completely covered the floor, the quality of the existing walls is not worthy to be re-used as load bearing to the roof structure.
2. Steel beams used to support high walls thus they are now redundant.

The extent of the fire was observed by conducting the general inspection on all structural members, notably the roof, beams, walls and floors. We carefully adjudicated all of these and none were found to be structurally sound, it is our opinion that to make the area safe, the entire building must be demolished and rebuilt.
