Basic Assessment for the Proposed Construction of Electrical Grid Infrastructure to support the Sutherland 2 Wind Energy Facility (WEF), Northern and Western Cape Provinces (Sutherland 2 WEF - Electrical Grid Infrastructure)

Map 1 Proposed Alternative 1 of the 132 kV overhead line and substations associated with the Sutherland 2 WEF.

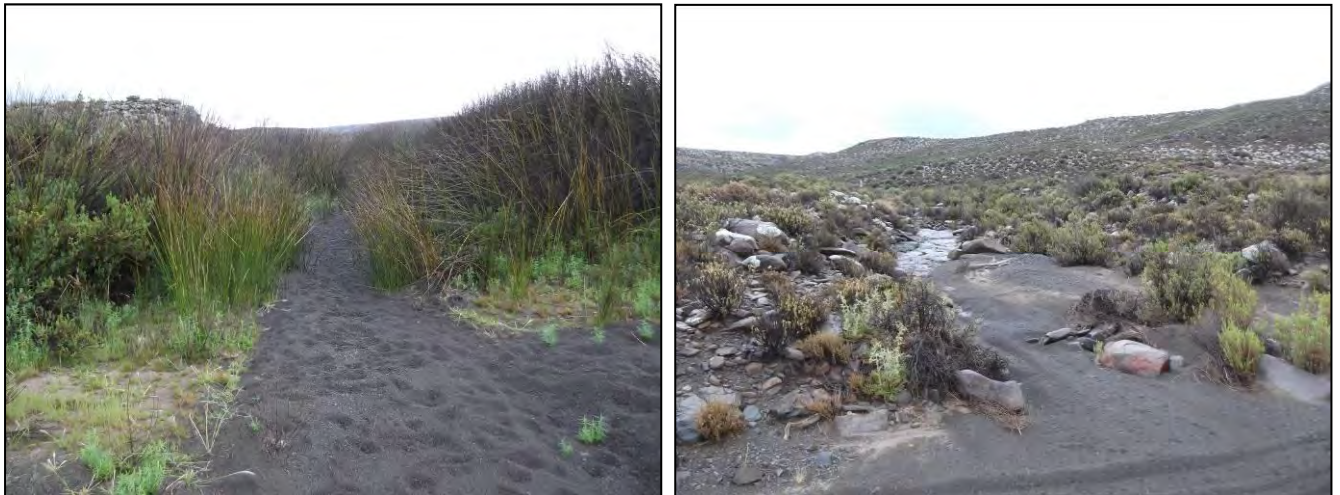
Figure 17: Representative photographs of evidence of alluvial soils present within smaller tributaries and ephemeral drainage lines.

- Terrain units were used to determine in which parts of the landscape freshwater resources would most likely occur in;
- The presence of alluvial soils was used as an indication of where and how water would flow across a landscape (Figure 17). The deposition of alluvial soils within channels/gullies was used to identify possible watercourses; and
- The vegetation indicator was used where possible in the identification of the riparian boundary through the identification of the distribution of both facultative and obligate wetland vegetation associated with soils that are frequently saturated. Key species utilised included *Scirpoides dioecus* and *Schoenoplectus sp.* (Figure 18). Changes in vegetation density and levels of greening were also considered during the delineation process, particularly in instances where ephemeral drainage lines were identified.

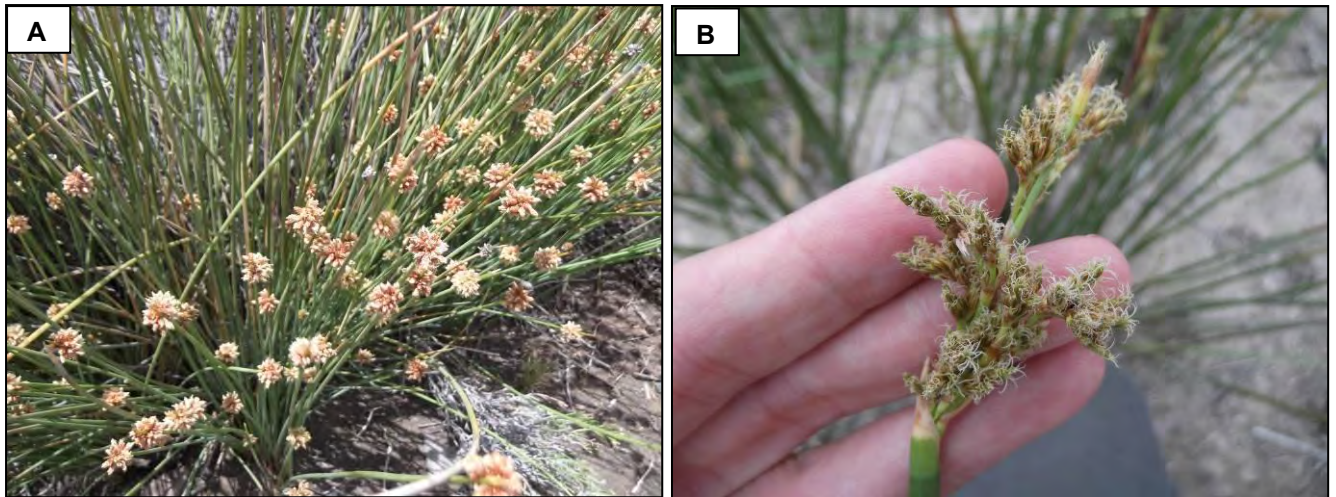
Figure 18: Representative photographs of some of the floral species associated with the riparian and drainage features identified within the study area (A: *Scirpoides dioecus*; B: *Schoenoplectus sp.*)

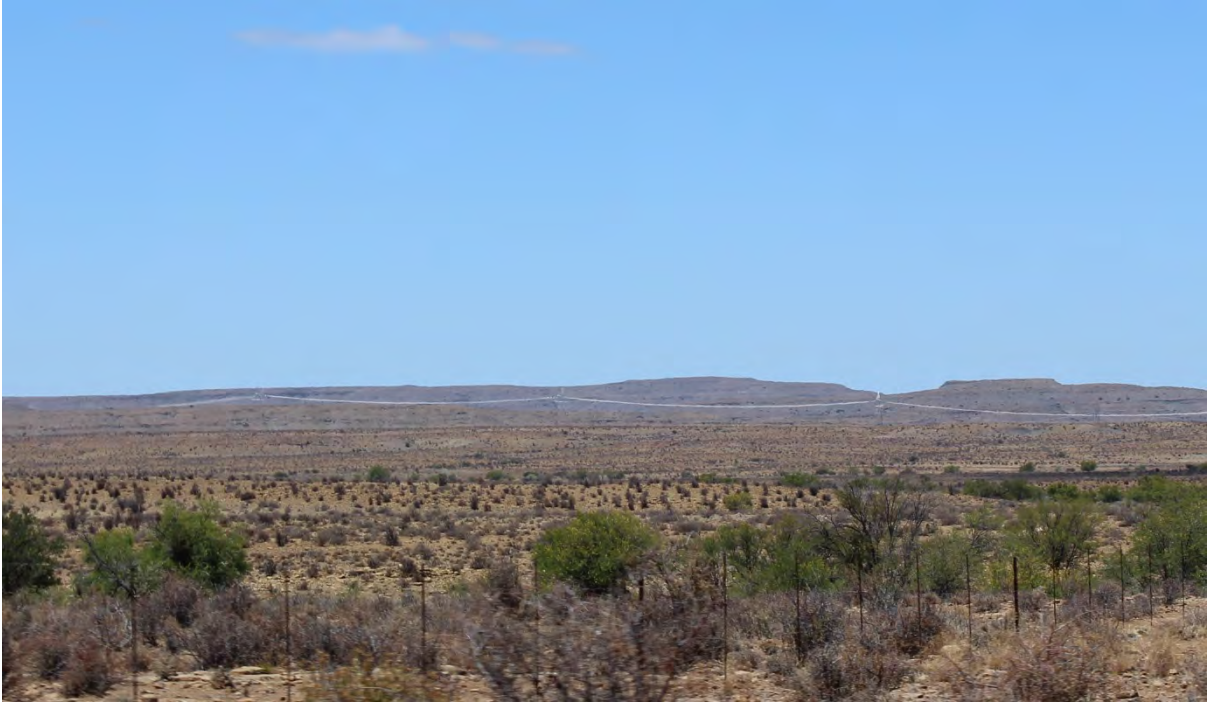
Figure 1-19 View south from the road between SVP023 and SVP024 showing the existing high voltage power lines that form a prominent man-made feature of the landscape in this region.

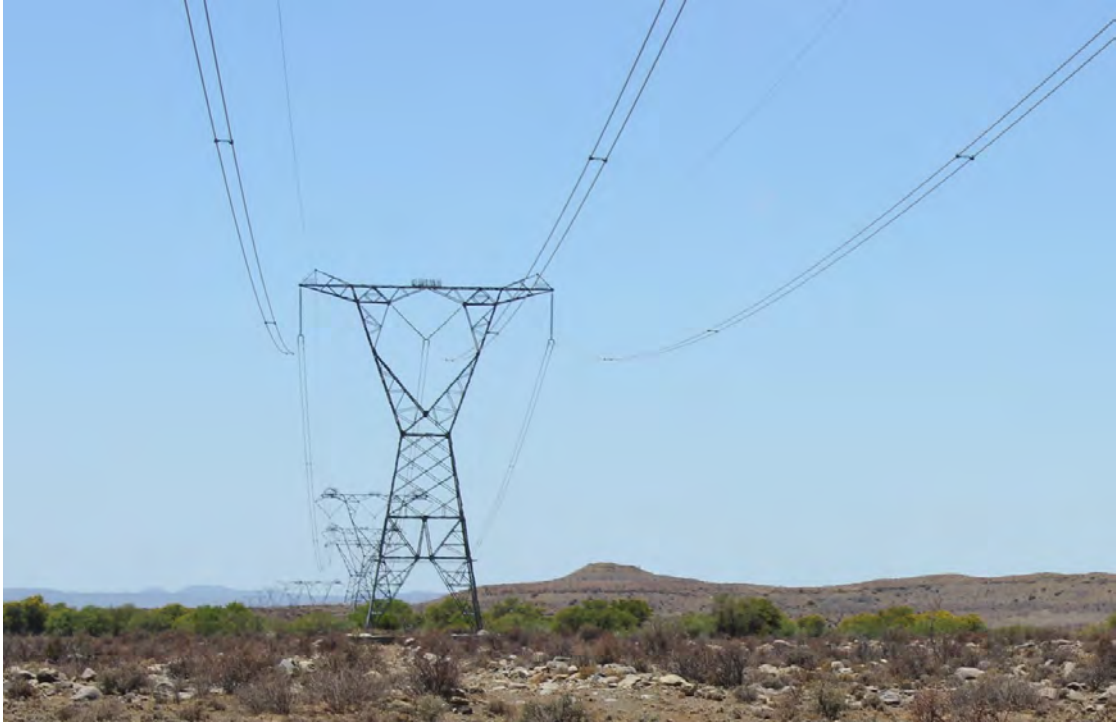
Figure 1-21 High voltage power lines crossing the road at SVP025 (looking east).

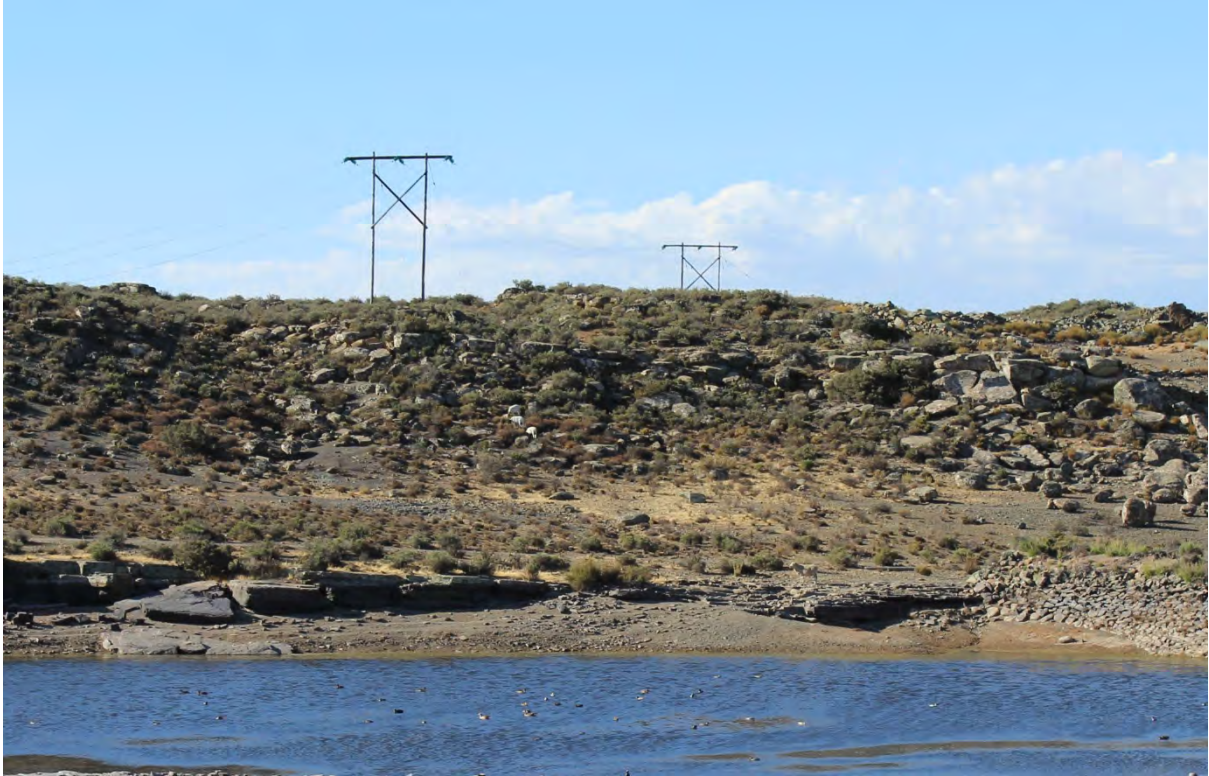
Figure 1-23 View north-west from SVP005 next to the Theronrus farmstead. An existing 132 kV power line exposed above the ridge - the power line follows along most of this road.

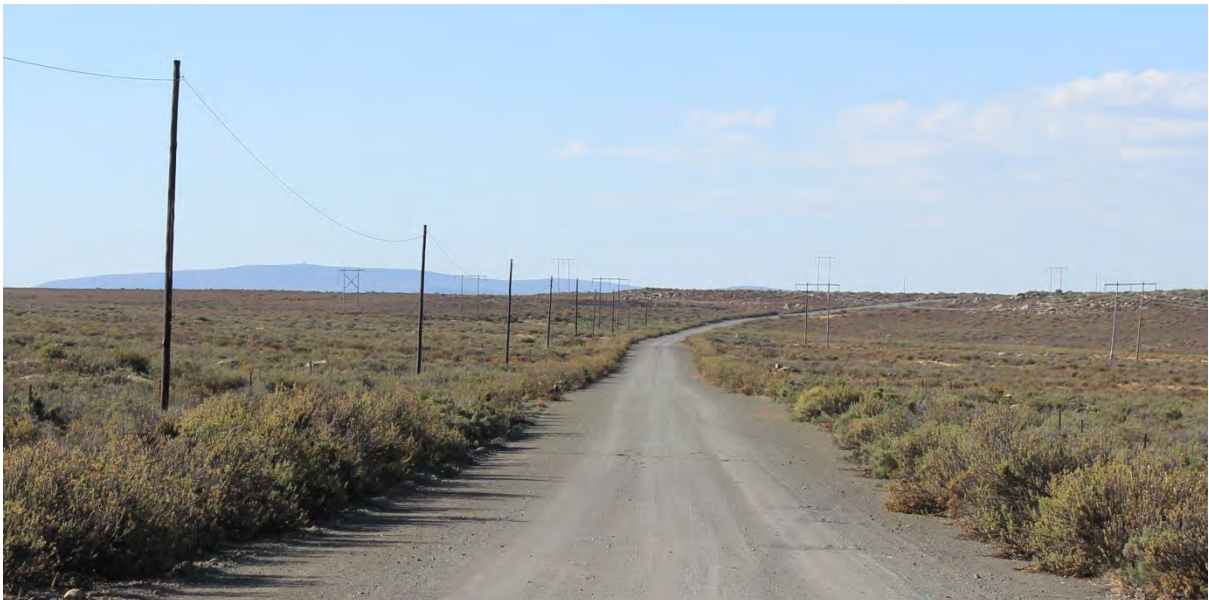
Figure 1-24 View north-west from SVP006 along the gravel road showing power lines and pylons/towers.

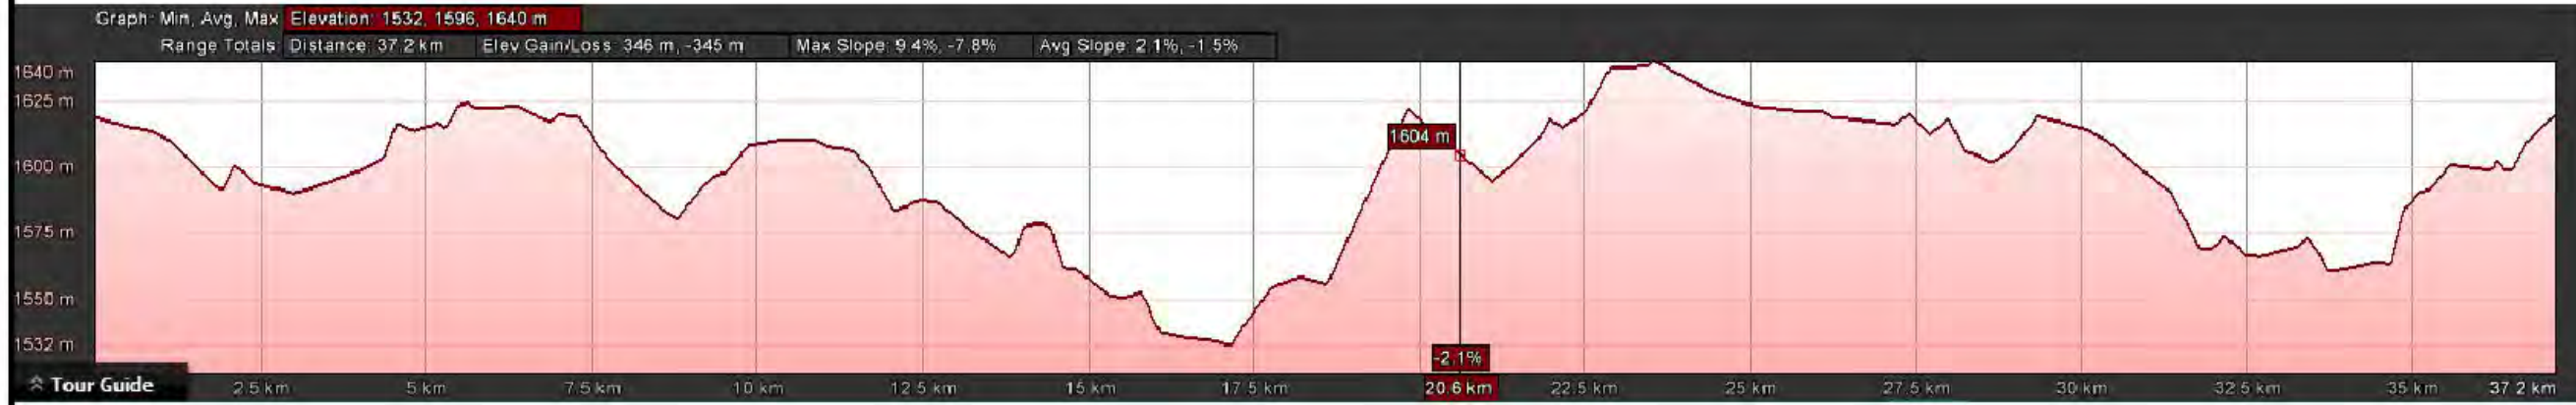
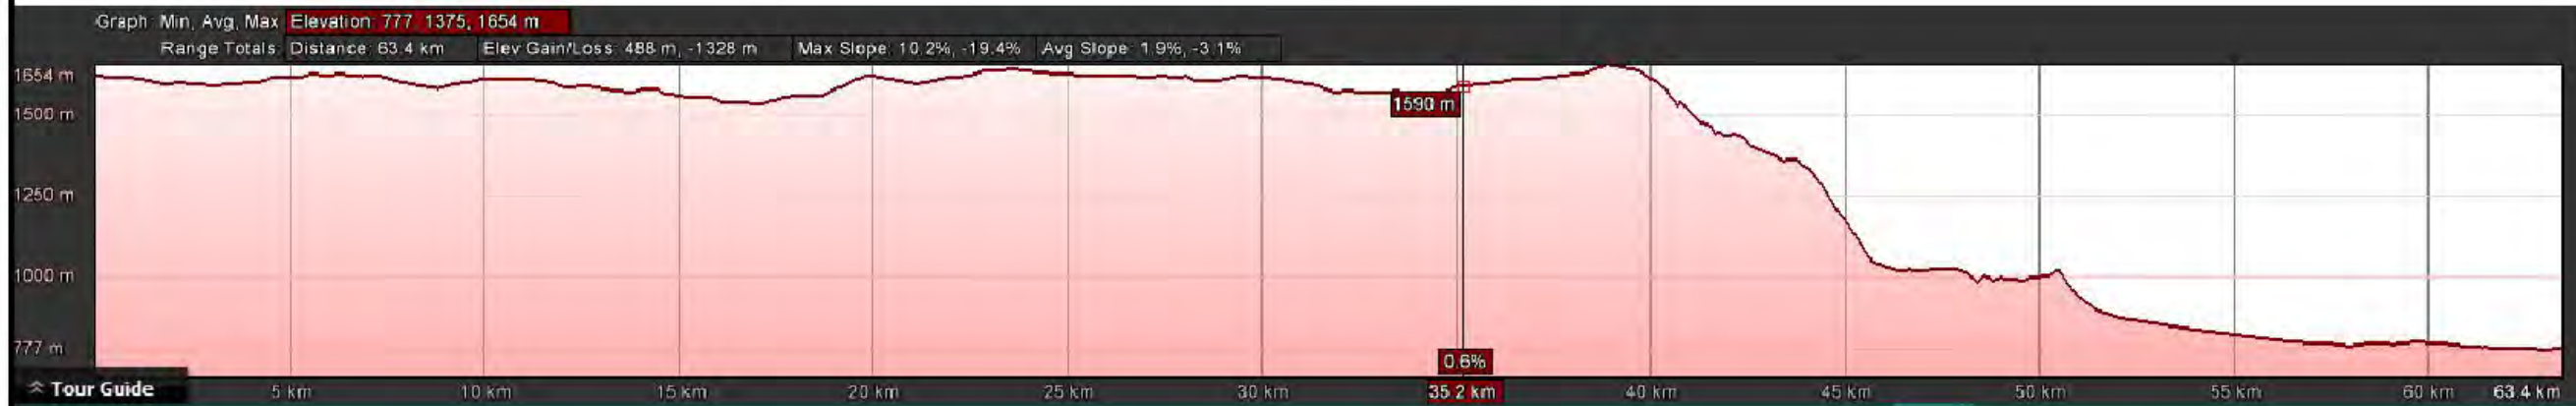
a) Alternative 1 topographic profile.

b) Alternative 2 topographic profile.

Map 5 Topographic profiles of proposed alternative routes for the overhead lines.
