# PHASE 1 HERITAGE IMPACT ASSESSMENT REPORT

## PROPOSED RIETKOL MINING OPERATIONS VICTOR KHANYE LOCAL MUNICIPALITY NKANGALA DISTRICT MPUMALANGA

> Frans Roodt January 2017 Updated March 2018

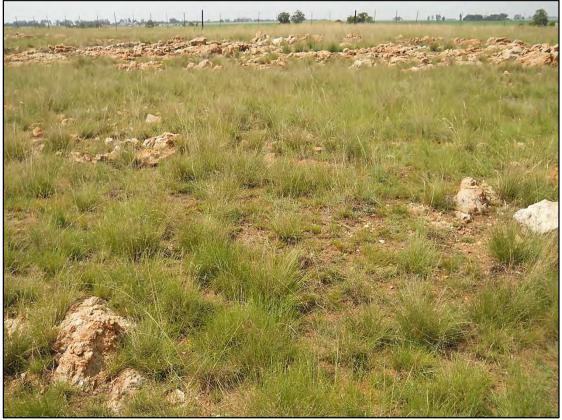
The proposed development terrain contains quartzite outcrops. Quartzite is а nonfoliated metamorphic rock composed almost entirely of quartz. It forms when quartzrich sandstone is altered by the heat, pressure, and chemical activity of metamorphism. These conditions recrystallise the sand grains and the silica cement that binds them together. Quartz is the most common sand-forming mineral. If the particular sand deposit contains almost nothing but guartz, it is often called silica sand. Such sand deposits are said to be mature because other rockforming minerals are already broken down by the weathering process leaving only the superresistant quartz as a residue.

Figure 8. View of quartzite outcrops – northern part.

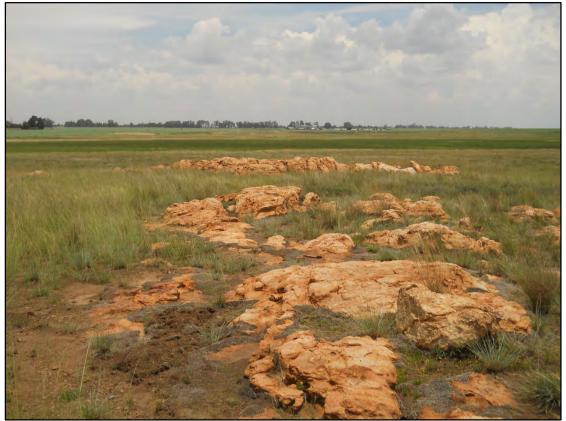
Figure 9. View of quartzite outcrops - southern part.

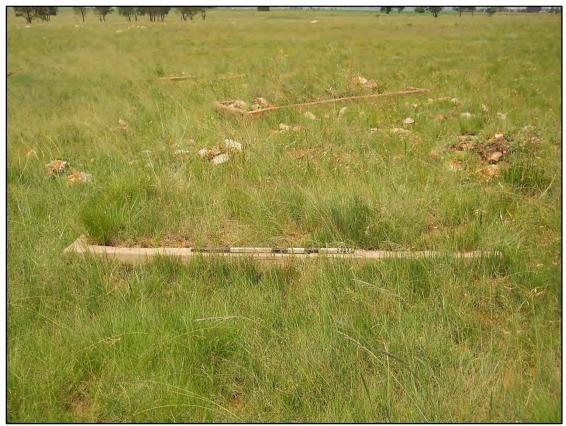
An informal graveyard consisting of about 20 graves was recorded at coordinates S26°07'41.5" E28°36'32.2". Some of these graves are delineated by brick and mortar walls, whereas others are stone stacked. The graves are not maintained, are overgrown and some have been damaged by burrowing porcupines, while others have collapsed. Graves of both adults and children are present. None of the graves have headstones and no names could be discerned. The exact size of the graveyard and number of graves could not be determined accurately. The grave fall just outside of the mining pit area (see figure 7). The proposed mining will be undertaken in this particular area by year 14 according to the mining schedule, which activity may impact on the graves.

Figure 10. Part of the informal graveyard.

- During the survey an informal graveyard was recorded. This must be relocated as if falls within the mining activity area. The correct legal procedures and protocols must be followed for this action.

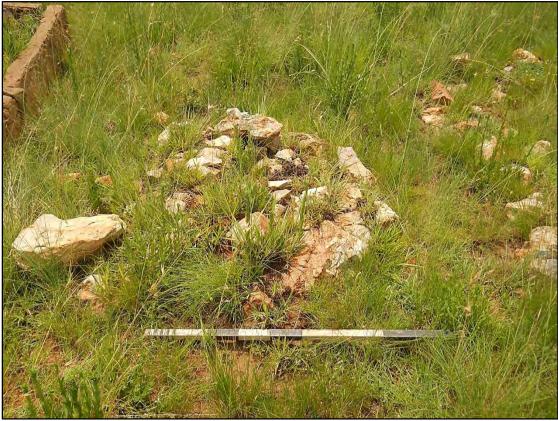
Figure 11. Grave of an infant.

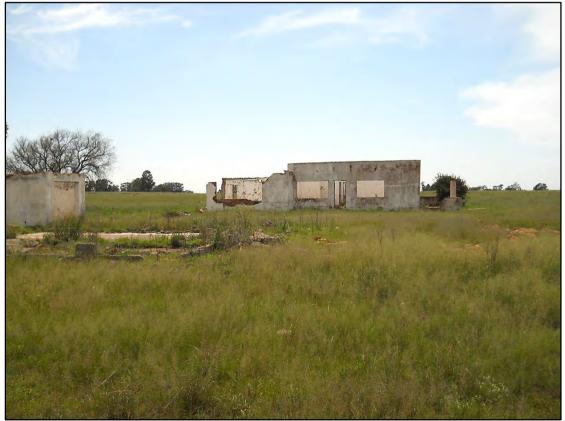
- Ruins of a house and outbuilding constructed with a combination of fired clay bricks and cement blocks. The architectural design (shape and large windows) and building materials makes it highly unlikely that the structures are older than 60 years. Significance: Low. Coordinates: S26°07'40" E28°36'37"

Figure 12. Ruin of homestead at recording 1.

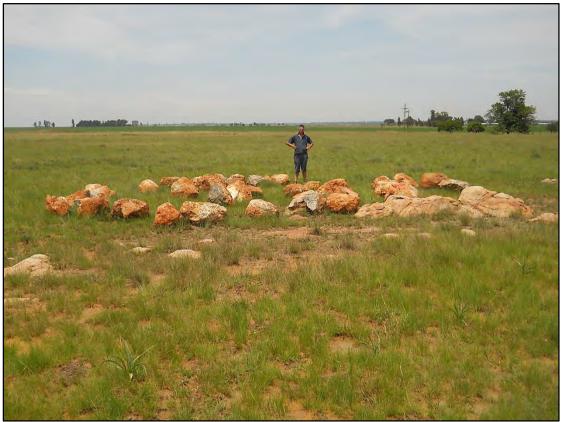
- 2. Stacked large stones in two groups, the one resembling the letter J. Probably cleared from the adjacent ploughed field. Significance: None. Coordinates: S26°07'39.4" E28°36'22.8"

Figure 13. Rock pile at recording 2.

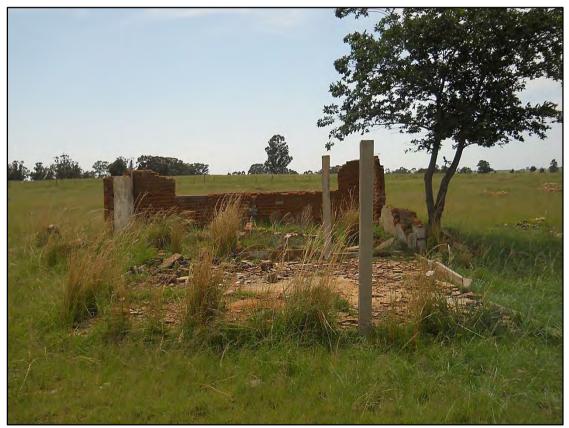
- 3. A structure that probably was a fowl-house. Contains modern pre-fab material. Connected to recording 1. Significance: None. Coordinates: S26°07'37" E28°36'23.4"

Figure 14. The probably fowl-house ruin at recording 3.

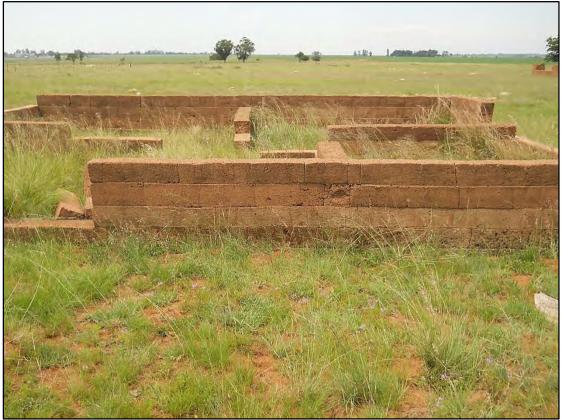
- 4. A pigsty constructed with cement blocks. Connected to recording 1. Significance: None. Coordinates: S26°07'35" E28°36'25.5"
- 5. Water trough and livestock pen. Connected to recording 6. Significance: None. Coordinates: S26°07'31.8" E28°36'25.2"

Figure 15. Probable pigsty at recording 4.

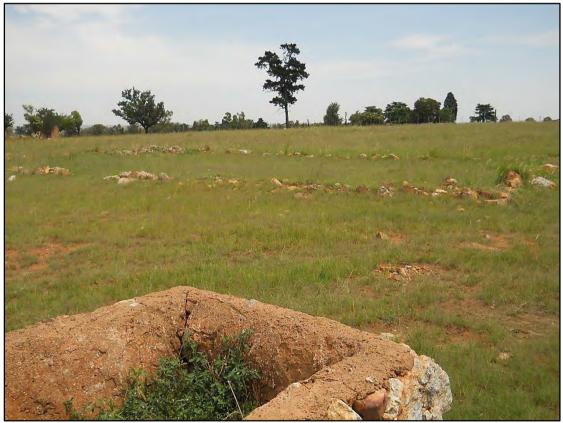
Figure 16. Water trough and livestock pen at recording 5.

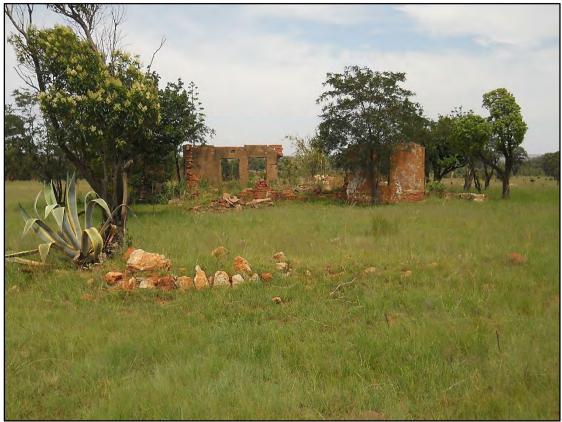
- 6. Ruins of a house and outbuilding. The house was constructed with fired clay bricks and mortar and the outbuilding of stone. Aspects such as the architectural design, ventilation ports and building material makes it highly unlikely that the structure is older than 60 years. A water tank stand constructed of brick and mortar stands near the house. Significance: Low. Coordinates: S26°07'29.8" E28°36'22.4"

Figure 17. Homestead ruin at recording 6.

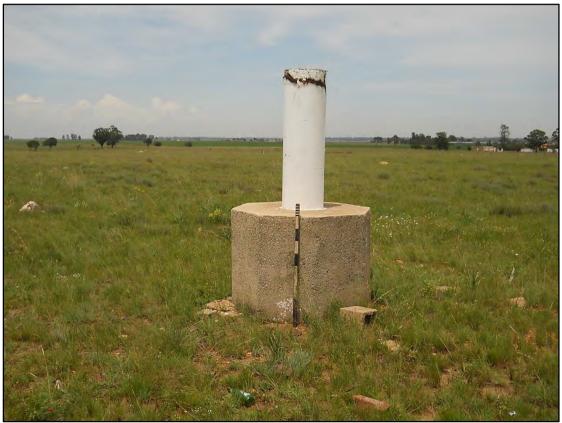
Recording **7** is an old trigonometrical beacon (No. 626). Coordinates: S26°07'35.6" E28°36'30.3". (See figure 18) The network of trigonometrical beacons on top of mountains and tall structures and buildings is known as a passive network since the beacon merely represents the position of the coordinate assigned to it and plays no role in updating or monitoring its position (<u>http://www.ngi.gov.za/index.php</u>).

Figure 18. Trigonometrical beacon (No. 626) at recording 7.

- A trigonometrical beacon is located in the project area. For the removal of this structure it is recommended that the office Chief Directorate: National Geo-Spatial Information be consulted in order to establish the correct procedure for its removal
