Heritage Impact Assessment Report

Improvement of Visitor Facilities, Site Infrastructure and
Heritage Conservation Measures at the Taung Skull World Heritage Site

DOCUMENT FOR COMMENT
JULY 2015

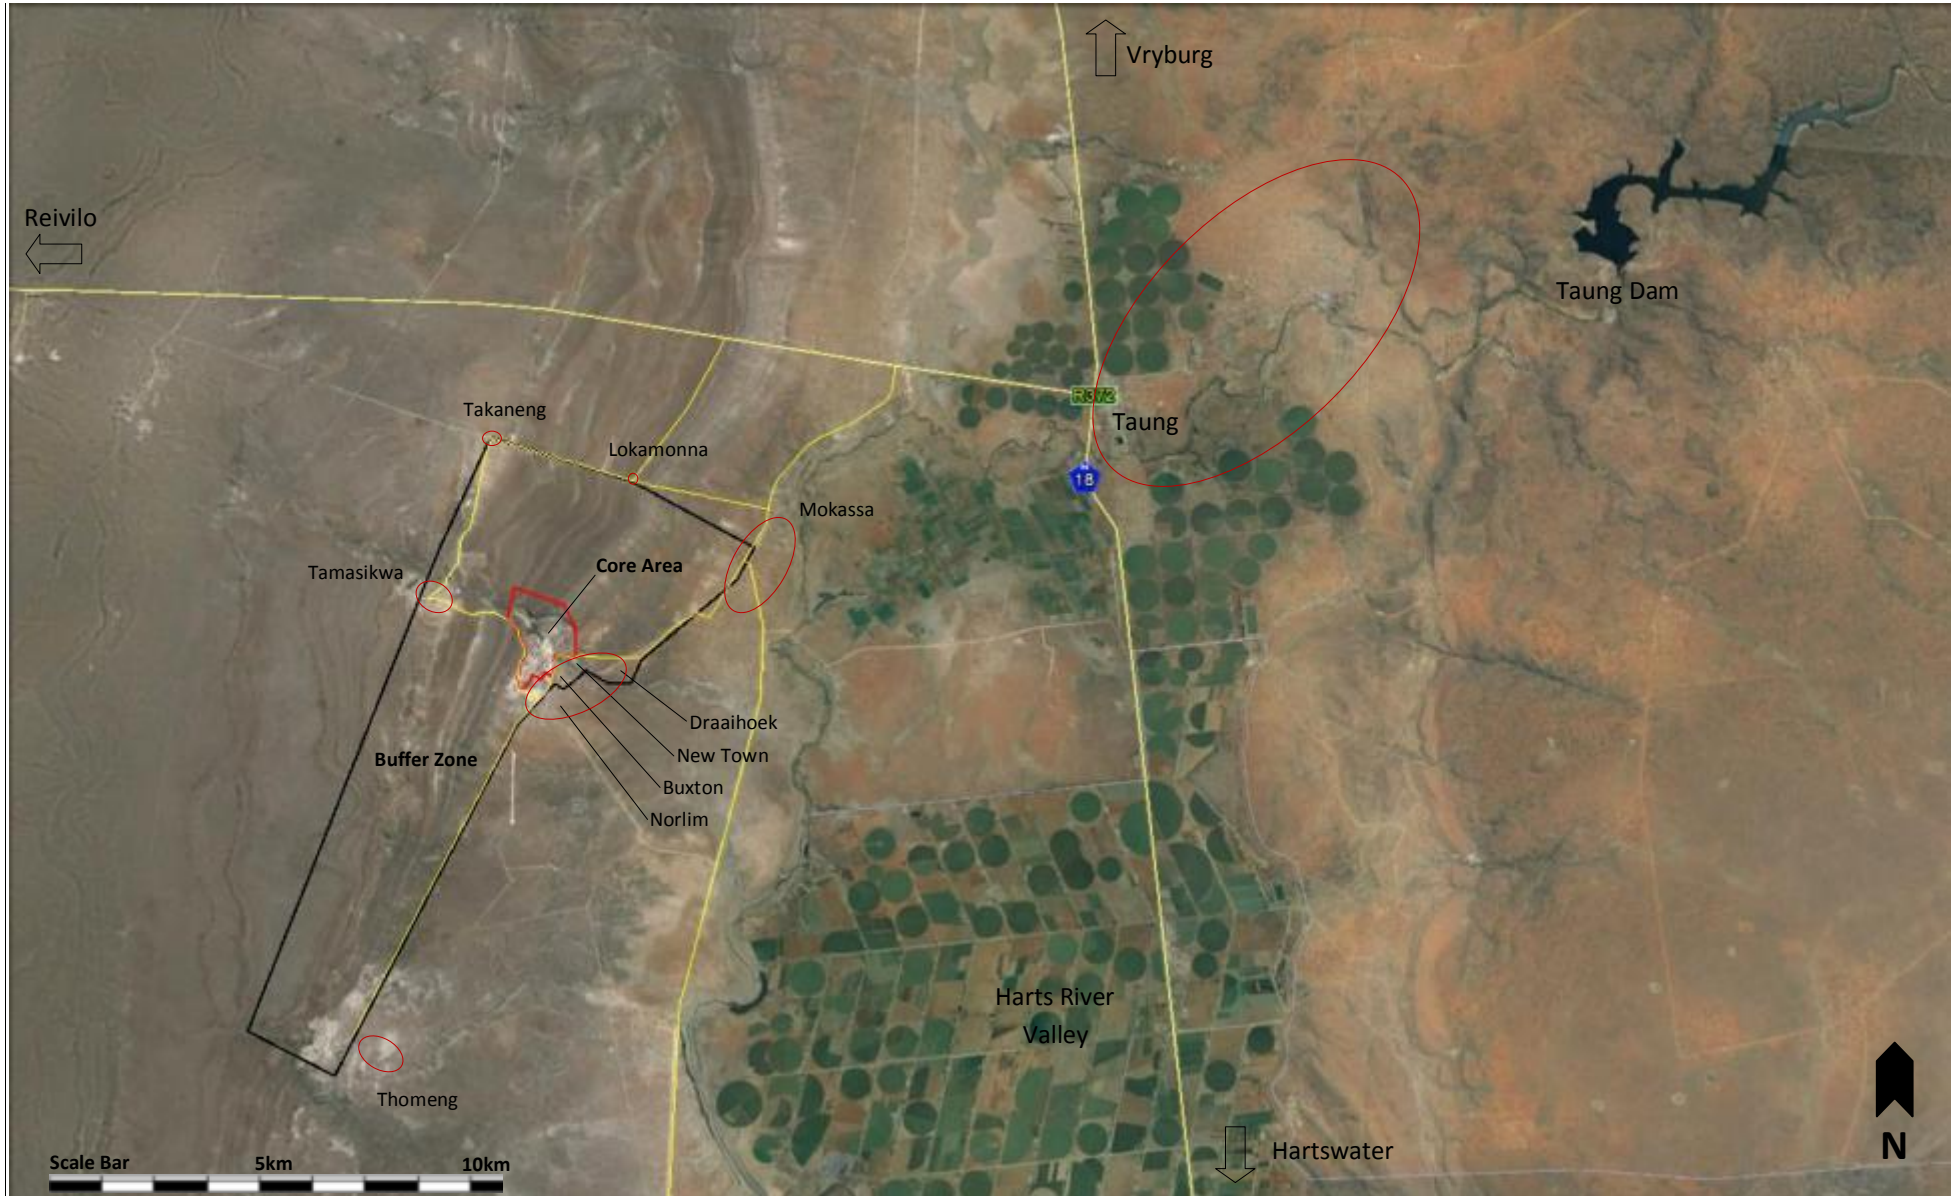
Figure 1: Locality Diagram of Core Area and Buffer Zone with roads to Villages and Taung

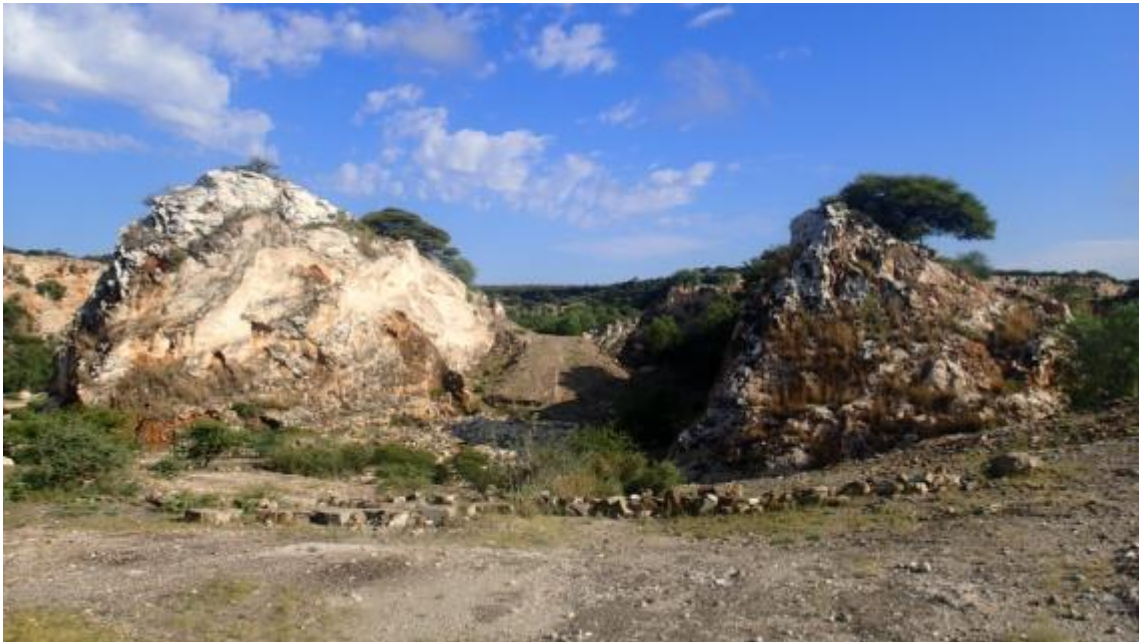
Figure 2: North view of Dart's Pinnacle (left) and Hrdlička's Pinnacle (right)
