# HERITAGE WALKDOWN REPORT

# for the approved Rietkloof WEF Grid Connection near Matjiesfontein in the Western Cape

September 2021

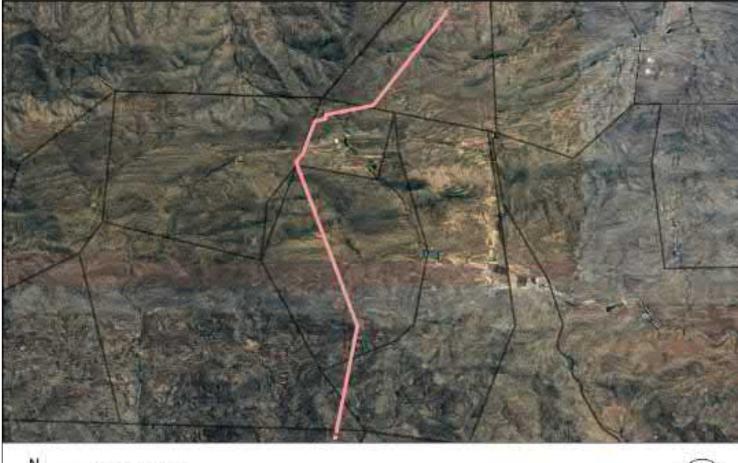
Figure 1.2: Final proposed layout for the Rietkloof WEF OHL development

Rietkloof 132kV OHL **Rietkloof Substation** Farm portinos

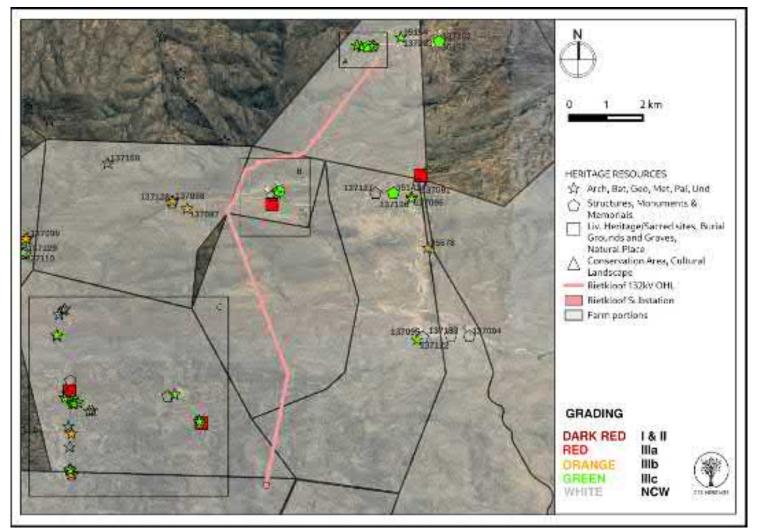
Figure 3. Heritage Resources Map. Heritage Resources previously identified in and near the study area from SAHRIS

All of the heritage resources identified by Booth (2016) have been recorded on SAHRIS and mapped relative to the final proposed layout. The previously identified heritage resources located in close proximity to the development area have been listed in Table 2 and mapped in Figure 3.

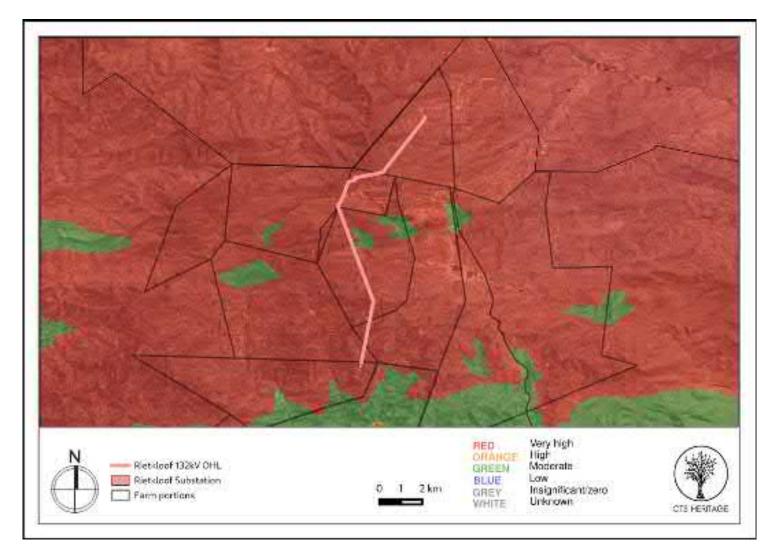
Figure 4.1: Palaeosensitivity Map. Indicating fossil sensitivity underlying the study area

According to the SAHRIS Palaeosensitivity Map, the area proposed for development is underlain by sediments that are of moderate, high and very high palaeontological sensitivity (Figure 4.1).

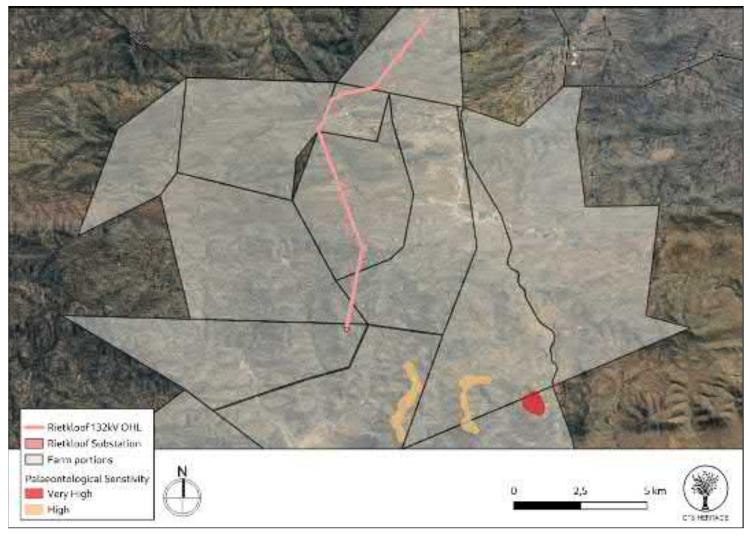
Figure 4.2: Palaeosensitivity Map. Indicating fossil sensitivity underlying the study area

- The area marked in RED in Figure 4.2 and 4.3 has very high levels of palaeontological sensitivity and no impact here is permitted.
- The area marked in Orange in Figure 4.2 and 4.3 has high levels of palaeontological sensitivity and as such, these two areas should be inspected for fossil wood occurrences by a professional palaeontologist. Mitigation would normally involve the scientific recording and judicious sampling or collection of fossil material as well as associated geological data (e.g. stratigraphy, sedimentology, taphonomy). Where practicable, fossils remaining on site should be safeguarded, for example by moving them away from the development footprint.

Although the EA did not make any specific conditions pertaining to the conservation of palaeontological heritage, the PIA completed for the Rietkloof WEF recommended that the area marked in Orange in Figure 4.2 should be inspected for fossil wood occurrences by a professional palaeontologist prior to construction. These areas of paleontological sensitivity are not going to be impacted by the proposed grid connection and as such, this recommendation is not applicable to this development.

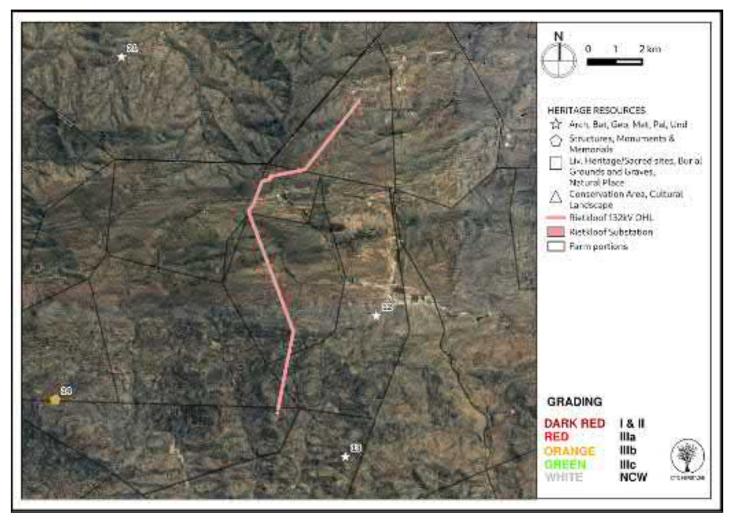
Figure 7.: Location of observations recorded during the walkdown

Stone Age sites were expected to be very scarce and this was borne out yet again in the foot survey of the ridges where the WEF roads and turbine positions have been planned. Only a couple of isolated Later and Middle Stone Age sites were located and the artefacts showed signs of retouch. These locations have therefore been interpreted as representing temporary hunting and foraging locales taking advantage of the wide views down onto the valleys either side of the ridges. Less than 1% of the overall archaeological material found in the area is therefore located on the ridges that are windswept, highly rocky and difficult to move through on foot. No overhangs or even substantial outcrops of boulders providing natural shelter were found on the ridges.

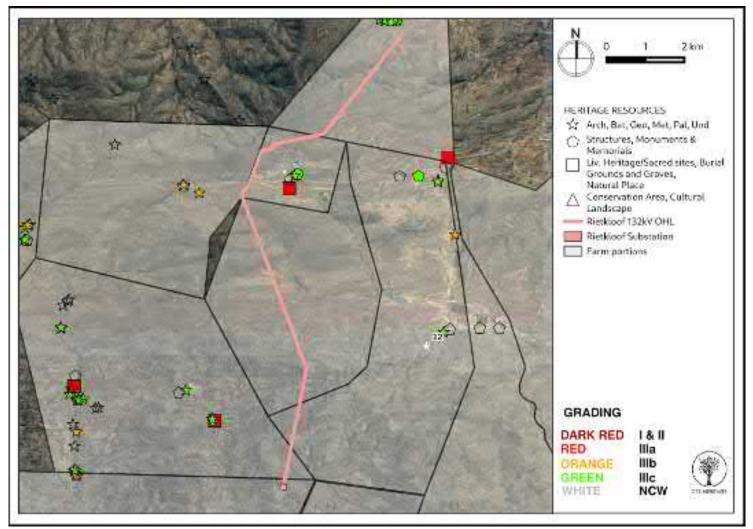
The survey provided a very good account of the generally ubiquitous MSA material spread across the study area in low densities. No impacts on significant heritage resources are anticipated as the layout of the WEF OHL has been drawn up to avoid the previously recorded sites of significance by Booth in 2016.

Figure 9: Map of all known heritage resources relative to the final proposed grid development footprint
