STRETCH'S COURT FABRIC ANALYSIS METHODOLOGY

>> STRETCH'S COURT LAYOUT, NUMBERING AND GRADING

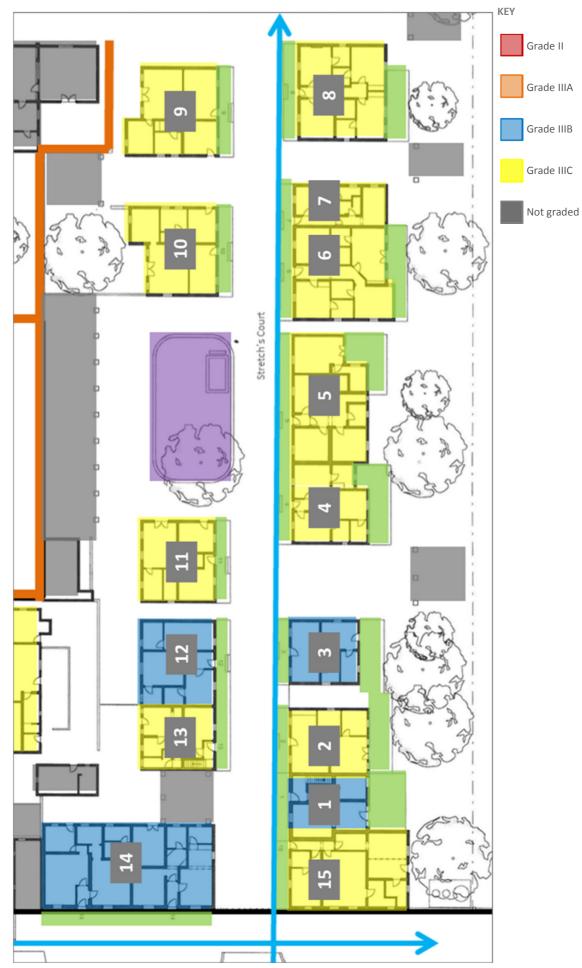
>> Degrees of Intactness

To accurately evaluate the historical fabric and the significance thereof, three degrees of intactness have been identified and assigned to the cottages, along with their proposed heritage grading:

- >>1 Wall fabric 70 to 90% intact. Retain remaining historic wall fabric. Some internal finishes significant to the character of the building. Replace/patch inappropriate finishes with that stripped from other buildings i.e. Oregon Pine instead of plasterboard, carpeted concrete.
- >>2 Wall fabric 50 to 70% intact. Retain remaining wall fabric where possible. Internal finishes not significant but authentic to the character of the building. Allow internal finishes to be replaced/patched from stripped cottages, or updated with minimal intervention to the remaining historic wall fabric.
- >>3 Wall fabric 20 to 50% intact. Retain exterior wall fabric/shell. Internal finishes not significant nor authentic to the character of the building. Allow full extent of interior to be updated.
