**AGES OMEGA: PROPOSED CLUSTER 6 GQAGA BULK RISING MAIN WEST WATER SUPPLY SCHEME PROJECT, LIXENI AND NCITYANA AREAS, CHRIS HANI DISTRICT MUNICIPALITY, EASTERN CAPE PROVINCE**

**Archaeological Impact Assessment**

## **ARCHAEOLOGICAL IMPACT ASSESSMENT (AIA) OF AREAS DEMARCTED FOR THE PROPOSED CLUSTER 6 GQAGA BULK RISING MAIN WEST WATER SUPPLY SCHEME PROJECT, LIXENI AND NCITYANA AREAS, CHRIS HANI DISTRICT MUNICIPALITY, EASTERN CAPE PROVINCE**

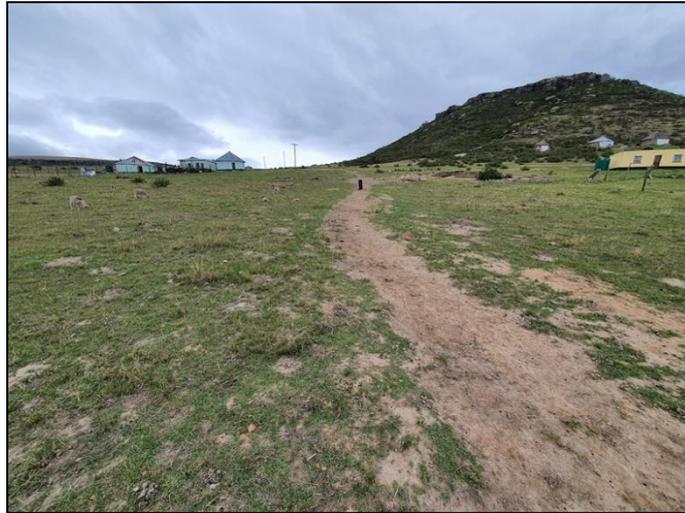
It should be noted that portions of the planned Lixeni pipeline infrastructure had already been installed at the time of compilation of this assessment (see Figure 1-1 – Figure 1-3).

Figure 1-1: View of installed pipeline infrastructure in the Lixeni area.

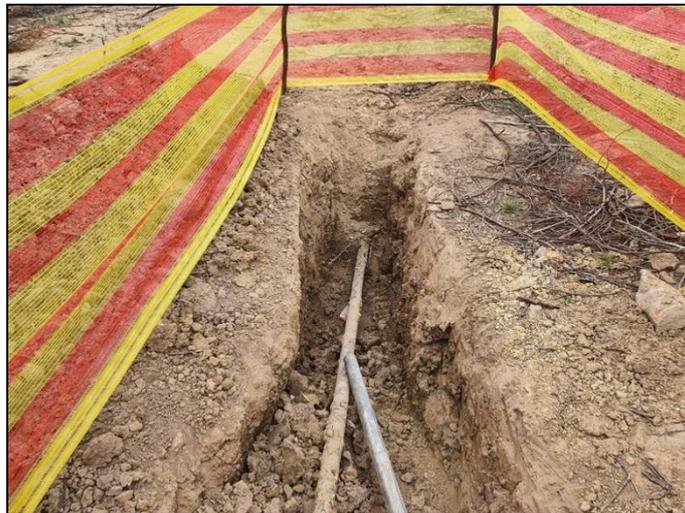
Figure 1-2: View of partially installed pipeline infrastructure in the Lixeni area.

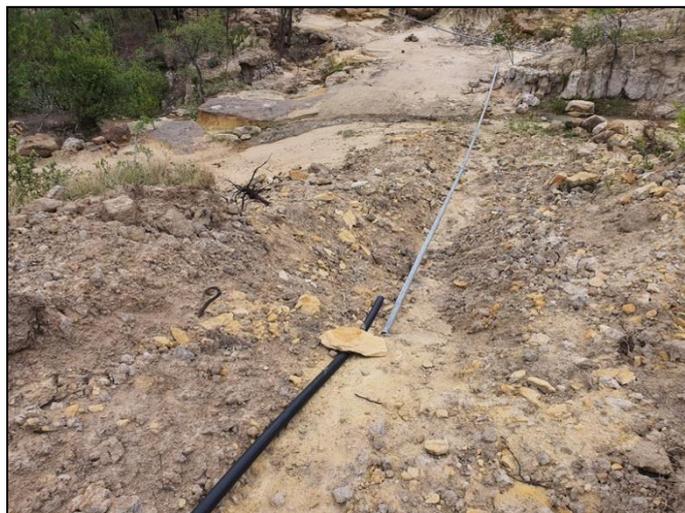
Figure 1-3: View of filled partially installed pipeline infrastructure across a water course in the Lixeni area.

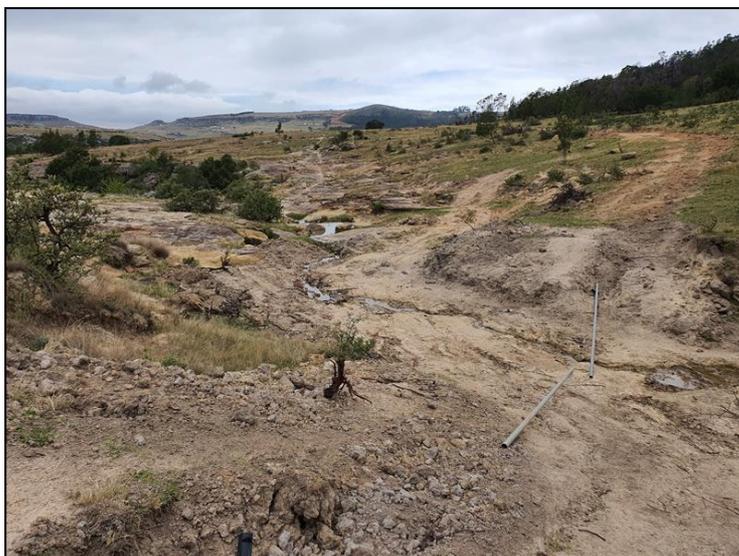
Figure 3-2: View of partially installed pipeline infrastructure in the Lixeni area.

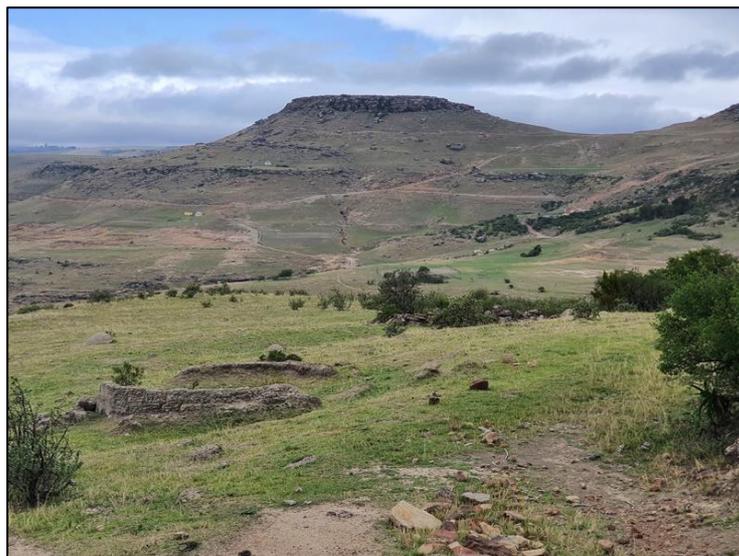
The dilapidated remains of at least 2 mud and clay huts as well as material culture such as glass, metal, and plastic were noted in the Sidikidini area. In addition, the ruined remains of a stone walled livestock enclosure were noted. An absolute age for the structures could not be ascertained but an analysis of historical topographical maps and aerial photographs indicates that the area was relatively densely populated during the previous century. According to indications, the structure was in use by around 1960 and the structure are probably older than 60 years - and generally protected under the National Heritage Resource Act (NHRA 1999). However, the feature is poorly preserved and of low heritage significance.

Figure 5-1: View of Historical Period remains at Site EXIGO-C6LX-HP01.

- The remains of Historical Period structures and features (**Site Exigo-C6LX-HP01; Site Exigo-C6LX-HP02**) are of low significance due to the poor state of preservation of the sites and features. The sites are located in close proximity of the project area and it is recommended that any activities occurring at these sites be monitored in order to avoid the destruction of previously undetected heritage remains.

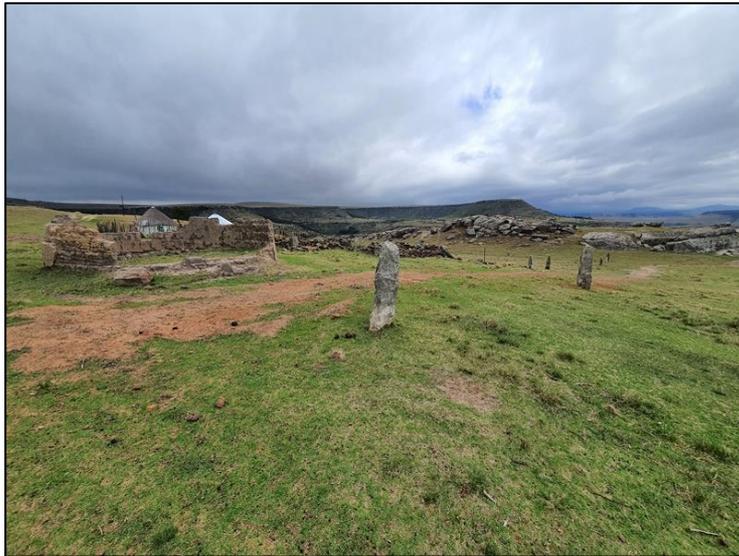
In addition, the dilapidated remains of a hut, a stone livestock enclosure and a number of upright monoliths were noted in the Lixeniarea. Material culture such as glass, metal and plastic occur at the site. An absolute age for the structure could not be ascertained but an analysis of historical topographical maps and aerial photographs indicates that the area was relatively densely populated during the previous century. According to indications, the building was in use by around 1960 and the structure remains is probably older than 60 years - and generally protected under the National Heritage Resource Act (NHRA 1999). However, the feature is poorly preserved and of low significance.

Figure 5-2: View of a hut remains at Site EXIGO-C6LX-HP02. Note the presence of upright monoliths.

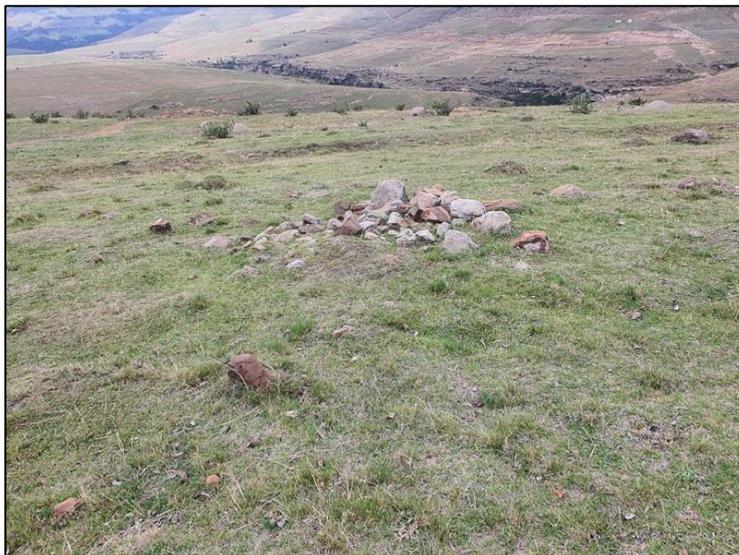
A single grave occurs on a slope near the northern offset of the Lixeni pipeline in Sidikidini. The grave is indicated by an elongated stone cairn filled in with stone. The site is not maintained and the condition of the burial is poor. The burial site is of high heritage significance, it is situated in close proximity of proposed pipeline construction alignments and a conservation buffer should be observed. Alternatively, the burial should be relocated according to the applicable social and statutory requirements, should impact prove inevitable.

Figure 5-3: View of a burial at Site EXIGO-C6LX-BP01.

- **Should impact on any human burial prove inevitable, full grave relocations are recommended for these burial grounds. This measure should be undertaken by a qualified archaeologist, and in accordance with relevant legislation, permitting, statutory permissions and subject to any local and regional provisions and laws and by-laws pertaining to human remains. A full social consultation process should occur in conjunction with the mitigation of cemeteries and burials (see Addendum B).**

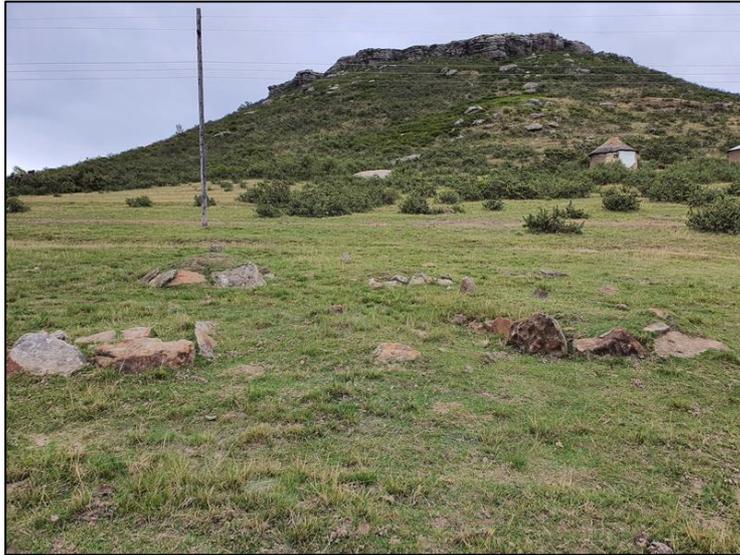
At least 4 graves were noted in an open field in the Sidikidini area. The graves are indicated by rough elongated stone cairns filled in with soil and covered with surface grass. The site is not maintained and the condition of the burials is fair. The burial site is of high heritage significance, it is situated in close proximity of proposed pipeline construction alignments and a conservation buffer should be observed. Alternatively,

Figure 5-4: View of a burial at Site EXIGO-C6LX-BP02.

the burials should be relocated according to the applicable social and statutory requirements, should impact prove inevitable.

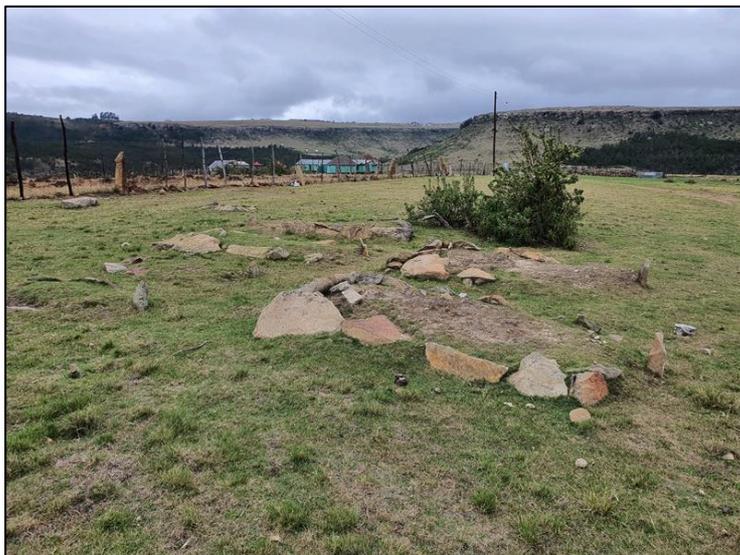
Another 5 graves were noted in an open field in the Sidikidini area. The graves are indicated by rough elongated stone cairns filled in with soil and covered with surface grass. The site is not maintained and the condition of the burials is fair. The burial site is of high heritage significance, it is situated in close proximity of proposed pipeline construction alignments and a conservation buffer should be observed. Alternatively, the burials should be relocated according to the applicable social and statutory requirements, should impact prove inevitable.

Figure 5-5: View of a burial at Site EXIGO-C6LX-BP03.

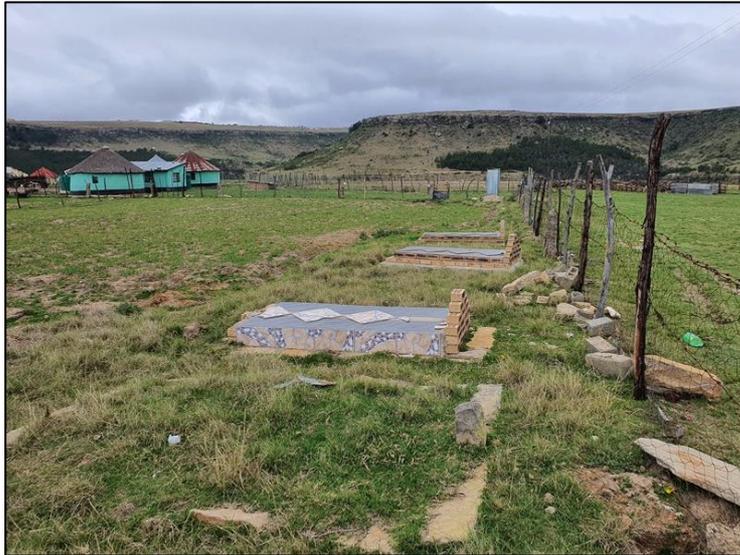
homestead fence, the site is not maintained and the condition of the burials is fair. The burial site is of high heritage significance, it is situated in close proximity of proposed pipeline construction alignments and a conservation buffer should be observed. Alternatively, the burials should be relocated according to the applicable social and statutory requirements, should impact prove inevitable.

Figure 5-6: View of a burial at Site EXIGO-C6LX-BP01.

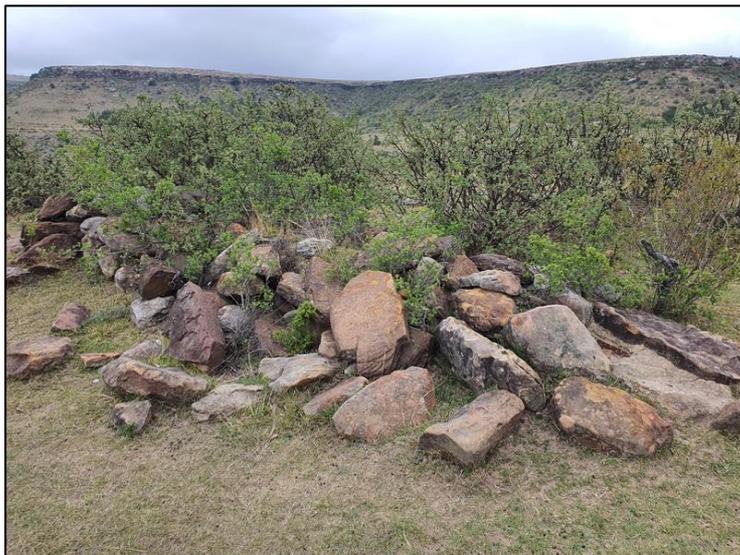
A possible grave was noted in an open field in the Sidikidini area. The grave is indicated by a large elongated stone cairn. The site is not fenced off, it is not maintained and the condition of the potential burial is poor. The burial site is of high heritage significance, it is situated in close proximity of proposed pipeline construction alignments and a conservation buffer should be observed. Alternatively, the burials should be relocated according to the applicable social and statutory requirements, should impact prove inevitable.

Figure 5-7: View of a burial at Site EXIGO-C6LX-BP05.

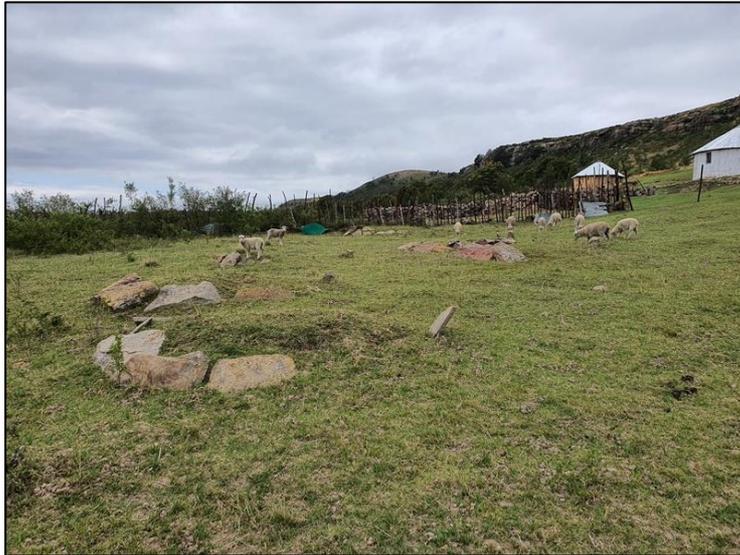
5 Graves were noted in an open field along a slope in the Lixeni area. The graves are indicated by rough elongated stone cairns filled in with soil and covered with surface grass. The site is not maintained and the

condition of the burials is fair. The burial site is of high heritage significance, it is situated in close proximity of proposed pipeline construction alignments and a conservation buffer should be observed. Alternatively, the burials should be relocated according to the applicable social and statutory requirements, should impact prove inevitable.

Figure 5-8: View of a burial at Site EXIGO-C6LX-BP06.

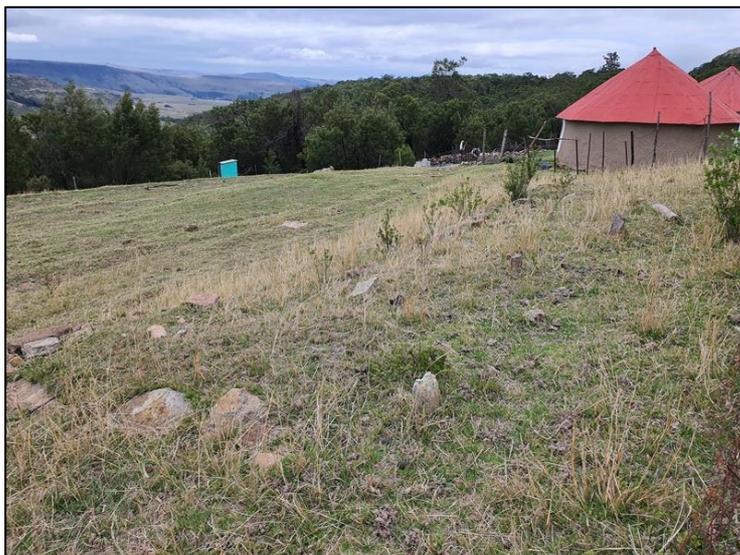
Another 3 graves were noted in an open field next to a homestead in the Lixeni area. The densely overgrown graves are indicated by rough elongated stone cairns filled in with soil and covered with surface grass. The site is not maintained and the condition of the burials is fair. The burial site is of high heritage significance, it is situated in close proximity of proposed pipeline construction alignments and a conservation buffer should be observed. Alternatively, the burials should be relocated according to the applicable social and statutory requirements, should impact prove inevitable.

Figure 5-9: View of a burial at Site EXIGO-C6LX-BP07

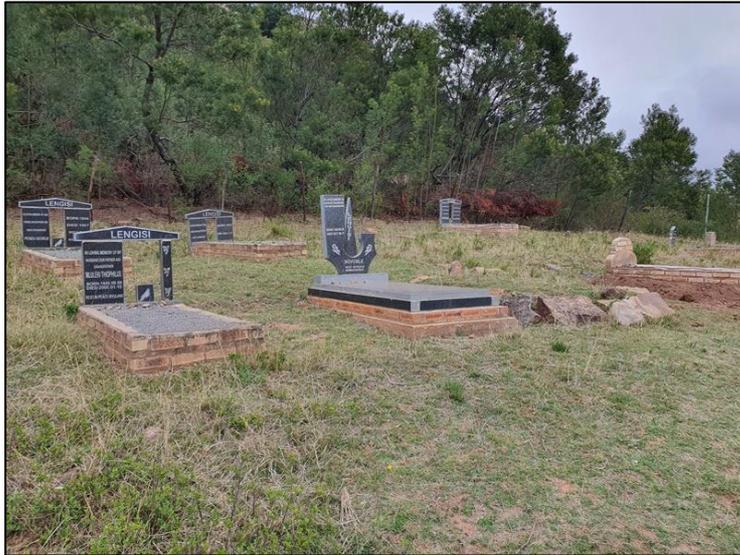
A family cemetery containing a large number of graves, occurs near a homestead complex in Lixeni. Most of the graves are indicated by marble slab grave dressings with marble headstones and other burials are indicated by elongated stone mounds covered with soil. The site is enclosed in a fence, the site is maintained and the condition of the burials is good. The burial site is of high heritage significance, it is situated in close proximity of proposed pipeline construction alignments and a conservation buffer should be observed. Alternatively, the burials should be relocated according to the applicable social and statutory requirements, should impact prove inevitable.

Figure 5-10: View of a burial at Site EXIGO-C6LX-BP08.

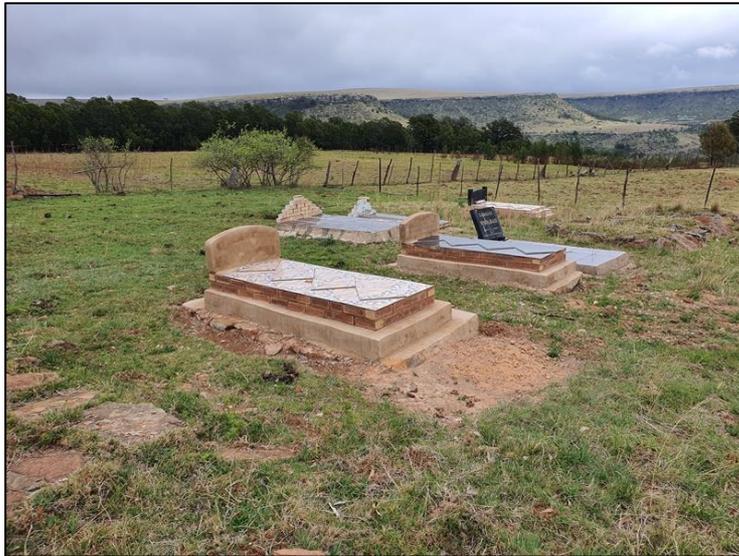
Another family cemetery containing at least 8 graves, occurs near a homestead complex in Lixeni. Most of the graves are indicated by marble slab grave dressings with marble headstones, others are indicated by brick structures fashioned with ceramic tiles with brick headstones and other graves are indicated by elongated stone mounds covered with soil. The site is enclosed in a fence, the site is maintained and the condition of the burials is good. The burial site is of high heritage significance, it is situated in close proximity of proposed pipeline construction alignments and a conservation buffer should be observed. Alternatively, the burials should be relocated according to the applicable social and statutory requirements, should impact prove inevitable.

Figure 5-11: View of a burial at Site EXIGO-C6LX-BP09.

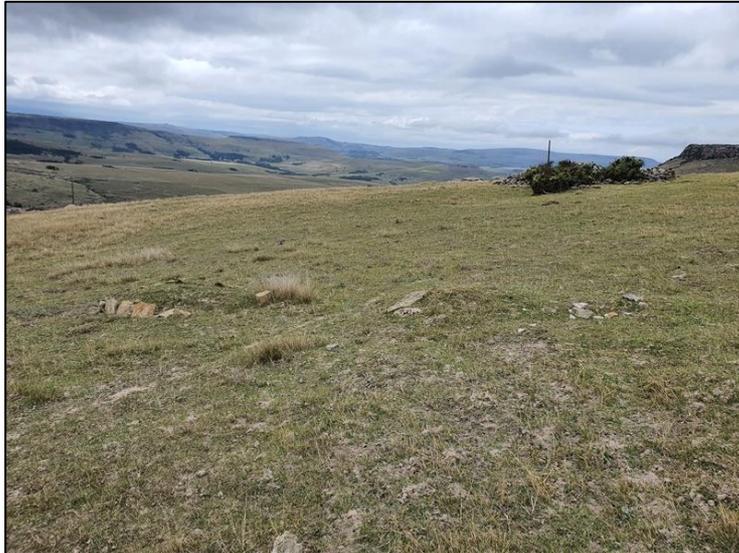
At least 2 graves occur in an open field in the Lixeni area. The graves are indicated by elongated stone cairns filled in with soil and covered with surface grass. The burial site is of high heritage significance, it is situated in close proximity of proposed pipeline construction alignments and a conservation buffer should be observed. Alternatively, the burials should be relocated according to the applicable social and statutory requirements, should impact prove inevitable.

Figure 5-12: View of a burial at Site EXIGO-C6LX-BP10.

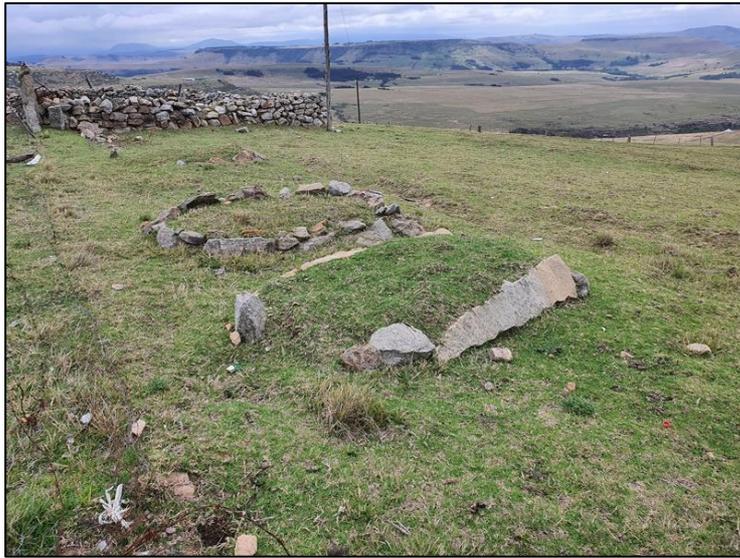
A further 2 graves occur next to homestead in the Lixeni area. The graves are indicated by elongated stone cairns filled in with soil and covered with surface grass. The burial site is of high heritage significance, it is situated in close proximity of proposed pipeline construction alignments and a conservation buffer should be observed. Alternatively, the burials should be relocated according to the applicable social and statutory requirements, should impact prove inevitable.

Figure 5-13: View of a burial at Site EXIGO-C6LX-BP11.

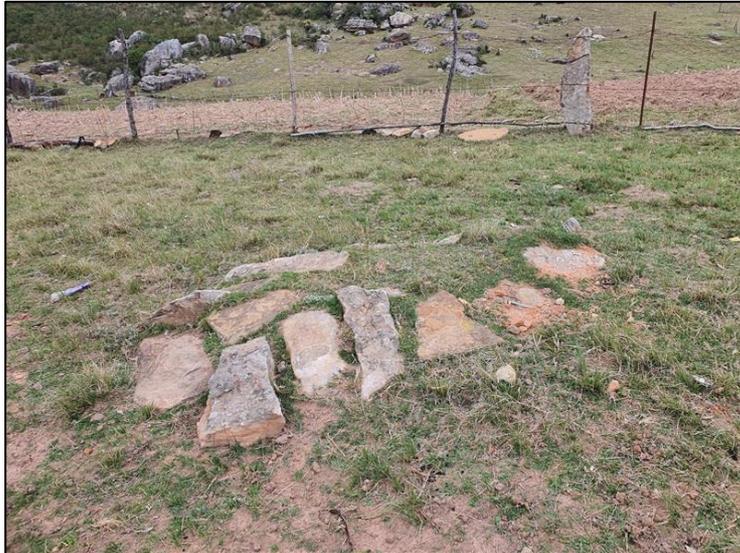
A single grave occurs in an open field in the Lixeni. The grave is indicated by an elongated stone cairn filled in with soil and covered with surface grass. The burial is not fenced off and the condition of the grave is fair. The burial site is of high heritage significance, it is situated in close proximity of the proposed pipeline construction alignments and a conservation buffer should be observed. Alternatively, the burial should be relocated according to the applicable social and statutory requirements, should impact prove inevitable.

Figure 5-14: View of a burial at Site EXIGO-C6LX-BP12.

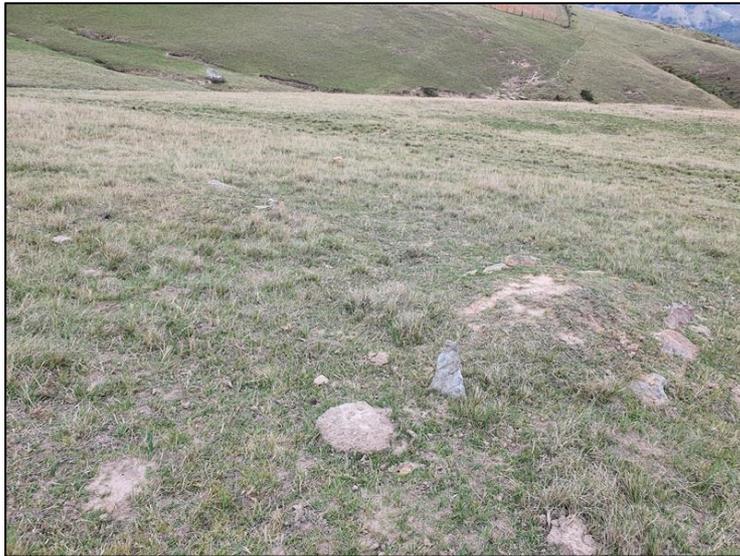
A single grave occurs on a high ridge in an open field in the Taleni. The grave is indicated by an elongated stone cairn filled in with soil and covered with surface grass. The burial is not fenced off and the condition of the grave is fair. The burial site is of high heritage significance, it is situated in close proximity of the proposed pipeline construction alignments and a conservation buffer should be observed. Alternatively, the burial should be relocated according to the applicable social and statutory requirements, should impact prove inevitable.

Figure 5-15: View of a burial at Site EXIGO-C6LX-BP13.

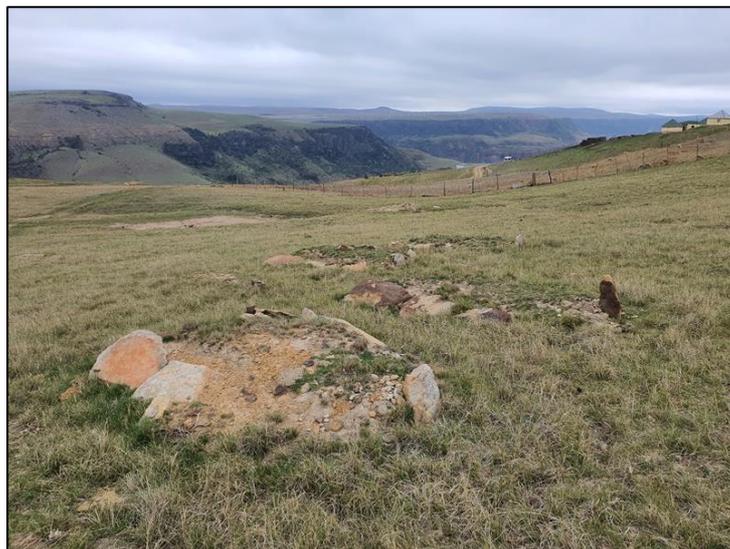
Two graves occur in an open field in the Taleni area. The graves are indicated by elongated stone cairns filled in with soil and covered with surface grass. The burials are not fenced off and the condition of the graves is fair. The burial sites are of high heritage significance, they are situated in close proximity of the proposed pipeline construction alignments and a conservation buffer should be observed. Alternatively, the burials should be relocated according to the applicable social and statutory requirements, should impact prove inevitable.

Figure 5-16: View of a burial at Site EXIGO-C6LX-BP14.

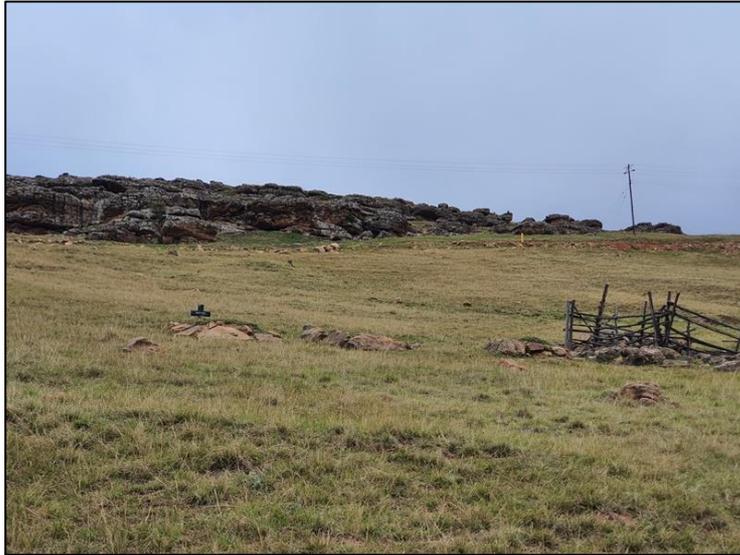
A number of graves occur along a slope in the Taleniarea. The burials area indicated by concrete bases with marble headstones and elongated stone cairns filled in with soil and covered with surface grass. The burials are not fenced off and the condition of the graves is good. The burial sites are of high heritage significance, they are situated in close proximity of the proposed pipeline construction alignments and a conservation

Figure 5-17: View of a burial at Site EXIGO-C6LX-BP15.

buffer should be observed. Alternatively, the burials should be relocated according to the applicable social and statutory requirements, should impact prove inevitable.

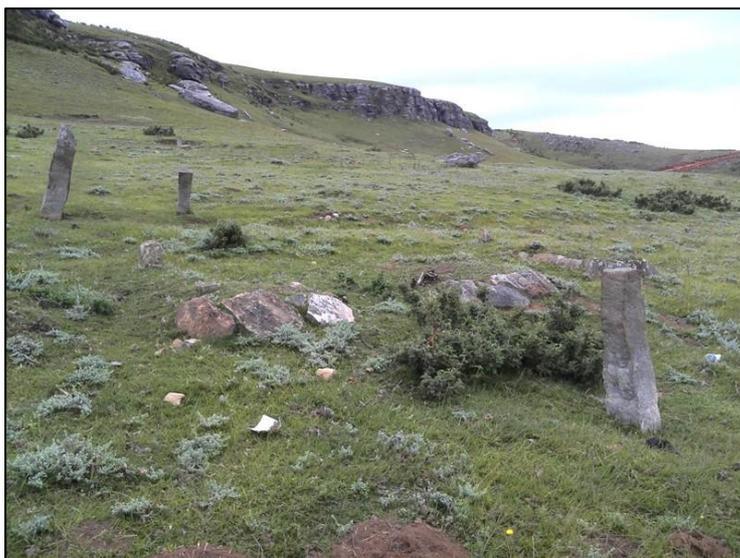
Two graves occur near homesteads in a river valley in the Lixeni area. The burials are indicated by elongated stone cairns filled in with soil and covered with surface grass as well as upright monoliths. The site is not fenced and the general condition of the graves is good. The burial site is of high heritage significance, it is situated in close proximity of proposed pipeline construction alignments and a conservation buffer should be observed. Alternatively, the burials should be relocated according to the applicable social and statutory requirements, should impact prove inevitable.

Figure 5-18: View of a burial at Site EXIGO-C6LX-BP16.

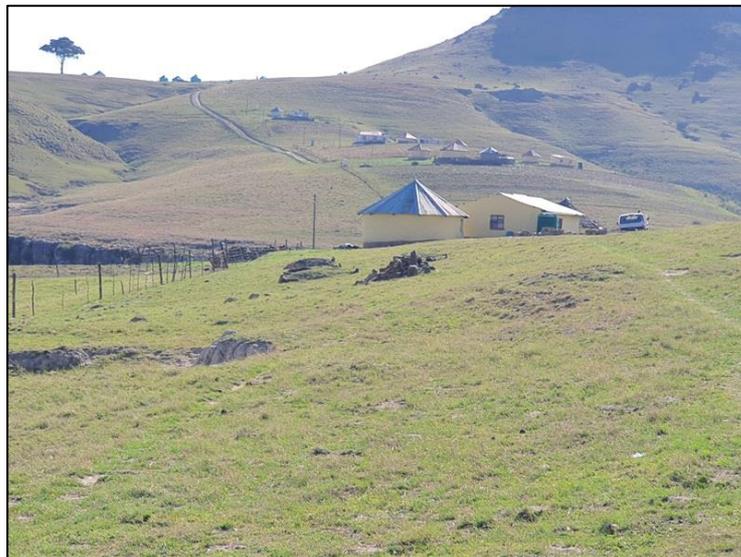
At least 4 graves were noted next to a homestead in the Nkanga area. The graves are indicated by elongated stone cairns filled in with soil and covered with surface grass and in some instances, rough and irregular and unmarked rocks were placed as headstones on the burials. The site is not maintained and the condition of the burials is fair. The burial site is of high heritage significance, it is situated in close proximity of proposed pipeline construction alignments and a conservation buffer should be observed. Alternatively, the burials should be relocated according to the applicable social and statutory requirements, should impact prove inevitable.

Figure 5-20: View of a burial at Site EXIGO-C6NC-BP01.

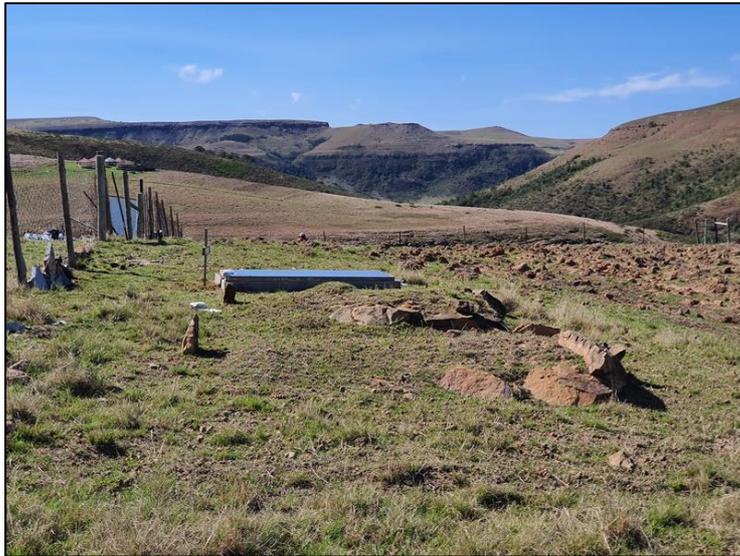
A small family cemetery containing at least 4 graves, occurs next to a homestead complex in Nkanga. One of the graves is indicated with a brick structures fashioned with ceramic tiles and the other burials are indicated by an elongated stone mounds covered with soil. The site is enclosed in the homestead fence, the site is not maintained and the condition of the burials is fair. The burial site is of high heritage significance, it is situated in close proximity of proposed pipeline construction alignments and a conservation buffer should be observed. Alternatively, the burials should be relocated according to the applicable social and statutory requirements, should impact prove inevitable.

Figure 5-21: View of a burial at Site EXIGO-C6NC-BP02.

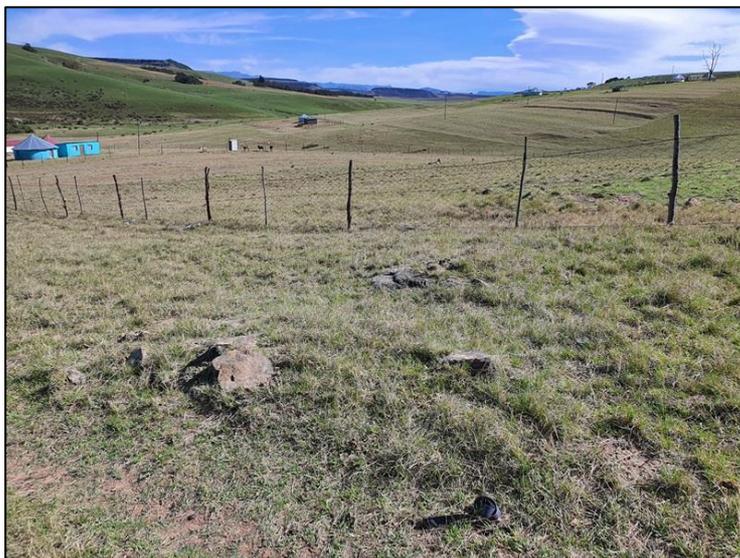
A poorly visible single grave occurs in an open field in the KuManzimdaka area. The grave is indicated by a elongated stone cairn filled in with soil and covered with surface grass. The burial is not fenced off and the condition of the grave is poor. The burial site is of high heritage significance, it is situated in close proximity of the proposed pipeline construction alignments and a conservation buffer should be observed. Alternatively, the burial should be relocated according to the applicable social and statutory requirements, should impact prove inevitable.

Figure 5-22: View of a burial at Site EXIGO-C6NC-BP03.

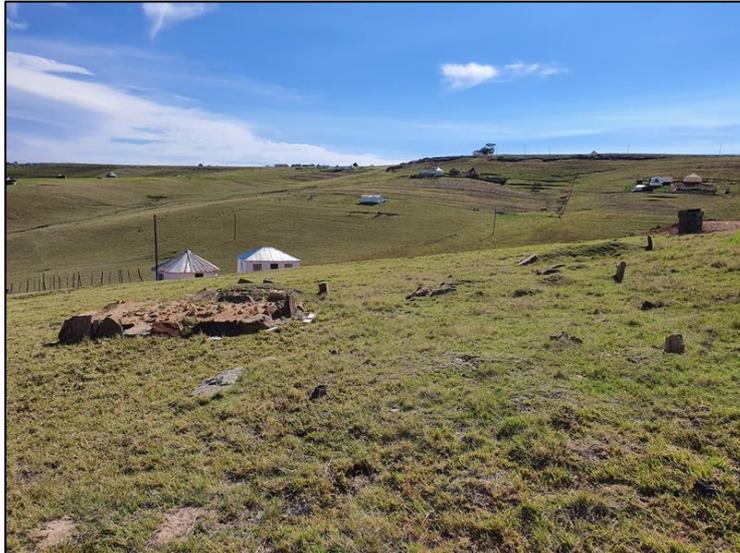
At least 5 graves were noted in an open field in the KuManzimdaka area. The graves are indicated by elongated stone cairns filled in with soil and covered with surface grass and in some instances, rough and irregular and unmarked rocks were placed as headstones on the burials. The site is not maintained and the condition of the burials is fair. The burial site is of high heritage significance, it is situated in close proximity of proposed pipeline construction alignments and a conservation buffer should be observed. Alternatively,

Figure 5-23: View of a burial at Site EXIGO-C6NC-BP04.

the burials should be relocated according to the applicable social and statutory requirements, should impact prove inevitable.

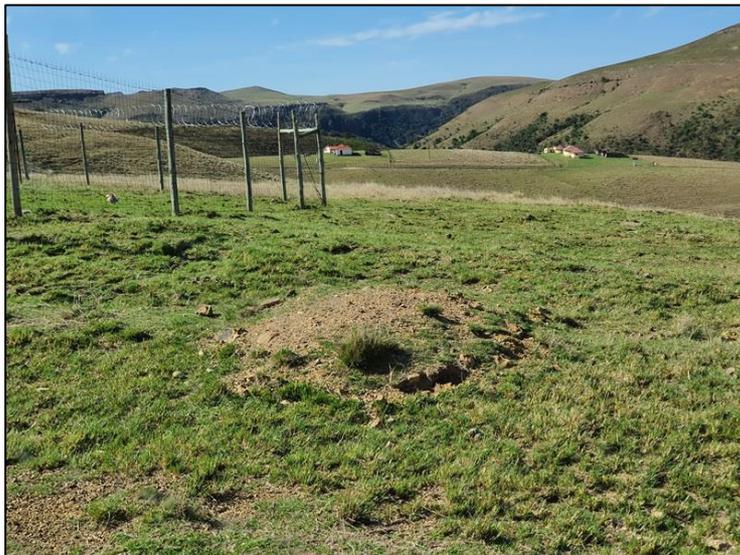
A single grave occurs in an open field in the KuManzimdaka area. The grave is indicated by an elongated stone cairn filled in with soil. The burial is not fenced off and the condition of the grave is fair. The burial site is of high heritage significance, it is situated in close proximity of the proposed pipeline construction alignments and a conservation buffer should be observed. Alternatively, the burial should be relocated according to the applicable social and statutory requirements, should impact prove inevitable.

Figure 5-24: View of a burial at Site Exigo-C6NC-BP27.

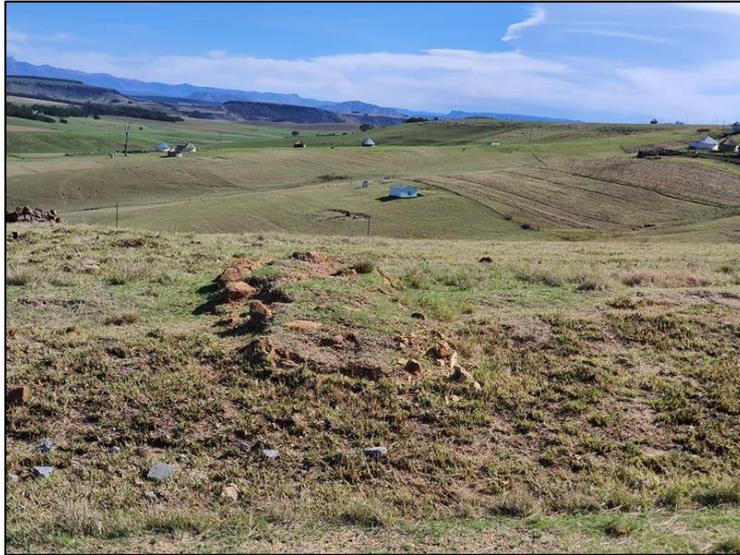
Another single grave occurs in an open field in the KuManzimdaka area. The grave is indicated by an elongated stone cairn filled in with soil and covered with surface grass. The burial is not fenced off and the condition of the grave is fair. The burial site is of high heritage significance, it is situated in close proximity of the proposed pipeline construction alignments and a conservation buffer should be observed. Alternatively,

Figure 5-25: View of a burial at Site EXIGO-C6NC-BP06

the burial should be relocated according to the applicable social and statutory requirements, should impact prove inevitable.

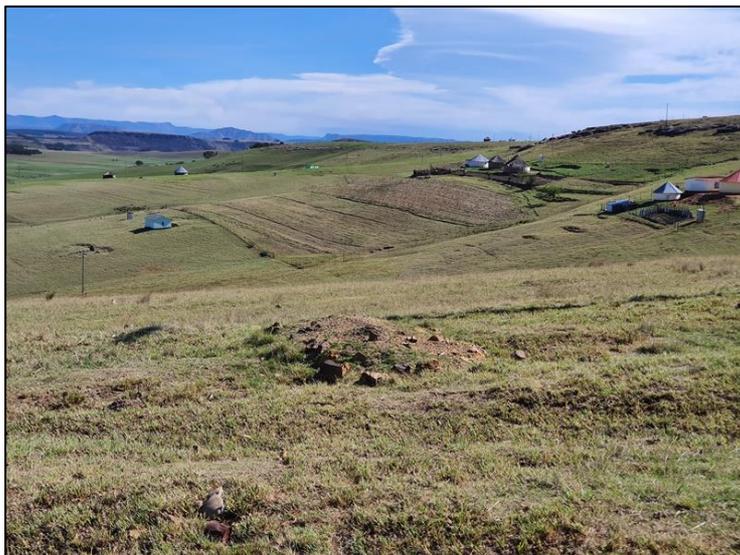
A single grave occurs next to the road in an open field in KuManzimdaka. The grave is indicated by an elongated stone cairn filled in with soil and covered with surface grass. The burial is not fenced off and the condition of the grave is fair. The burial site is of high heritage significance, it is situated in close proximity of the proposed pipeline construction alignments and a conservation buffer should be observed. Alternatively, the burial should be relocated according to the applicable social and statutory requirements, should impact prove inevitable.

Figure 5-26: View of a burial at Site EXIGO-C6NC-BP07.

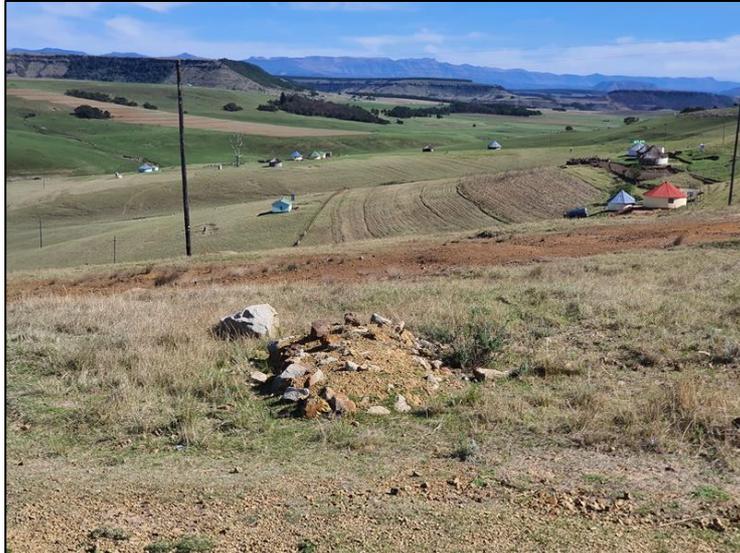
Another single grave occurs next to the road in an open field in the KuManzimdaka area. The grave is indicated by an elongated stone cairn filled in with soil and covered with surface grass. The burial is not fenced off and the condition of the grave is fair. The burial site is of high heritage significance, it is situated

in close proximity of the proposed pipeline construction alignments and a conservation buffer should be observed. Alternatively, the burial should be relocated according to the applicable social and statutory requirements, should impact prove inevitable.

Figure 5-27: View of a burial at Site EXIGO-C6NC-BP08

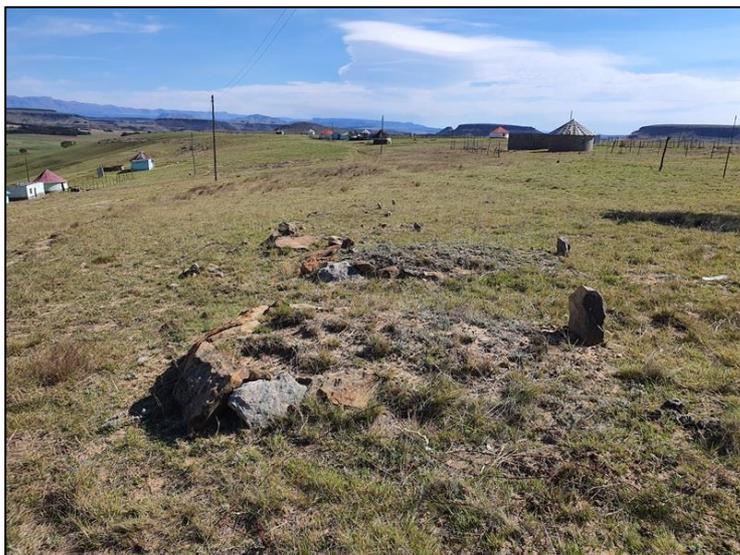
- **EXIGO-C6NC-BP09** -31.42980949 28.12905927

At least 3 graves were noted in an open field in the KuManzimdaka area. The graves are indicated by elongated stone cairns filled in with soil and covered with surface grass and in some instances, rough and irregular and unmarked rocks were placed as headstones on the burials. The site is not maintained and the condition of the burials is fair. The burial site is of high heritage significance, it is situated in close proximity of proposed pipeline construction alignments and a conservation buffer should be observed. Alternatively, the burials should be relocated according to the applicable social and statutory requirements, should impact prove inevitable.

Figure 5-28: View of a burial at Site EXIGO-C6NC-BP09

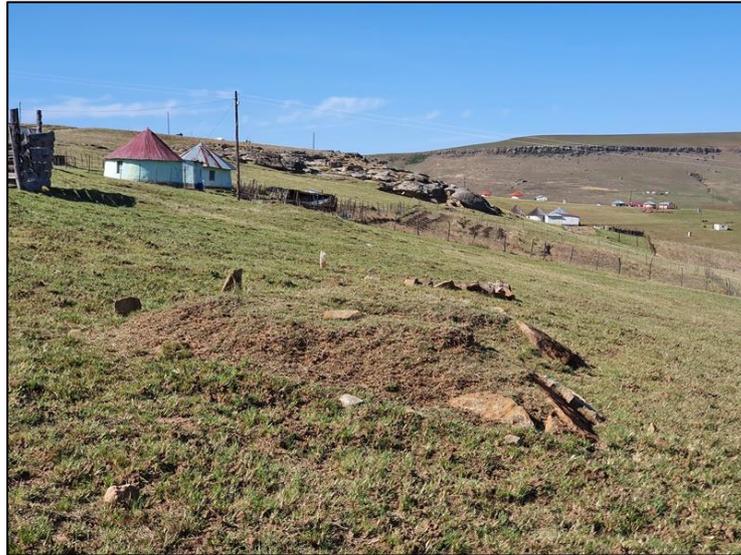
- **EXIGO-C6NC-BP10** -31.42798207 28.12835561

Another 3 graves were noted in an open field in the KuManzimdaka area. The graves are indicated by elongated stone cairns filled in with soil and covered with surface grass and in some instances, rough and irregular and unmarked rocks were placed as headstones on the burials. The site is not maintained and the condition of the burials is fair. The burial site is of high heritage significance, it is situated in close proximity of proposed pipeline construction alignments and a conservation buffer should be observed. Alternatively, the burials should be relocated according to the applicable social and statutory requirements, should impact prove inevitable.

Figure 5-29: View of a burial at Site EXIGO-C6NC-BP10

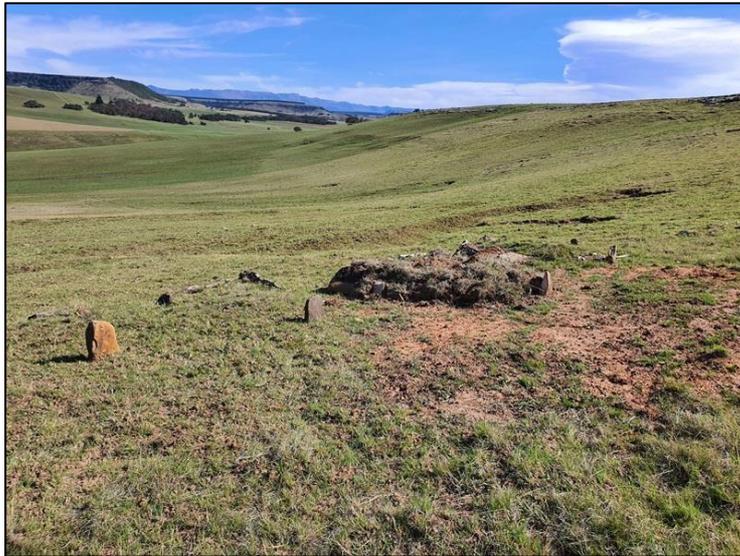
- **EXIGO-C6NC-BP11** -31.4278384 28.12768942

At least 4 graves were noted in an open field in the KuManzimdaka area. The graves are indicated by elongated stone cairns filled in with soil and covered with surface grass and in some instances, rough and irregular and unmarked rocks were placed as headstones on the burials. The site is not maintained and the condition of the burials is poor. The burial site is of high heritage significance, it is situated in close proximity of proposed pipeline construction alignments and a conservation buffer should be observed. Alternatively, the burials should be relocated according to the applicable social and statutory requirements, should impact prove inevitable.

Figure 5-30: View of a burial at Site EXIGO-C6NC-BP11

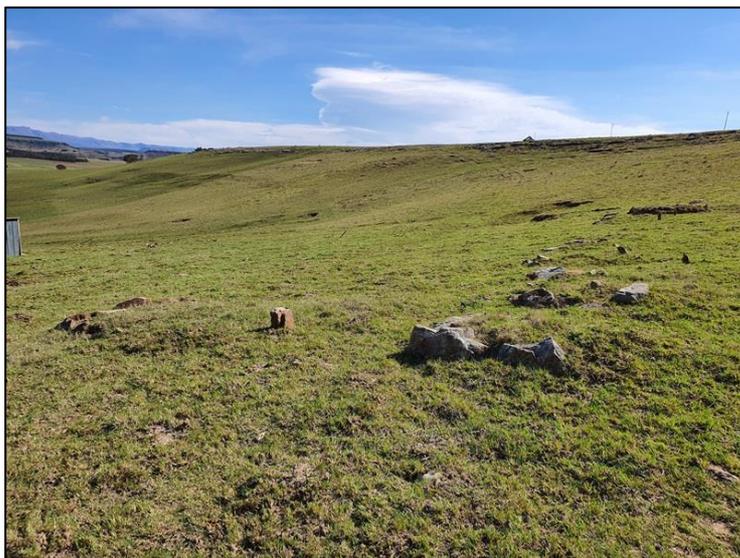
- **EXIGO-C6NC-BP12** -31.42793488 28.12751792

At least 7 poorly visible graves were noted in an open field in the KuManzimdaka area. The graves are indicated by elongated stone cairns filled in with soil and covered with surface grass and in some instances, rough and irregular and unmarked rocks were placed as headstones on the burials. The site is not maintained and the condition of the burials is fair. The burial site is of high heritage significance, it is situated in close proximity of proposed pipeline construction alignments and a conservation buffer should be observed. Alternatively, the burials should be relocated according to the applicable social and statutory requirements, should impact prove inevitable.

Figure 5-31: View of a burial at Site EXIGO-C6NC-BP12

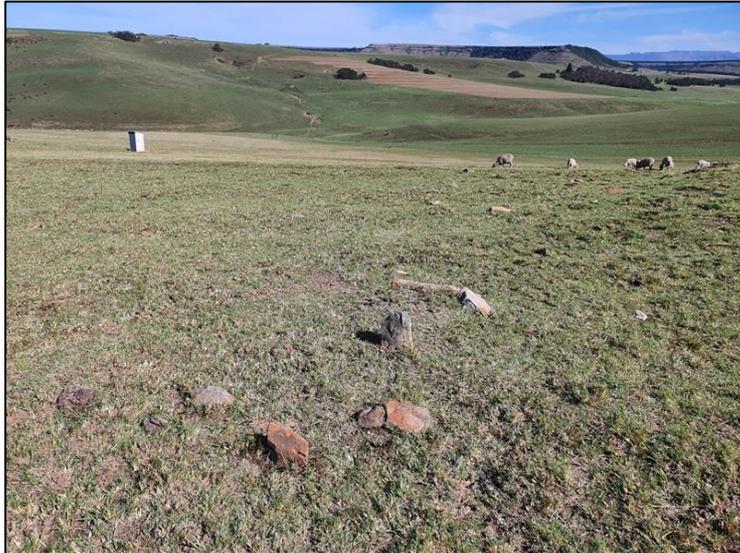
- **EXIGO-C6NC-BP13** -31.42820494 28.12709967

At least 2 graves were noted in an open field in the KuManzimdaka area. The poorly visible graves are indicated by elongated stone cairns filled in with soil and covered with surface grass and in some instances, rough and irregular and unmarked rocks were placed as headstones on the burials. The site is not maintained and the condition of the burials is fair. The burial site is of high heritage significance, it is situated in close proximity of proposed pipeline construction alignments and a conservation buffer should be observed.

Figure 5-32: View of a burial at Site EXIGO-C6NC-BP13

Alternatively, the burials should be relocated according to the applicable social and statutory requirements, should impact prove inevitable.

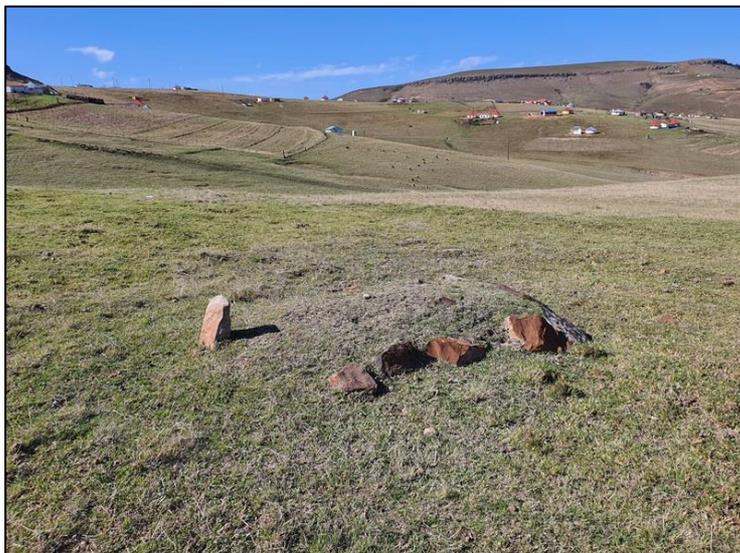
- **EXIGO-C6NC-BP14** -31.42854047 28.12629048

A single grave occurs in an open field in the KuManzimdaka area. The grave is indicated by an elongated stone cairn filled in with soil and covered with surface grass. The burial is not fenced off and the condition of the grave is fair. The burial site is of high heritage significance, it is situated in close proximity of the proposed pipeline construction alignments and a conservation buffer should be observed. Alternatively, the burial should be relocated according to the applicable social and statutory requirements, should impact prove inevitable.

Figure 5-33: View of a burial at Site EXIGO-C6NC-BP14

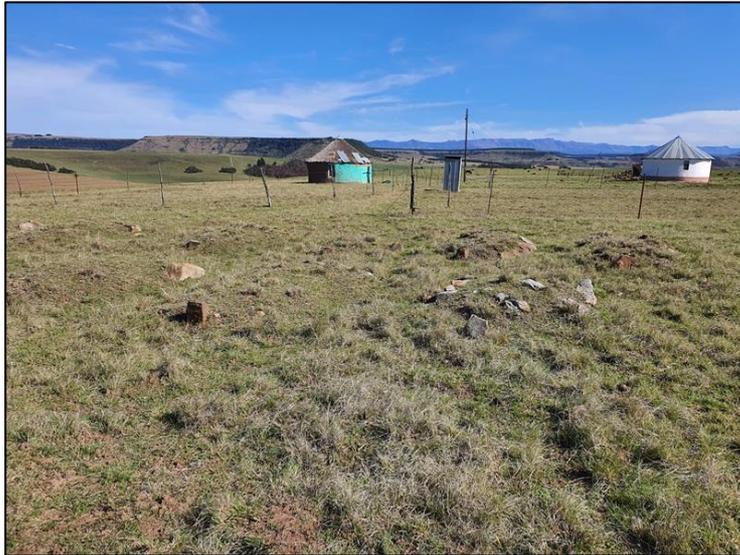
- **EXIGO-C6NC-BP15** -31.425655 28.12912859

At least 6 graves were noted in an open field in the Ngqayi area. The graves are indicated by elongated stone cairns filled in with soil and covered with dense surface grass and in some instances, rough and irregular and unmarked rocks were placed as headstones on the burials. The site is not maintained and the condition of

the burials is fair. The burial site is of high heritage significance, it is situated in close proximity of proposed pipeline construction alignments and a conservation buffer should be observed. Alternatively, the burials should be relocated according to the applicable social and statutory requirements, should impact prove inevitable.

Figure 5-34: View of a burial at Site EXIGO-C6NC-BP15

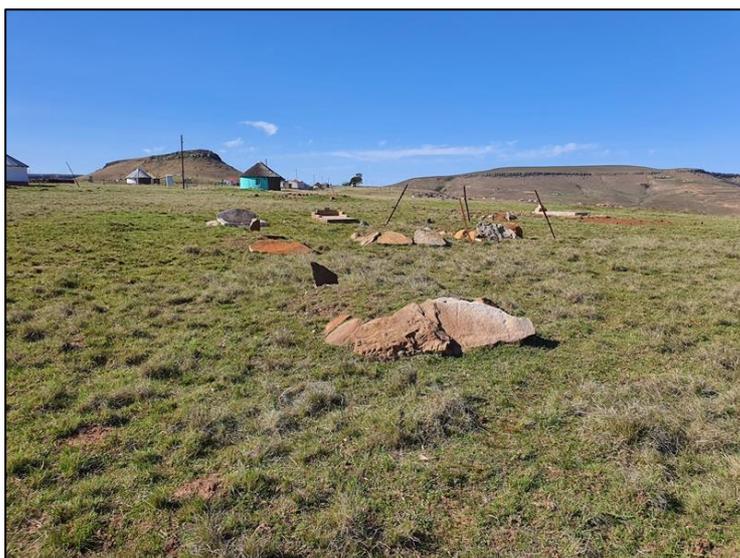
- **EXIGO-C6NC-BP16** -31.42464465 28.12858284

A small family cemetery containing at least 7 graves, occurs next to a homestead complex in KuManzimdaka. One of the graves is indicated with a brick structures fashioned with ceramic tiles, another is fashioned with a concrete structure and the other burials are indicated by an elongated stone mounds covered with soil. One of the graves is enclosed in a fence, the site is not maintained and the condition of the burials is fair. The burial site is of high heritage significance, it is situated in close proximity of proposed pipeline construction alignments and a conservation buffer should be observed. Alternatively, the burials should be relocated according to the applicable social and statutory requirements, should impact prove inevitable.

Figure 5-35: View of a burial at Site EXIGO-C6NC-BP16
