**AGES OMEGA: PROPOSED CLUSTER 6 GQAGA BULK RISING MAIN WEST WATER SUPPLY SCHEME PROJECT, LIXENI AND NCITYANA AREAS, CHRIS HANI DISTRICT MUNICIPALITY, EASTERN CAPE PROVINCE**

**Archaeological Impact Assessment**

## **ARCHAEOLOGICAL IMPACT ASSESSMENT (AIA) OF AREAS DEMARCTED FOR THE PROPOSED CLUSTER 6 GQAGA BULK RISING MAIN WEST WATER SUPPLY SCHEME PROJECT, LIXENI AND NCITYANA AREAS, CHRIS HANI DISTRICT MUNICIPALITY, EASTERN CAPE PROVINCE**

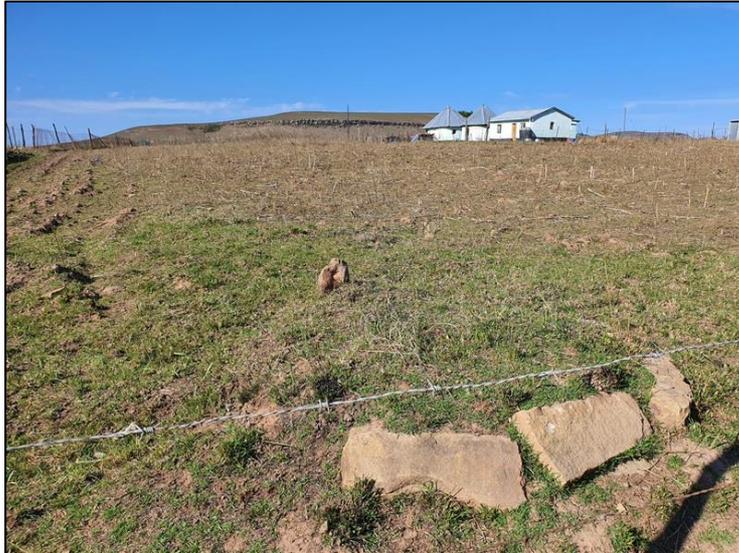
- **EXIGO-C6NC-BP17** -31.43356567 28.13060816

A single grave occurs within a homestead complex in the KuManzimdaka. The grave is indicated by an elongated stone cairn filled in with soil and covered with surface grass. The burial is not fenced off and the condition of the grave is fair. The burial site is of high heritage significance, it is situated in close proximity of the proposed pipeline construction alignments and a conservation buffer should be observed. Alternatively, the burial should be relocated according to the applicable social and statutory requirements, should impact prove inevitable.

Figure 5-36: View of a burial at Site EXIGO-C6NC-BP17

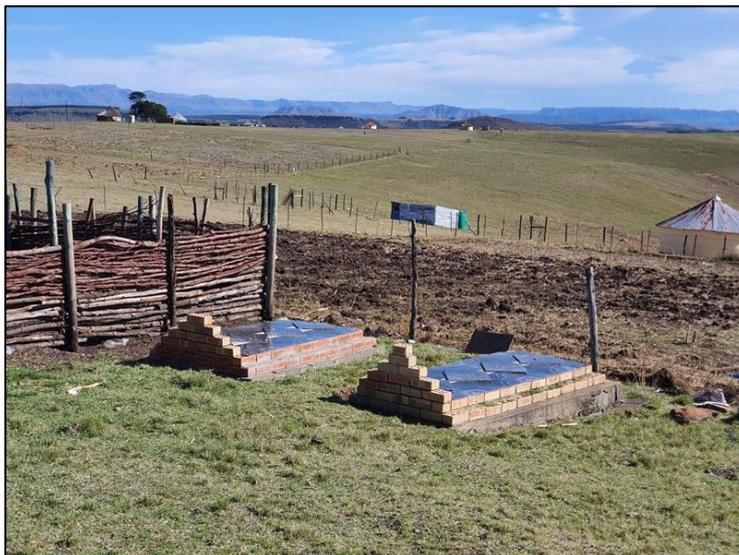
- **EXIGO-C6NC-BP18** -31.43338496 28.13089114

Two graves were noted in a homestead complex in KuManzimdaka. The graves are indicated by brick structures fashioned with ceramic tiles with brick headstones. The site is enclosed in the homestead fence, the site is maintained and the condition of the burials is good. The burial site is of high heritage significance, it is situated in close proximity of proposed pipeline construction alignments and a conservation buffer should be observed. Alternatively, the burials should be relocated according to the applicable social and statutory requirements, should impact prove inevitable.

Figure 5-37: View of a burial at Site EXIGO-C6NC-BP18

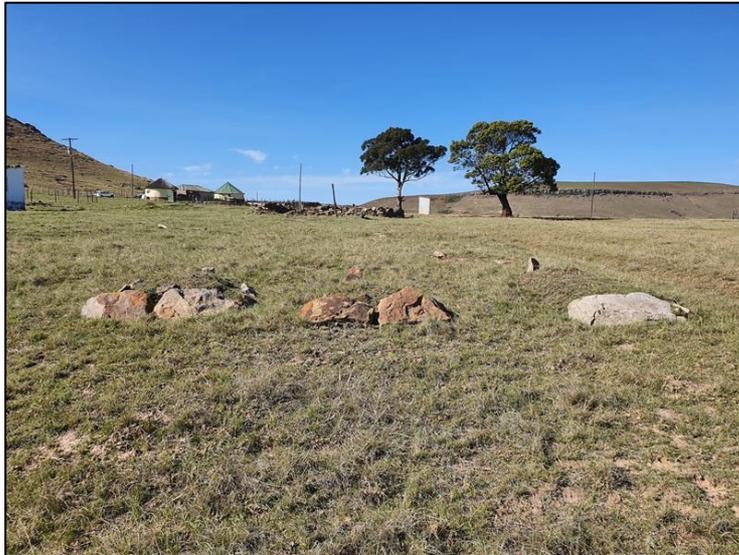
- **EXIGO-C6NC-BP19** -31.43388427 28.1319527

At least 3 graves were noted in an open field in the KuManzimdaka area. The graves are indicated by elongated stone cairns filled in with soil and covered with surface grass and in some instances, rough and irregular and unmarked rocks were placed as headstones on the burials. The site is not maintained and the condition of the burials is fair. The burial site is of high heritage significance, it is situated in close proximity of proposed pipeline construction alignments and a conservation buffer should be observed. Alternatively, the burials should be relocated according to the applicable social and statutory requirements, should impact prove inevitable.

Figure 5-38: View of a burial at Site EXIGO-C6NC-BP19

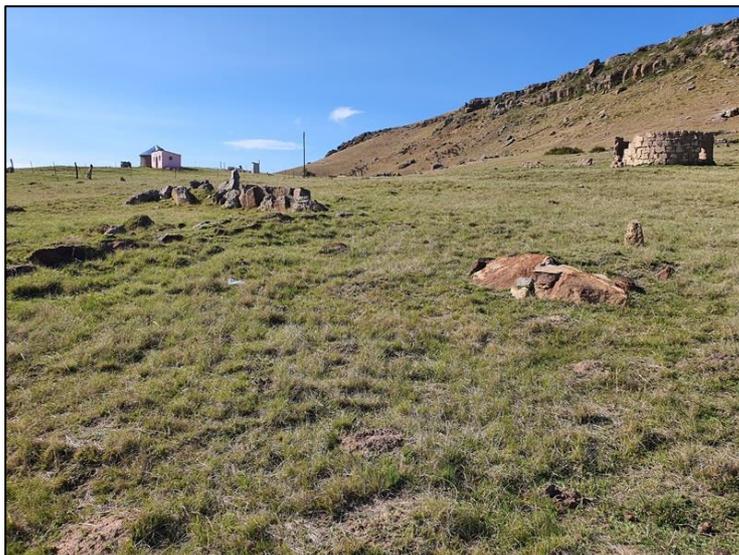
- **EXIGO-C6NC-BP20** -31.43449062 28.13425463

A single grave occurs in an open field in the KuManzimdaka. The grave is indicated by an elongated stone cairn filled in with soil and covered with surface grass. The burial is not fenced off and the condition of the grave is fair. The burial site is of high heritage significance, it is situated in close proximity of the proposed pipeline construction alignments and a conservation buffer should be observed. Alternatively, the burial should be relocated according to the applicable social and statutory requirements, should impact prove inevitable.

Figure 5-39: View of a burial at Site EXIGO-C6NC-BP20

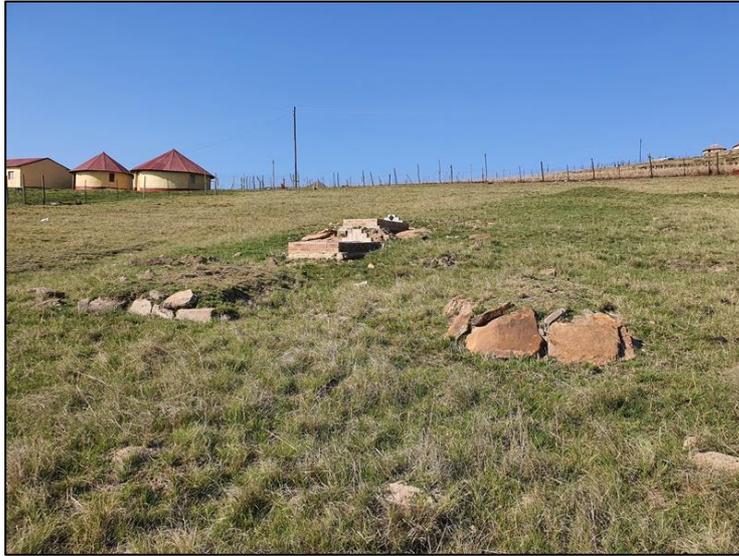
- **EXIGO-C6NC-BP21** -31.43656614 28.14105084

At least 4 graves were noted in an open field in the KuManzimdaka area. Two of the graves are indicated by brick structures fashioned with ceramic tiles with brick headstones and the other graves are indicated by elongated stone cairns filled in with soil. The site is not maintained and the condition of the burials is fair. The burial site is of high heritage significance, it is situated in close proximity of proposed pipeline construction alignments and a conservation buffer should be observed. Alternatively, the burials should be relocated according to the applicable social and statutory requirements, should impact prove inevitable.

Figure 5-40: View of a burial at Site EXIGO-C6NC-BP21

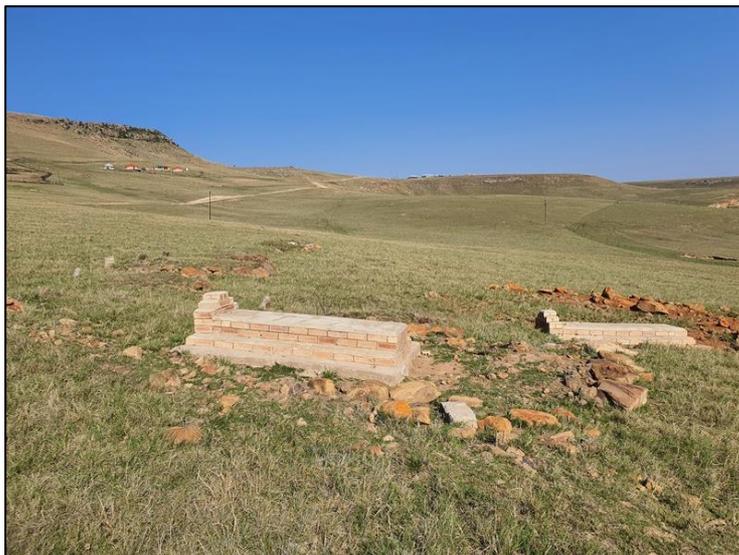
- **EXIGO-C6NC-BP22** -31.43589458 28.14398007

A small cemetery containing at least 7 graves, occurs in an open field in the KuManzimdaka area. Two of the graves are indicated by brick structures fashioned with ceramic tiles with brick headstones and the other burial is indicated by an elongated stone mound covered with soil. The site is enclosed in the homestead fence, the site is not maintained and the condition of the burials is fair. The burial site is of high heritage significance, it is situated in close proximity of proposed pipeline construction alignments and a conservation buffer should be observed. Alternatively, the burials should be relocated according to the applicable social and statutory requirements, should impact prove inevitable.

Figure 5-41: View of a burial at Site EXIGO-C6NC-BP22

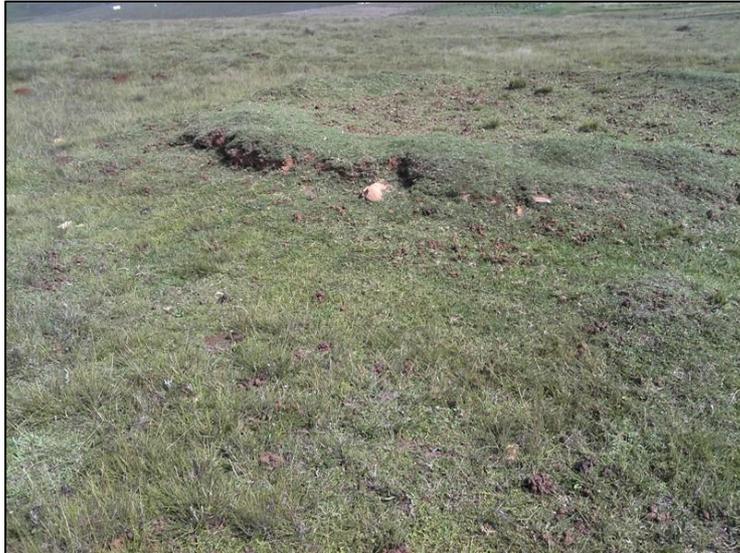
- **EXIGO-C6NC-BP23** -31.44294083 28.15972782

A poorly visible single grave occurs in an open field in the Nkanga area. The grave is indicated by an elongated soil mound and covered with surface grass. The burial is not fenced off and the condition of the grave is poor. The burial site is of high heritage significance, it is situated in close proximity of the proposed pipeline construction alignments and a conservation buffer should be observed. Alternatively, the burial should be relocated according to the applicable social and statutory requirements, should impact prove inevitable.

Figure 5-42: View of a burial at Site EXIGO-C6NC-BP23

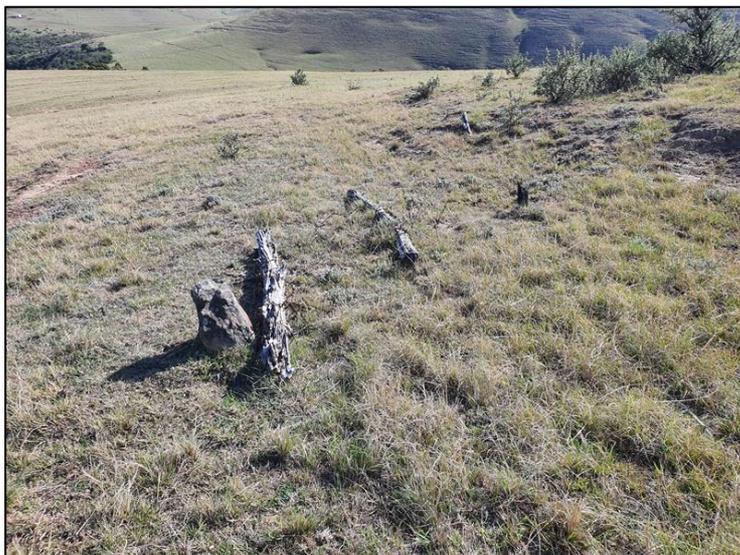
- **EXIGO-C6NC-BP24** -31.44302775 28.14851023

A single grave occurs in an open field in Nkanga. The grave is indicated by a soil mound with an upright headstone. The burial is not fenced off and the condition of the grave is fair. The burial site is of high heritage significance, it is situated in close proximity of the proposed pipeline construction alignments and a conservation buffer should be observed. Alternatively, the burial should be relocated according to the applicable social and statutory requirements, should impact prove inevitable.

Figure 5-43: View of a burial at Site EXIGO-C6NC-BP24

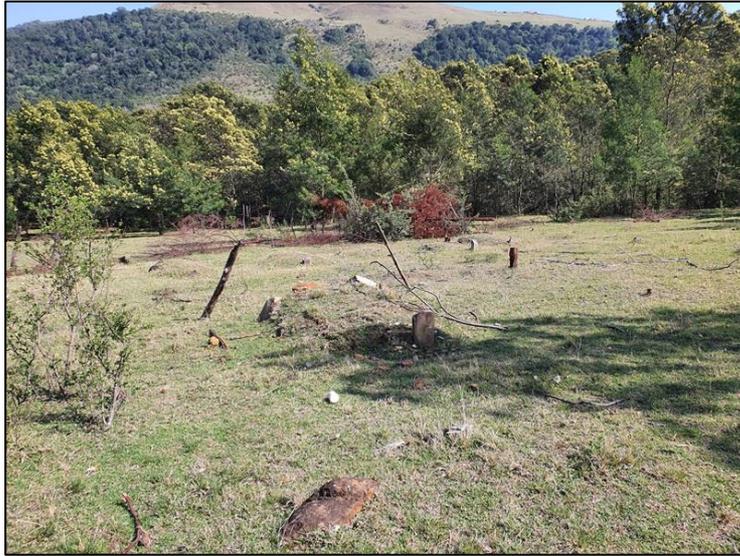
- **EXIGO-C6NC-BP25** -31.44858059 28.14681357

Another single grave occurs in an open field in the Nkanga area. The grave is indicated by an elongated stone cairn filled in with soil and covered with surface grass. A dilapidated fenced encloses the burial and the condition of the grave is fair. The burial site is of high heritage significance, it is situated in close proximity of the proposed pipeline construction alignments and a conservation buffer should be observed. Alternatively, the burial should be relocated according to the applicable social and statutory requirements, should impact prove inevitable.

Figure 5-44: View of a burial at Site EXIGO-C6NC-BP25

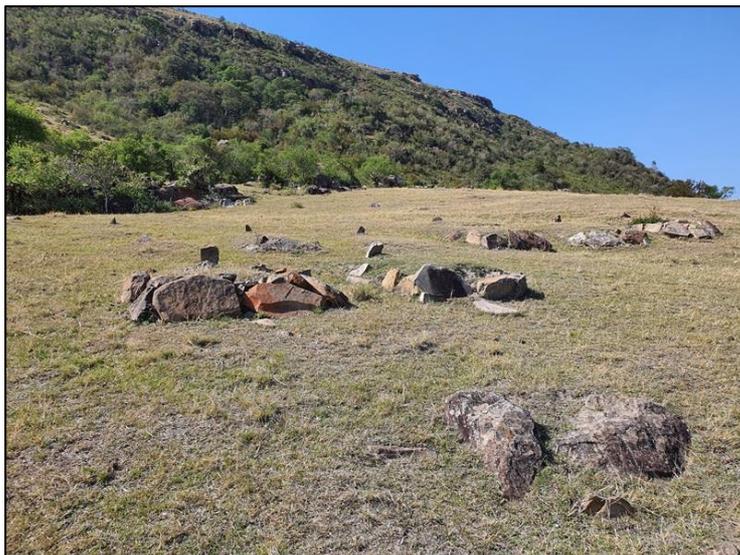
- **EXIGO-C6NC-BP26** -31.45343422 28.14503325

At least 7 graves were noted in an open field in the Nkanga area. The graves are indicated by elongated stone cairns filled in with soil and covered with surface grass and in some instances, rough and irregular and unmarked rocks were placed as headstones on the burials. The site is not maintained and the condition of the burials is fair. The burial site is of high heritage significance, it is situated in close proximity of proposed pipeline construction alignments and a conservation buffer should be observed. Alternatively, the burials should be relocated according to the applicable social and statutory requirements, should impact prove inevitable.

Figure 5-45: View of a burial at Site EXIGO-C6NC-BP26

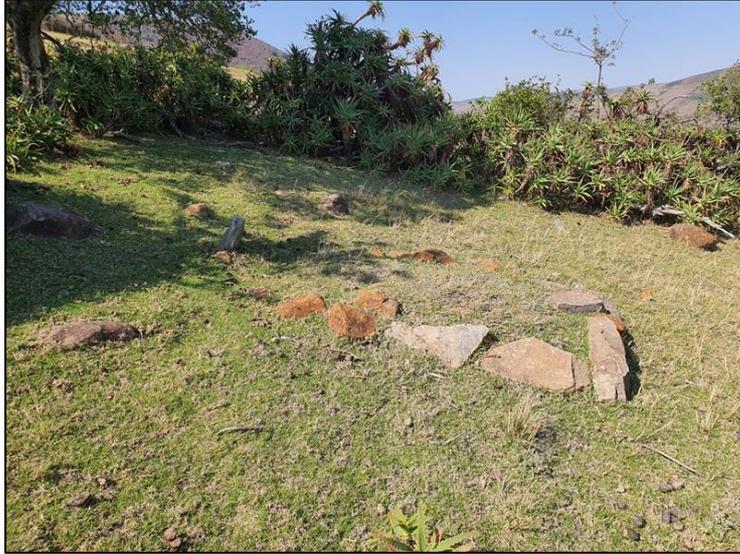
- **EXIGO-C6NC-BP27** -31.45477356 28.14129291

A single grave occurs next to a stone wall in Nkanga. The grave is indicated by an elongated stone cairn filled in with soil and covered with surface grass. The burial is not fenced off and the condition of the grave is fair. The burial site is of high heritage significance, it is situated in close proximity of the proposed pipeline construction alignments and a conservation buffer should be observed. Alternatively, the burial should be relocated according to the applicable social and statutory requirements, should impact prove inevitable.

Figure 5-46: View of a burial at Site EXIGO-C6NC-BP27
