AFRICAN HERITAGE CONSULTANTS CC

28 August 2007

CULTURAL HERITAGE RESOURCES IMPACT ASSESSMENT OF REMAINDER 13 AND PORTION 287 - 296 OF THE FARM MOOIPLAATS 367 JR TSHWANE GAUTENG

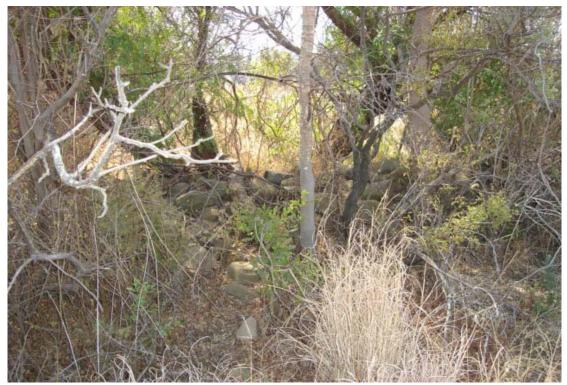
A typical site consists of an outer stone circle and an inner stone circle. In many cases the inner stone circle is again sub-divided. Some of the sites are only 10 metres in diameter while others are 50 to 100 metres and more in diameter (see photographs 1-4).

No. 1 Typical stonewalled site with dense vegetation

- A phase II investigation of the archaeological site be conducted. For this
 purpose the veld will have to be burned in the spring to get rid of the tall grass.
 Some bush clearing will also have to take place so that individual sites can be
 recorded.

- Two or possible three of the most important sites should be preserved in a heritage park in the new development and be properly restored in a phase III investigation.

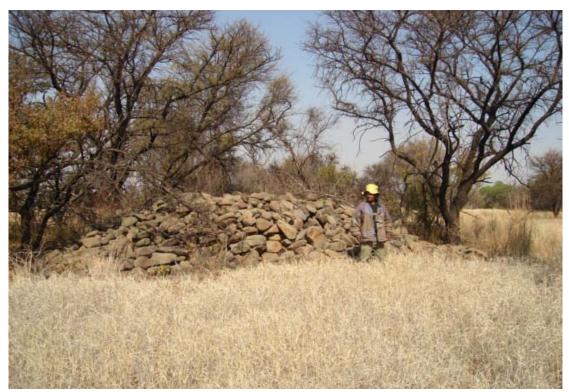
On average the stonewalling is less than one meter high though some stonewalls are nearly two metres high. It is also clear that some of the stonewall have been reused for modern cattle kraals (square) while others may even have been used as redoubts during the battle of Diamond Hill in the Second Anglo Boer War (see Berg 1999 p 52 -53).

No. 2 One of the sites with high walling

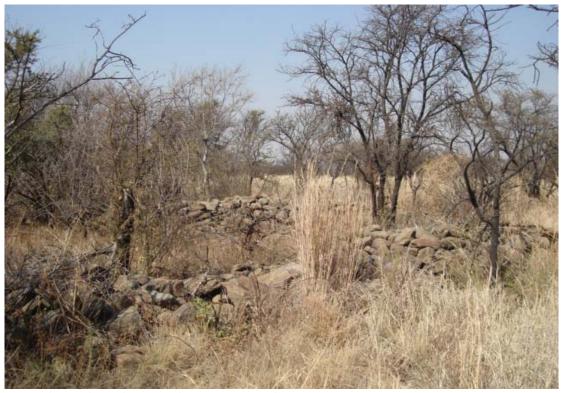
No. 3 A Typical site showing outer and inner walls

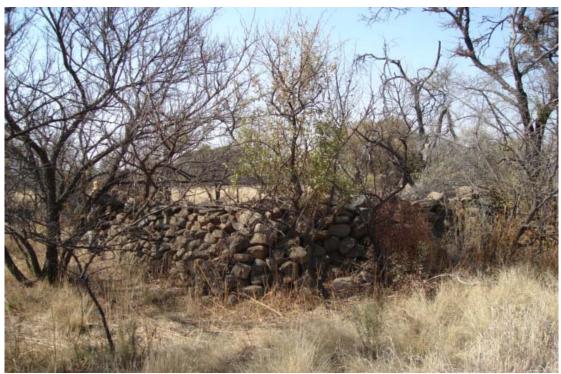
No. 4 One of the sites where the walls were reused for a modern cattle kraal

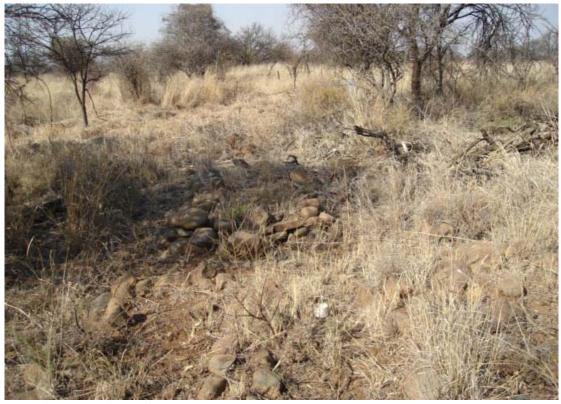
At S25° 49' 35.6" and E28° 24' 54.6 a large cemetery of fairly recent times was found. The graves are mostly just heaps of stones. Some are difficult to see because of the vegetation and stones, which have over the years been scattered. There might be up to forty graves. From the grave goods it is clear that these graves are not older than sixty years and thus fall outside the jurisdiction of Act 25 of 1999, but are protected by Provincial legislation (for detail see annexure A).

Two of the graves are in a good condition and according to one of the present farm workers are still visited by family members.

No 5 General view of the cemetery

The graves are important and should be properly cleaned and protected or mitigated.

- A heritage management plan must be compiled for the preserved heritage sites after the completion of the phase II and III mitigation.
- The cemetery should be cleaned the graves recorded and a decision must be taken to either preserve the cemetery or to move the graves to a new locality in accordance with present provincial legislation.

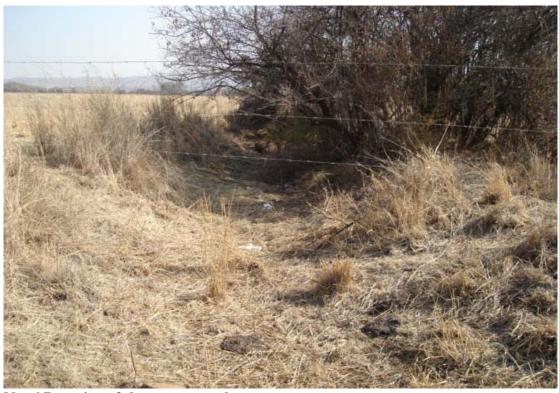
The remains of a canal was found on the north-western portion of the site near the river. This canal is typical of early Boer farm settlements.

A Furrow was dug to bring water to the house and for irrigating fields and orchards. Farming and the new road have destroyed the northern portion of the canal. The original farm settlement most probably was north of the present road. The canal will most probably date to the 1860 when the first farms were allocated to White farmers in the area (see photograph 5).

No. 6 Remains of the water canal

- The old water canal should be recorded in detail and be preserved as a feature in the new development if possible. If not a permit for destruction must be applied for
