# CHAPMANS PEAK DRIVE - HERITAGE IMPACT ASSESSMENT OF PROPOSED LOCATIONS OF TOLL PLAZAS

Prepared for

**Ninham Shand Consulting Services**

September 2003

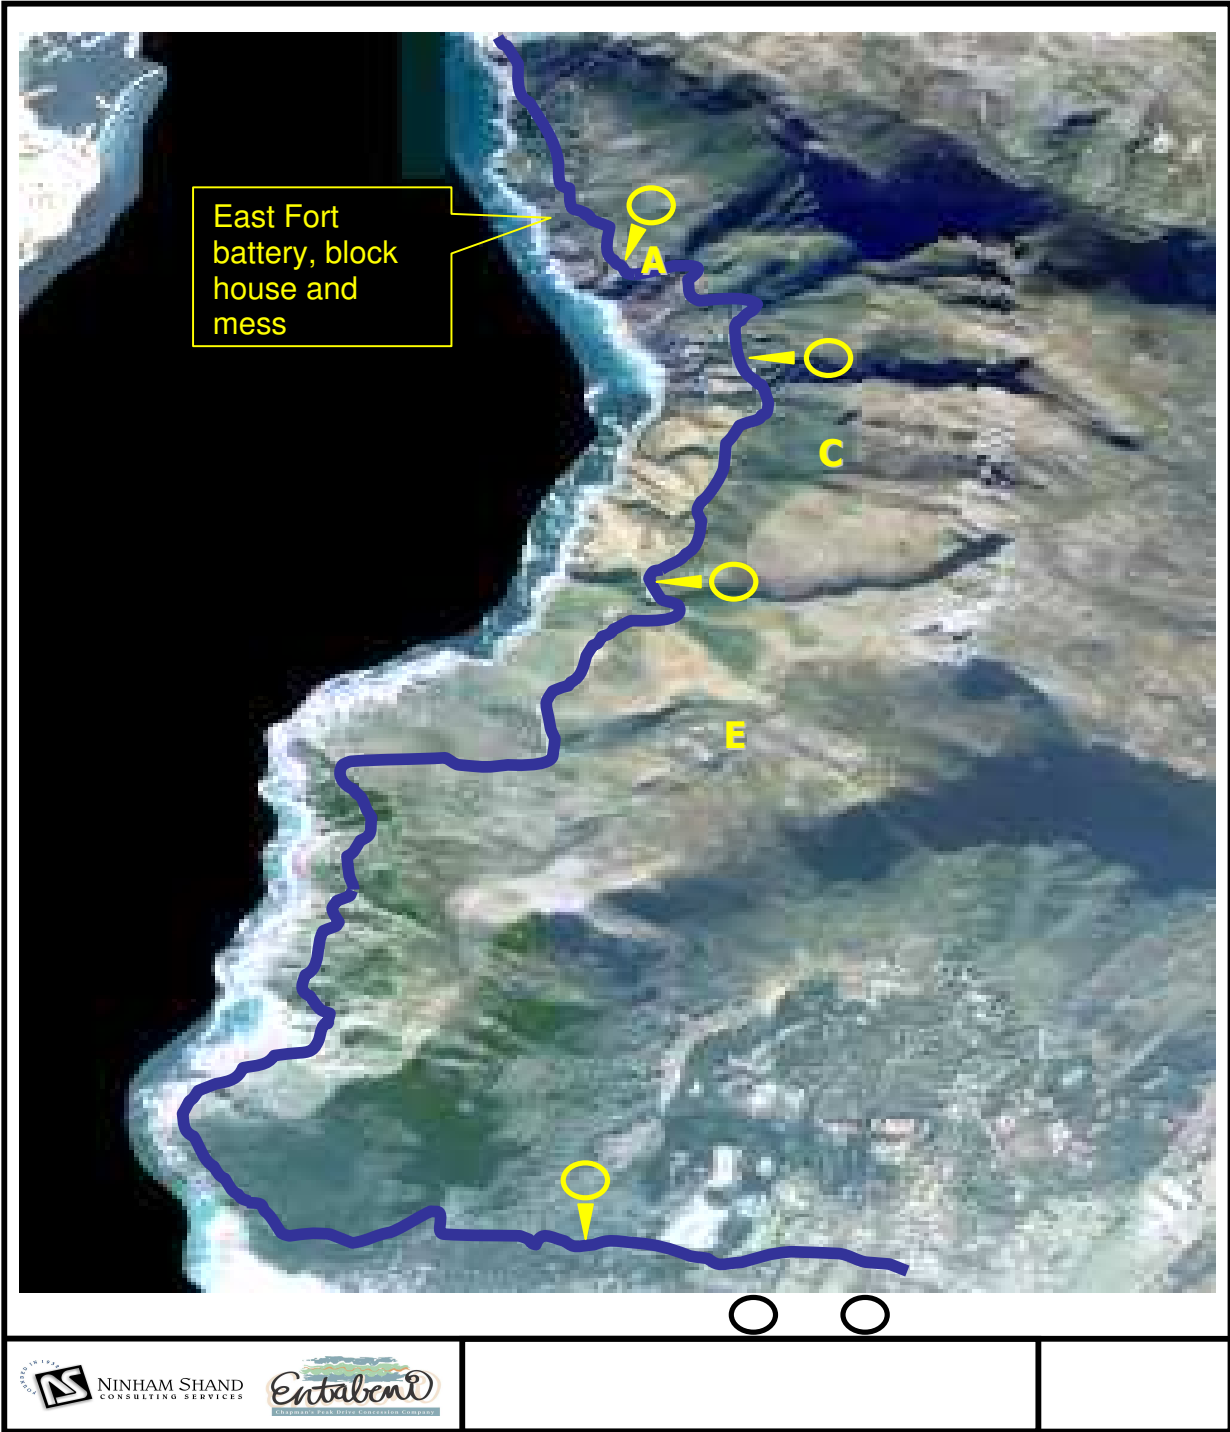
**Fig 1**

**A to H = alternative sites**

Aerial photograph showing the various feasible alternative locations for the tolling structure(s)
