Agency for Cultural Resource Management

21 September, 2011

ARCHAEOLOGICAL IMPACT ASSESSMENT THE PROPOSED EKSTEENFONTEIN WASTE SITE, NORTHERN CAPE

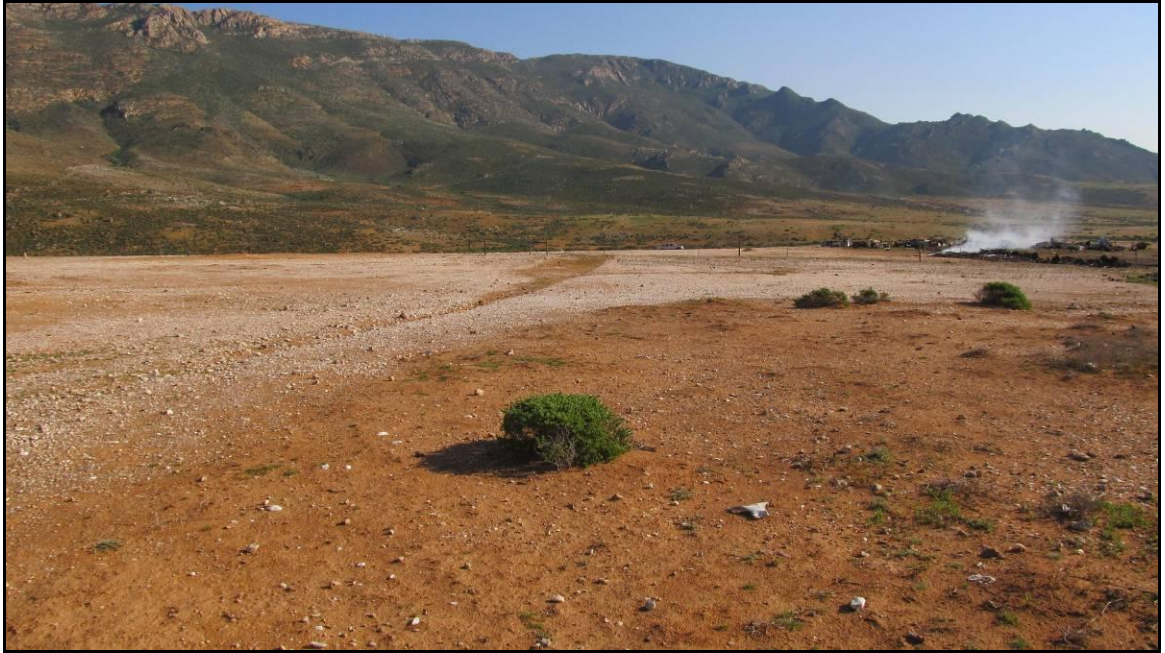
The proposed waste site is located about 1.5 kms north east of the village alongside (i.e. to the south of) the gravel road that leads into the Park. The site is quite flat at the top, but slopes fairly steeply toward the gravel road and a small, dry stream bed. The proposed site is already fairly severely degraded, as it is the settlements existing waste refuse facility. The site is currently fenced off and dumping of domestic waste occurs in the north east (Figures 4-6). The site has also been 'scraped' and partially shaped and there are several gravel tracks that intersect the footprint area. The slopes are covered in small quartz pebbles. There is virtually no natural vegetation on the proposed site.

Figure 4. View of the proposed Eksteenfontein waste site facing north east.

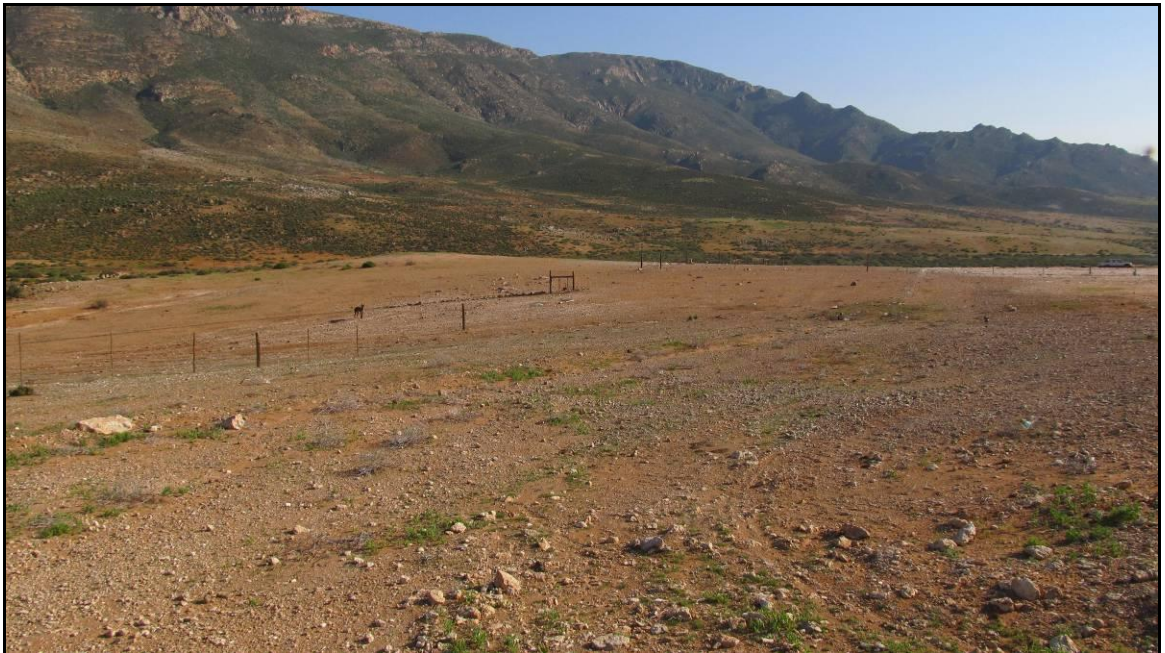
Figure 5. View of the proposed Eksteenfontein waste site facing north east.

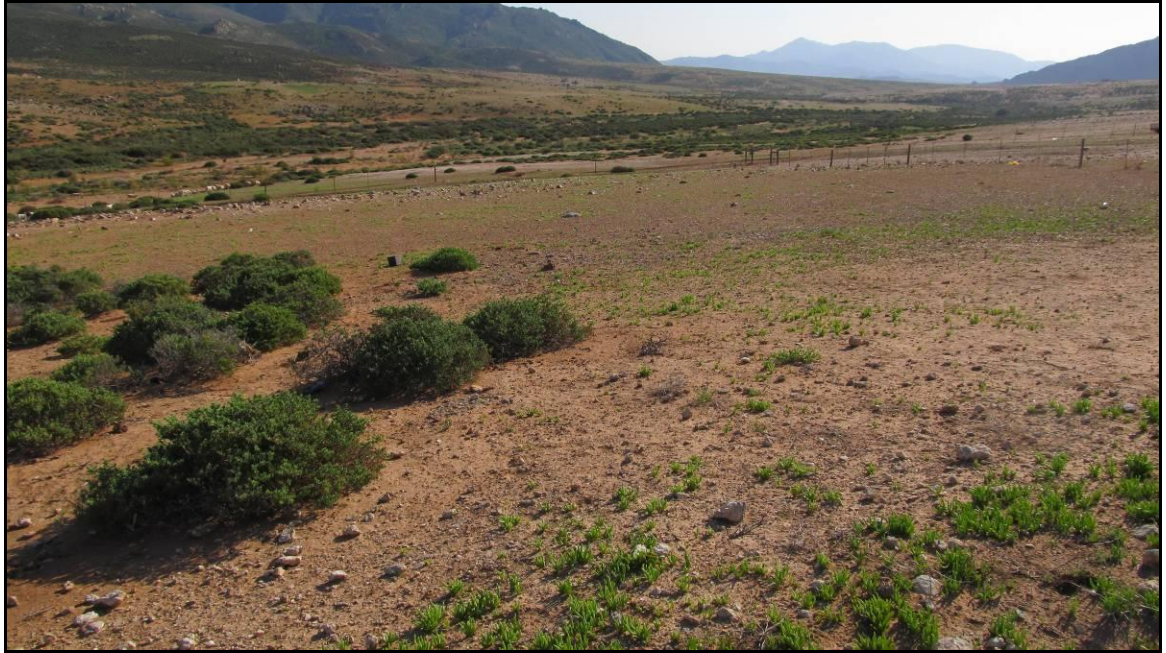
Figure 6. View of the proposed site Eksteenfontein waste facing north east.

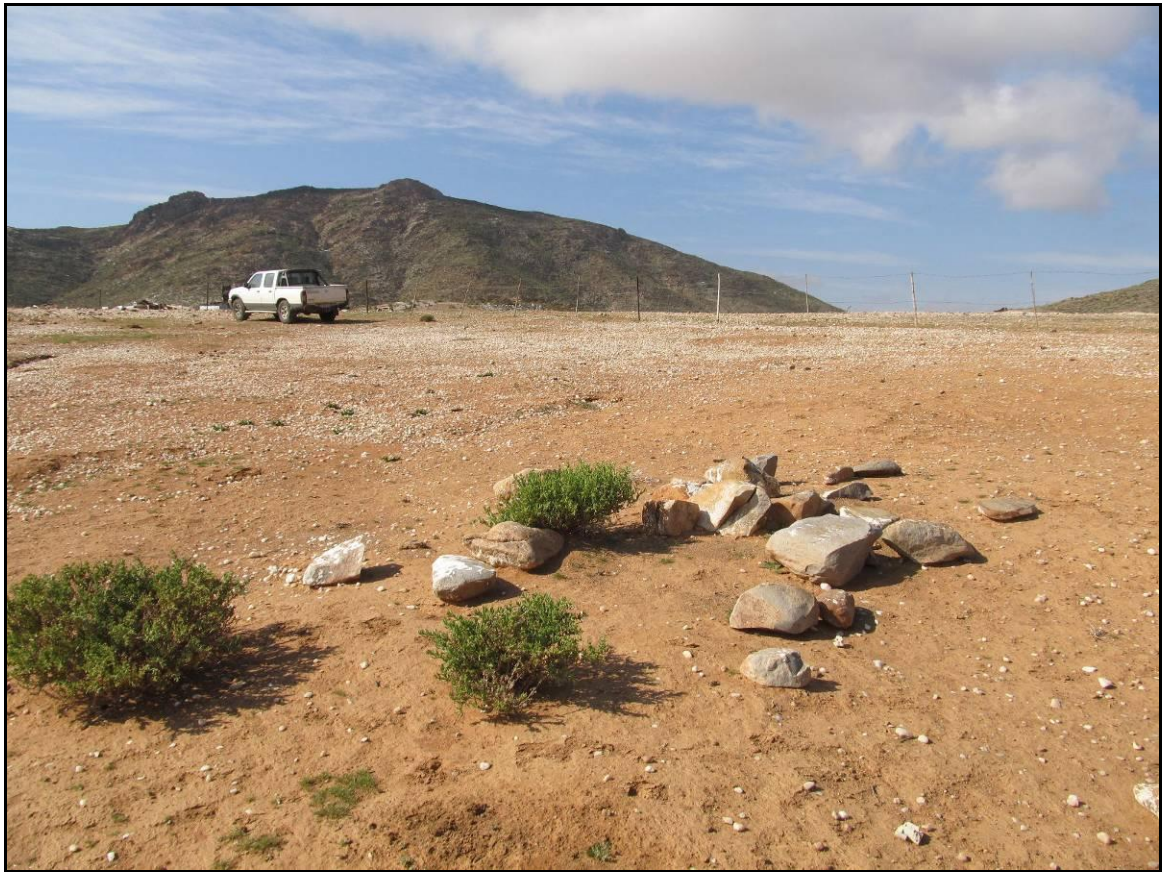
A possible 'traditional' (i.e. non-Christian) grave (S 28 48.887 E 17 15.993 on map datum wgs 84) was recorded close to the existing waste site (Figures 7 & 8). Typically, 'traditional' forms of graves appear in the landscape as circular stone cairns and are common in the Richtersveld landscape (Halkett 1999¹ and personnel observation).

The Eksteenfontein grave does not appear as a cairn, and has possibly collapsed with just a few stones and rocks lying about. There are no grave goods such as glass jars, bottles or marine shell, but the feature is still reasonably visible to the naked eye.

Figure 7. Remains of a possible grave alongside the existing Eksteenfontein waste site

As a precaution, the 'grave' location site has been 'Red Flagged'.

1. The project is deemed to be viable.
2. No archaeological mitigation is required.
3. The possible grave that has been identified must be fenced off prior to construction work commencing.
4. Should any unmarked human remains, or features such as buried ostrich eggshell caches be exposed or uncovered during excavations and bulk earthworks these must immediately be reported to the South African Heritage Resources Agency (Ms Mariagrazia Galimberti 021 4624502). Burials must not be disturbed until inspected by the archaeologist and will have to be removed by an archaeologist under a permit issued by SAHRA.

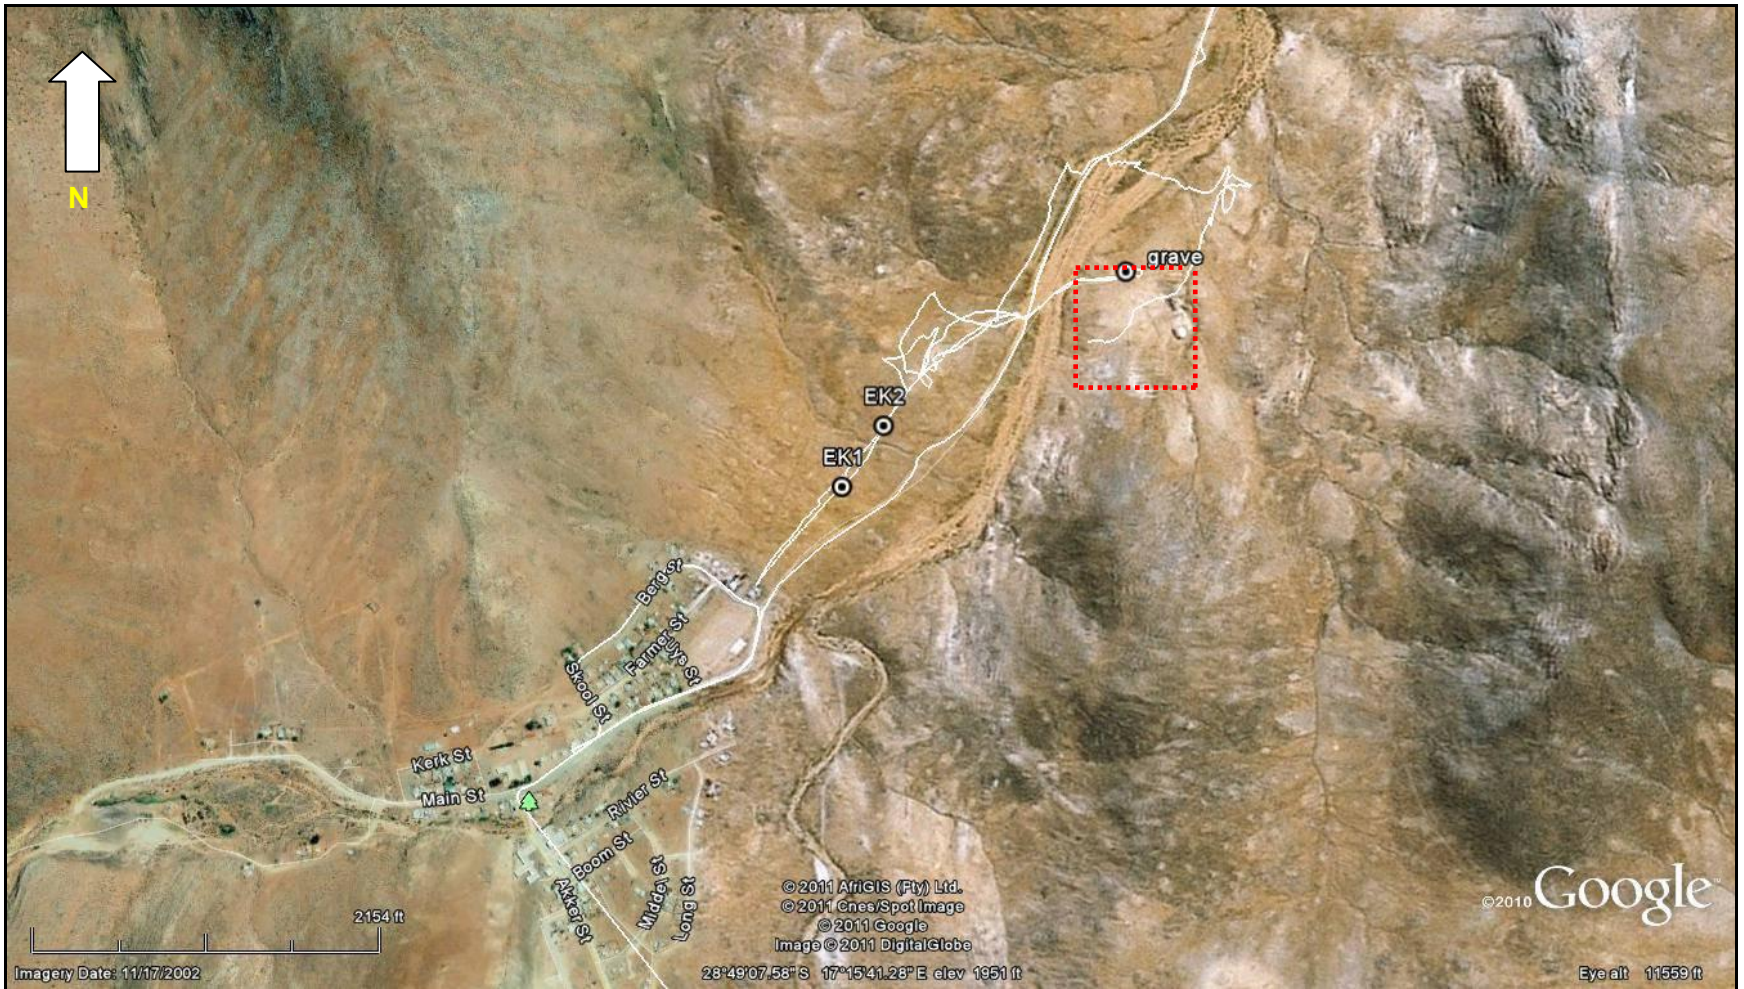
The proposed development may impact on a possible grave that is located close to the existing waste site, and measures must be taken to avoid damaging or disturbing this potentially sensitive feature.

Figure 8. Approximate boundary of the proposed Eksteenfontein waste site (dotted red line), illustrating the location of the possible grave site.
