ARCHAEOLOGICAL SURVEY OF THE
MAJUBA RAILWAY REALIGNMENT

Archaeological Resources Management

December, 1994

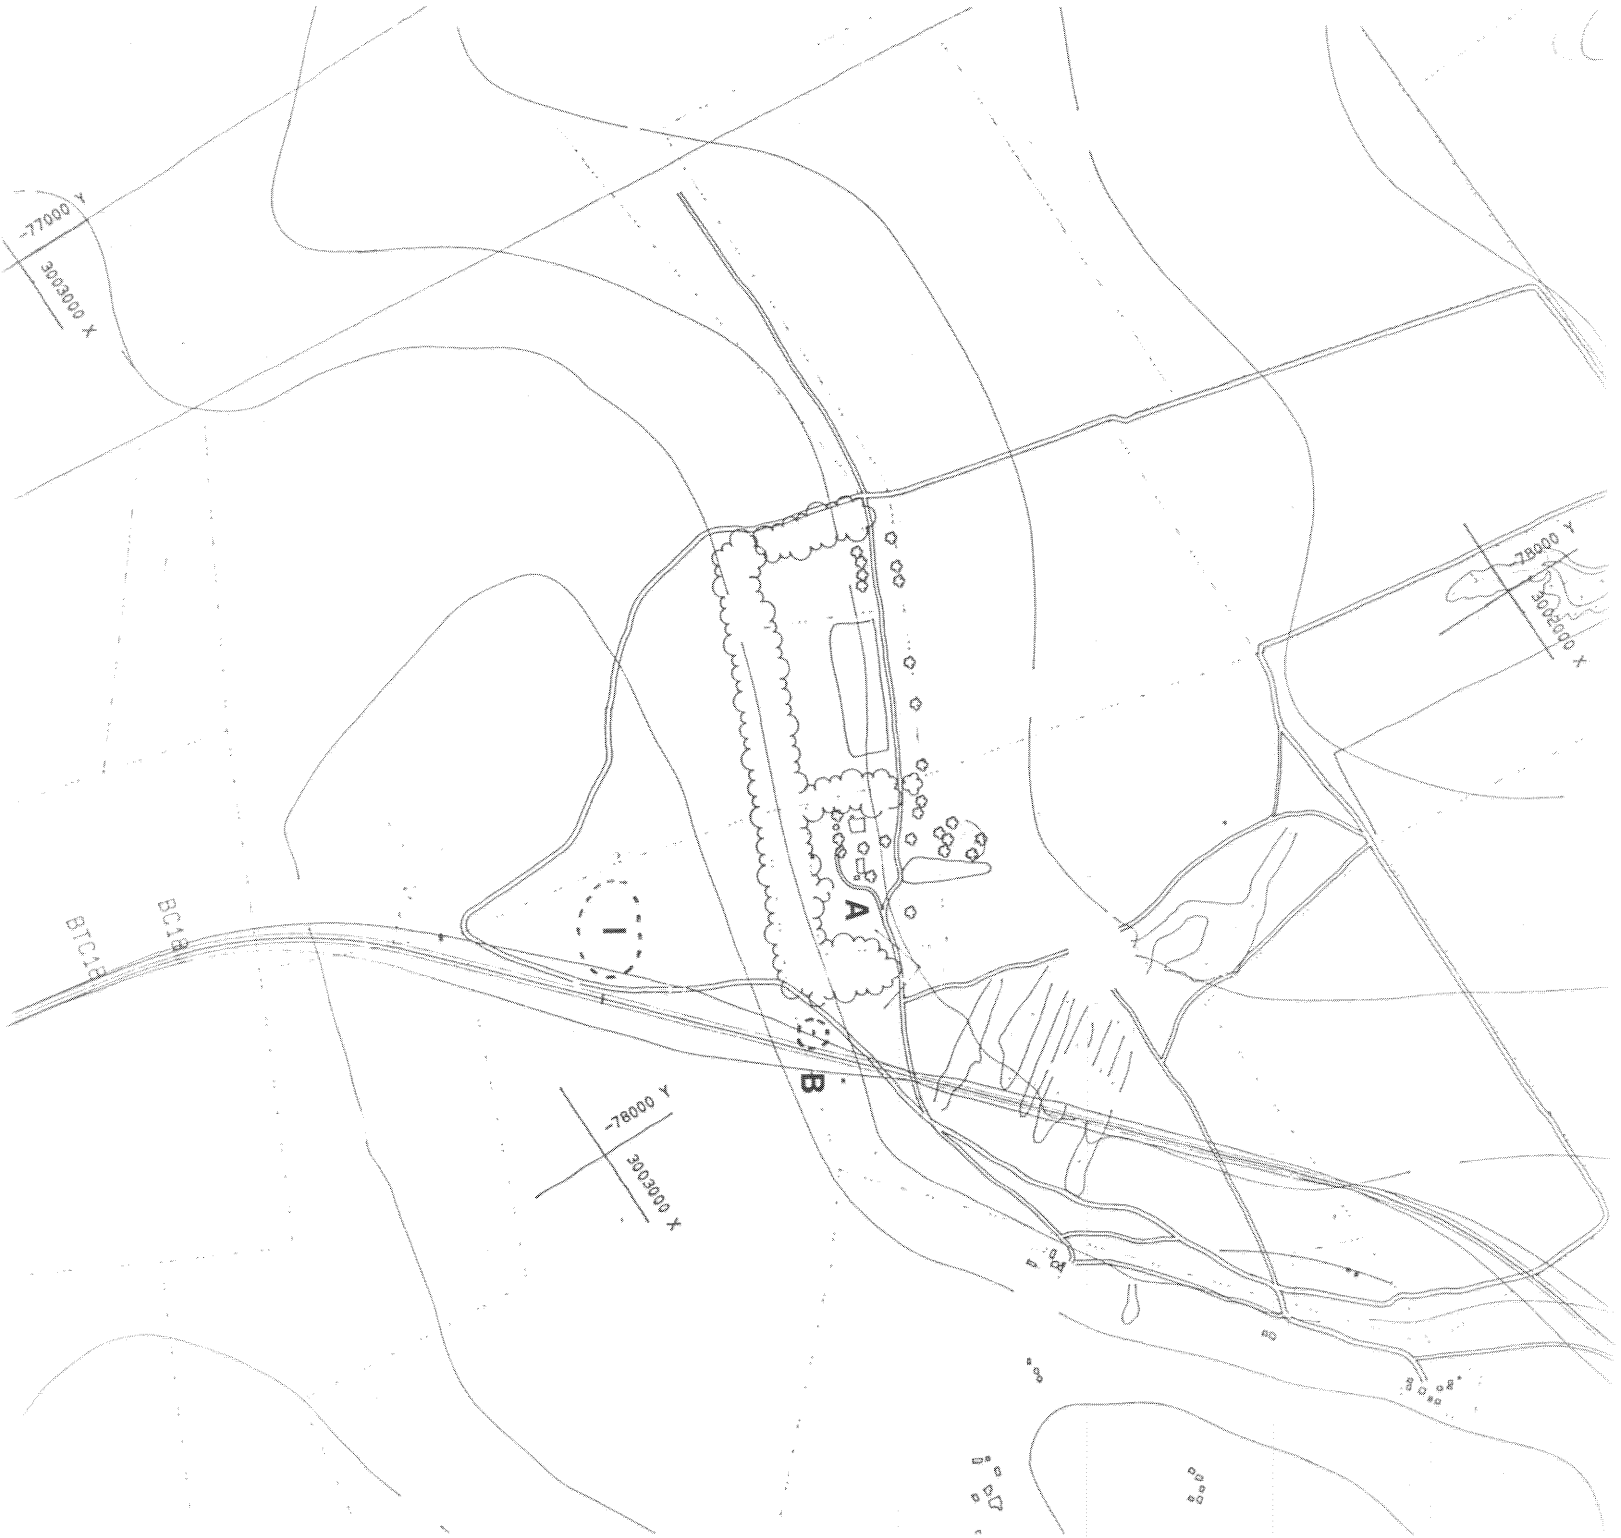
Between the 16.2km flag and a cement reservoir lies the remains of an unusual African settlement (Site 1 on Figure 1). The settlement remains include at least 7 rectangular mud houses, 3 circular stone structures and 1 stone-based wagon house (ca 7-8m wide by 11-14m long). The wagon house and size of the complex indicates that the inhabitants were prosperous.

In the case of Site 1, the land owner most likely lived in the main farm house a few hundred metres to the north (Site 1a). Remains there show that the original building was a three-room longhouse with a kitchen at the back, all made of stone and sundried brick. Later, fired brick walls were added. This sequence indicates that the original house probably dates to about the 1880s

Figure 1. Archaeological sites between 16 and 17km.

Another fountain was later utilized near the 16.4km flag (Site 1b). This second fountain is now dry, but it might become active with an increase in rainfall. The proposed new route passes directly over this area.

Because it represents a special relationship that existed between many black and white farmers, the share-cropper complex should be avoided. It physically begins about 37m west of the 16.2km flag. By shifting the line a few metres further east, the complex can be avoided altogether. If this is not possible, then the site must be extensively mapped and excavated in the areas that will be damaged. To protect the rest, the site should be fenced off during construction.

Spoornet should note the existence of the second fountain.
