## Archaeology-Heritage Impact Assessment – Alternative Routes for the Swellendam Link Road

**Title:** Swellendam Link Road.

Proposal to upgrade the eastern access road to the N2 at Swellendam, Western Cape.

21 May 2009

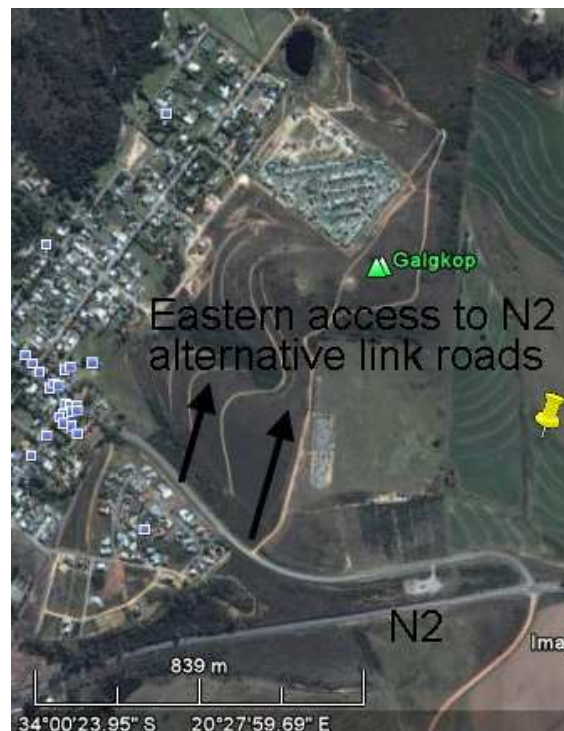
**Figure 1. Location of possible eastern access routes to the N2 from Swellendam (1:50 000 3420 AB, GPS 34° 01'10.913\" S; 20°27'39.126\" E)**

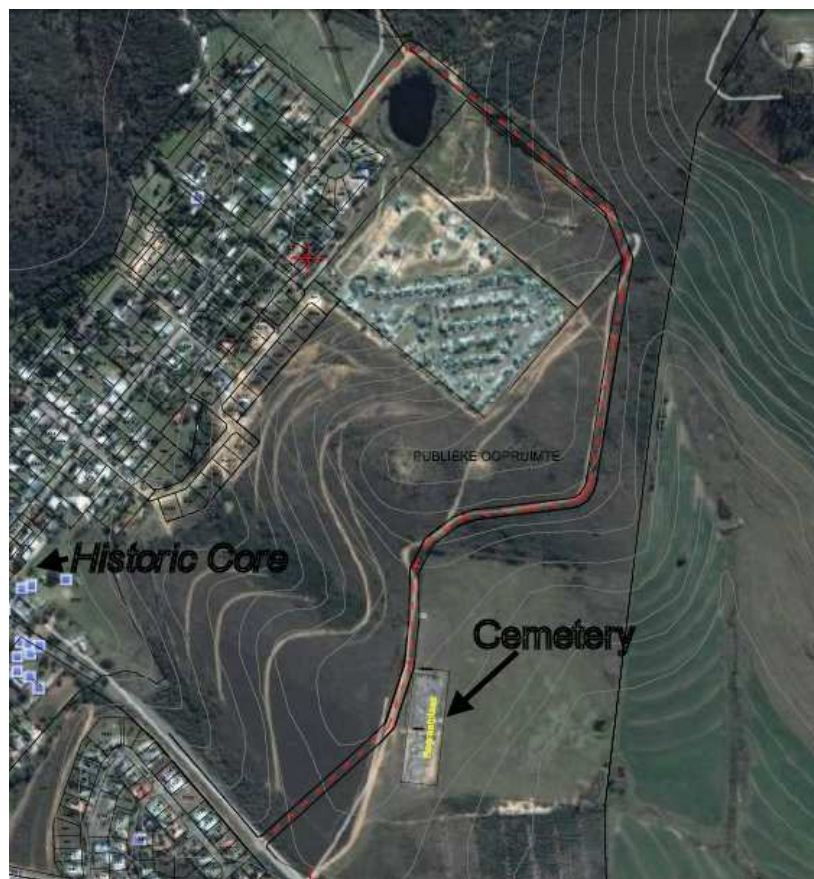
**Route 1**, the preferred route (Fig. 2), follows an existing road for most of its path. The initial short section will be a new road across what has been cultivated land and will not be a negative factor. The route skirts a fenced-off formal cemetery but will not endanger it.

**Fig. 2.** Route 1 option follows an existing road for most of its path. It leads past the cemetery

It is recommended that Route 1 be preferred over the alternative Route 2.

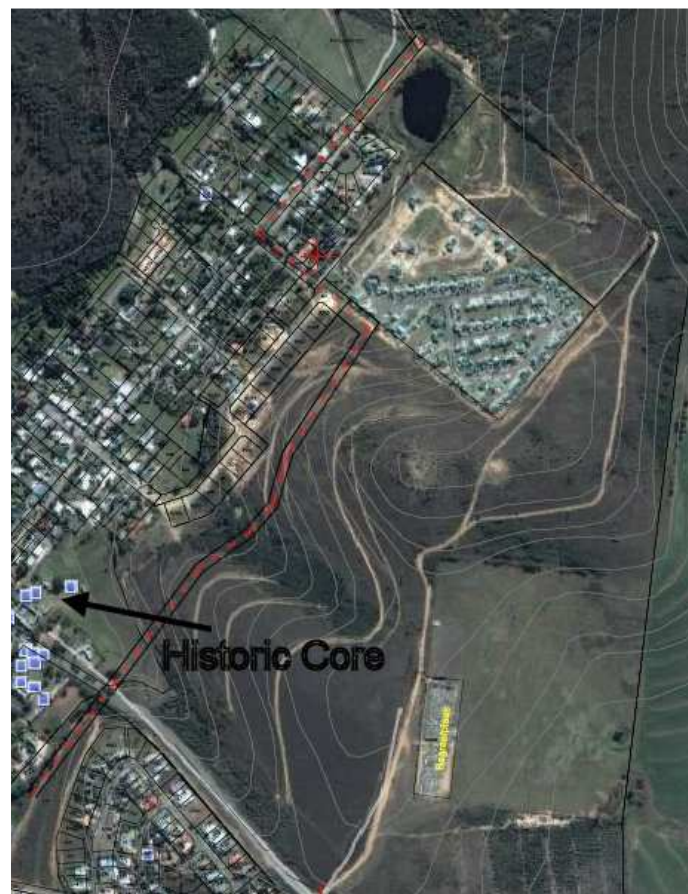
**Route 2**, the second alternative route (Fig. 3), starts close to the historic core of Swellendam that includes important buildings and is a focus for tourism. This route is not preferred for that reason. Heritage conservation is based on minimising and avoiding impacts on significant resources and this would include directing traffic away from such resources. Route 2 would also entail construction of a greater length of new road in contrast to Route 1.

**Fig. 3. The Route 2 option passes close to a number of historically significant properties, marked by blue squares on the satellite view**
