**AN INVENTORY OF  
THE OLD BUILDINGS  
OF COLESBERG**

**R.H.FITCHETT**

UNIVERSITY OF THE WITWATERSRAND, JOHANNESBURG. 1989.

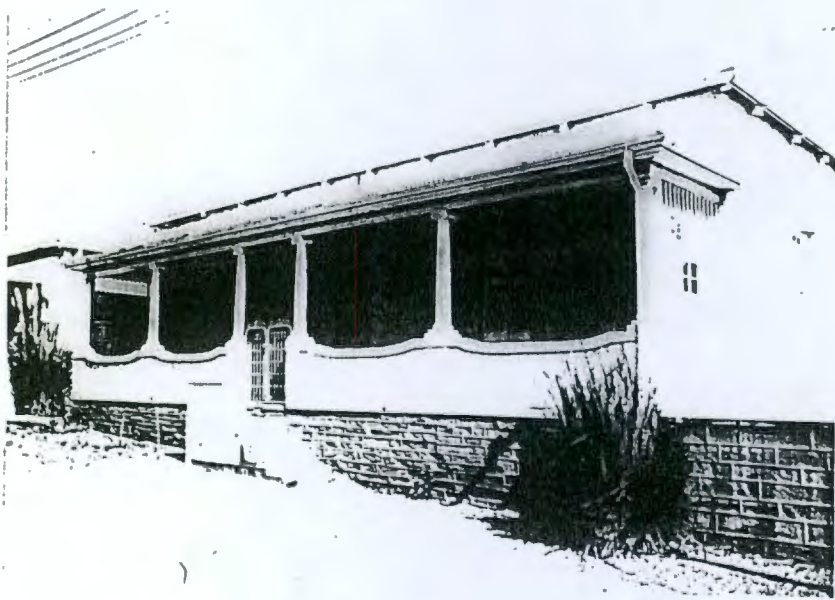
5. Erf 365: 38 Stockenstrom Street.

5. Erf 365 (new no.)  
 Erf 25 (old no.)  
 Granted 1834.  
 38 Stockenström Street - Photograph, p.78.  
 Single storey with hipped roof, originally flat.  
 Symmetrical three bay facade. Pebble dash plaster with  
 smooth door and window surrounds.  
 Stone stoep with plastered walls. Veranda with concrete  
 Ionic columns.  
 18-light double sliding sash windows with Venetian shutters.  
 Modern door.  
 Good condition, but original appearance lost.

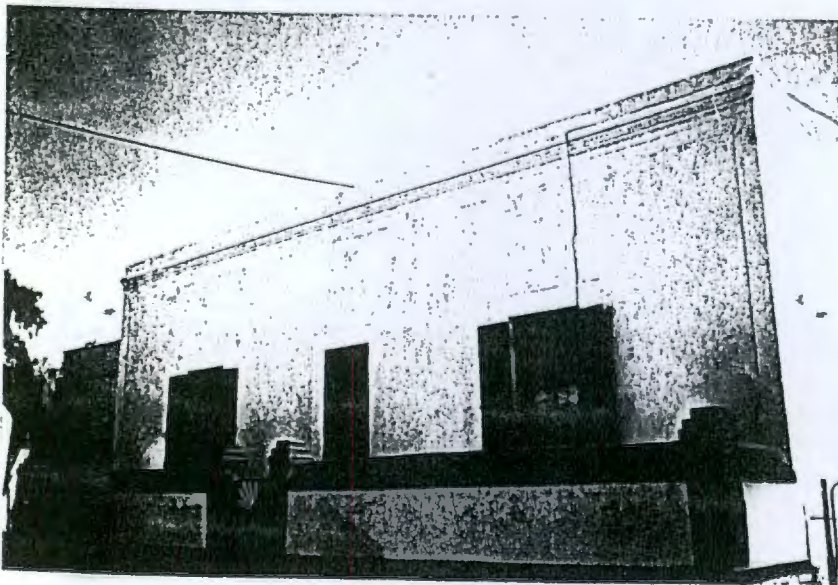
6. Erven 366, 367 & 368: 36 Stockenstrom Street.

6. Erven 366, 367 and 368 (new nos.)  
 Erven (-), (-) and (-) (old nos.)  
 Granted 1864, 1867 and 1880 respectively.  
 38 Stockenström Street - Photograph, p.78.  
 Single storey with flat roof and cornice.  
 Symmetrical three bay facade. Corner pilasters and door and  
 window surrounds.  
 Stone stoep with plastered walls and corner piers.  
 8-light double sliding sash windows with Venetian shutters.  
 Modern door (?) with 2-pane fanlight.  
 Excellent condition and largely original.

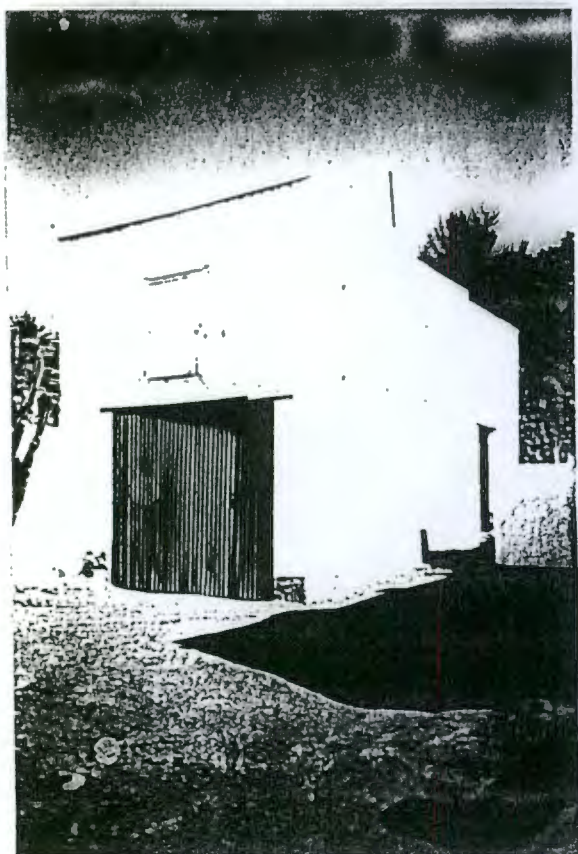
6. Erven 366, 367 & 368: Garage, 36 Stockenstrom Street.

Garage of 38 Stockenström Street - Photograph, p.79.  
 Flat roofed with loft and light cornice.  
 Corrugated iron door.  
 Good condition, original apart from door.

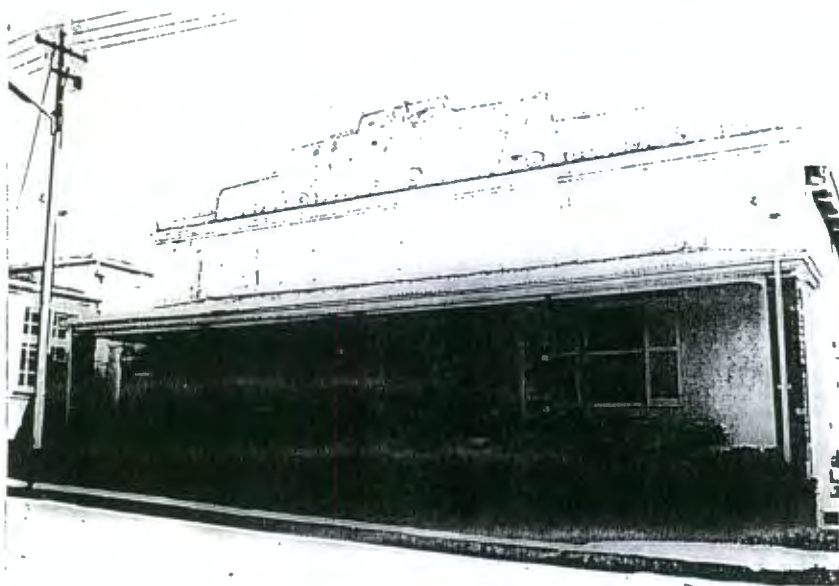
8. Erven 371, 372 & 373: 32 Stockenstrom Street.

32 Stockenstrom Street - Photograph, p.80.  
Single storey with pitched roof behind stepped parapet.  
Straight cornice beneath parapet.  
Symmetrical three bay facade, smooth plaster with no door or window surrounds.  
Face-brick stoep with no walls. Veranda of face-brick piers.  
12-light double sliding sash windows with Venetian shutters.  
Modern door.  
Good condition, but original appearance affected by brick piers and pitched roof.

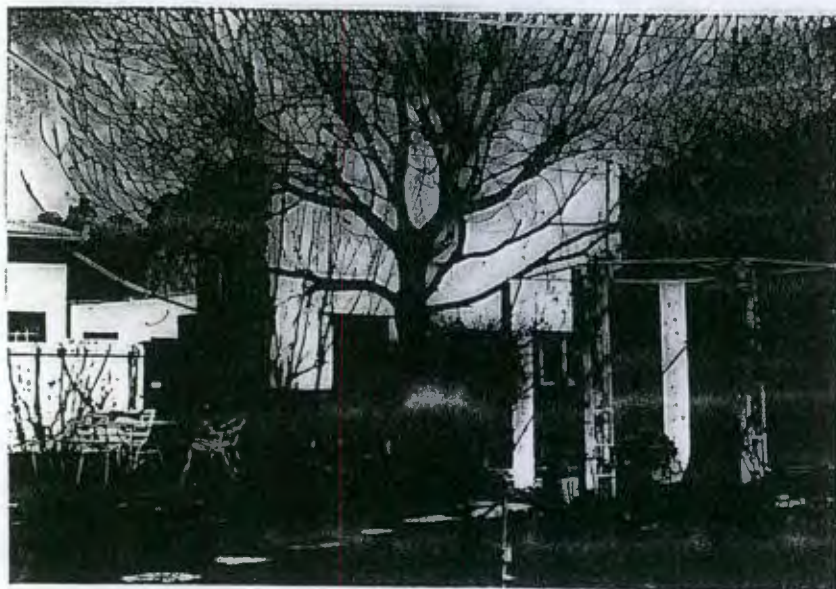
8. Erven 371, 372 & 373: Warehouse behind 32 Stockenstrom Street.

Warehouse (garage ?) behind 32 Stockenstrom Street - Photograph, p.81.  
Flat roofed with loft and light cornice.  
Steel windows.  
Good condition, largely original.

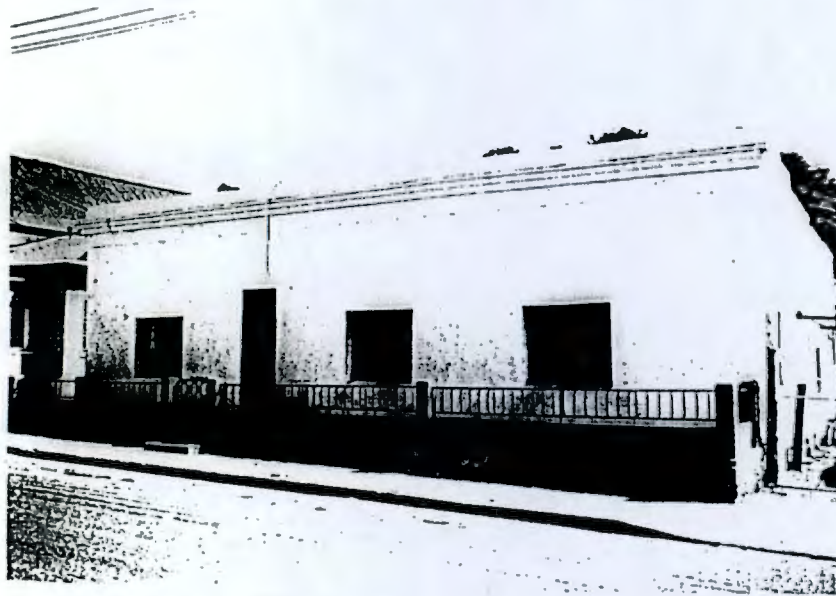
11. Erven 380 & 381: 26 Stockenstrom Street.

26 Stockenstrom Street - Photograph, p.82.  
Single storey with flat roof and cornice.  
Asymmetrical four bay facade, no door or window surrounds.  
Stone stoep with face-brick piers and steel railings.  
Steel windows. Modern door.  
Good condition, but original appearance lost apart from cornice.

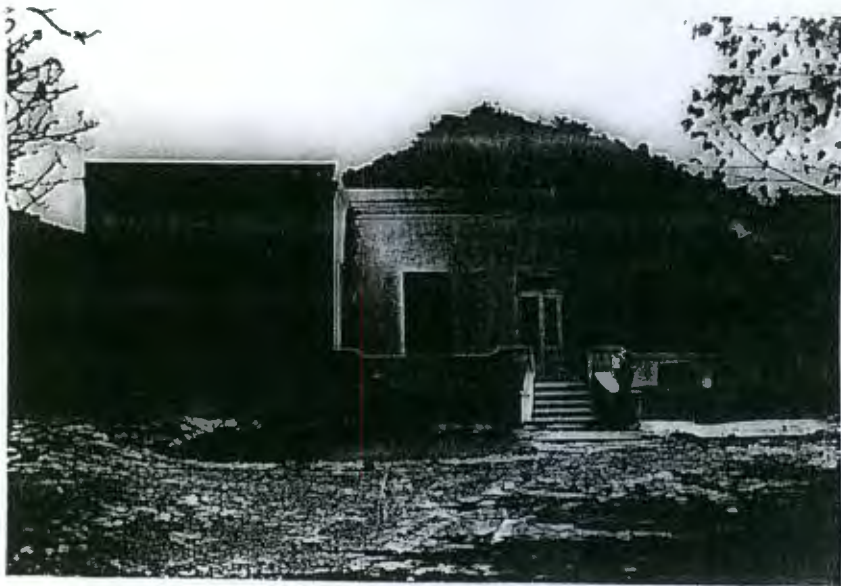
16. Erven 398 & 399: 18 Kort Street.

18 Kort Street - Photograph, p.83.  
Single storey with flat roof and cornice.  
Symmetrical three bay facade with projecting stoepkamer on left. Raked joints, no door or window surrounds.  
Stone stoep with plastered walls and projecting steps.  
4-light double sliding sash windows. Original double leaf glazed door.  
Excellent condition, largely original.

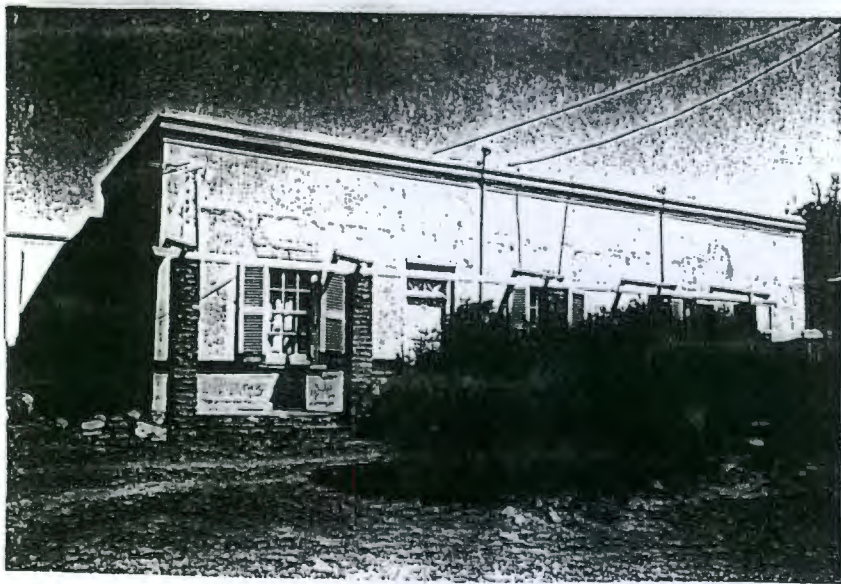
17. Erf 400: 14 Kort Street.

14 Kort Street - Photograph, p.83.  
Single storey with flat roof and cornice.  
Asymmetrical five bay facade.  
Face-brick stoep with face-brick piers supporting pergola.  
Traces of previous veranda.  
12-light double sliding sash windows with Venetian shutters.  
Modern door but original decorative fanlight.  
Good condition, largely original.

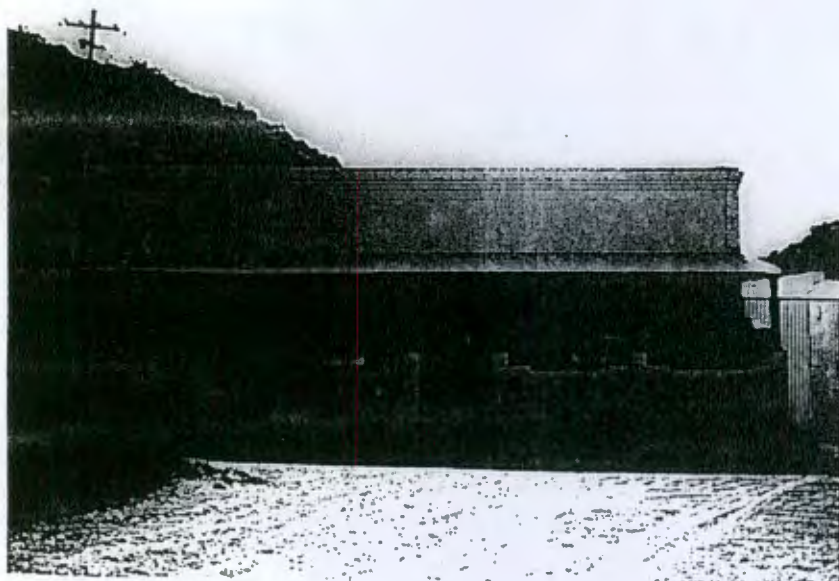
19. Erf 402: 10 Kort Street.

10 Kort Street - Photograph, p.84.  
Single storey with flat roof and cornice.  
Asymmetrical four bay facade with corner pilasters.  
Plastered stoep with plastered walls. Veranda on concrete columns.  
Steel windows and modern door.  
Good condition, but original appearance lost apart from cornice and pilasters.

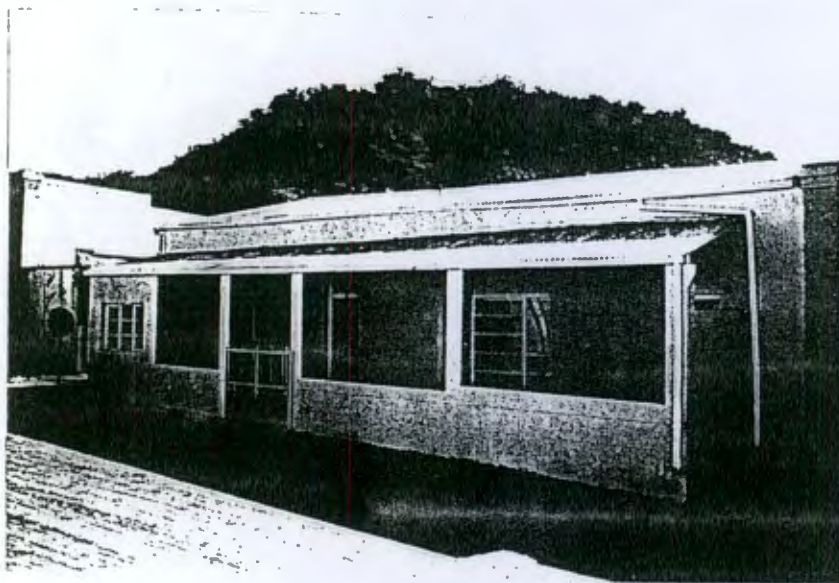
20. Erf 405: 8 Kort Street.

8 Kort Street - Photograph, p.84.  
Single storey with shallow-pitched double pile roof, but no end gables.  
Asymmetrical three bay facade with raked joints.  
No stoep : veranda with plastered walls and piers, partially enclosed.  
Steel windows and modern door.  
Fair condition, but original appearance lost.

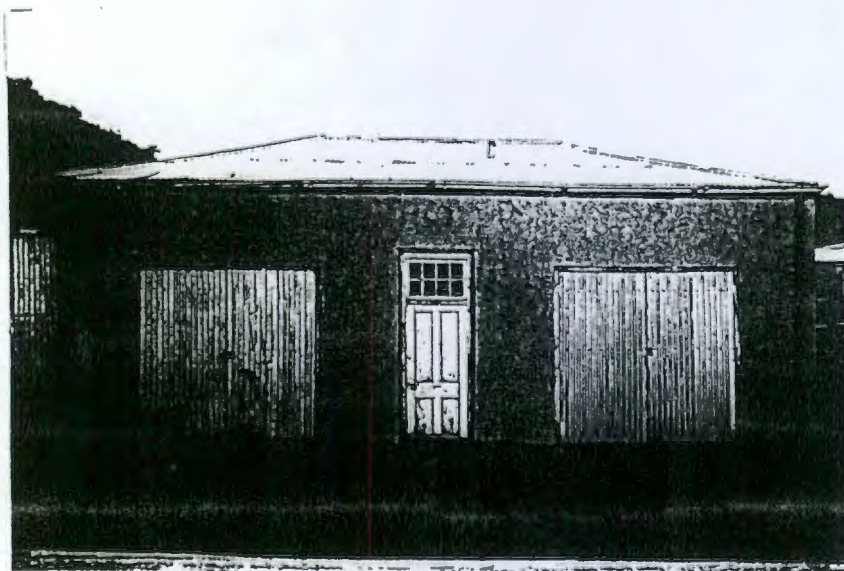
21. Erf 406: 6 Kort Street.

6 Kort Street - Photograph, p.85.  
Single storey with hipped roof.  
Symmetrical three bay facade.  
No stoep.  
Windows replaced by corrugated iron garage doors. New door, original 8-pane fanlight.  
Fair condition, original appearance almost entirely lost.

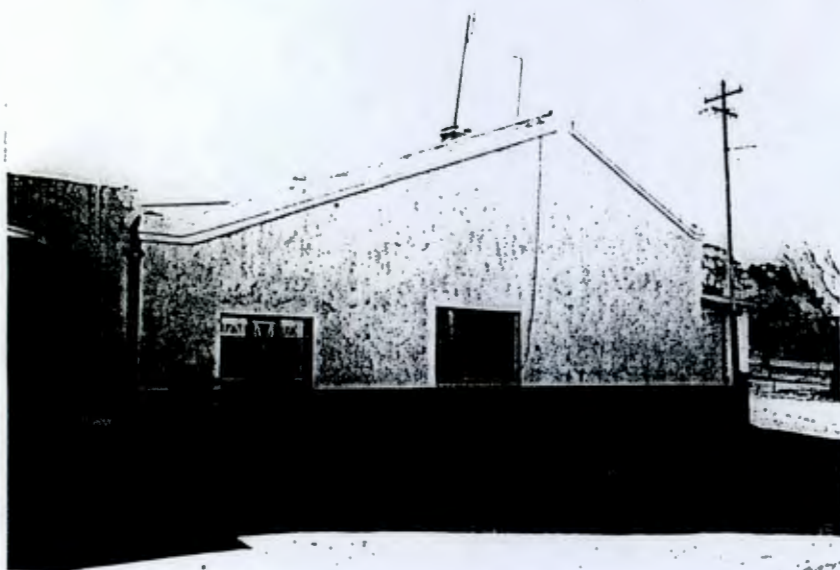
24. Erf 422: 1 Stockenstrom Square.

1 Stockenstrom Square - Photographs, p.87.  
Single storey with double pile roof and moulded end gables with false chimneys. Front pitch steeper than back. Symmetrical three bay facade.  
Low stoep with plastered walls. Verandah on plastered brick piers.  
Steel windows and modern door.  
Very good condition. Original apart from openings and veranda.

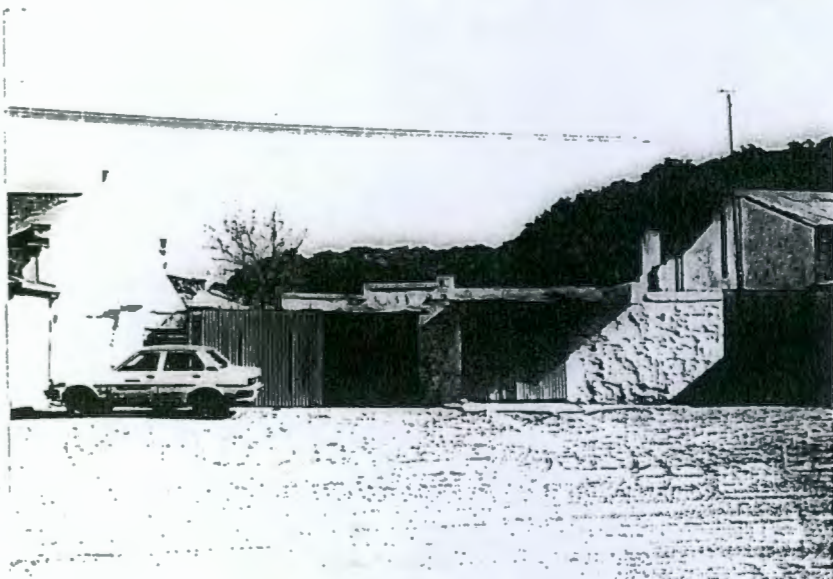
24/25. Erven 422/420: Garages between 1 & 2 Stockenstrom Square.

Garages of 1 and 2 Stockenstrom Square - Photograph, p.88.  
Single storey with flat roofs and stepped cornice.  
Corrugated iron doors.  
Poor condition, but essential as street edge linkages.

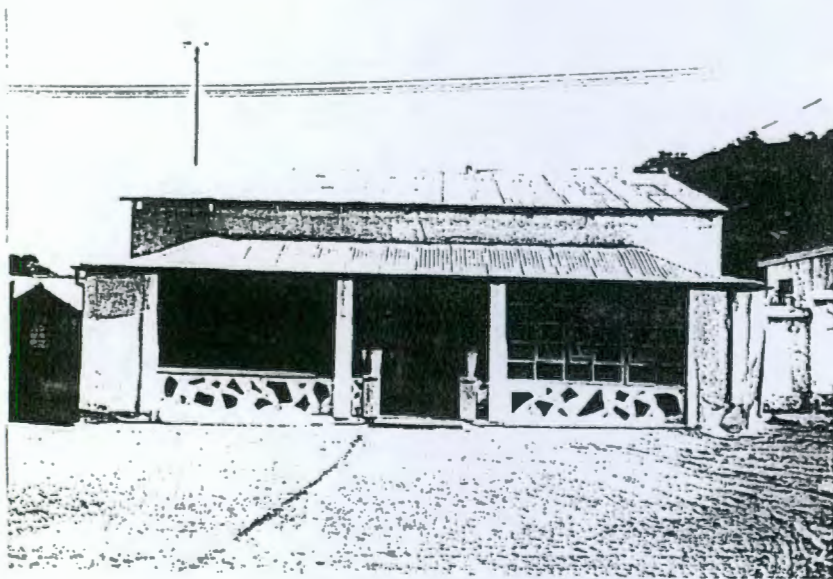
25. Erf 420: 2 Stockenstrom Square.

2 Stockenstrom Square - Photograph, p.88.  
Single storey with shallow-pitched double pile roof but no gables.  
Symmetrical three bay facade.  
Low stoep with rough slate set into plaster wall. Veranda on plastered piers, partially enclosed in glass.  
Steel windows and modern door.  
Good condition, but almost all original appearance lost.

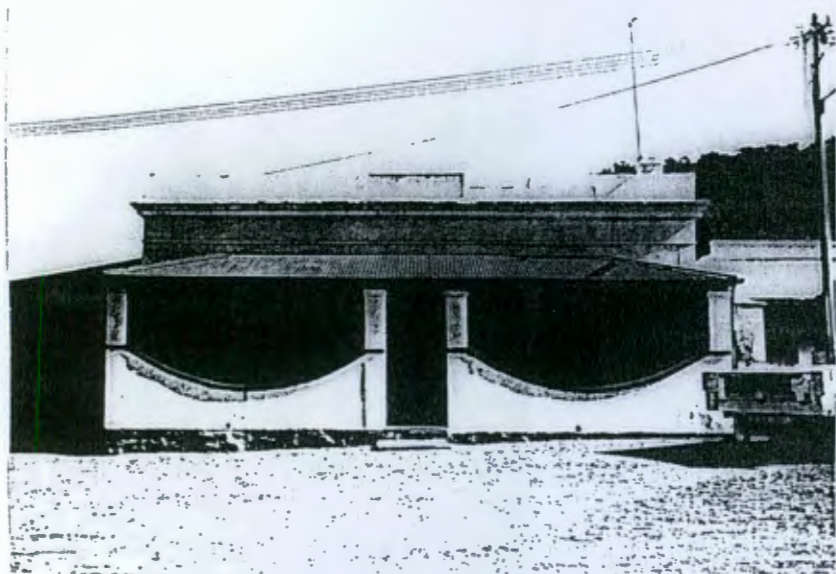
26. Erven 418 & 417: 3 Stockenstrom Square.

3 Stockenstrom Square - Photograph, p.89.  
Single storey with flat roof and cornice with rectangular moulding above latter.  
Symmetrical three bay facade with edge pilasters.  
Low stoep with plastered walls. Veranda on plastered piers.  
12-light double sliding sash windows. Modern door.  
Good condition. Original apart from veranda.

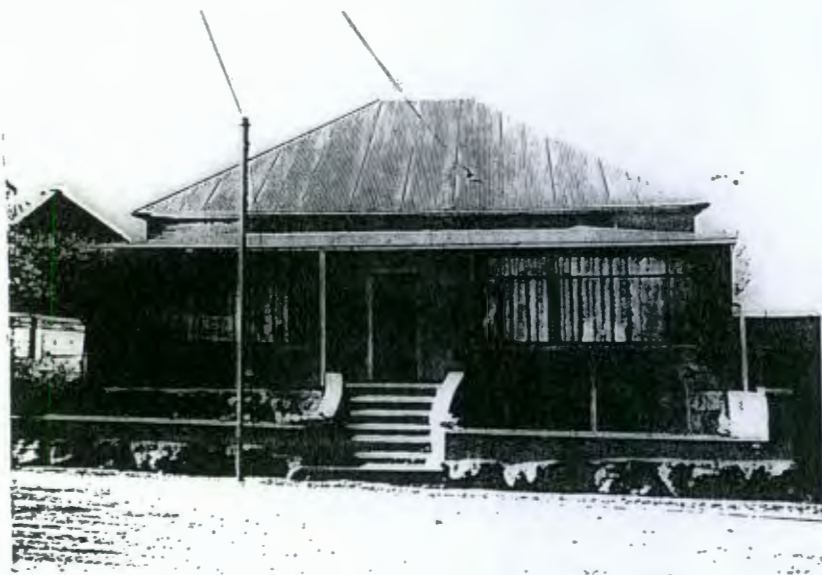
37. Erf 767: 13 Stockenstrom Square.

13 Stockenstrom Square - Photograph, p.92.  
Single storey with hipped roof.  
Symmetrical three bay facade.  
Plastered stoep with completely enclosed veranda.  
Steel windows and modern door to enclosed veranda.  
Good condition. Original appearance obscured by additions.

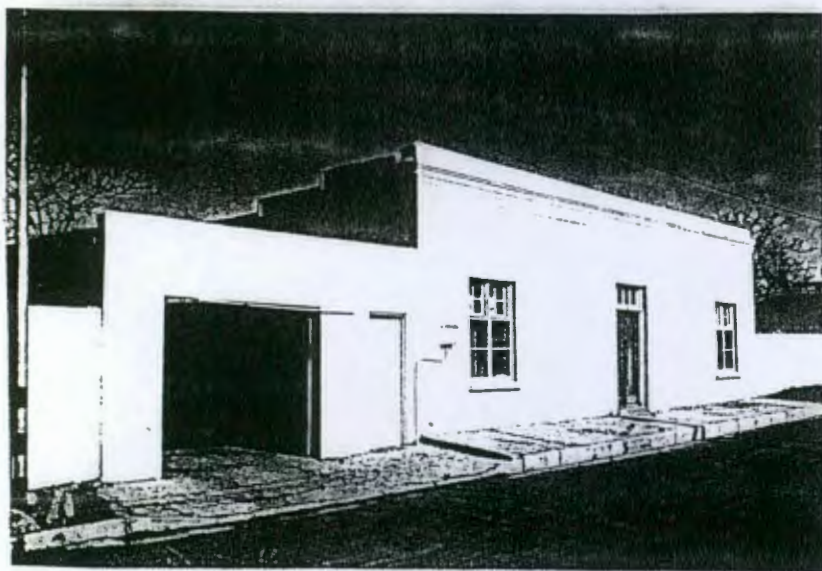
39. Erf 425: 1 Kort Street.

1 Kort Street - Photograph, p.93.  
Single storey with flat roof and cornice.  
Symmetrical three bay facade with edge pilasters and door and window surrounds.  
No stoep, entrance at pavement level.  
Timber casement windows, modern door.  
Good condition, largely original appearance.

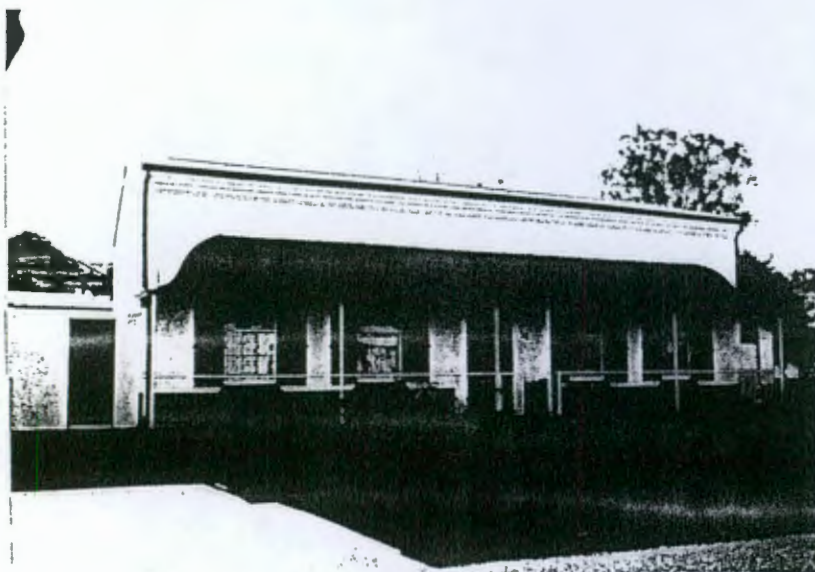
41. Erf 427: 10 Stockenstrom Street.

10 Stockenstrom Street - Photograph, p.94.  
Single storey with double pitched roof. Cornice suggests original flat roof.  
Symmetrical five bay facade.  
Low stoep with steel railings. Veranda on steel poles.  
12-light double sliding sash windows with shutters. Original 6-panel door.  
Good condition. Original appearance altered but many details survive.

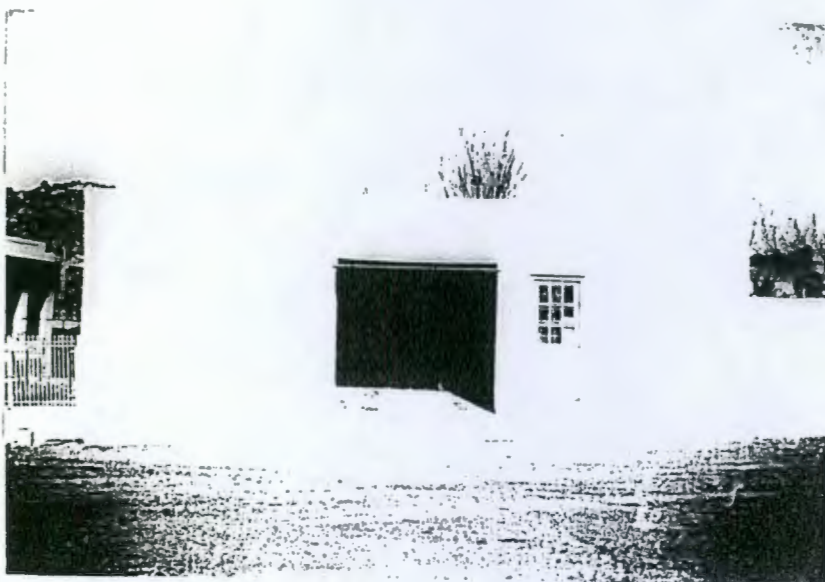
45. Erf 389: Garage of 15 Stockenstrom Street.

Garage of 15 Stockenstrom Street - Photograph, p.96.  
Single storey with flat roof and string cornice.  
Asymmetrical facade, evidently altered.  
Steel door but original lintol.  
Good condition. Original appearance largely maintained.

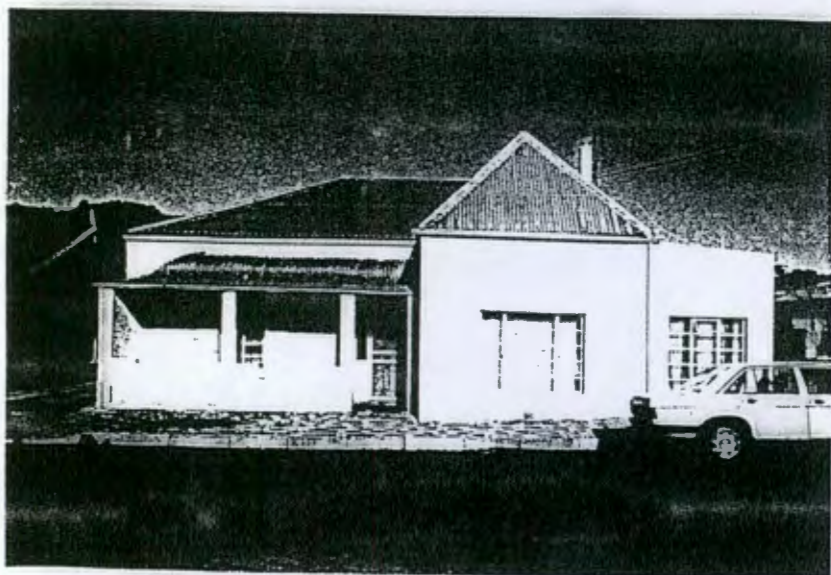
46. Erf 390: 15 Stockenstrom Street.

15 Stockenstrom Street - Photograph, p.96.  
Single storey with hipped roof.  
Asymmetrical three bay facade with projecting wing. Raked joints.  
Low stoep with plastered walls. Veranda on plastered piers.  
One original 4-light double sliding sash window with Venetian shutters.  
Good condition. Original appearance largely lost in detail.

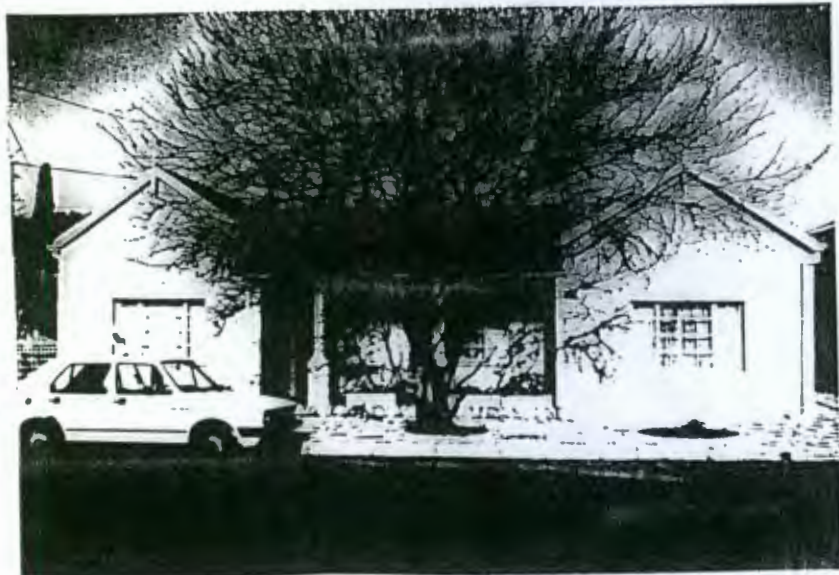
47. Erf 391: 13 Stockenstrom Street.

13 Stockenstrom Street - Photograph, p.97.  
Single storey with pitched roof. Bargeboards and finials.  
Double pitched stoepkamers, asymmetrical three bay core.  
Low stoep with veranda on precast concrete columns.  
Steel windows and modern door.  
Good condition, but original appearance almost entirely lost.

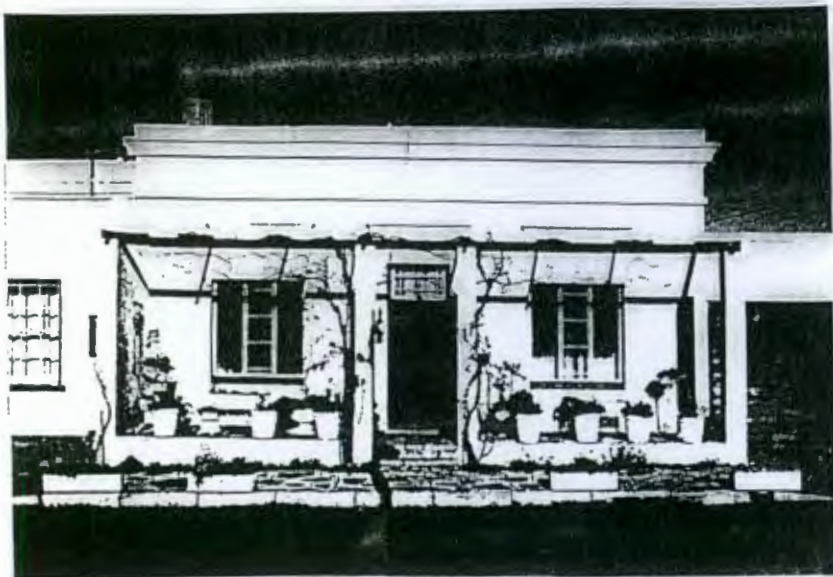
48. Erf 392: 11 Stockenstrom Street.

11 Stockenstrom Street - Photograph, p.98.  
Single storey with flat roof and cornice.  
Symmetrical three bay facade with window and door hood mouldings.  
Low stoep with pergola on plastered piers.  
Steel windows, original door frame and fanlight.  
Very good condition, largely original.

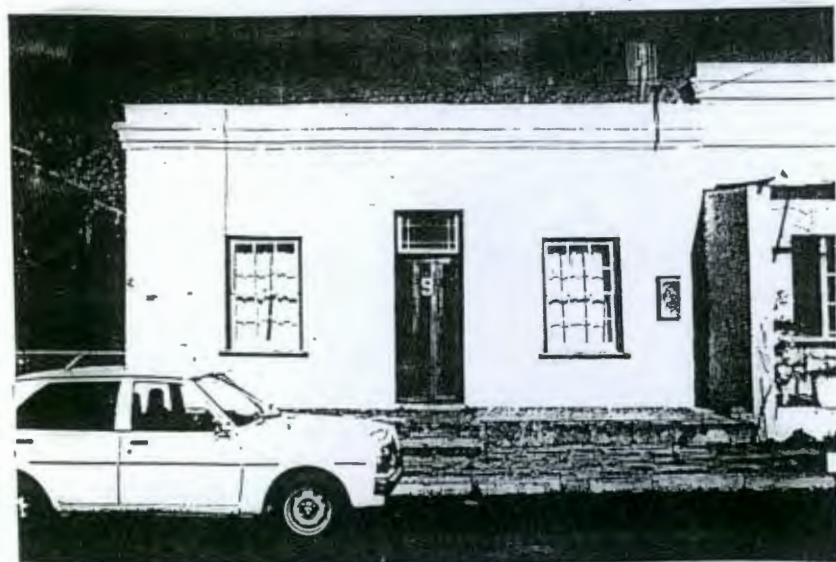
49. Erf 393: 9<sup>A</sup> Stockenstrom Street.

9<sup>A</sup> Stockenstrom Street - Photograph, p.98.  
Single storey with flat roof and cornice.  
Symmetrical three bay facade with rusticated edges and door and window surrounds.  
Low stoep, plastered.  
12-light double sliding sash windows. Modern door but original fanlight.  
Very good condition, almost original appearance.

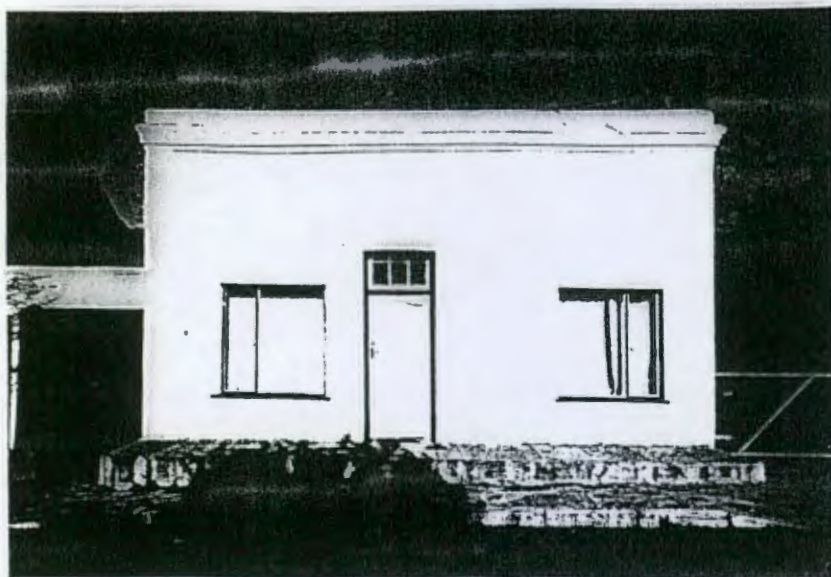
50. Erf 394: <sup>9</sup> Stockenstrom Street.

<sup>9</sup>  
✓ Stockenstrom Street - Photograph, p.99.  
Single storey with flat roof and cornice.  
Asymmetrical three bay facade with rusticated edges and door and window surrounds.  
Low plastered stoep.  
Steel windows and modern door, but original frame and fanlight.  
Very good condition, largely original.

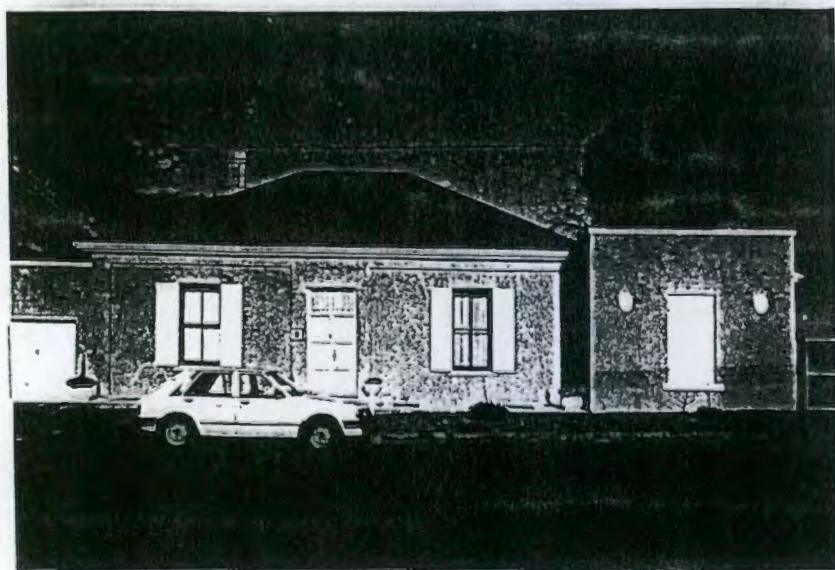
52. Erf 396: 3 Stockenstrom Street.

3 Stockenstrom Street - Photograph, p.99.  
Single storey with hipped roof, flat roof with string cornice over stoepkamer.  
Symmetrical three bay facade with edge pilasters and door surround.  
Projecting stoepkamer to right.  
Low plastered stoep.  
4-light double sliding sash windows with Venetian shutters.  
Original 6-panel door.  
Excellent condition, but over-restored.

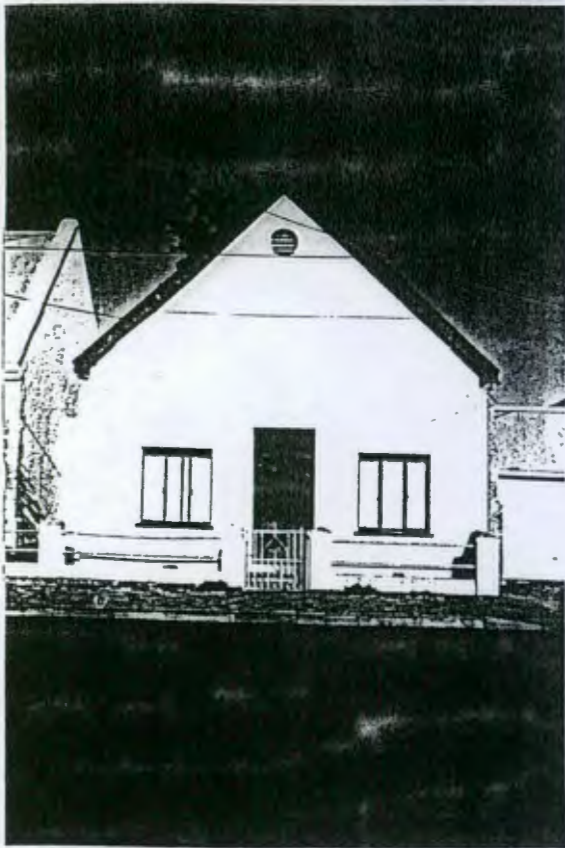
53. Erf 397: Methodist Church Hall.

Methodist Church Hall - Photograph, p.100.  
Single storey with double pitched roof and bargeboards, with round ventilator in gable.  
Symmetrical three bay facade.  
Steel windows. Original 6-panel door and fanlight.  
Good condition. Appearance affected by windows.

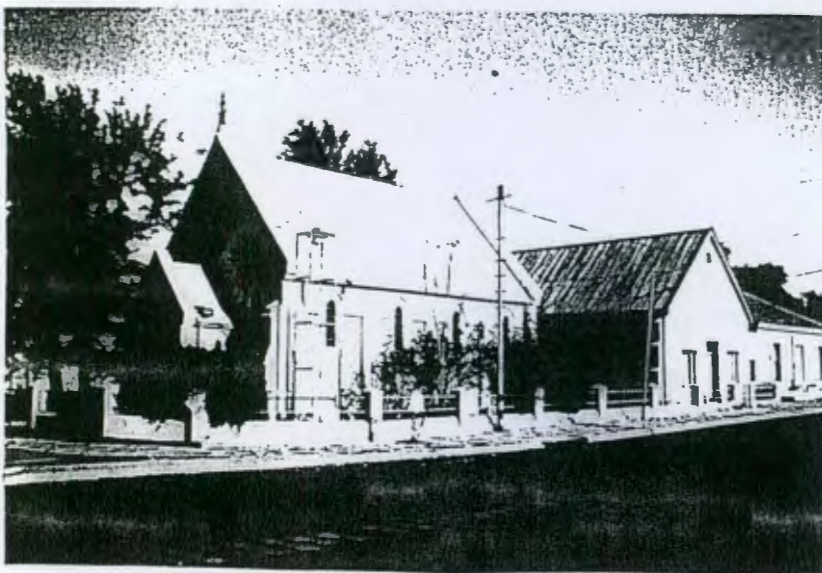
53. Erf 397: Methodist Church.

Methodist Church - Photograph, p.100.  
Single volume Gothic Revival church with no aisles or galleries. Entrance porch.  
Plastered exterior, buttresses between openings.  
Plastered enclosing wall with steel railings.  
Pointed arched door and windows with hood mouldings.  
Excellent condition. Original appearance.

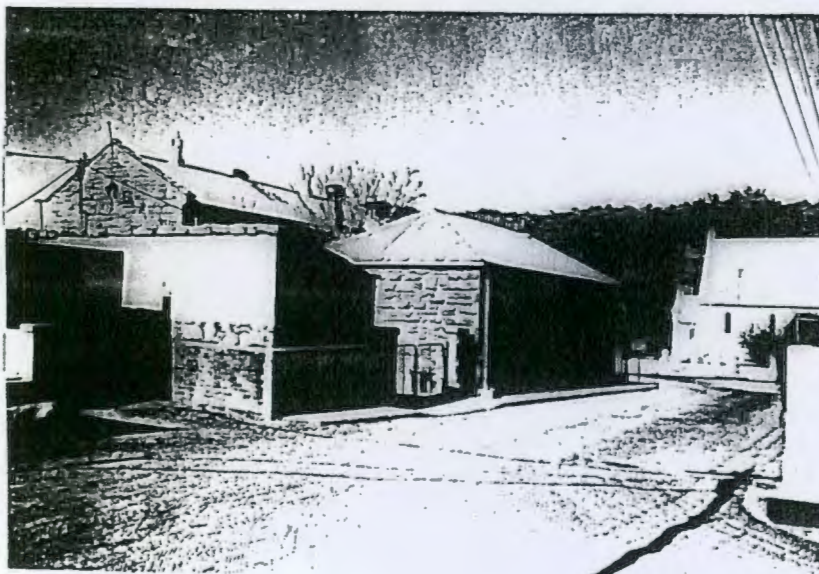
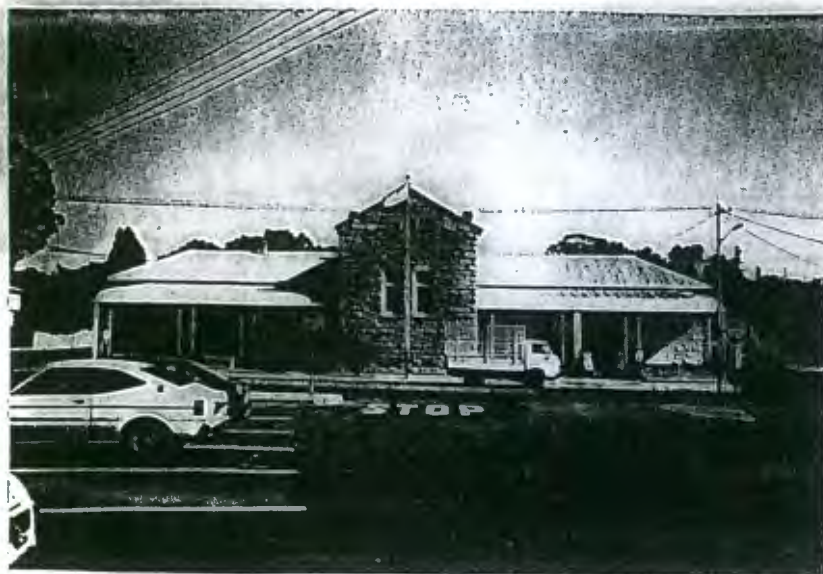
54. Erf 435: Magistrate's Court.

Magistrate's Court (1890) - Photographs, pp.101 & 102.  
Single storey with hipped roofs on wings, double pitched  
with parapet gable in centre.  
Symmetrical facade of stone.  
Veranda on cast iron columns.  
Original doors and casement windows.  
Excellent condition, almost entirely original appearance.

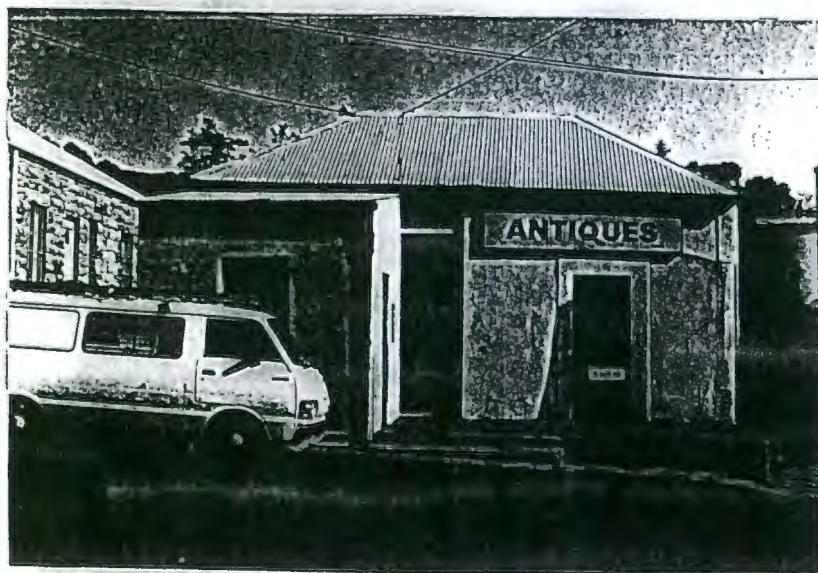
55. Erf 768: 1 d'Urban Row.

1 d'Urban Row - Photograph, p.102.  
Single storey with hipped roof, lean-to over forward  
projection.  
Asymmetrical facade with stoepkamer to left.  
Low plastered stoep.  
12-light double sliding sash window on stoepkamer. Modern  
door.  
Good condition. Original appearance largely lost, but  
important as street edge.

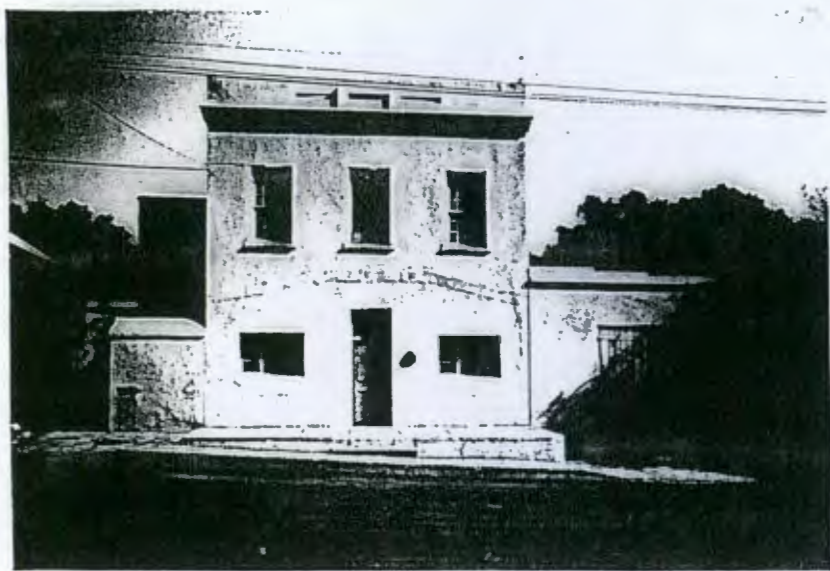
55. Erf 768: 3 d'Urban Row.

3 d'Urban Row - Photograph, p.103.  
Double storey with flat roof, cornice and decorative  
parapet.  
Symmetrical three bay facade.  
Low stoep, plastered. Veranda on plastered piers removed  
after 1980.  
Lower windows steel, upper 24-light double sliding sash.  
Original 6-panel door and Gothic Revival fanlight.  
Excellent condition, largely original.

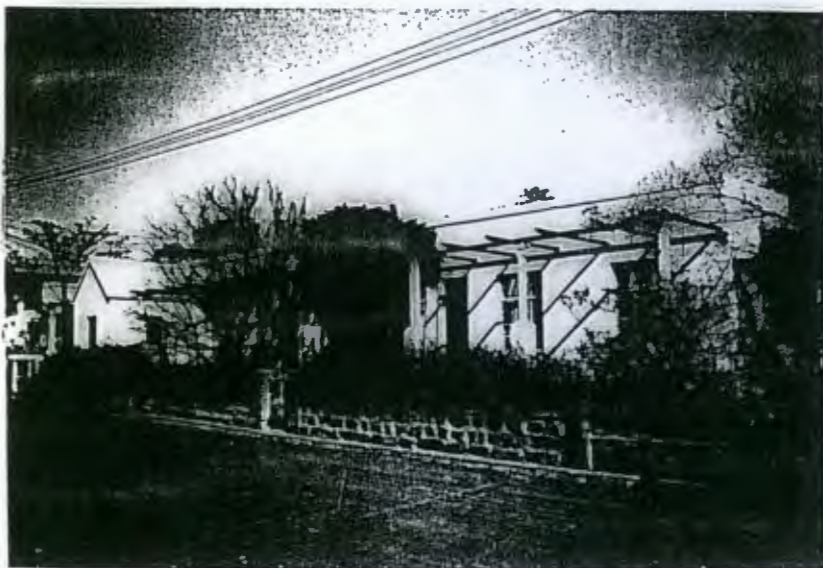
61. Erven 783 & 780: 15/17 d'Urban Row.

15/17 d'Urban Row - Photographs, pp.106 & 107.  
Single storey with flat roof and light cornice.  
Asymmetrical entrance lobby double pitched with bargeboard gables.  
Long facade, each house symmetrical five bay.  
Pergola on concrete columns with plastered pedestals.  
Steel windows and modern doors.  
Good condition, but largely altered appearance.

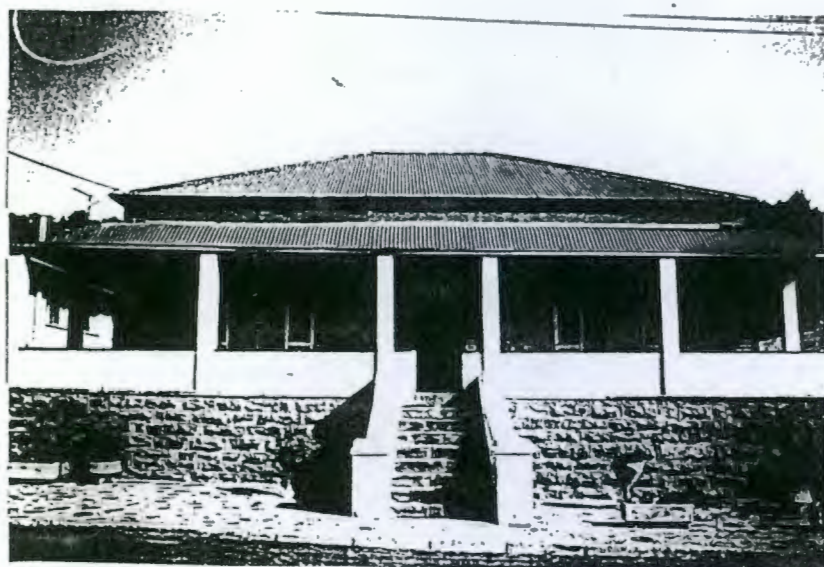
63. Erf 458: 21 d'Urban Row.

21 d'Urban Row - Photograph, p.107.  
Single storey with hipped roof.  
Symmetrical three bay facade with face-brick edge and rusticated openings.  
High stone stoep with plastered walls and projecting staircase. Veranda on plastered piers on three sides.  
Timber French doors with Venetian shutters. Modern door.  
Good condition, largely original.

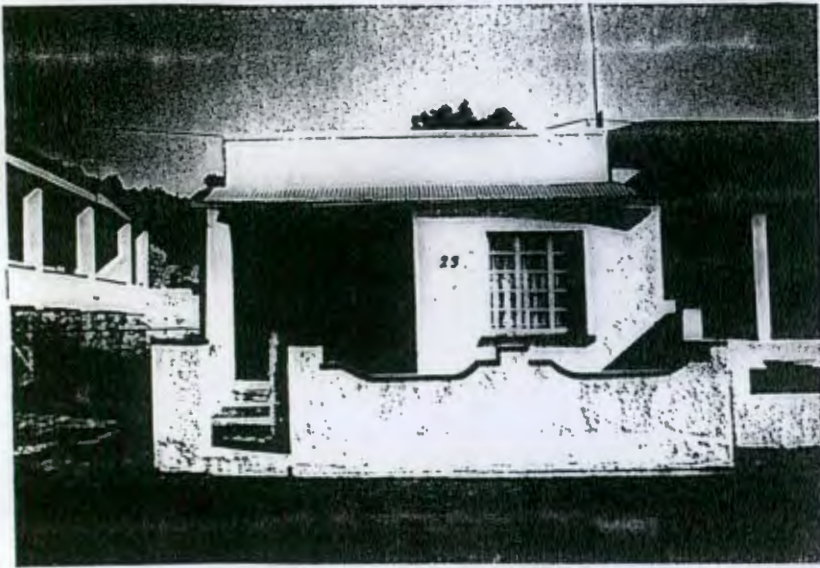
64. Erf 459: 23 d'Urban Row.

23 d'Urban Row - Photograph, p.108.  
Single-storey with flat roof and light cornice.  
Two bay facade with lateral entrance to projecting room.  
Steel windows and modern door.  
Good condition but original appearance largely lost.

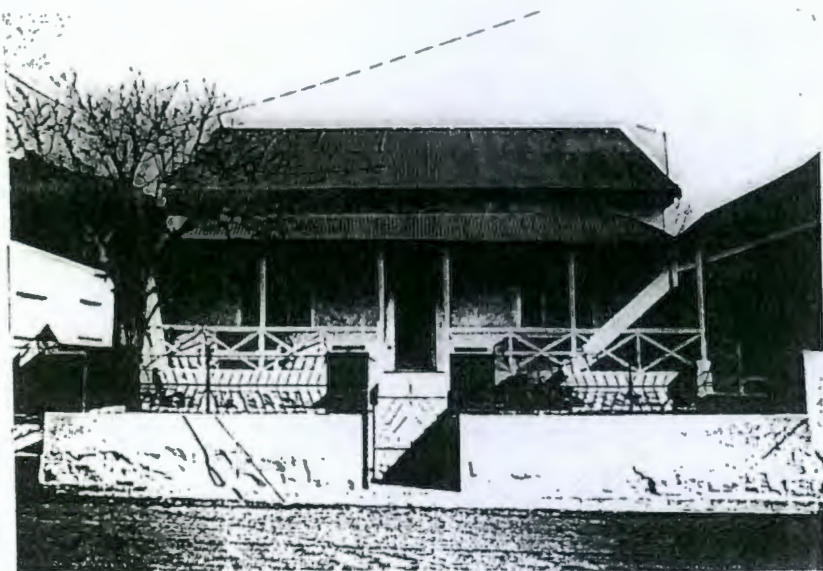
66. Erf 462: 27 d'Urban Row.

66. Erf 462 (new no.)  
Erf 105A (old no.)  
Granted 1904 (erf 105, vacant, granted 1882).
- 27 d'Urban Row - Photograph, p.109.  
Single storey, double pitched roof with bargeboard gabled ends.  
Symmetrical three bay facade.  
Plastered stoep with trellissed railings. Double curvature veranda on timber posts.  
Steel windows, original door.  
Good condition but original appearance largely lost.

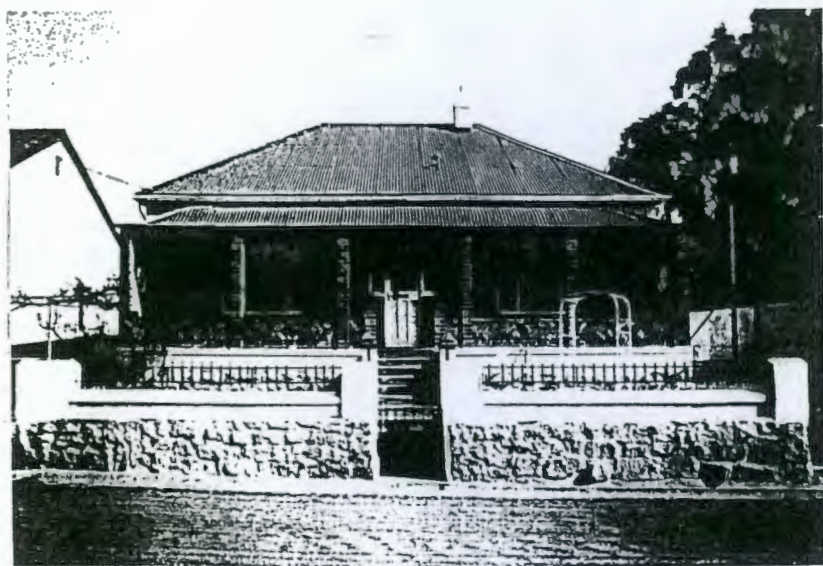
67. Erf 463: 29 d'Urban Row.

67. Erf 463 (new no.)  
Erf 104 (old no.)  
Granted 1849.
- 29 d'Urban Row - Photograph, p.109.  
Single storey with hipped roof.  
Symmetrical three bay facade.  
High plastered stoep with brick wall. Double curvature veranda on brick posts.  
Steel windows, modern door.  
Good condition but original appearance almost entirely lost.

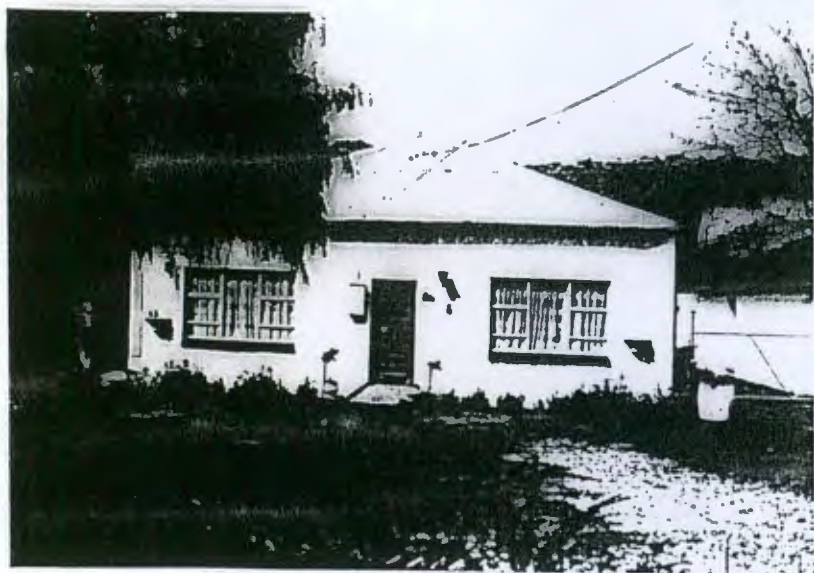
83. Erf 487: 4 d'Urban Row.

4 d'Urban Row - Photograph, p.110.  
Single storey with hipped roof.  
Symmetrical three bay facade with edge pilasters.  
No stoep.  
Steel windows, modern door.  
Good condition but original appearance almost entirely lost.

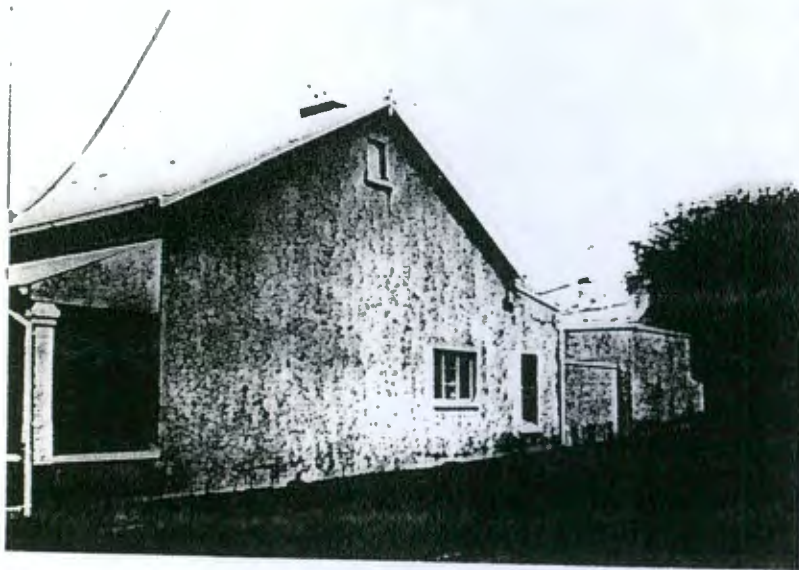
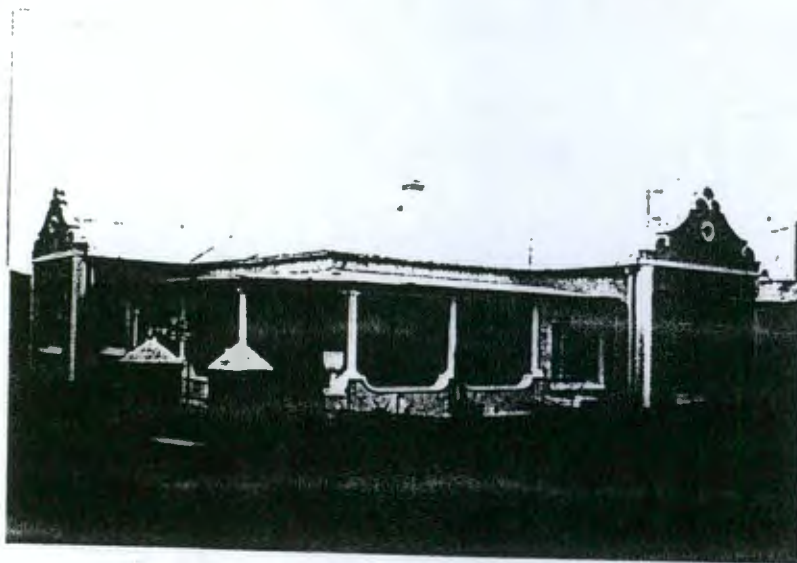
356. Erf 37: 21 West Church Street.

21 West Church Street (now President Kruger St) -  
Photographs, pp.221 & 222.  
Single storey with double pitched roof with bargeboard end gables and finials.  
Symmetrical three bay facade with remains of ruled joints and door and window surrounds.  
Plastered boundary wall with steel railings, stoep set back with plastered wall, veranda on plastered piers.  
Steel windows, modern door.  
Good condition but original appearance almost entirely lost.

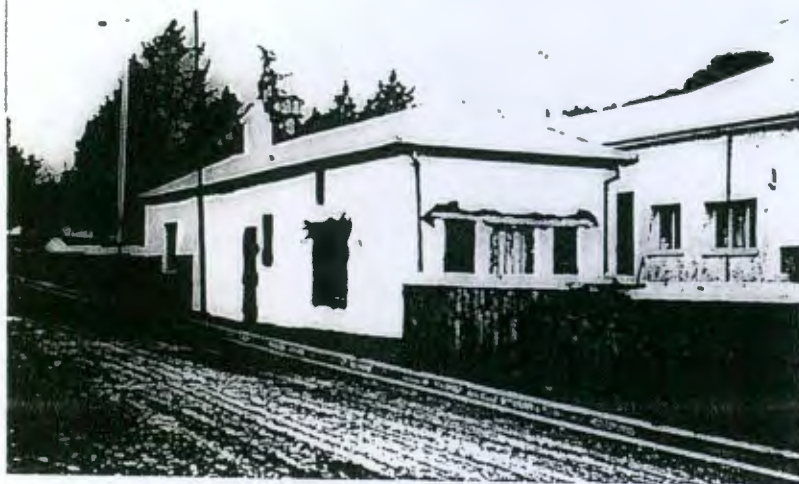
357. Erven 38, 39 & 40: ? Sluiters Road.

357. Erven 38, 39 and 40 (new nos.)  
Erven 335 and 336 (old nos. - No.40 not yet proclaimed)  
Granted 1929 and 1921 respectively.
- ? Sluiters Road - Photograph, p.222.  
Single storey with hipped roof and parapet gabled wings  
(late).  
No predominant facade : house symmetrical about the  
diagonal.  
Low stoep with plastered wall. Veranda on concrete columns,  
between wings.  
Timber bow windows, otherwise steel.  
Modern door.  
Fair condition but retains little of original appearance.
