**AN INVENTORY OF  
THE OLD BUILDINGS  
OF COLESBERG**

**R.H.FITCHETT**

UNIVERSITY OF THE WITWATERSRAND, JOHANNESBURG. 1989.

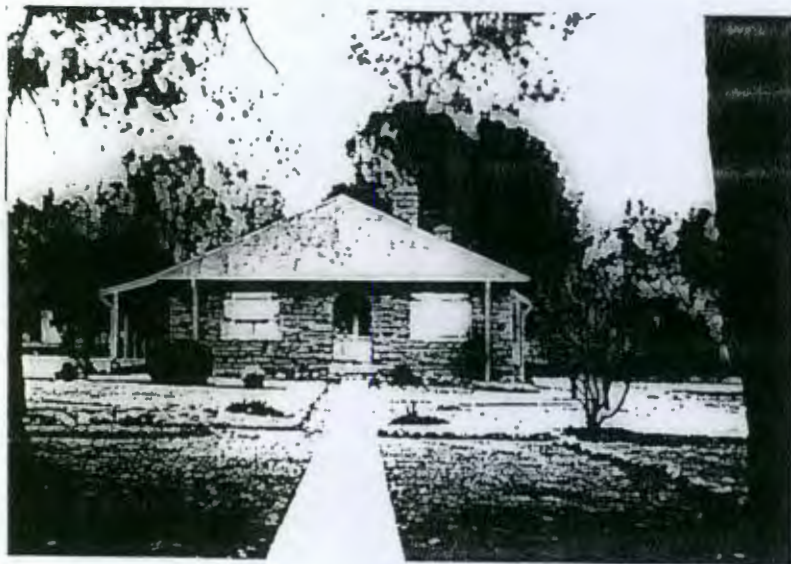
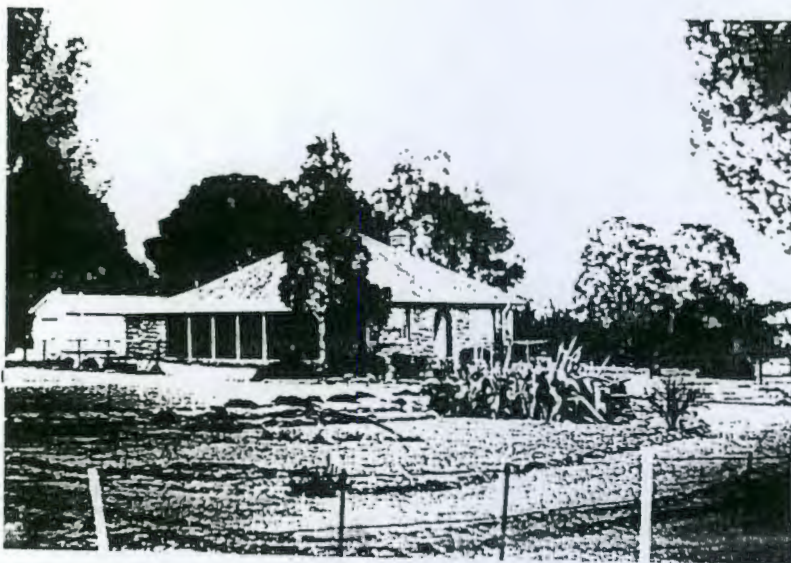
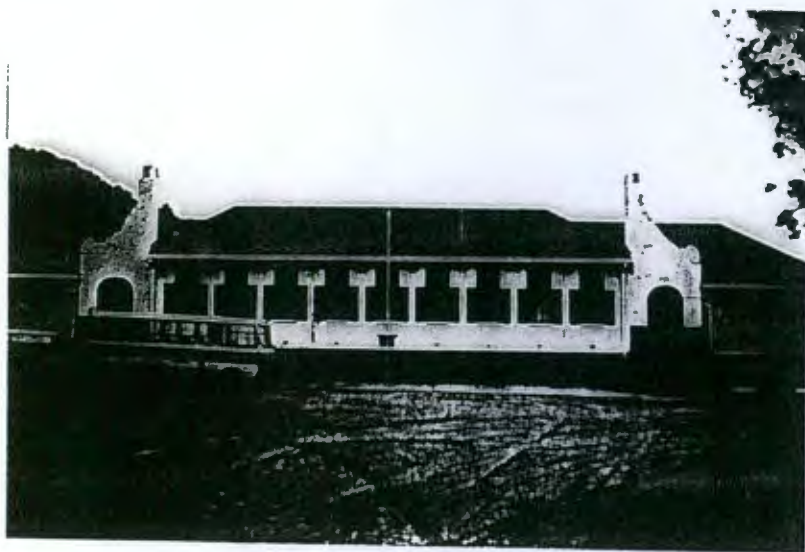
368. Erf 23: Residency.

368. Erf 23 (new no.)  
The Residency Site (old no.)  
Granted 1913.
- The Residency - Photographs, pp.223 & 224.  
Single storey with pyramidal hipped roof.  
Symmetrical three bay stone facade and arched opening.  
Verandas on minor facades.  
Steel windows, original door.  
Good condition, largely original appearance.

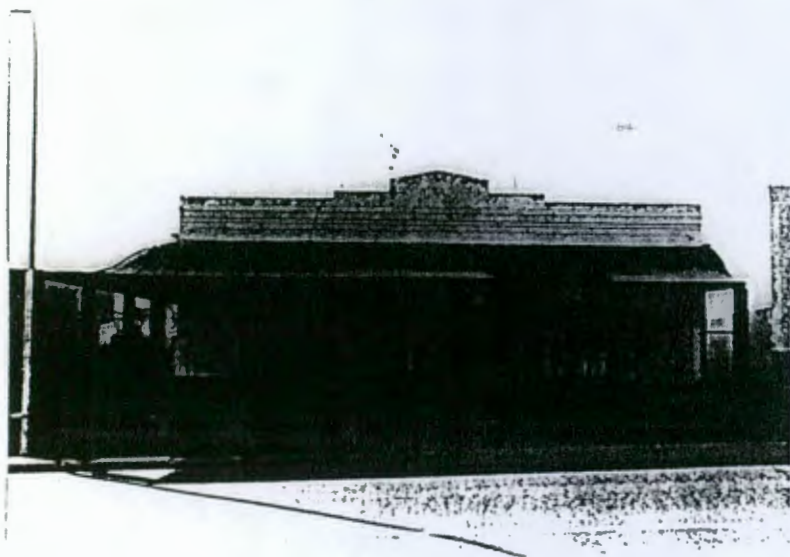
374. Erf 54: 25 Ventershoek Street.

25 Ventershoek Street - Photographs, p.227.  
Single storey with cornice and central parapet.  
Symmetrical three bay facade with edge pilasters.  
Plastered stoep.  
Steel windows.  
Modern door in recessed opening flanked by engaged columns.  
Fair condition, but original appearance largely lost.

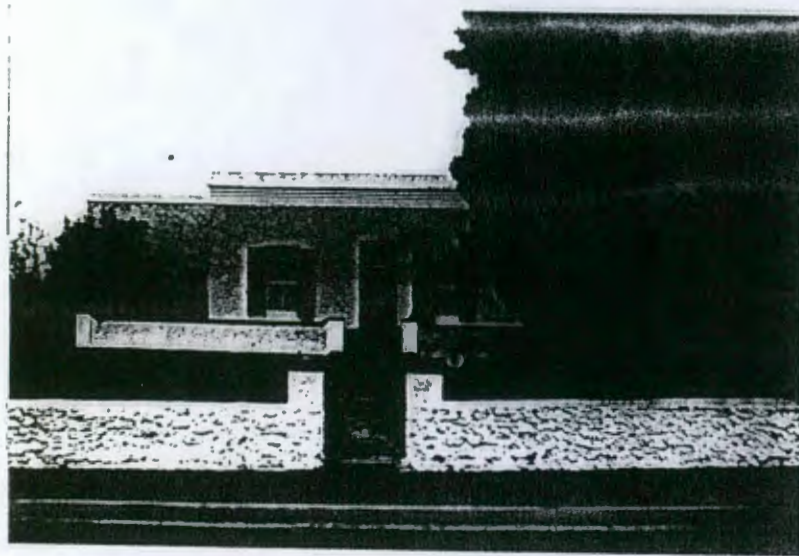
377. Erf 60: 19 Ventershoek Street.

19 Ventershoek Street - Photograph, p.229.  
Single storey with hipped roof.  
Symmetrical three bay facade.  
Stone stoep with plastered wall. Double curvature veranda on plastered piers.  
Modern windows, modern door.  
Good condition but original appearance largely lost.

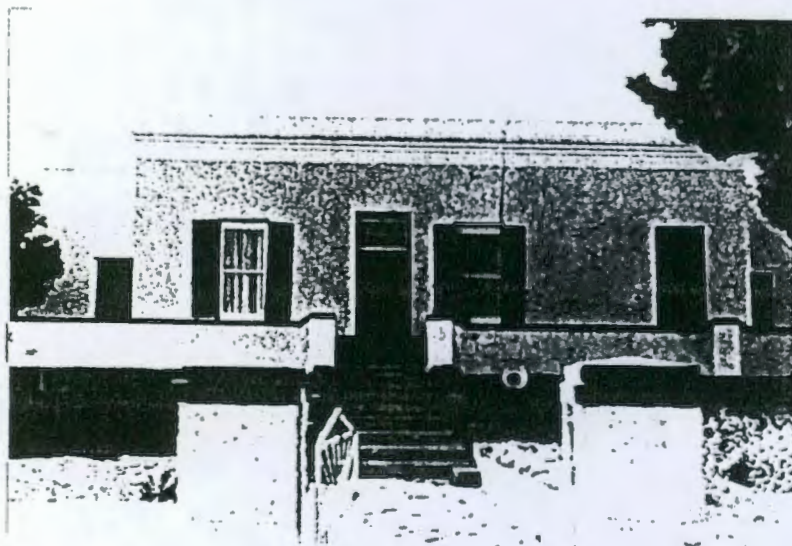
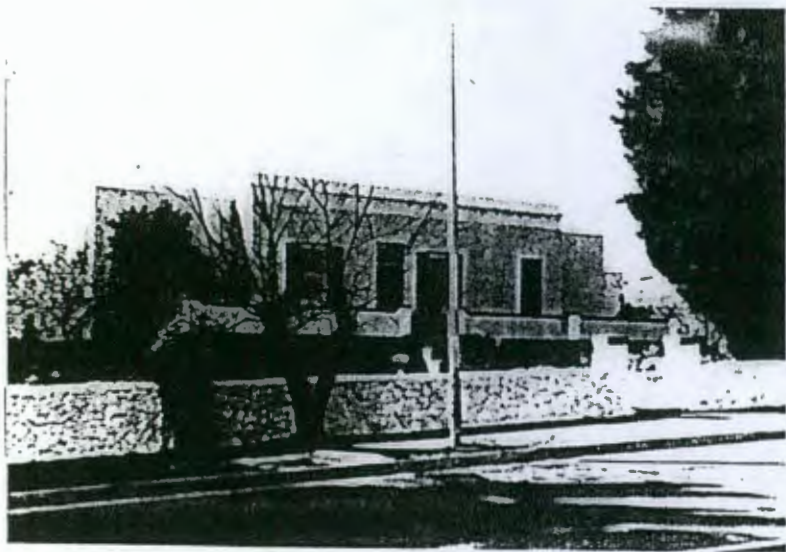
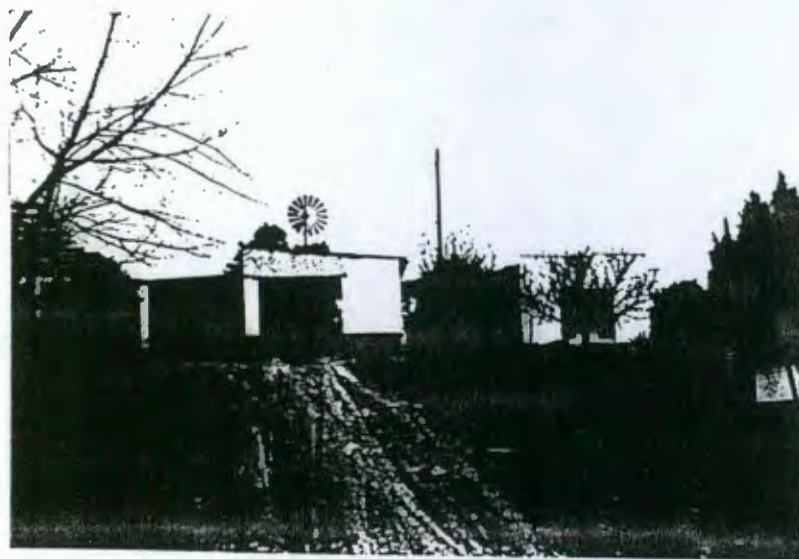
378. Erven 61, 62, 63 & 64: 17 Ventershoek Street.

17 Ventershoek Street - Photographs, pp.230 & 231.  
Single storey with flat roof and cornice with flat parapet above. Flanking wings with light cornice.  
Asymmetrical four bay facade flanked by symmetrical recessed wings.  
High stone stoep with plastered wall.  
4-light double sliding sash windows with Venetian shutters.  
6-panel door, replacement fanlight.  
Excellent condition. Original appearance.

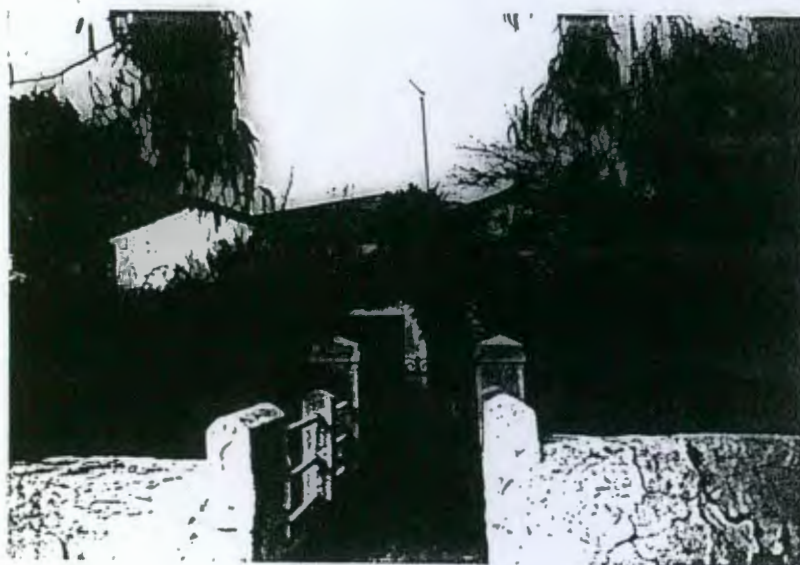
387. Erf 148: 9 Ventershoek Street.

9 Ventershoek Street - Photograph, p.232.  
Single storey with double pitched roof and bargeboard end  
gables.  
Facade originally symmetrical - now recessed door and window  
in centre.  
Stoep wall at recessed entrance.  
Two 12-light double sliding sash windows with metal canopies.  
Recessed door and window modern.  
Flat roofed garage with light cornice.  
Fair condition but original appearance lost.

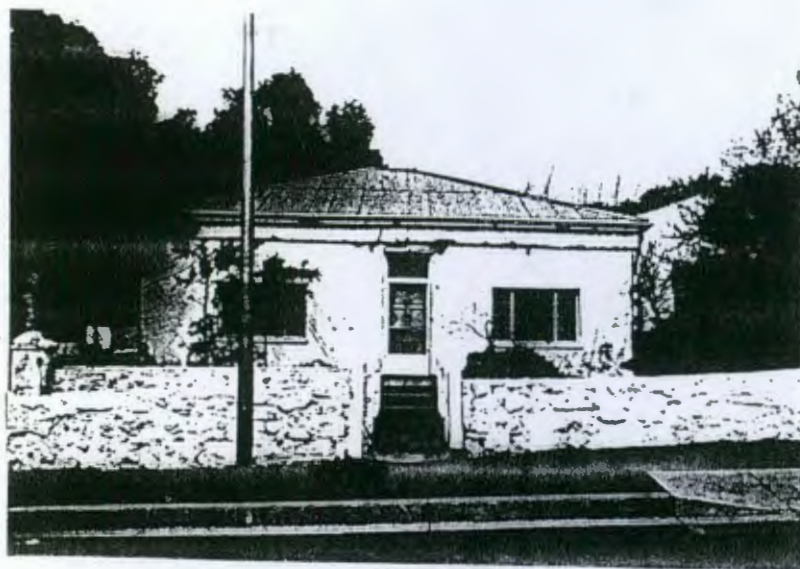
388. Erf 149: 7 Ventershoek Street.

7 Ventershoek Street - Photograph, p.233.  
Single storey with hipped roof and bargeboard gabled double pitched flanking wings.  
Facade altered by built-in veranda between wings. Rusticated edges.  
Modern windows and door.  
Fair condition, original appearance lost.

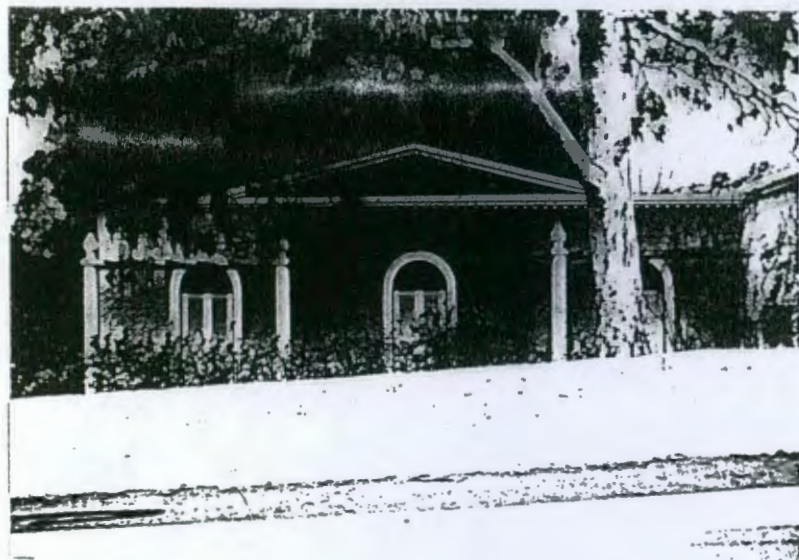
389. Erf 150: 5 Ventershoek Street.

5 Ventershoek Street - Photograph, p.233.  
Single storey with hipped roof.  
Symmetrical three bay facade.  
Veranda recently removed.  
Steel windows, modern door.  
Dilapidated condition, original appearance lost.

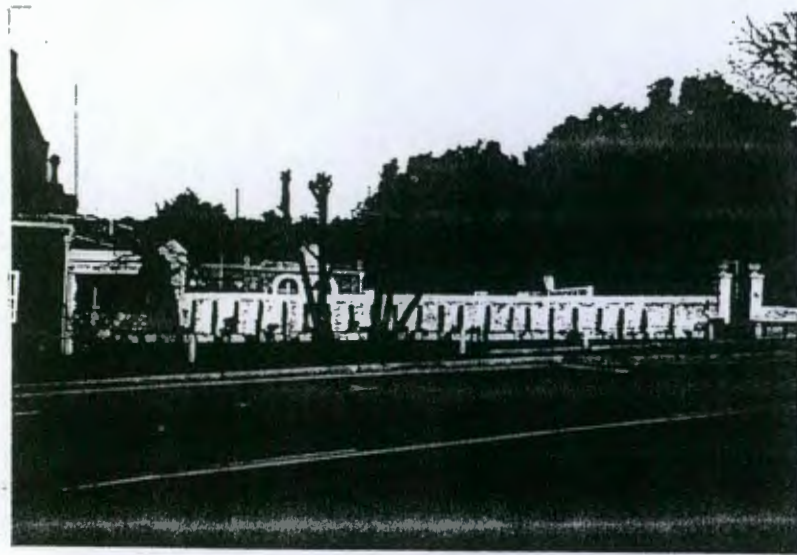
390. Erf 151: 3A Ventershoek Street.

3a Ventershoek Street - Photograph, p.234.  
Single storey with flat roof and pediment with dentil cornice.  
Symmetrical three bay facade.  
Pergola on anachronistic columns.  
Arched French doors with Venetian shutters and recent fanlights.  
Good condition, but either over-restored or else a recent building.

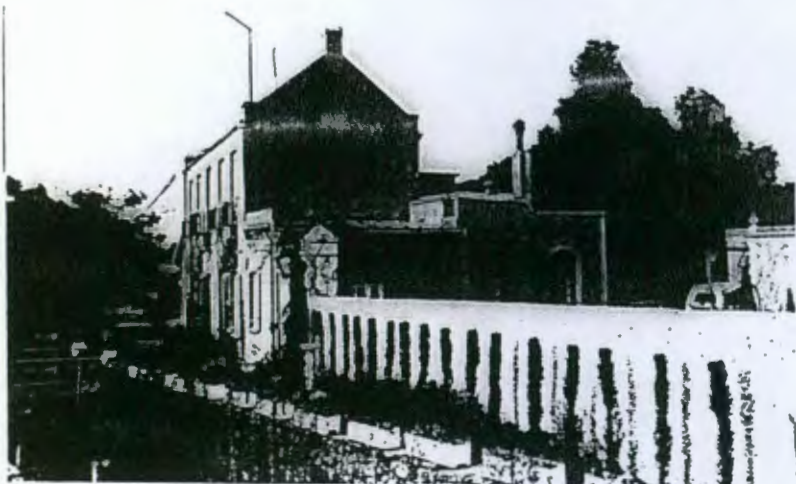
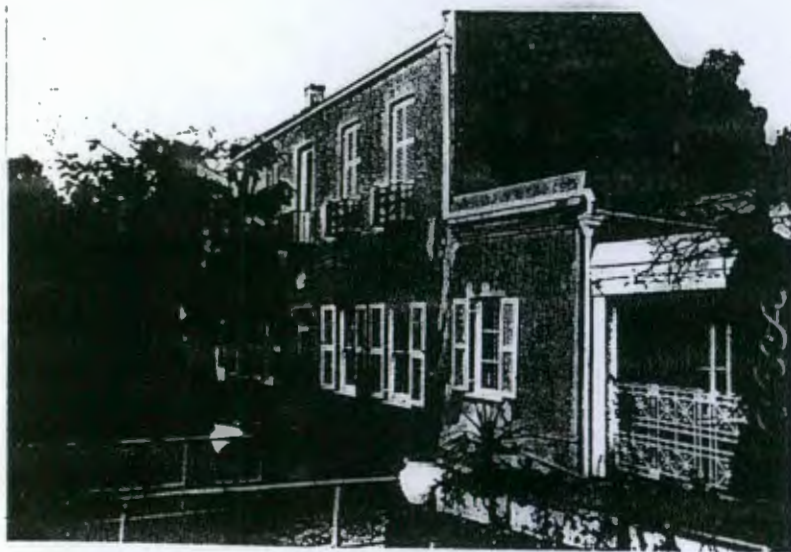
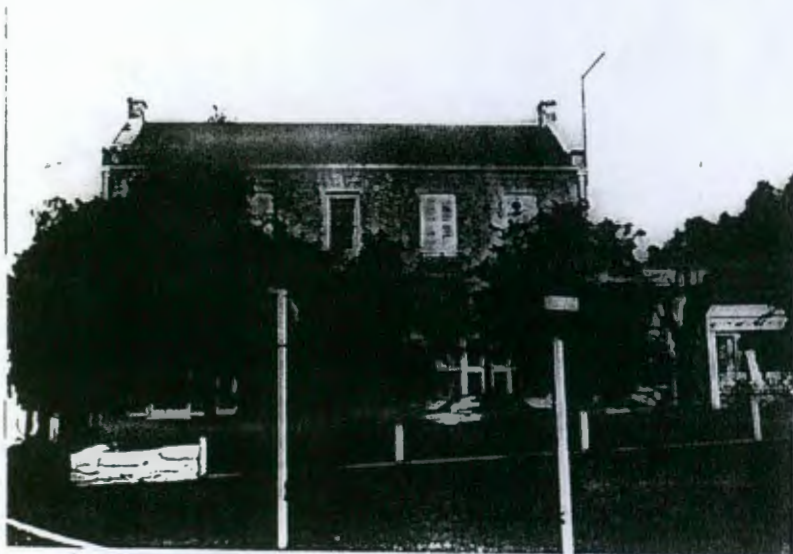
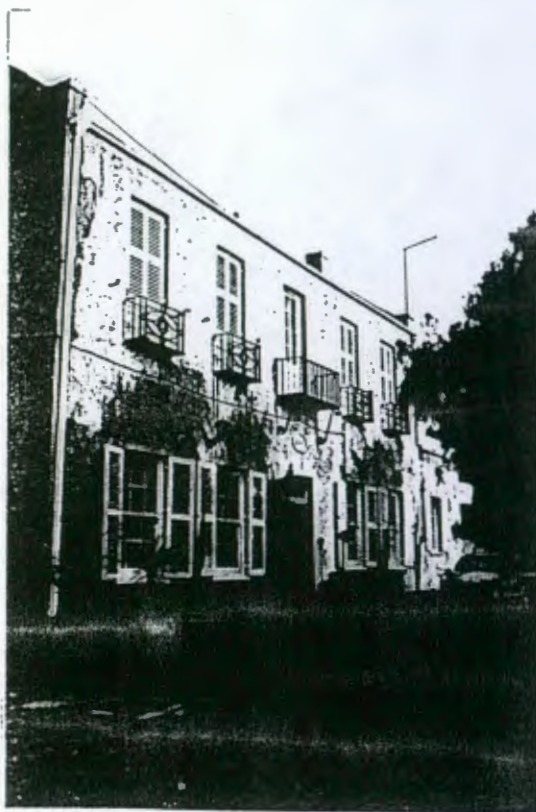
391. Erven 152 & 153: 3 Ventershoek Street.

3 Ventershoek Street - Photographs, pp.234, 235 & 236.  
Double storey with double pitched roof with moulded end gables. Single storey flat roofed extension with cornice.  
Symmetrical five bay facade with extension to the right.  
Stone stoep.  
2-light double sliding sash windows with Venetian shutters.  
Decorative iron balconies to upper windows.  
Original entrance door and fanlight, glazed upper door leading to iron balcony.  
Excellent condition, original appearance.
