GUI	DELINE	Disclosure Classification: CONTROLLED DISCLOSURE
Title: TRANSMISS	ION BIRD PREVENTION	Unique Identifier:	41-335
GUIDELINE	PREVENTION	Area of Applicability:	т
		Document Type:	GL
		Revision:	1
		Total pages:	12
		Next Review Date:	NOVEMBER 2014
COMPILED BY	FUNCT	IONAL RESP.	AUTHORIZED BY
H.F.VOSLOO SERVITUDE SPE	ECIALIST SENIO HIGH V	RCORMACK R MANAGER OLTAGE EERING	WILLY MAJOLA G.M. ASSET MANAGEMENT
DATE 24/03/20	10 DATE	24/03/2010	DATE 24/03/2010
Content			Page
2Supporting Clauses2.1Scope2.2Normative/Inform2.3Definitions2.4Abbreviations2.5Roles and Respo2.6Implementation E2.7Process for moni2.8Related / Suppor3Document Content3.1Document Specif3.1.1Background and3.2General Docume3.2.1Solutions to the p3.2.2Background3.2.3Static Devices3.2.4Dynamic Devices3.2.5Reflective device3.2.6Spacing intervals3.2.7Portion of span to3.2.8Illuminated device3.3Revision Control4Authorisation5Revisions6Development team	native References	of bird collisions	2 2 4 4 4 4 4 4 4 4 4 4 4 4 4 4 4 4 4 4

TRANSMISSION BIRD COLLISION	Unique Identifier:	41-335			
PREVENTION GUIDELINE	Revision:	1			
	Page:	2	Of	11

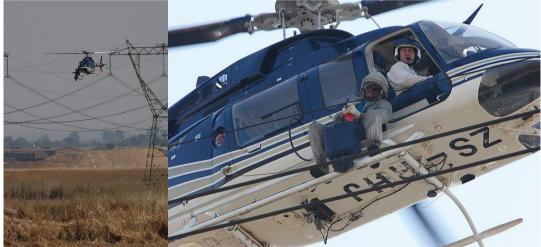
#### Figure 2: The installation of flappers on the shield wire from a helicopter.

Success rates of up to 60% reduction in mortality and even more have been documented (Ferrer and Janns, 1999). There are several devices available in southern Africa for the marking of power lines. These devices will be described below and the advantages and disadvantages discussed. The fitting of the marking devices are typically done from a helicopter, which adds considerably to the cost of any project.

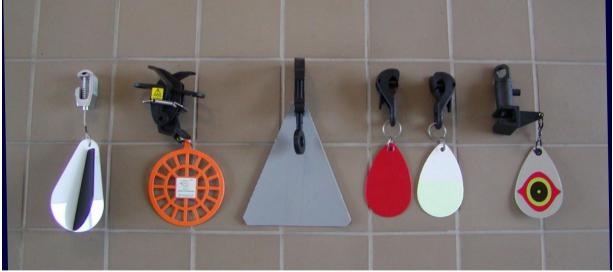
#### Figure 4: Examples of the dynamic bird flapper devices

Dynamic devices (usually called bird flappers), have moving parts as opposed to static devices where there are none.. Dynamic devices are very effective in reducing collisions as the birds seem to see them very well (van Rooyen unp. data) probably because of the movement that attracts attention. The disadvantage of dynamic devices is that they are subject to extensive wear and tear, inevitably limiting the lifespan of the device. Wear and tear has been observed on both those devices as well as recently on ADLASH optical fibres. In the latter case solution is in hand yet other than to avoid earth wires and placing devices on one shield wire only.

This has obvious cost implications if a line needs to be re-marked at intervals of a few years. No solution to that problem has been found to date and it must be accepted as a constraint. Figure 4 shows examples of bird flappers currently available on the market.

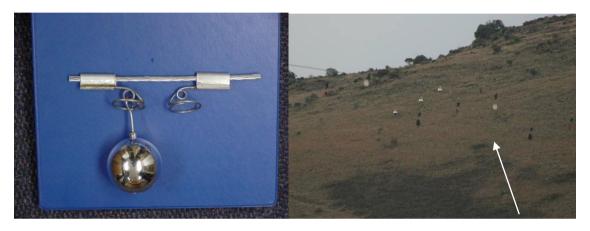
Figure 5: A Reflective Bird Diverter (left) installed on a line with conventional bird flappers (right).

A new product that shows great potential is the Inotec BFD88, a reflective stainless steel sphere of 70mm diameter. Experiments have shown the visibility of this device to be superior to coloured (red, yellow, white, black) objects especially during the low light conditions at dawn and dusk when birds may be flying from roosting areas to feeding areas and back. Due to the spherical shape, the device reflects any available light in all directions and is therefore visible from all directions including above or below the diverter. The diverter does not require direct sunlight and is effective during overcast conditions and the low light conditions before sunrise and after sunset (Van Rooyen, pers obs.) When viewed during these low light conditions the device is particularly visible against dark backgrounds such as the ground, trees or high ground. It is also particularly visible against bright cloud when viewed from below.
