FINAL HERITAGE IMPACT ASSESSMENT REPORT VERSION 3: PROPOSED HUDDLE PARK GOLF COURSE DEVELOPMENT, JOHANNESBURG

DATE OF SUBMISSION: 22 SEPTEMBER 2006

FINAL HERITAGE IMPACT ASSESSMENT REPORT, VERSION 3: PROPOSED HUDDLE PARK GOLF COURSE DEVELOPMENT, JOHANNESBURG

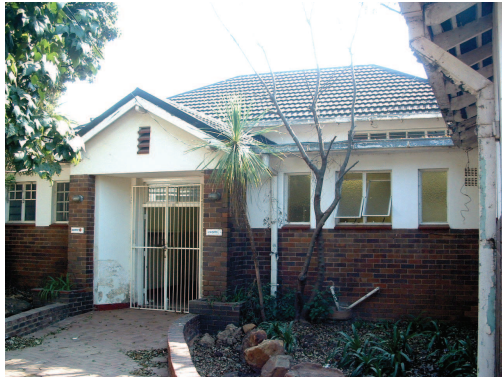
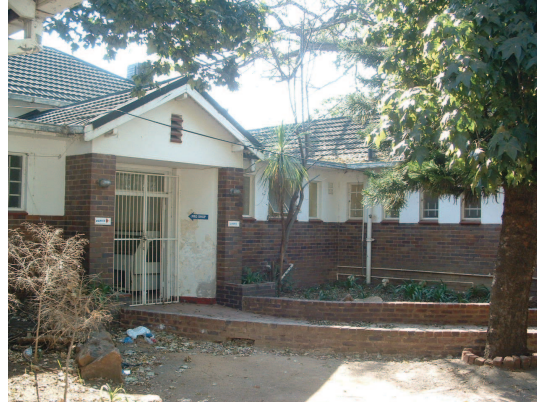
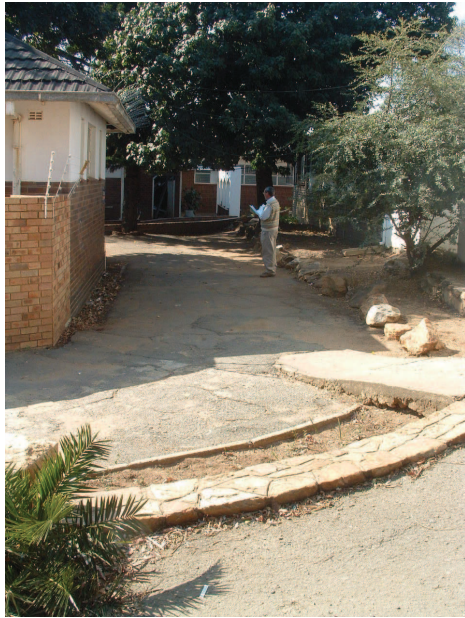
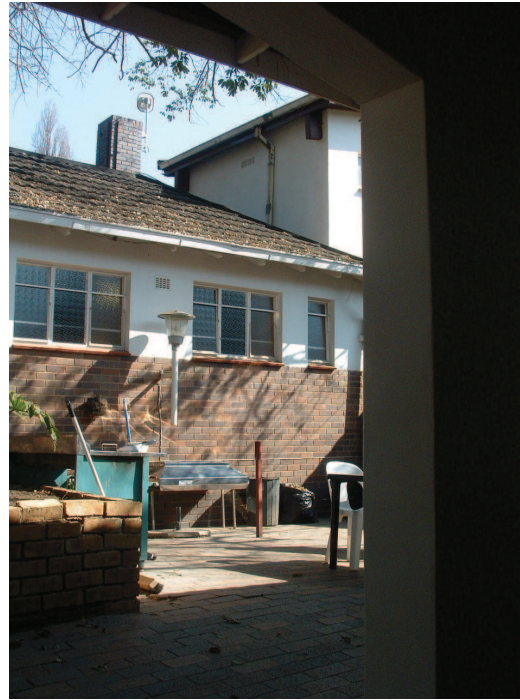
Views of the Clubhouse

Alterations: Most of the alterations relate to the addition described below. However, during that phase of the work the original slate shingles of the Clubhouse were removed and replaced by Harvey tiles, and the interior of the ablutions were extensively renovated.

Summary of mitigation measures: See Annexure 5. The existing 19th hole (in front) must be retained as a landscape element, while allowing congruent and compatible rehabilitation if required. Historic signs of the course be conserved and the historic golf links should be retained/re-used (with the necessary upgrading due to the development of the science of golf). The historical trees should be retained.

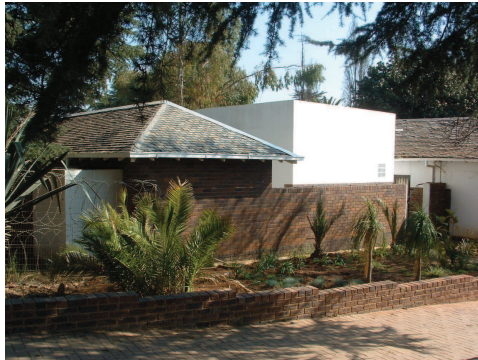
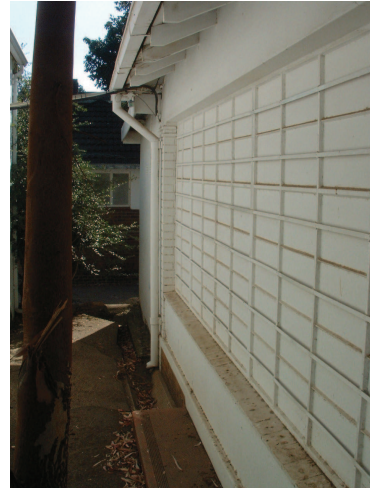
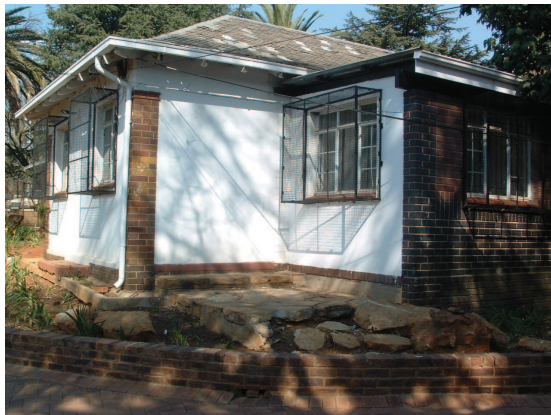
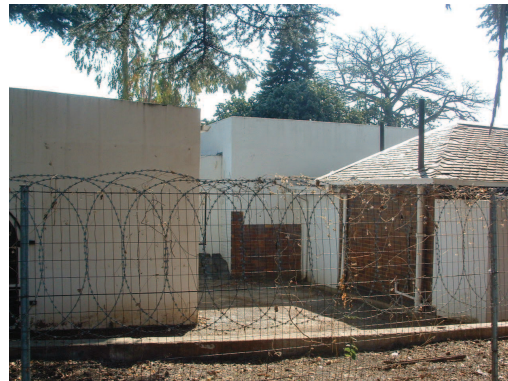
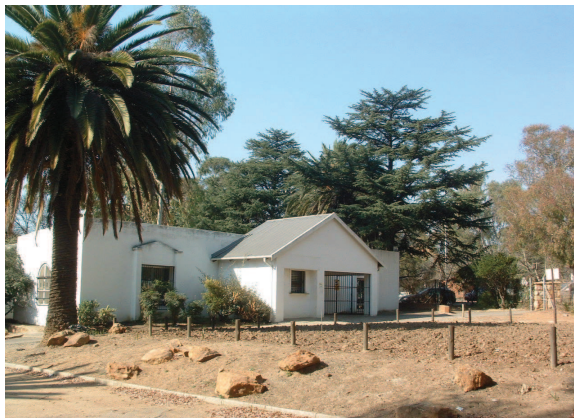
Views of the Pro shop and caddy shelter:

Heritage assessment: The building has medium remaining heritage integrity – due to the medium heritage value and low cultural significance, there is strictly no compelling reason to retain the structure and ensure retention of cultural significance in new development; however its forms part of the general fabric of the site and can be re-used; hence, retention is recommended.

Summary of mitigation measures: See Annexure 5.

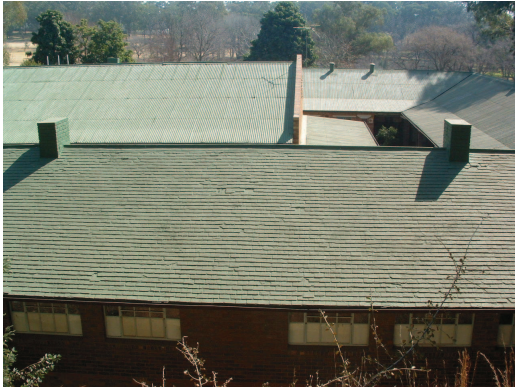
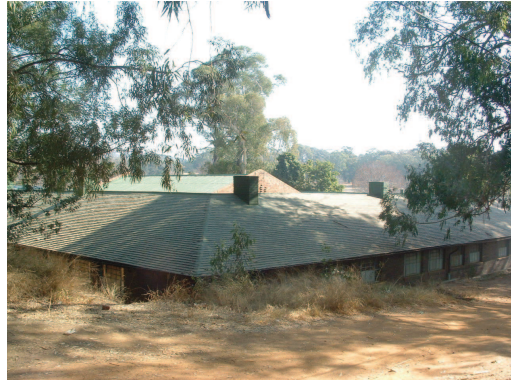
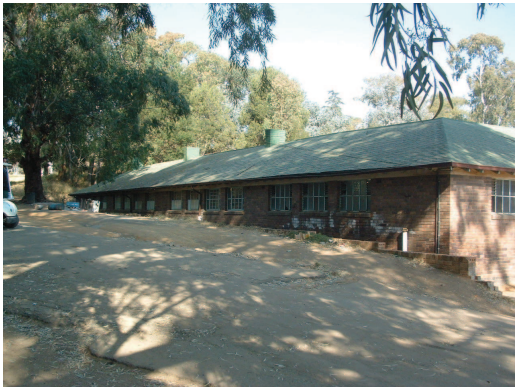
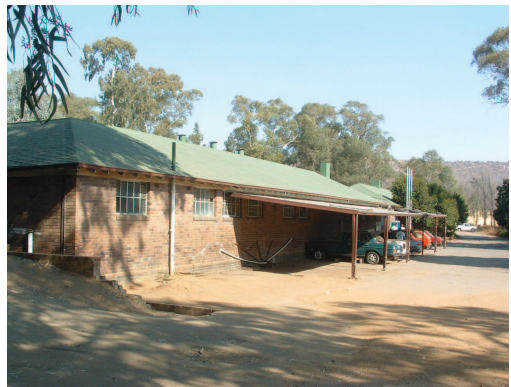
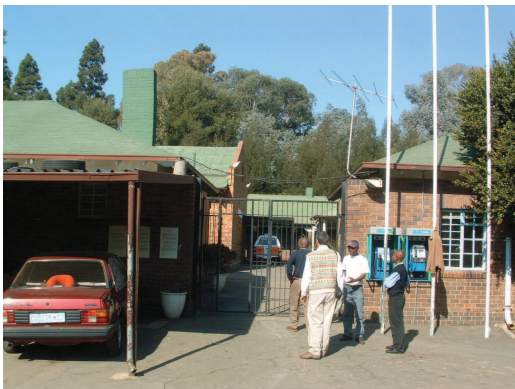
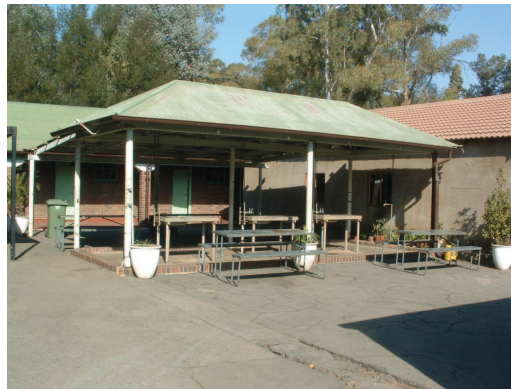
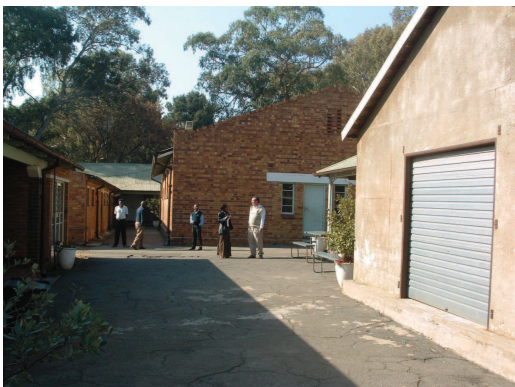
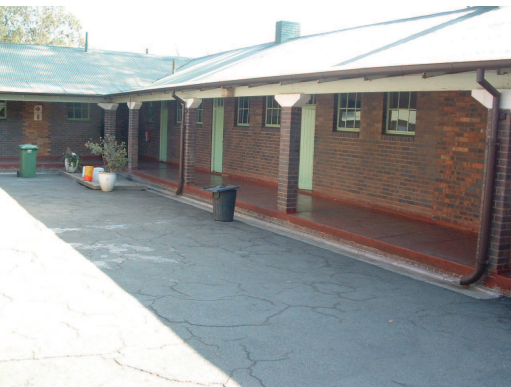
Views of the Caddies Compound

- The architectural typology known as 'Native Compound' was found in the mining and railway industries, and here a rare example in the municipal sport and recreational sector – the type has now become rare due to altered social values, labour practices and township development;

Summary of mitigation measures: See Annexure 5. The historic function should be commemorated through the reconstruction of one caddies room, or through a small workers' museum, or through a commemorative plaque, or a combination of these. The integrated management plan should also include the aspect of redress as it pertains to the dignity of past inhabitants, as well as the living circumstances of current inhabitants.

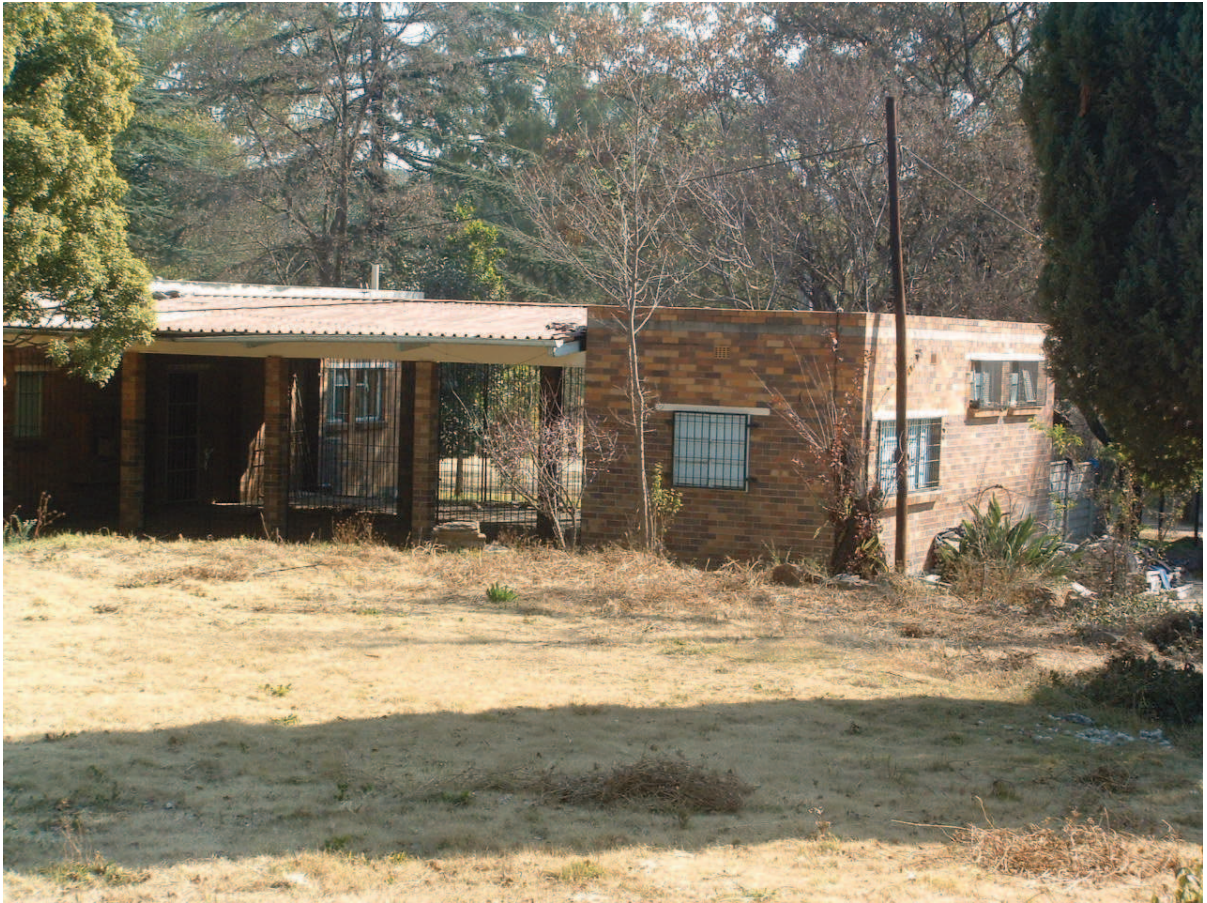
ITEM 4: Ticket office

The Ticket Office consists of two rectangular structures of yellow/brown face brick in stretcher bond with a flat concrete roof with parapet walls, and with a connecting structure of brick colonnades covered with a shallow pitched IBR sheet metal roof. The windows are steel framed, are placed irregularly, and have thin concrete lintels above. No plan drawings of the building could be traced. From the details and the design composition, as well as the difference in design relative to the other golf park buildings, it is clear that the building was built after the others, and most probably in the late 1940's to 1950's. The building has some value due to its particular functional design.

From the assessment, its demolition will not be supported. The building should be re-used in the new development. See Annexure 5.

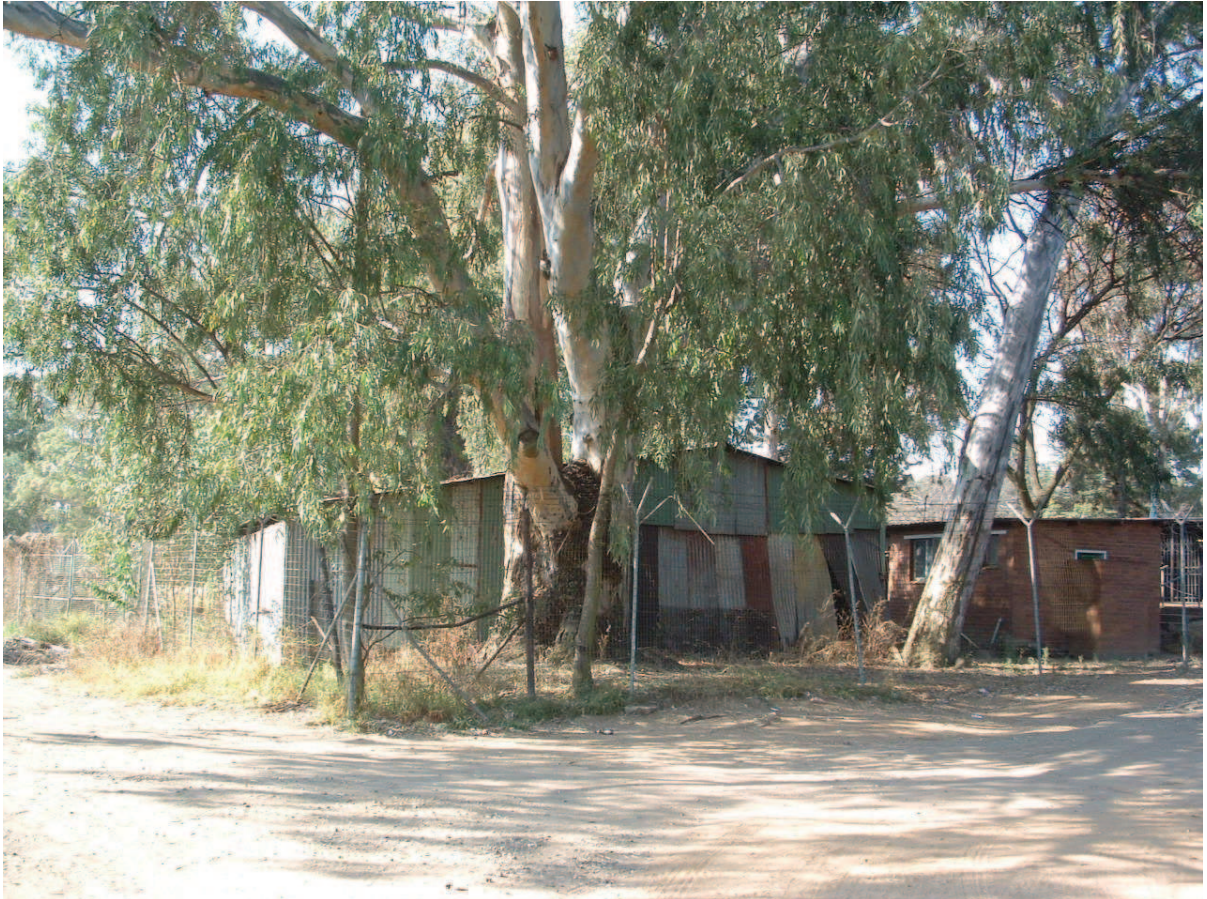
ITEM 5:Stores

The stores consist of two structures: The first is a large rectangular corrugated sheet metal shed with lean-to extension of the same material. The building is in a very dilapidated state. The second is a large rectangular face brick structure with a shallow pitched corrugated sheet metal mono-pitch roof, with small steel framed windows with thin concrete lintels, and timber framed access doors. No plan drawings of these structures could be traced. The structures are most probably part of the original development, if the materials and window details are anything to go by – only the lean-to structure may be of a later date. One may safely say the structures are older than 1945, i.e. older than 60 years – The building therefore enjoys general protection under the provision of the NHRA - Section 34(1) of the NHRA applies. The buildings are not unique.

From the assessment, their demolition will be supported if so required. The buildings should be photographed in full. Apply mitigation in terms of planting new non-invasive trees and a marker signifying the location and appearance of the stores.

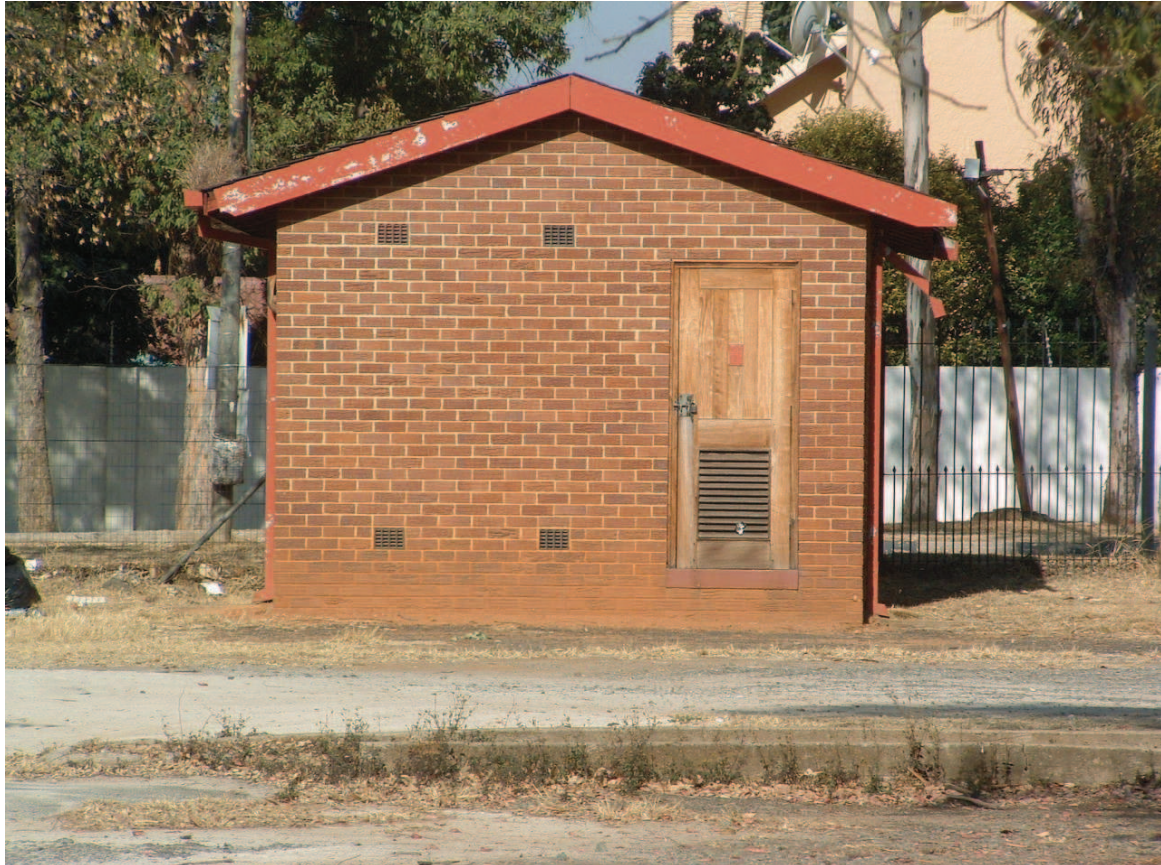
ITEM 6: Electrical substations

The electrical substation is a small rectangular structure of rock-face brickwork in stretcher bond, with a saddle roof of concrete tiles with timber fasciae and galv sheet metal gutters and down pipes, and a framed and battened solid hardwood door, situated along the main road (Club Street) alongside the golf park. Another, similar structure is located further along the road.

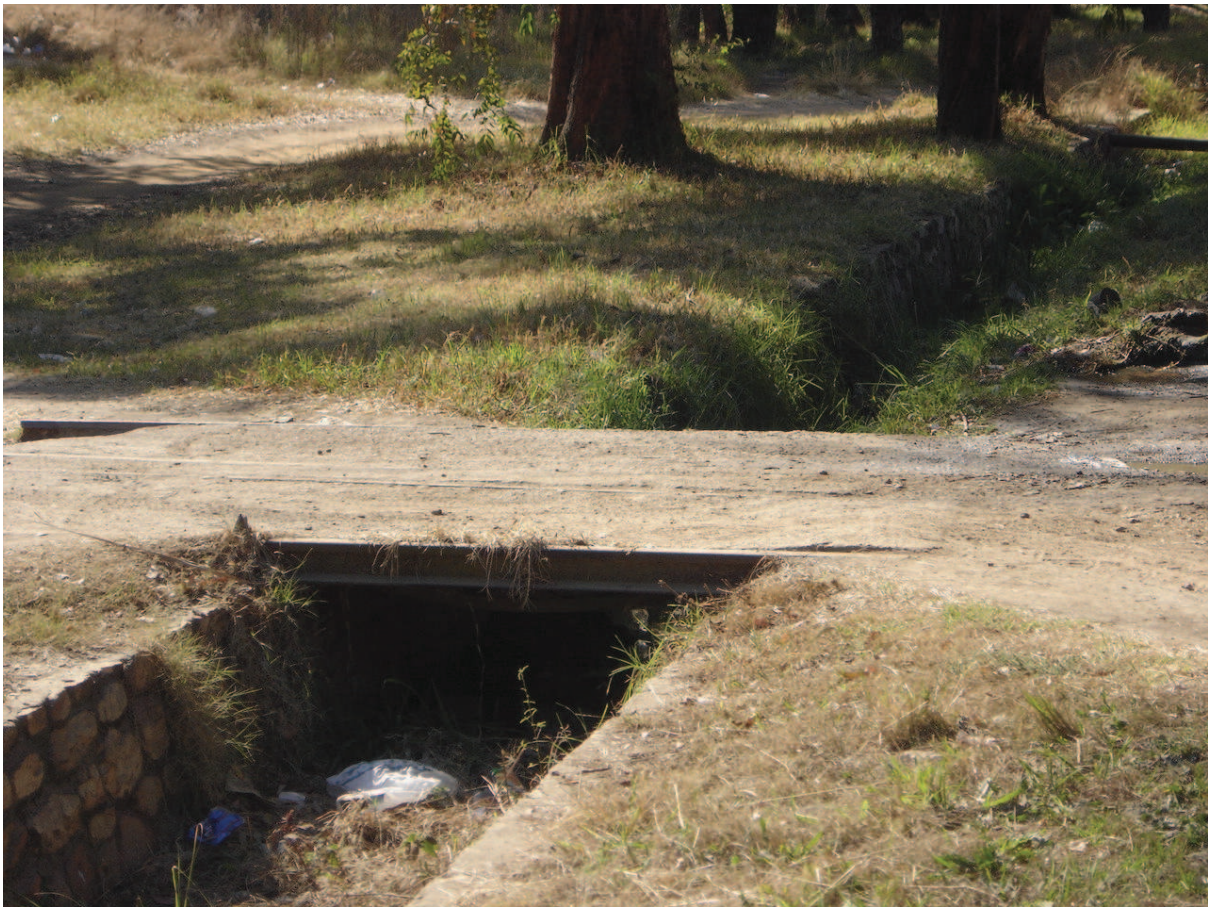
Impact significance Retention or partial destruction (mitigation): Low
Demolition without mitigation: Medium

Summary of mitigation measures: Retain and restore to working order the entire furrow (preferred option) or parts thereof. See Annexure 5.

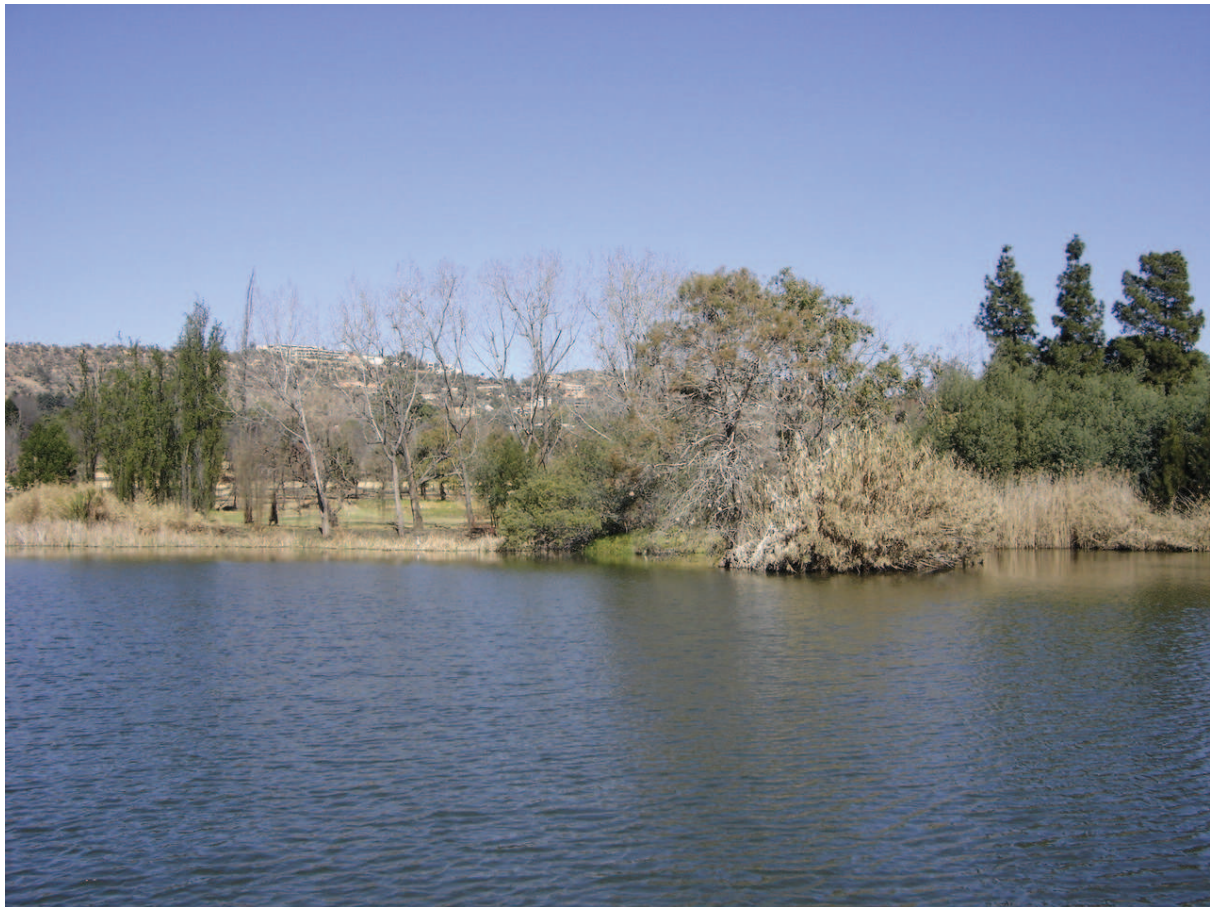
Impact significance Mitigation (retain and use): Low
Demolition without mitigation: High

Summary of mitigation measures: Retain

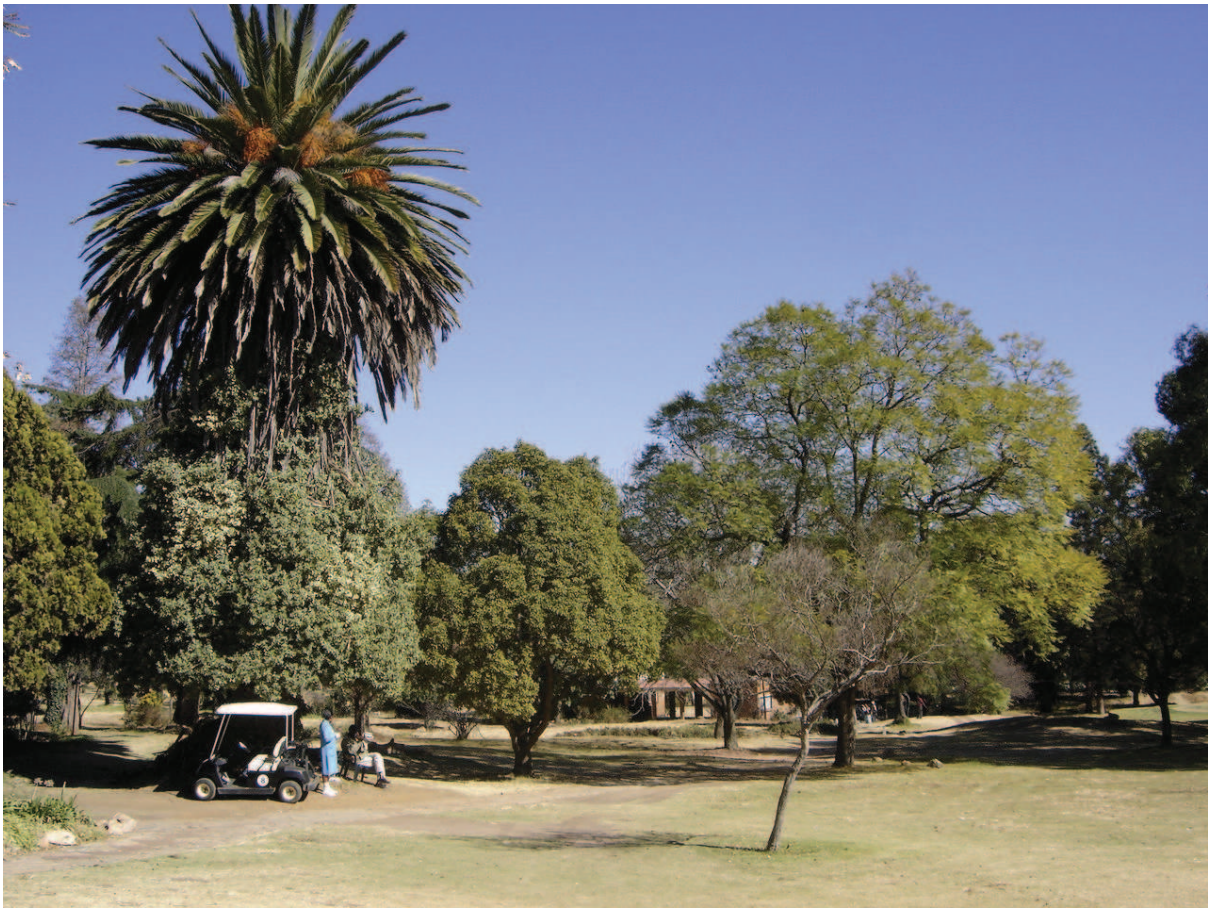
Impact significance Mitigation (retention): Low
Destruction without mitigation: High

Summary of mitigation measures: Retain where possible. Cultmatrix supports the proposals of the landscape architect whereby as many of the original trees will be retained if possible.
