HERITAGE SCREENER

CTS Reference Number:	CTS21_269
SAHRIS Ref:	
Client:	Savannah
Date:	January 2022
Title:	Development of the Wagt Solar PV1 Facility and associated Grid Connection Infrastructure near De Aar, Northern Cape Province

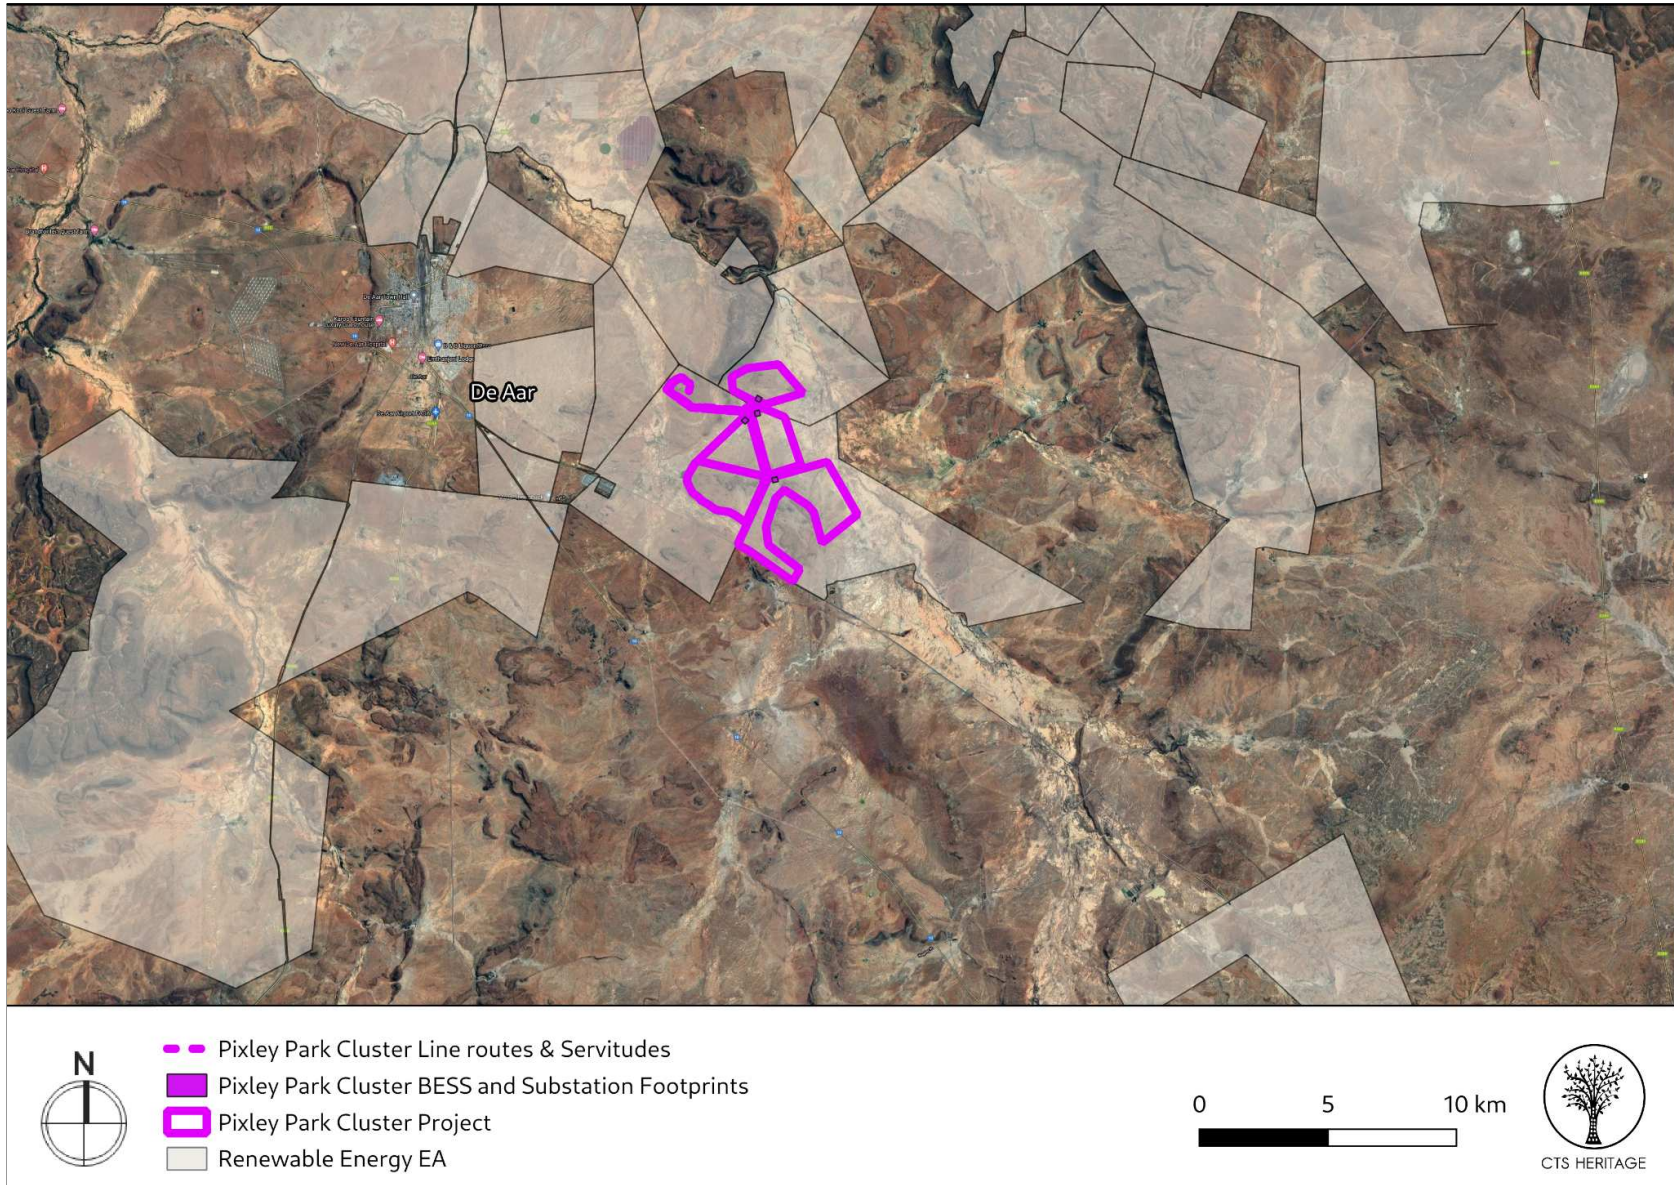
Figure 2b. Environmental Authorisations. Previous Environmental Authorisations issued for Renewable Energy Projects in the vicinity of the proposed development
