**HERITAGE SURVEY OF THE CHRIS HANI CLUSTER
9 WATER PROJECT, EASTERN CAPE**

FOR MALUTI GSM CONSULTING ENGINEERS

DATE: MAY 2009

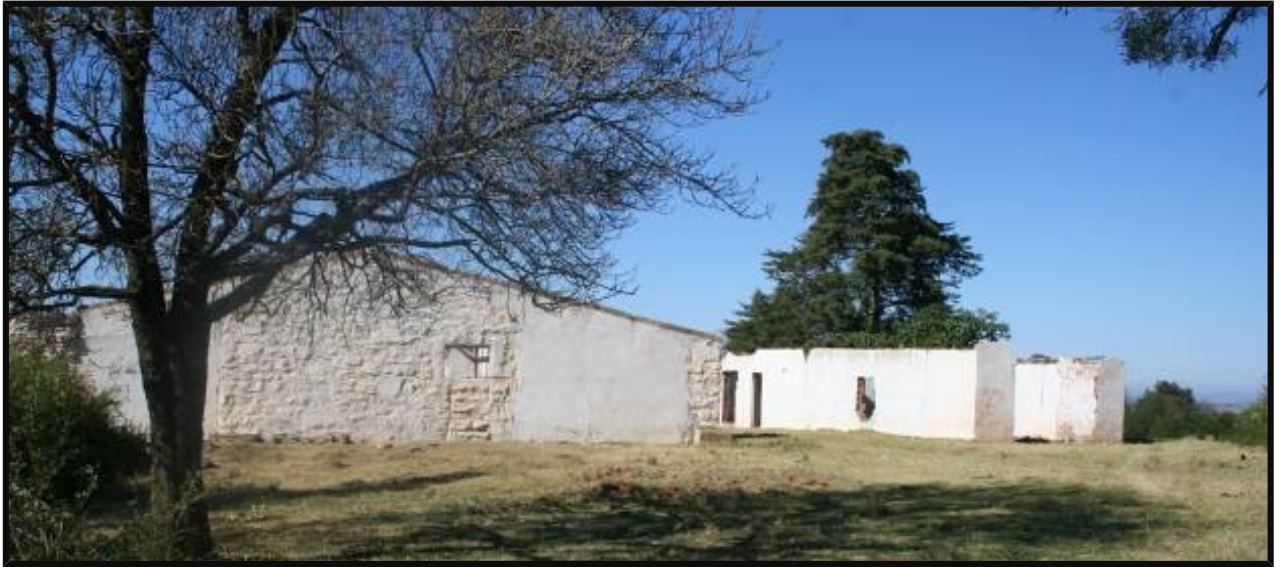
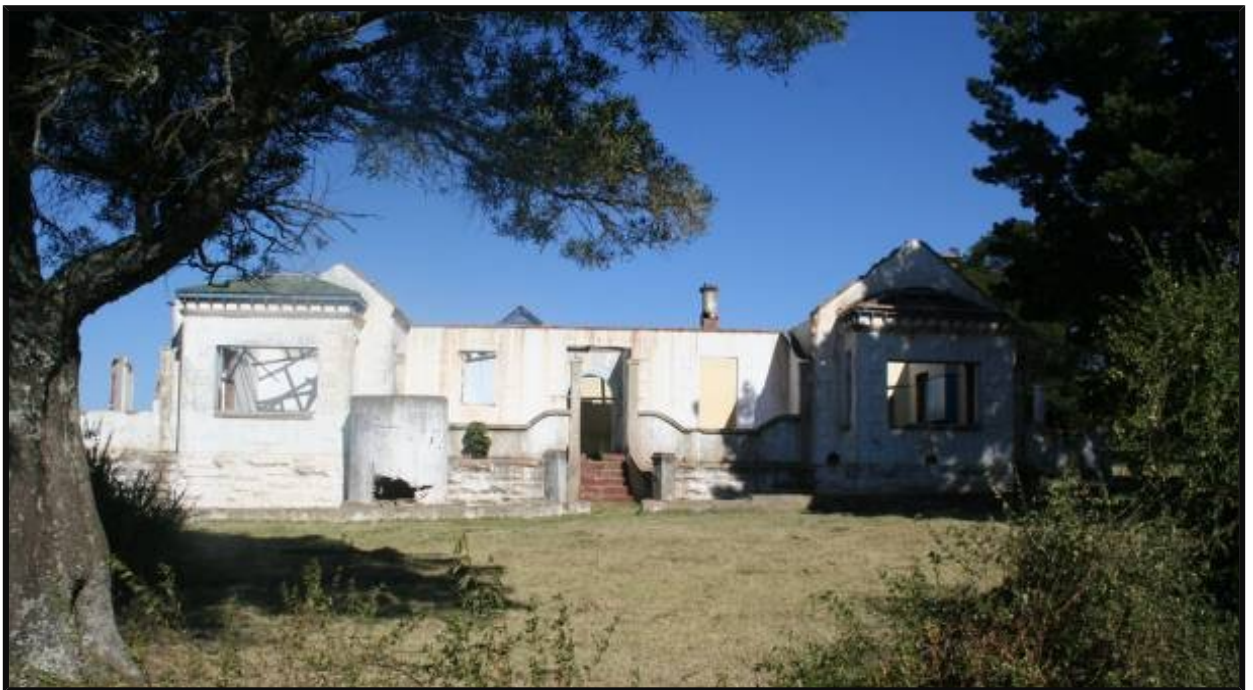
FIG. 4: FAIRVIEW VILLA, OUTBUILDINGS AND TRADING STORE

The site is located near the main dirt road on the top of a hill. It consists of several buildings that make up the old Fairview Villa and "trading post" (fig. 4). I assume that the buildings are older than 60 years in age. The site dates to the recent past.

Significance: The significance of the buildings would need to be assessed by an architect historian.

Mitigation: While the buildings are unlikely to be damaged, the pipeline may unearth old rubbish dumps. An environmental Control Officer should be on site when this area is excavated and report ANY artefacts. These then should be reported to SAHRA and or the heritage practitioner for comment. If historical artefacts, such as bottles and plates, were located, the excavations would need to stop and continue further along the line,

until the artefacts have been assessed. Any rubbish dump exposed in this area will need a further heritage assessment.

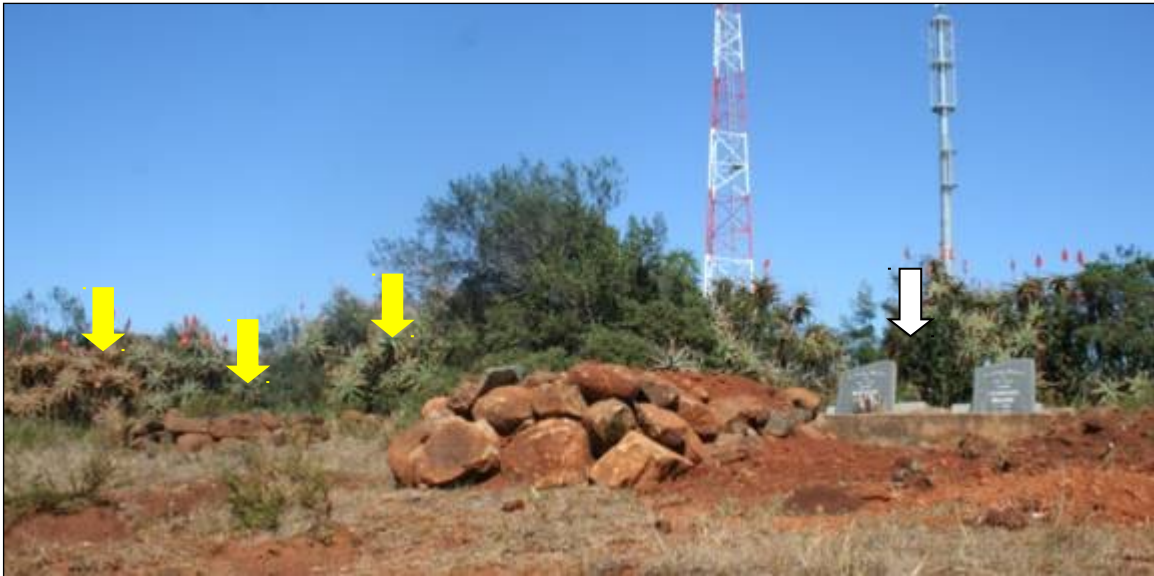
FIG. 5: GRAVES AT CHC06⁴

⁴ Yellow arrow = older graves, white arrow = recent graves

The site is located near the end of a long ridge just below a cell phone tower. The site consists of approx eight graves of various ages (fig. 5). The more recent graves date to c. 1974 and have headstones. Other graves do not have headstones and are presumably older. These older graves are surrounded by aloes and bushes. It appears that the graves are associated with the Mbane family.

Significance: The site is of high significance.

Mitigation: The graves should not be affected.

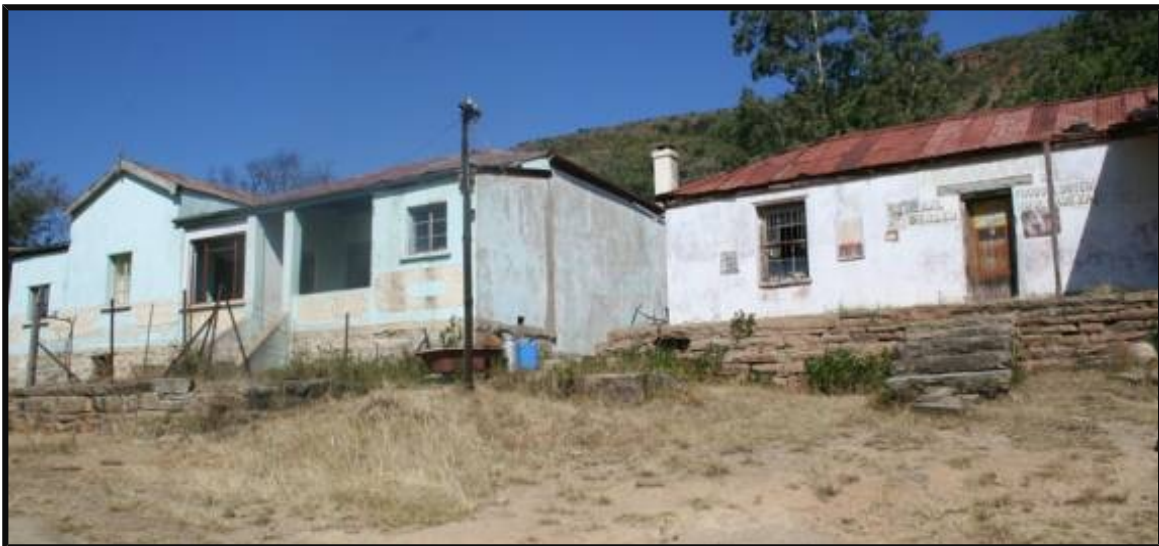
FIG. 6: MBULUKWEZA STORE AT CHC07

The site is located near the bottom of the valley and is just outside of the affected area. The site consists of the Mbulukweza Store (fig. 6) that appears to be older than 60 years.

Significance: The site is probably of low significance, but will need to be assessed by an architect historian.

Mitigation: the site will not be directly affected by the pipeline.

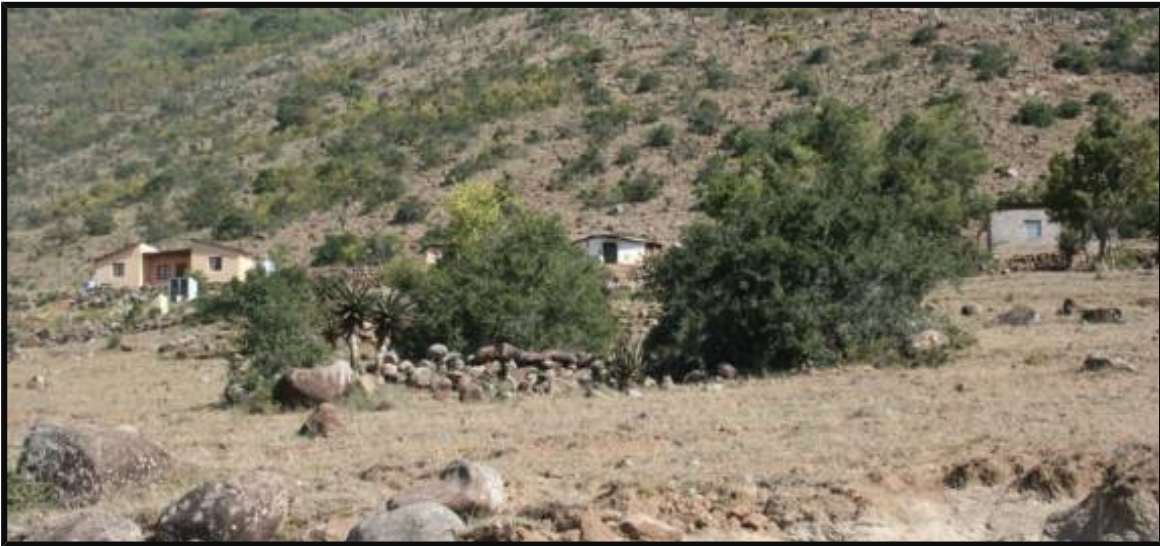
FIG. 7: STONE WALLING AT CHC09

The site is located just outside of the study area, and is located at the bottom of the valley. The site consists of a recent grave and several stone terraces and walling (fig. 7). The latter occur up to 200m away from the grave. The walling and terracing is may date to the 19th century as mentioned by Feeley (1987).

Significance: The grave is of high significance while the rest of the site is of low significance.

Mitigation: The site will not be affected by the pipeline. If it is affected by later pipelines then it will need to be mapped.

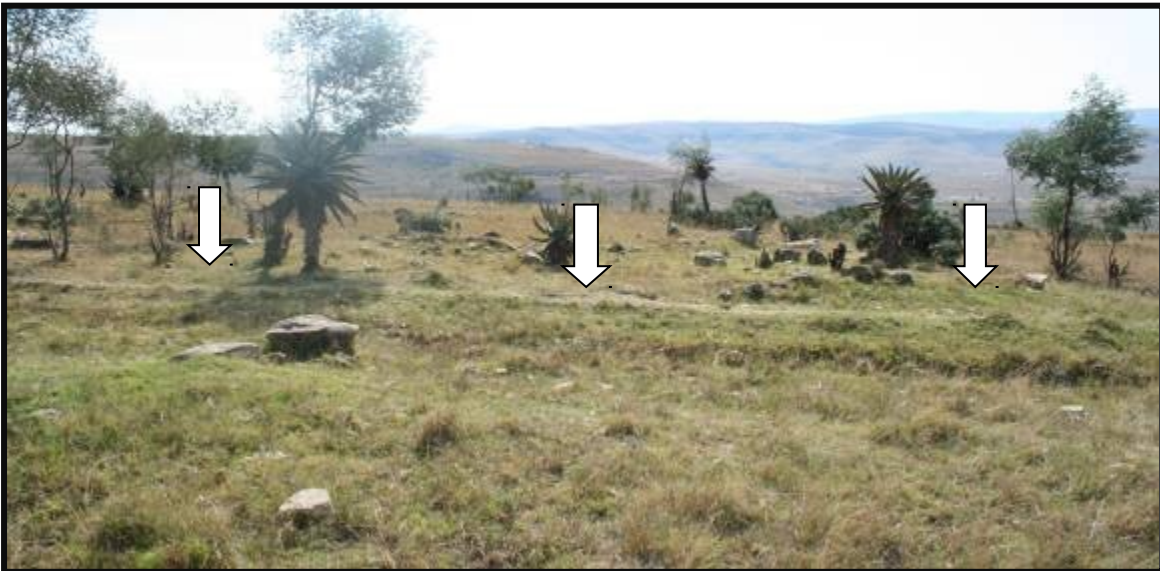
FIG. 8: STONE WALLING AT CHC010

The site is located just outside of the study area, and is located at the bottom of the valley. The site consists of stone walling and two graves associated with the stone walling.

Significance: The grave is of high significance while the rest of the site is of low significance.

Mitigation: The site will not be affected by the pipeline. If it is affected by later pipelines then it will need to be mapped.

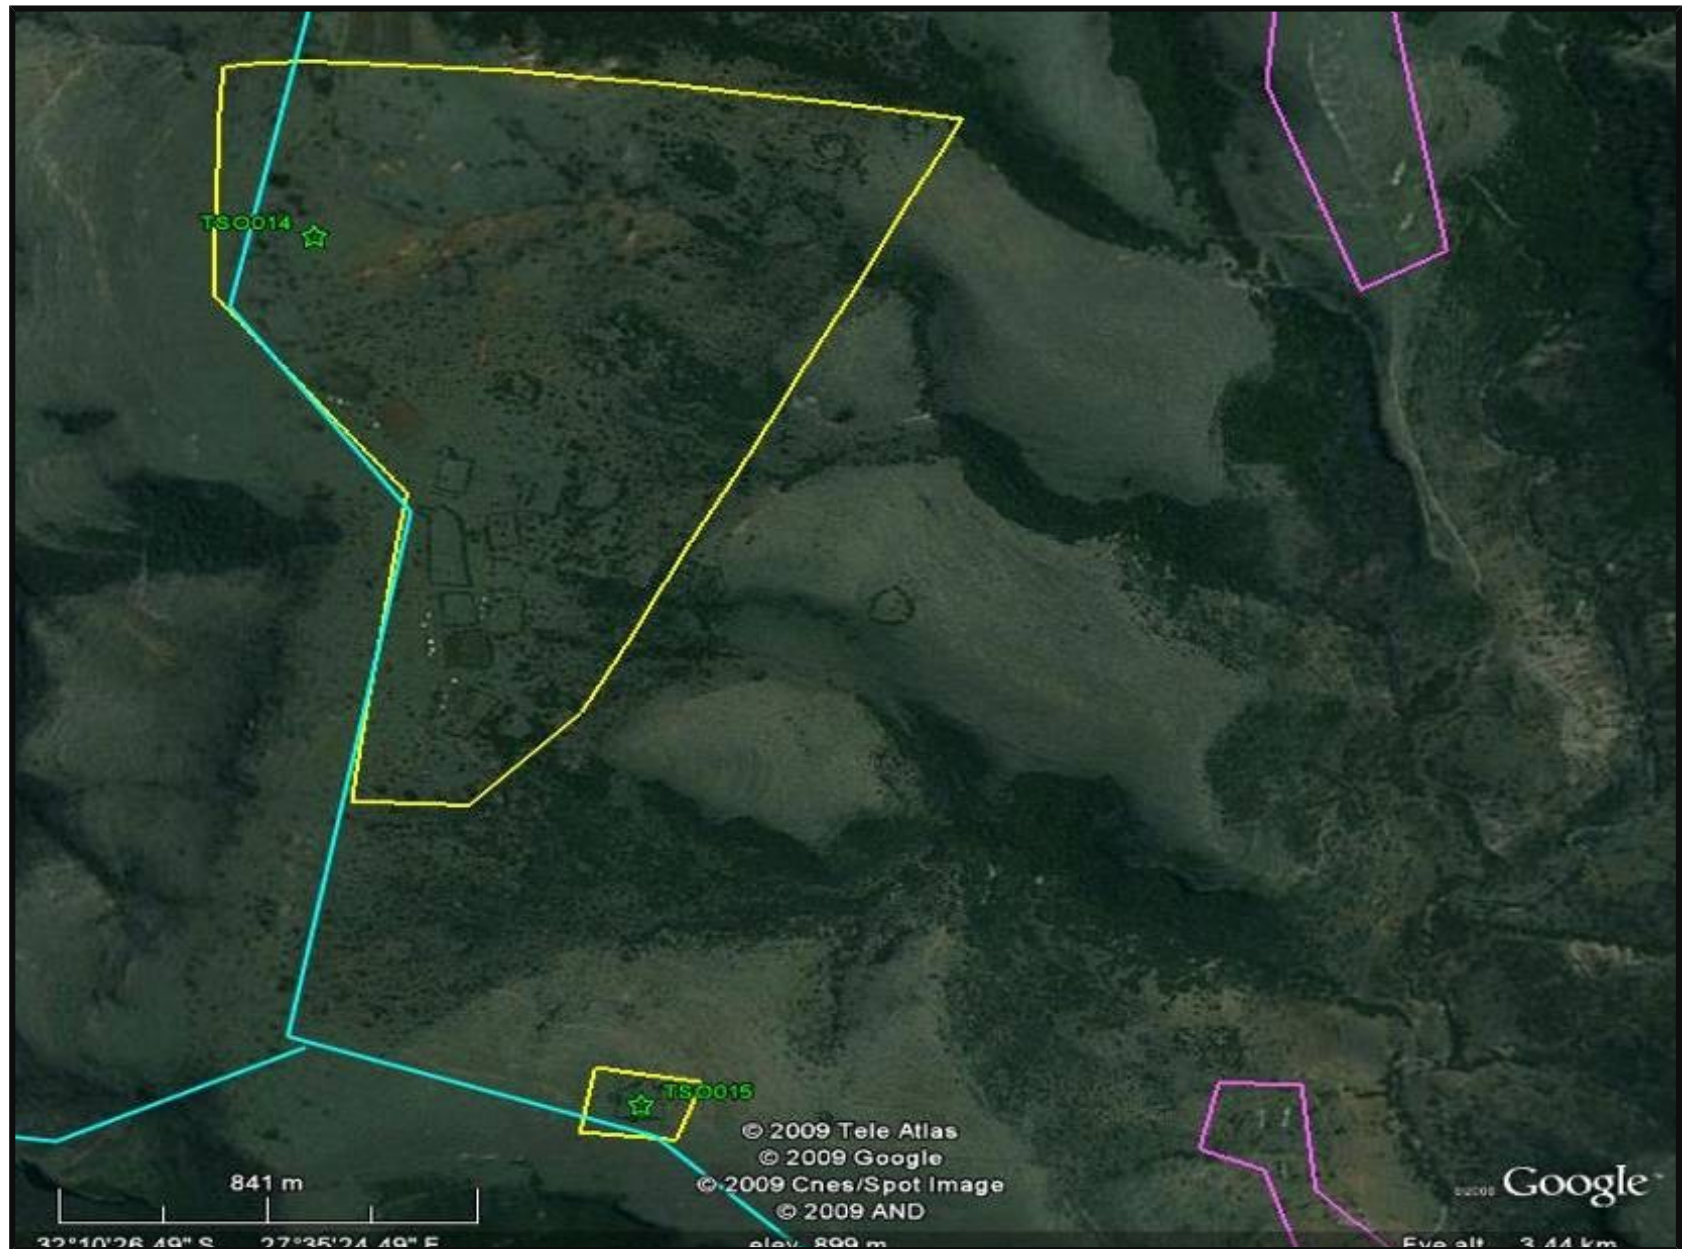
FIG. 9: SERIES OF SETTLEMENTS AT CHC014 AND CHC015

The site is located on the top of a hill overlooking the Tsomo and Kei Rivers. We could get access to the site and have relied on aerial photography to demarcate the site (fig. 9). The site consists of approx. twenty settlements, of which seven are currently occupied. These span ~1.5km of the pipeline. The other thirteen settlements conform to the standard settlement pattern of the area. The site appears to date to the recent past.

The pipeline will occur mostly to the west of these settlements and thus bypass any potential graves. However, the northern part of the area needs to be carefully monitored for potential graves.

Significance: The site is of low significance unless graves occur.

This site is located ~700m southeast of CHC014. The site consists of a single settlement and appears to date to the recent past. The pipeline occurs to the south of the settlement.

Mitigation: No further mitigation is required. An ECO should be on site when this section is excavated to ensure that potential recent graves are not disturbed.
