MAPUNGUBWE NATIONAL PARK AND WHS

Heritage Impact Assessment for Several Proposed Developments

January 2020

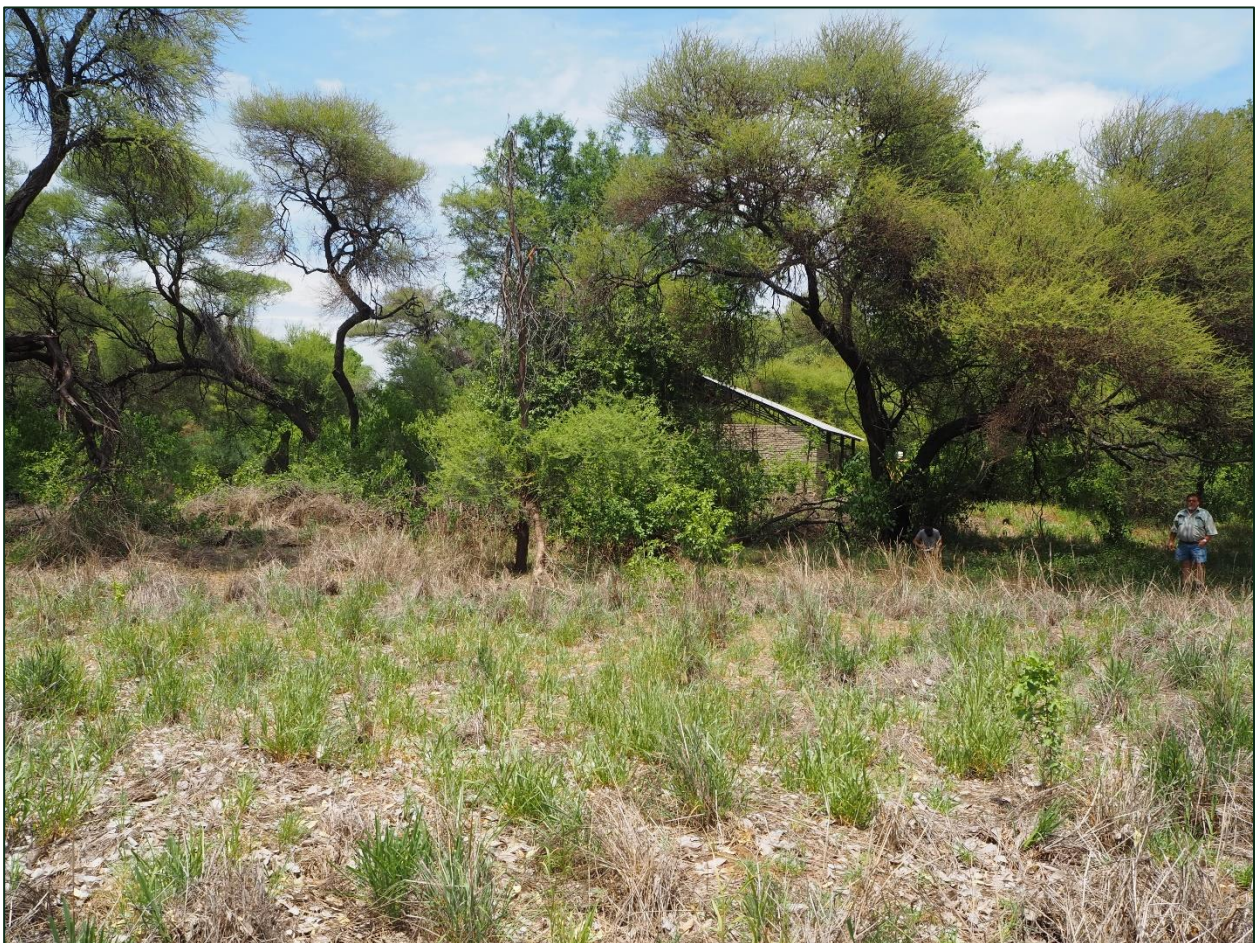
Figure 41. Recent brick shed on site

No finds of heritage value could be made within the proposed study area as indicated by SANParks personnel. Some recent agricultural structures such as a shed and outbuildings were noted. None of these were of heritage value and none of them will be affected by the proposed development. No archaeological deposits could be identified within the proposed development footprint.

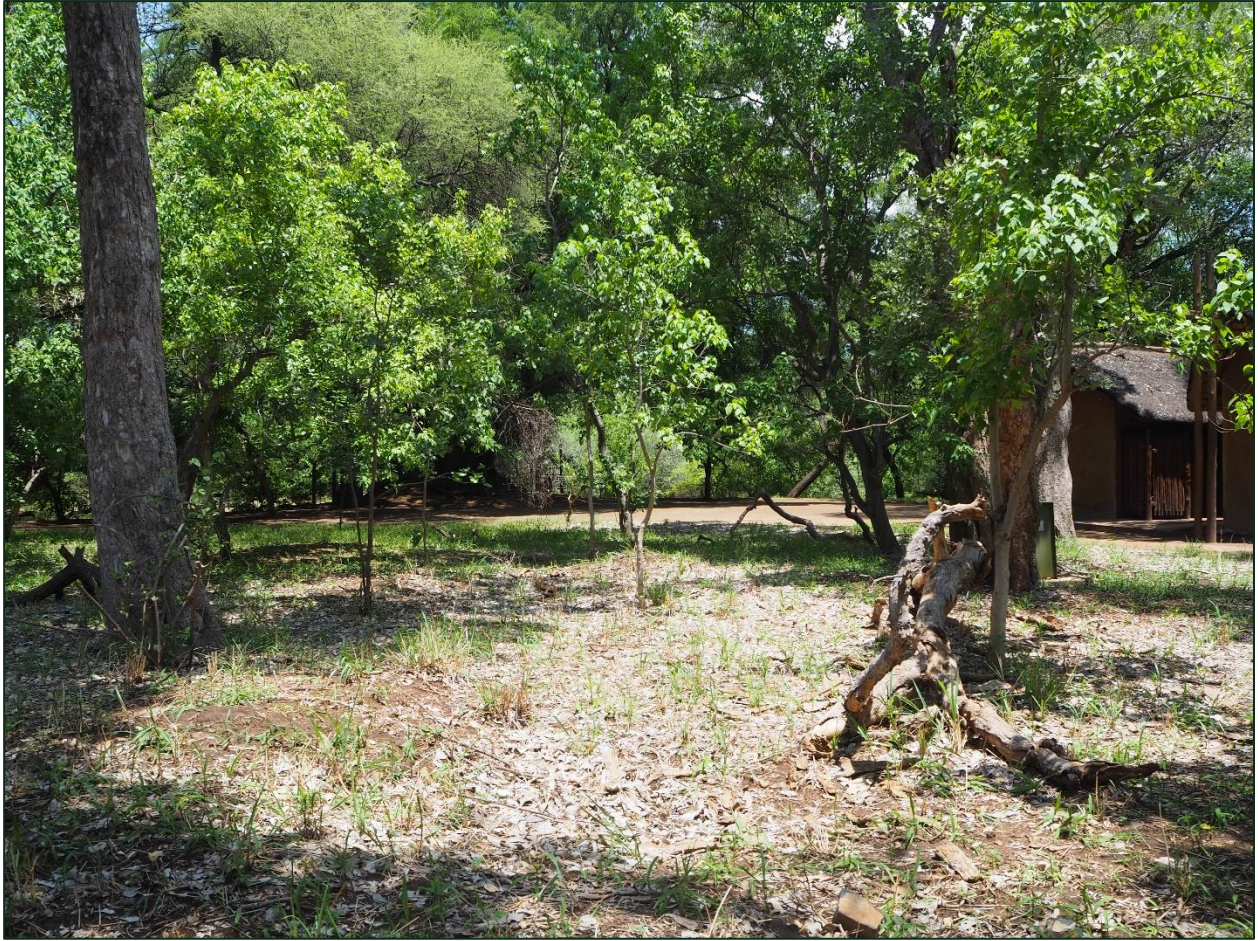
Figure 44. Proposed location for the new ablution facilities

No finds of heritage value could be made within the proposed study area as indicated by SANParks personnel. There are existing SANParks campsite structures such as ablution blocks, an electricity box and braai facilities. None of these were of heritage value and none of them will be affected by the proposed development. No archaeological deposits could be identified within the proposed development footprint.

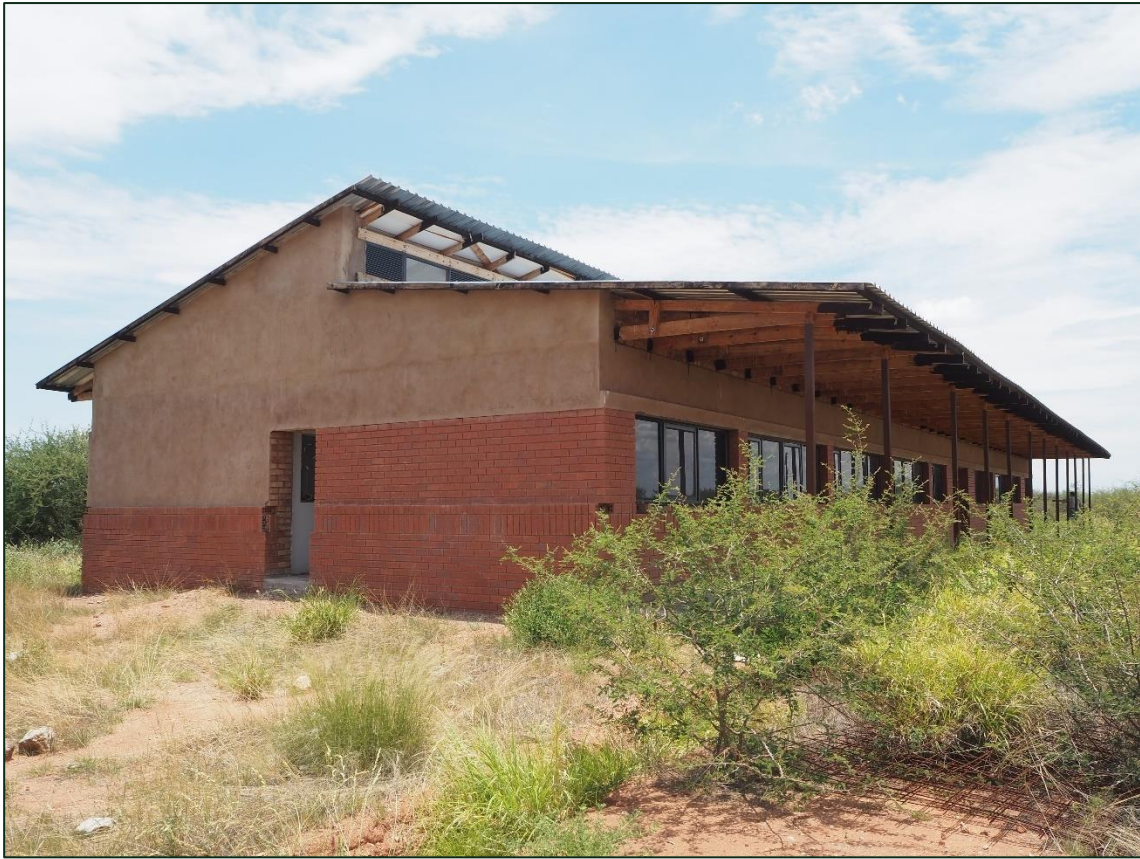
Figure 45. Largely finished Office Complex structures

No finds of heritage value could be made within the proposed study area as indicated by SANParks personnel. This development should be seen in the light of the fact that most of the groundworks and construction activities have already been completed. As such any possible impacts have already occurred. The areas were investigated for any sites of heritage importance that might be secondarily affected by the development. No archaeological deposits could be identified within the proposed development footprint.

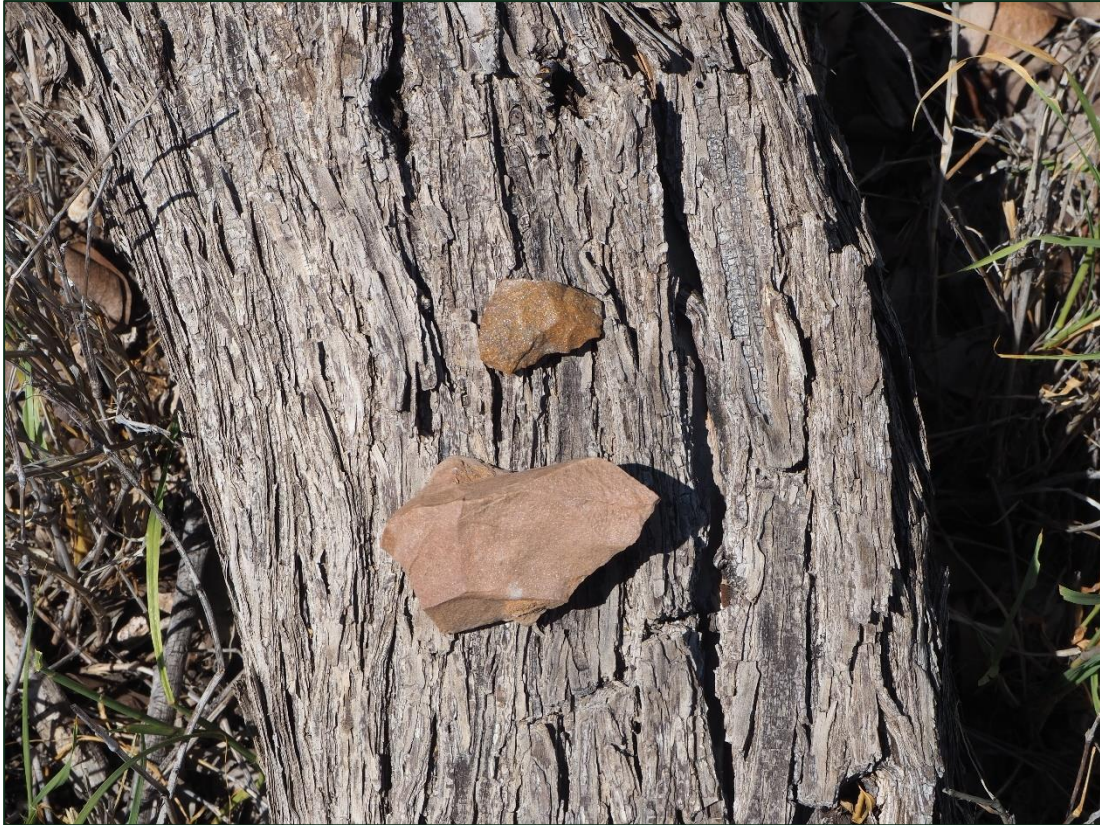
Figure 50. LSA Stone Tools noted on Site

The proposed Student Dormitories are located on the Hamilton section of The Park. The proposed site is to the east and north of the existing agricultural shed. A wide buffer zone of around 200m was investigated since previous archaeological deposits have been noted close to this location. The area produced some out of context isolated potsherds as well as some LSA stone tools. This seems to indicate that a deposit area is most likely located close enough to this site to facilitate the deposit of out of context artefacts through earth relocation activities such as wind and erosion. The origin of these artefacts could also be deeper lying sub surface deposits. For this reason, it is important that any alteration activities do not expand outside of the indicated footprint. It is also important that any excavations be monitored. Some historic ash deposits with more recent farming related artefacts was also noted. These are not thought to be of historic importance and will most likely relate to the adjacent Hamilton Farm Structures.

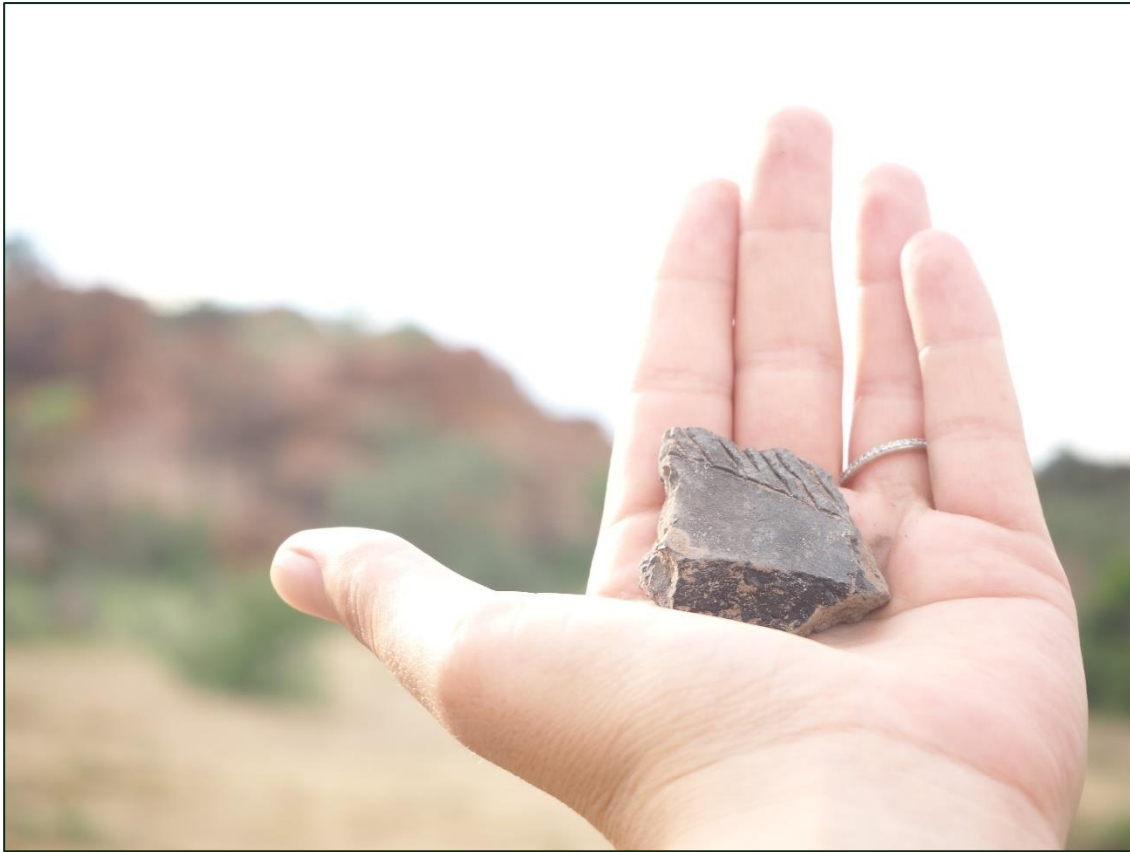
Figure 55. Pottery with hatched Mapungubwe type decoration

The sites contained mainly Middle Iron Age (K2, Mapungubwe) deposits as well as deposits associated with the later Bambandanyalo Phase and some LSA stone tools.

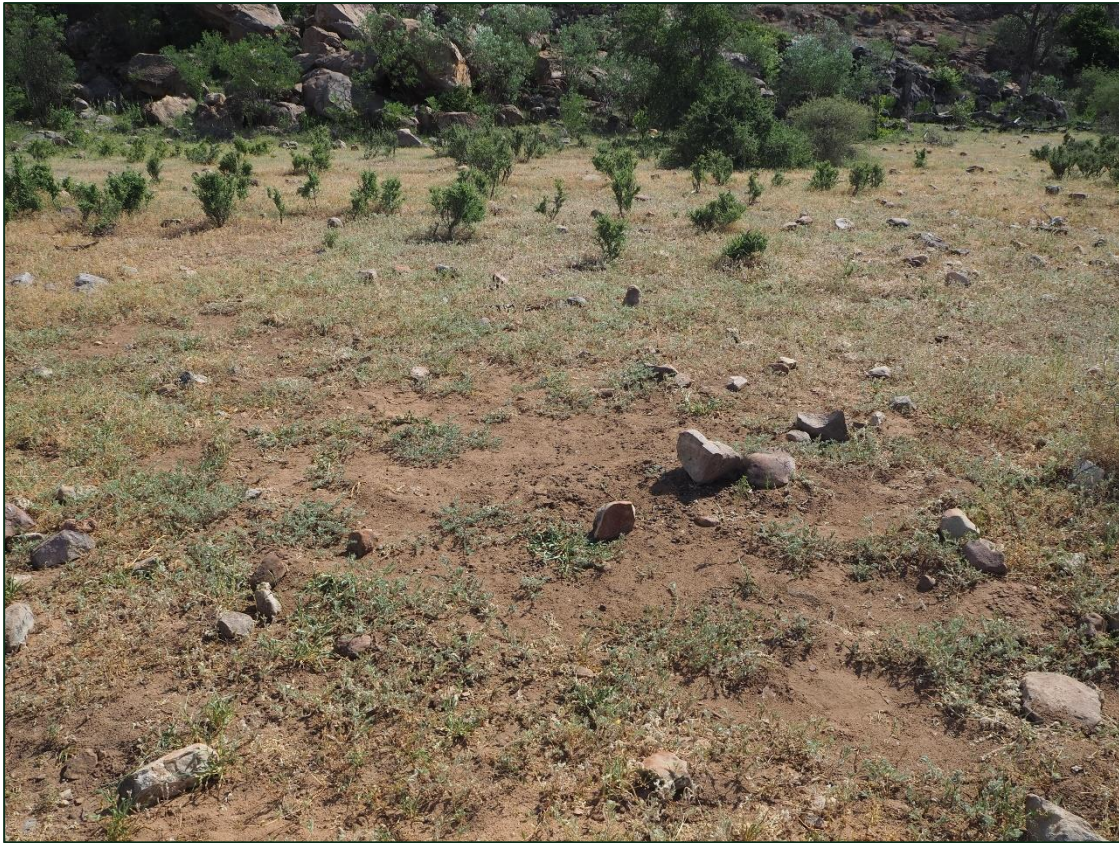
Figure 67. The Schroda Site

The proposed Schroda Orientation Centre proposed location is on top of the undisturbed Schroda Archaeological Site deposits. Even though the area is on this eastern section of the site has a thinner layer of deposit that other areas on the Schroda site, it is still virgin deposit and of great heritage significance. Extensive research has been done on this site and it would be redundant to repeat the available information here. Finds consisted of undisturbed ash deposits with in-situ potsherds and stone features as well as some LSA microliths and flakes.
