Historical and Architectural Impact Assessment for the Strachan Memorial Hall at uMzimkulu

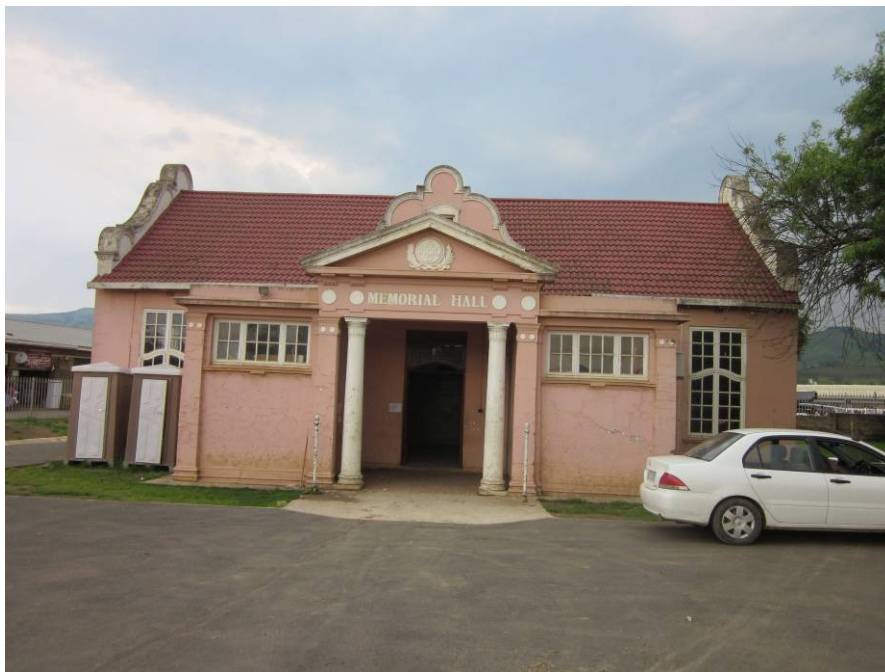
The building is a very good example of a Union period building. It is symmetrical, and the entrance portico is topped with a pediment noting the date of construction as 1920. This classical Revival element is then shadowed by a Cape Dutch Gable, which has a central timber louvered ventilator. The two gable ends are graced by matching gables, providing an aesthetic balance.

Fig 1: Front elevation of building

The entrance portico is supported by two Egyptian Revival Columns, which in turn adjoin pilasters which have detailed with medallions. The entablature above the columns has purely decorative and unreferenced *guttae* and two medallions marking out the line of the columns and the pilasters respectively.

Two, what were possibly coat check rooms, flank the entrance portico. They also have pilasters at the corners, balancing out those at the entrance. High level windows with a careful cill detail are found in each enclosed wall space. Symmetrical windows in Revived Cape Dutch fashion flank the main elevation to the hall.
