# HERITAGE SURVEY OF THE PROPOSED L311 CAUSEWAY UPGRADE, INKOSI LANGALIBALELE LOCAL MUNICIPALITY, KZN

# FOR HANSLAB ENVIRONMENTAL CONSULTANTS

# DATE: 10 OCTOBER 2019

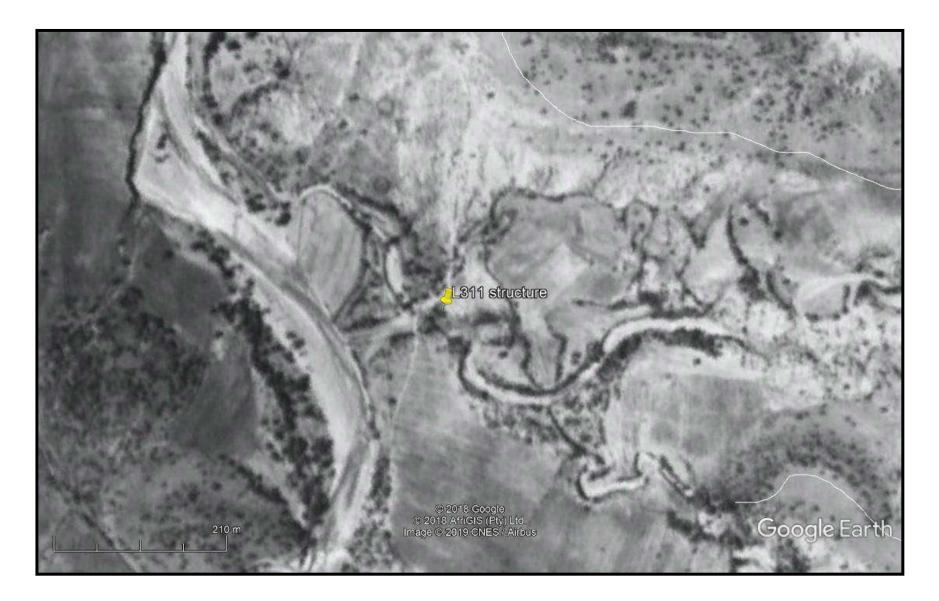
#### FIG. 6: LOCATION OF CAUSEWAY ALONG THE DEVELOPMENT IN 1937

The 1937 (fig.'s 6) shows a dirt track near the proposed causeway. However, this track does not exist by 1972 (fig 7). The current causeway probably post-dates the 1960s.

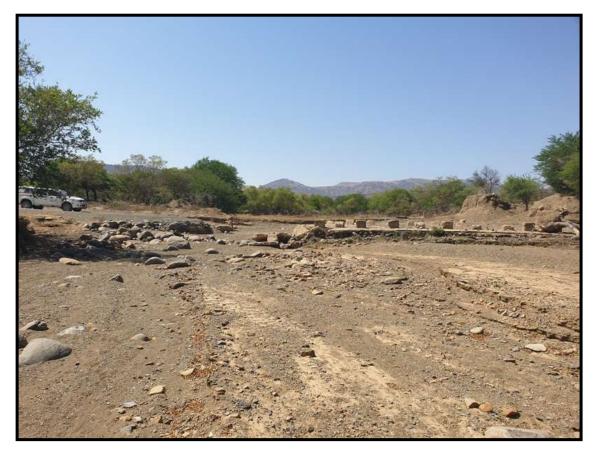
#### FIG. 9: EXISTING CAUSEWAY

The field survey was undertaken on 9 October 2019. The area had very good ground visibility due to the end of the winter season. The areas 50m around the causeway was surveyed for potential sites. The current causeway is shown in fig. 9.

The causeway will be built up above the ground and have minimal excavations. The proposed causeway requires no further mitigation.

The causeway at the L311 requires no further mitigation.

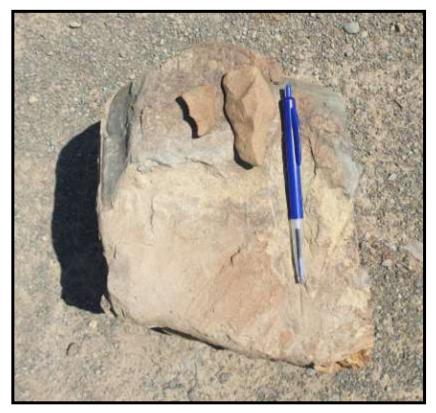
FIG. 10: MSA TOOLS NEAR THE CAUSEWAY

Two isolated MSA tools were noted above the river bed (fig. 10). They are in a secondary context and have low significance.
