MOOI-MGENI TRANSFER SCHEME, PHASE 2, KWA-ZULU NATAL

HERITAGE IMPACT ASSESSMENT

July 2012

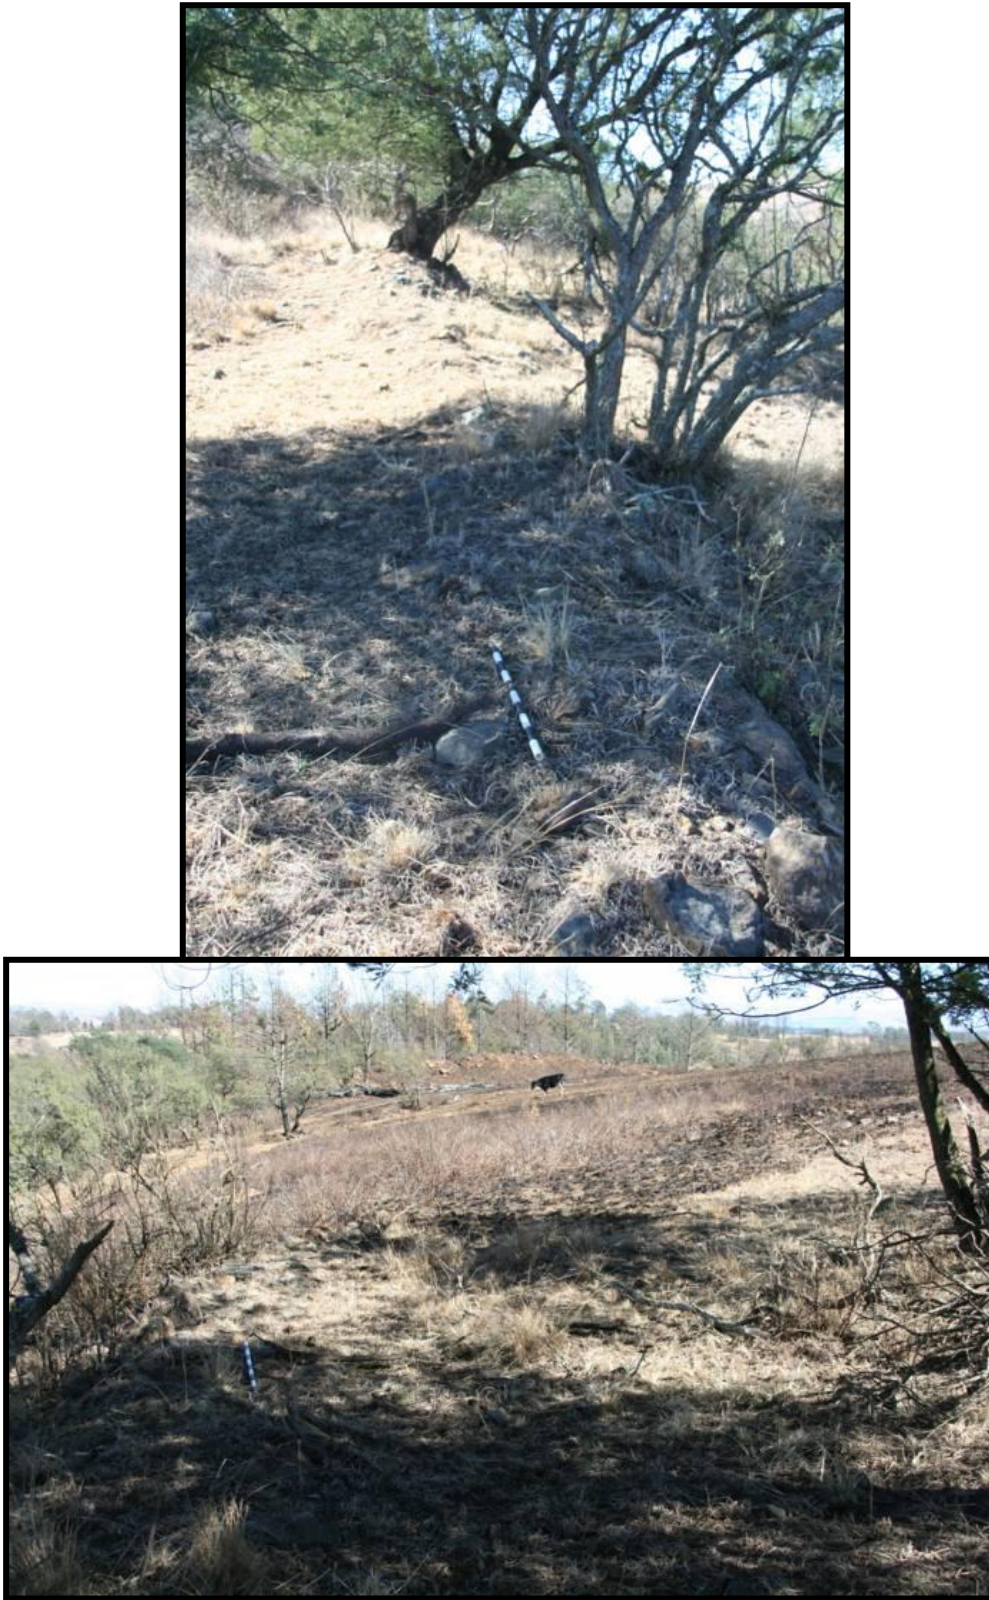
Figure 10: Stone terracing at MM02

MM02 is located ~465m southeast of MM1, on the same hill. The site consists of a stone walled terrace ~50m in length (fig. 10). There are no other features associated with the terrace; however, there is dense bush towards the hill that may contain features. It is not possible to date the terrace. The existing pipeline has gone through part of the terrace.

The site is of low significance.

The pipeline should be slightly rerouted to the west to avoid the terrace. If it is not possible to move the line, then the terrace will need to be fully documented before construction, and the minimum width for the pipeline should occur here. In addition to this, an archaeologist should be on site in case artefacts are exposed. The terrace should be rebuilt with the same material after construction, and thus it will have a minimum impact.

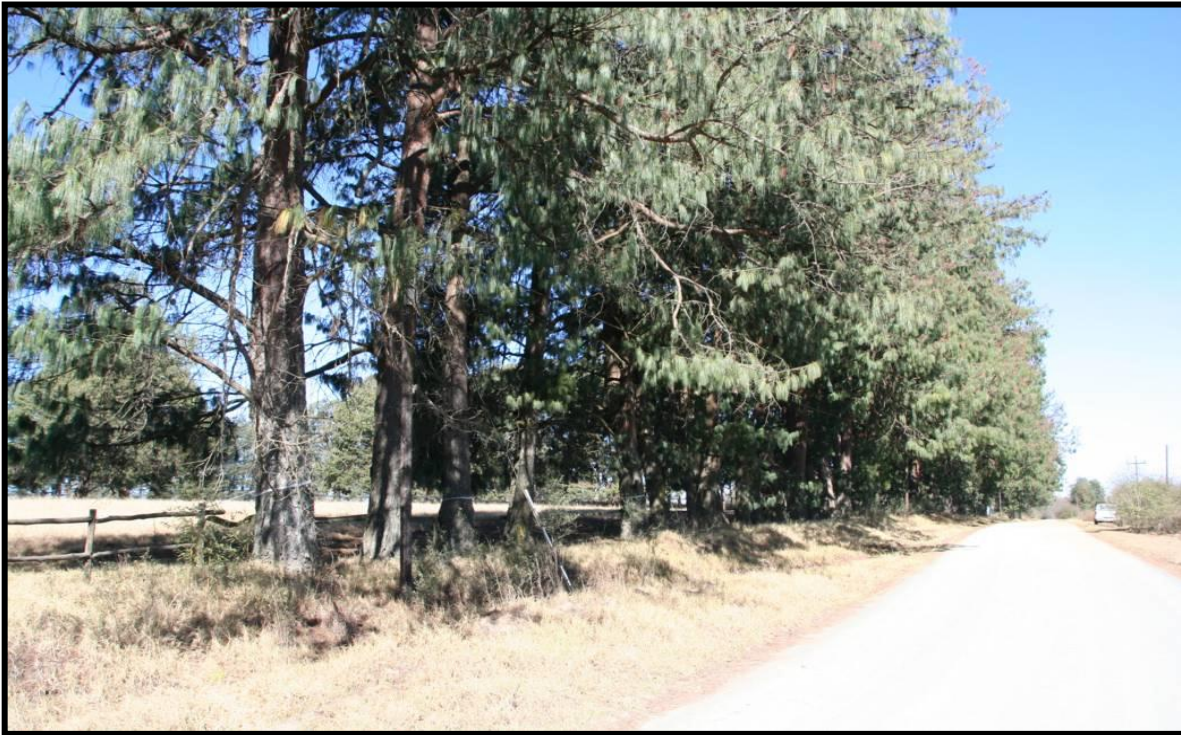
Figure 11: Pine tree boundary at MM03

MM03 is located beside the dirt road and amongst open land (fig. 11). The “site” consists of rows of pine trees that appear to be older than 60 years. The trees are part of a property boundary, of which some may predate 20th century. The trees form part of the cultural landscape, that gives the Midlands its sense of history. The original farmers of the 19th century tried to recreate England by dividing the land and planting trees as at home. A similar scenario of cultural landscapes with alien vegetation would be the Jacarandas of Pretoria.

The trees are of medium significance as it forms part of the cultural landscape

The old tree boundaries should not be removed, regardless of their alien status. Amafa KZN will need to approve the destruction of a cultural landscape.

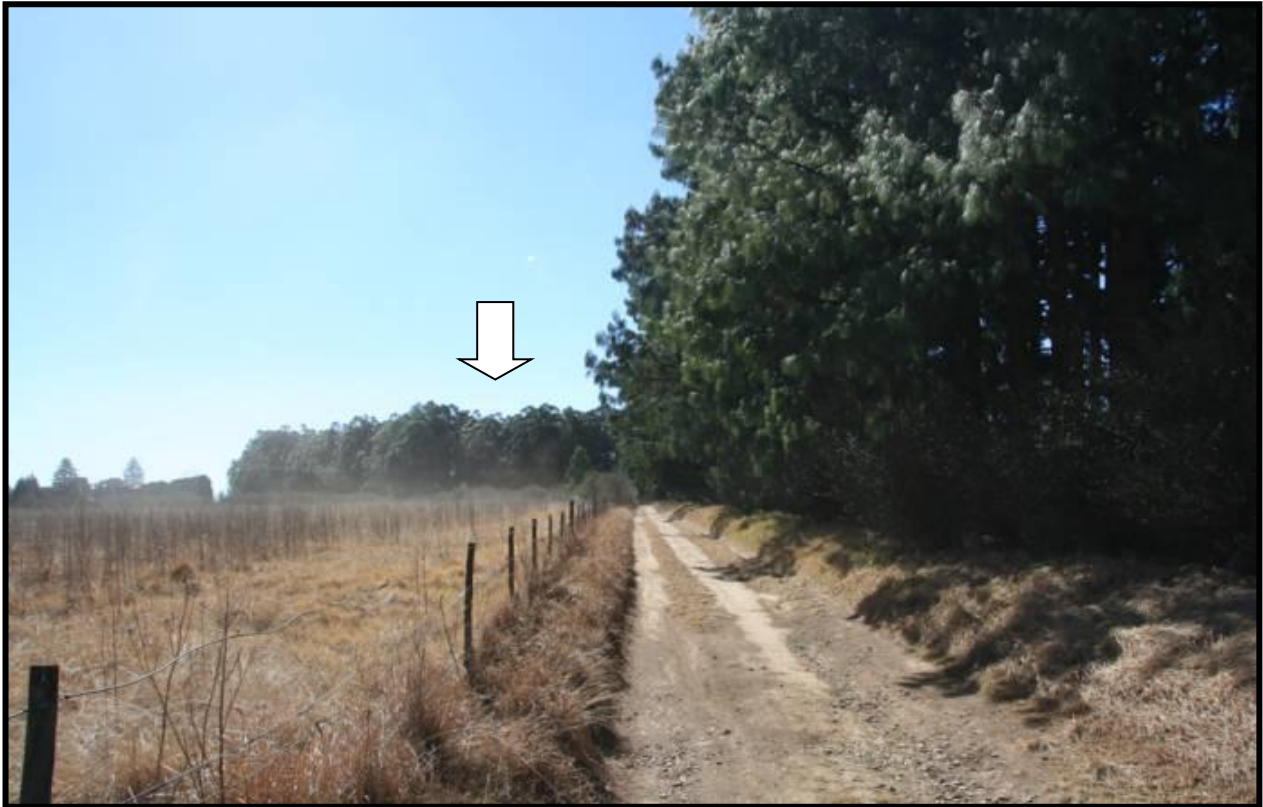
Figure 12: Tree boundaries at MM043

MM04 is located south of MM03. The “site” consists of rows of pine trees that appear to be older than 60 years, especially the northern parts of this row (fig. 12). The trees are part of a property boundary, of which some may predate 20th century. The trees form part of the cultural landscape, that gives the Midlands its sense of history.

The trees are of medium significance as it forms part of the cultural landscape

³ Arrow indicates the older trees

The old tree boundaries should not be removed, regardless of their alien status. Amafa KZN will need to approve the destruction of a cultural landscape.

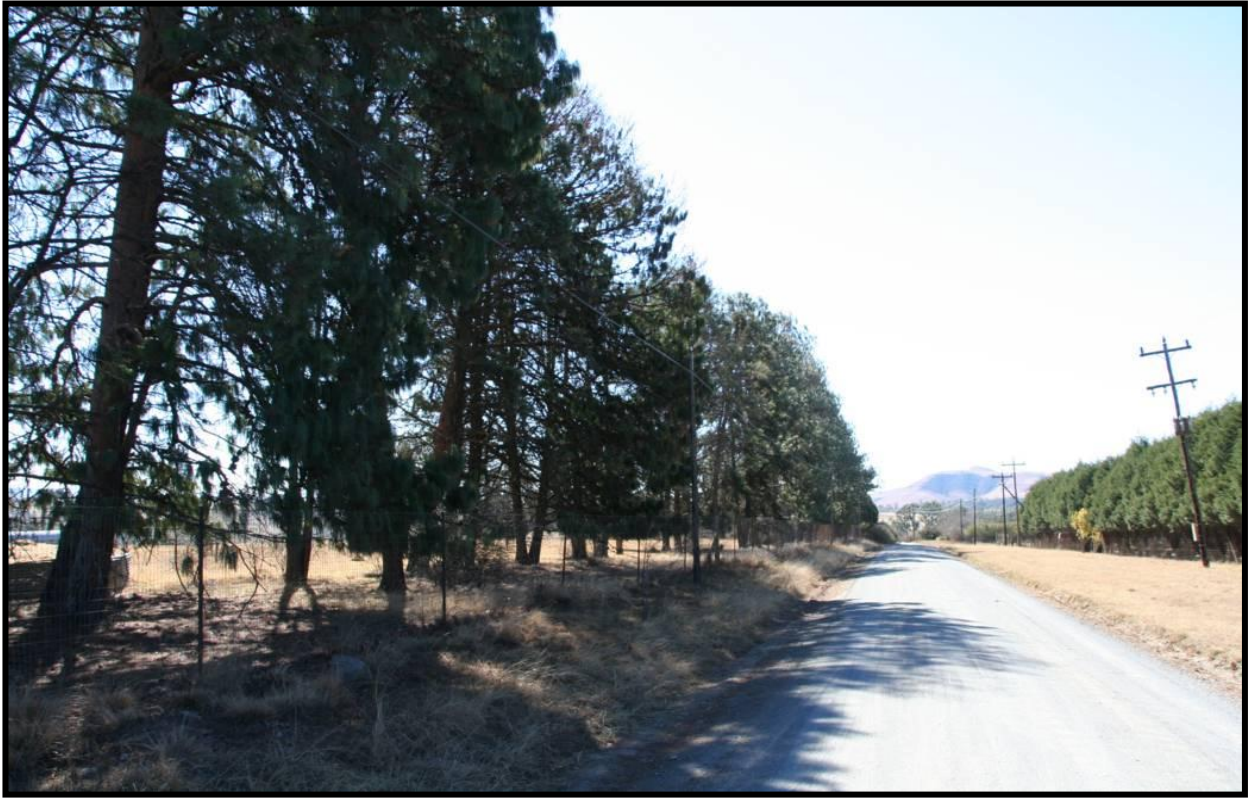
Figure 13: Row of recent trees at MM05

MM05 is located south of and near Springrove Dam. The “site” consists of a row of pine trees that appear to be recent in age (fig. 13). The trees are part of a property boundary, but were not part of the original farm boundary markers. The trees thus do not form part of the cultural landscape. The “site” was recorded as an example of ‘trees not forming part of the cultural landscape’

The trees are of low significance. While they form part of the cultural landscape, they are not the original trees.

No further mitigation is required.

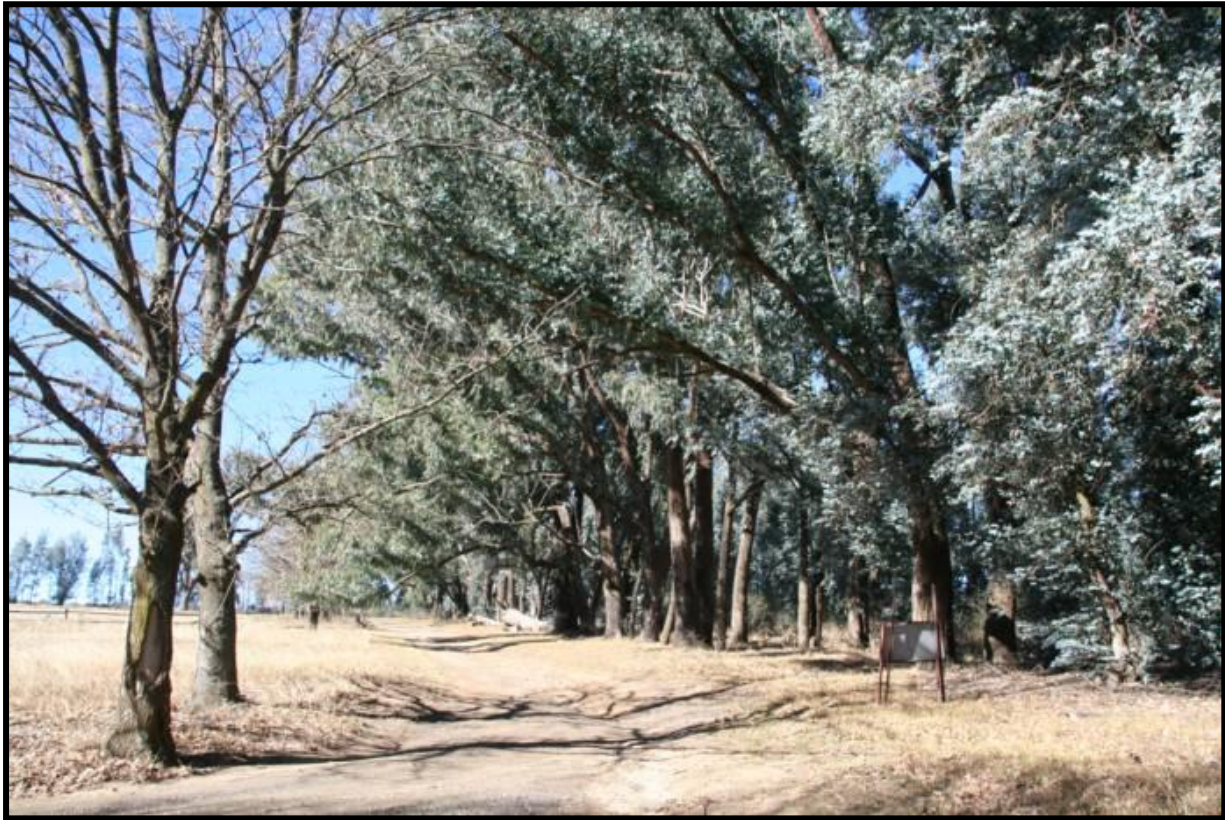
Figure 14: Blue gums at MM06

MM06 is located at the entrance of Shonalanga accommodation on the D146. The “site” consists of a row of old blue gum trees that appear to be older than 60 years (fig. 14). Saplings that are more recent have grown to the south of the original row. The trees are part of a property boundary, of which some may predate 20th century. The trees form part of the cultural landscape, that gives the Midlands it sense of history.

The trees are of medium significance as it forms part of the cultural landscape

The old tree boundaries should not be removed, regardless of their alien status. Amafa KZN will need to approve the destruction of a cultural landscape. The more recent trees can be removed for the pipeline, as they are not part of the original border.

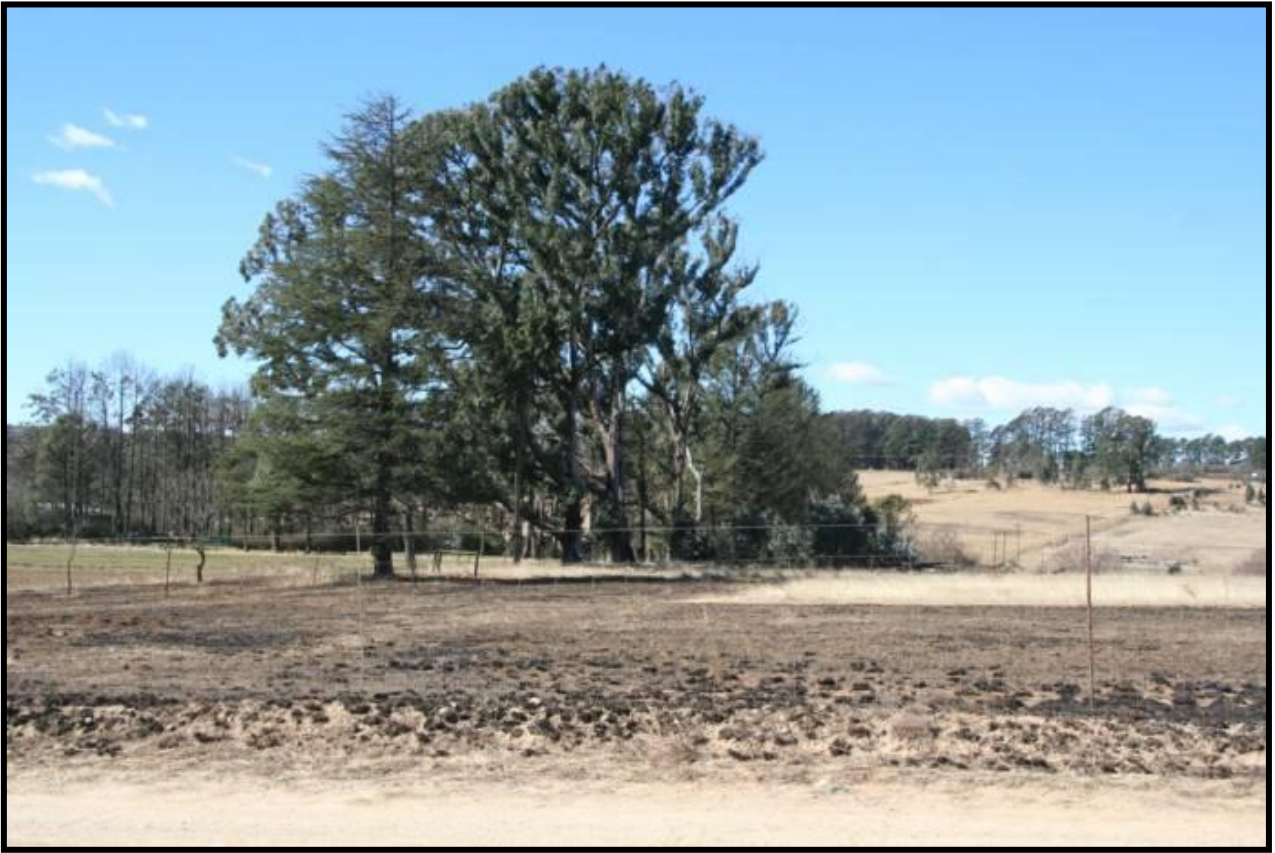
Figure 15: Old trees boundary at MM07

MM07 is located just north of MM06 on the D146. The “site” consists of a row of various old trees that appear to be older than 60 years (fig. 15). The trees are part of a property boundary, of which some may predate 20th century. The trees form part of the cultural landscape, that gives the Midlands its sense of history.

The trees are of medium significance as it forms part of the cultural landscape

The old tree boundaries should not be removed, regardless of their alien status. Amafa KZN will need to approve the destruction of a cultural landscape. The more recent trees can be removed for the pipeline, as they are not part of the original border.

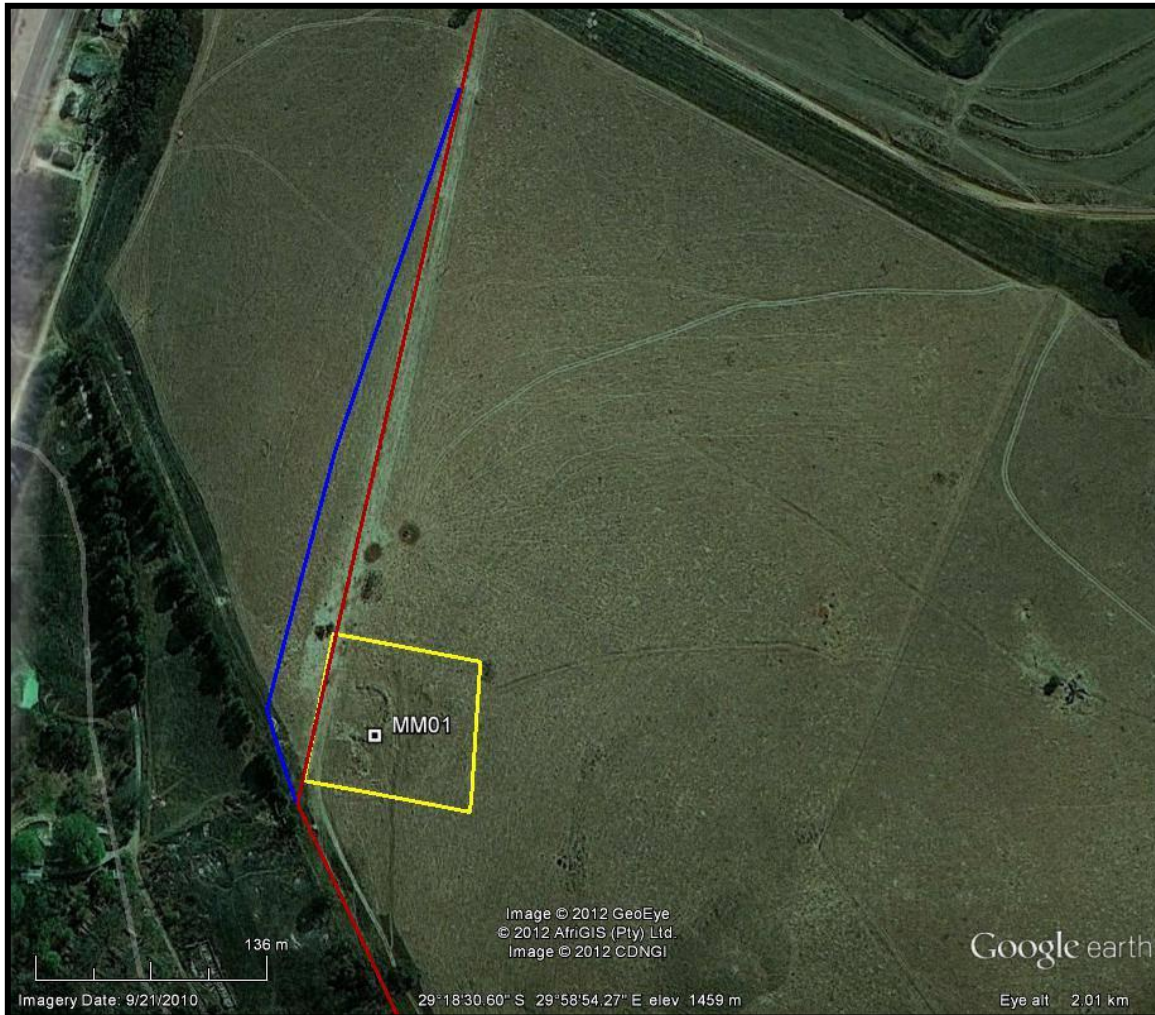
Figure 17: Management plan for MM01⁴

⁴ Yellow polygon = buffer zone around MM01; Blue line indicates suggested realignment

The stone walling at MM01 should not be disturbed due to the rarity of these features in the area. There needs to be a 5m boundary between the fence and the walling, and a 15m buffer between the fence and the pipeline). The existing pipeline may have already damaged part of the site. The pipeline will need to be placed on the western side of the existing pipeline (fig. 17). The fencing will need to be supervised by an archaeologist.

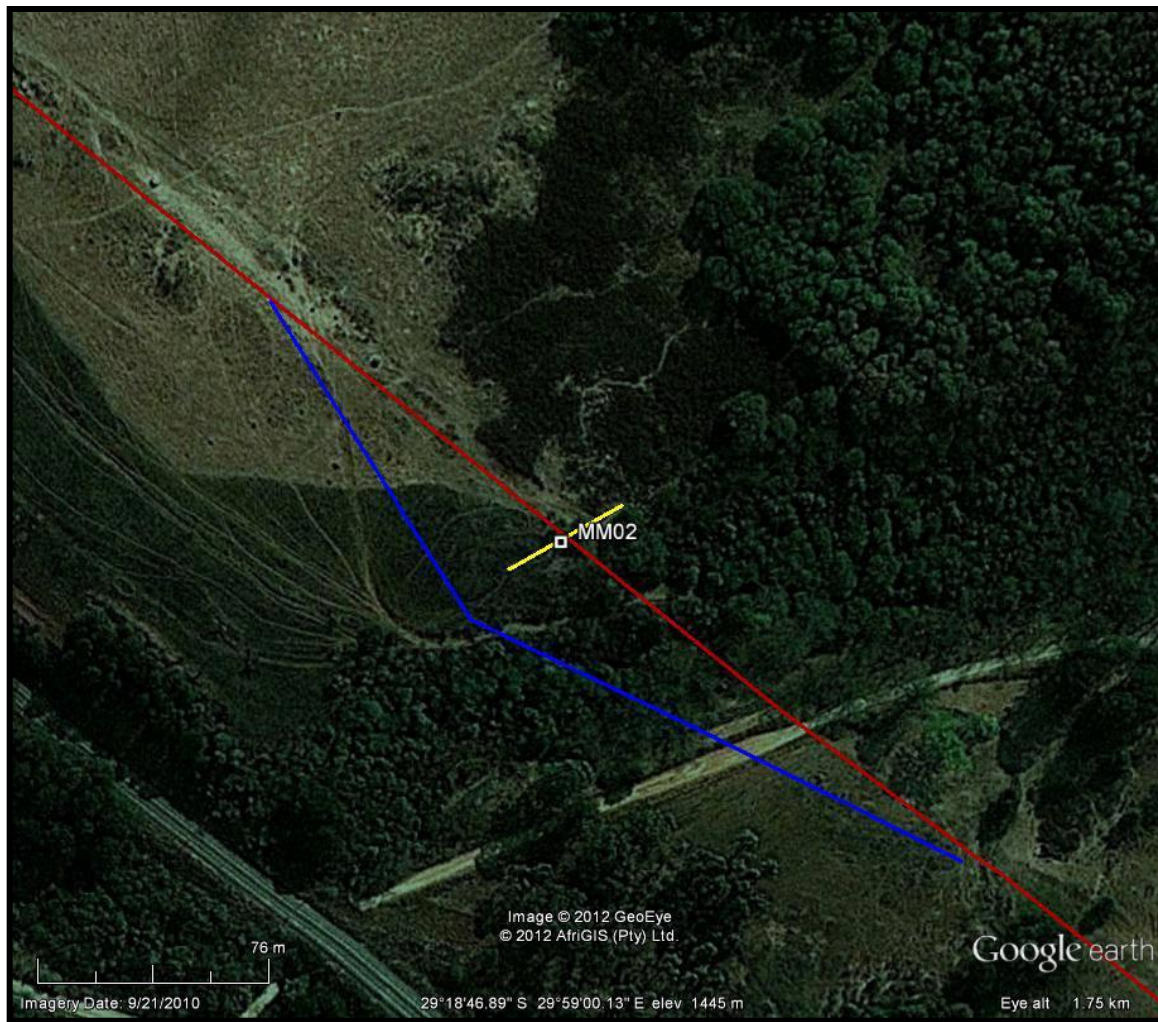
Figure 18: Location of terrace at MM02⁵

The terrace at MM02 has been partially damaged by the existing line. There are two options for the line. First, the line is moved ~40m southwest of the existing line, and thus not impact on the terrace (fig. 18). Second, the line continues in its current position; however, this area will need:

⁵ Red line = existing alignment; blue line = proposed re-alignment; yellow line = terrace

- To be monitored by an archaeologist for potential artefacts
- Minimum width for the pipe excavations
- Terracing on each side of the excavation needs to be sand-bagged during construction
- The terracing is replaced, with the same stones, after construction.

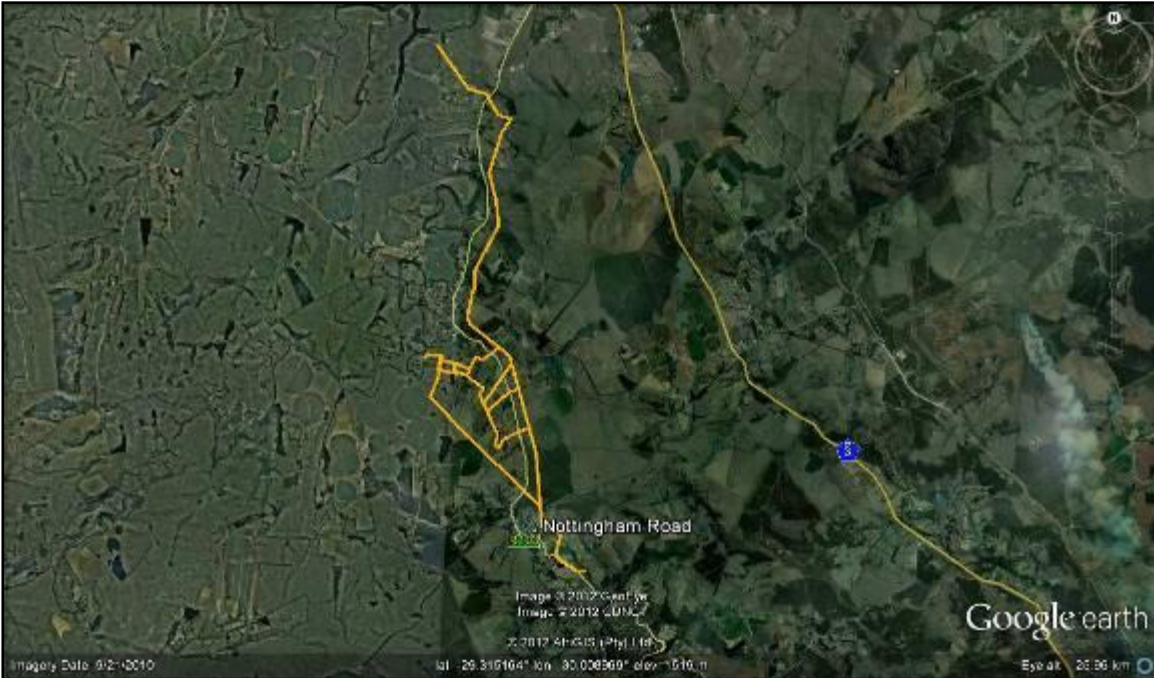
Figure 2 Sensitivity Map for pipeline north of Nottingham Road

For management purposes a colour scheme is proposed (Figure 2 & 3) with the following interpretations:

- Green areas along the proposed route indicate that the chances of finding fossils are too low to warrant any management action.
- Orange areas along the route cuts geology with a significant chance of finding fossils and these areas will have to be subjected to a Phase 1 Palaeontological Impact Assessment.
