**MULALO MAIN TRANSMISSION SUBSTATION AND  
ASSOCIATED POWER LINES PROJECT, SECUNDA,  
MPUMALANGA PROVINCE**

**Phase 1 Heritage Impact Assessment**

**May 2017**

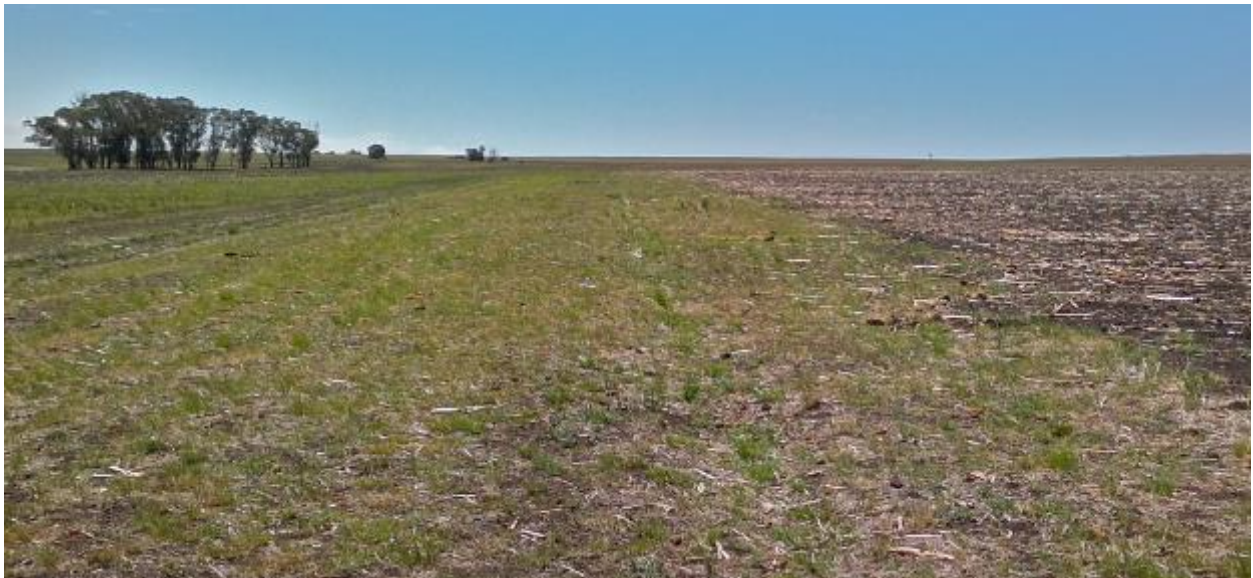
**Figure 3: Substation site B**

The site of Site B is situated south east of the Sasol Refinery and on an area that is currently utilised for the cultivation of maize. Small areas between the maize fields are less impacted on but are also disturbed by tractors, etc., which access the fields through these areas. The site is highly disturbed and no heritage sites were observed during the site inspection (see **Figure 3** below).

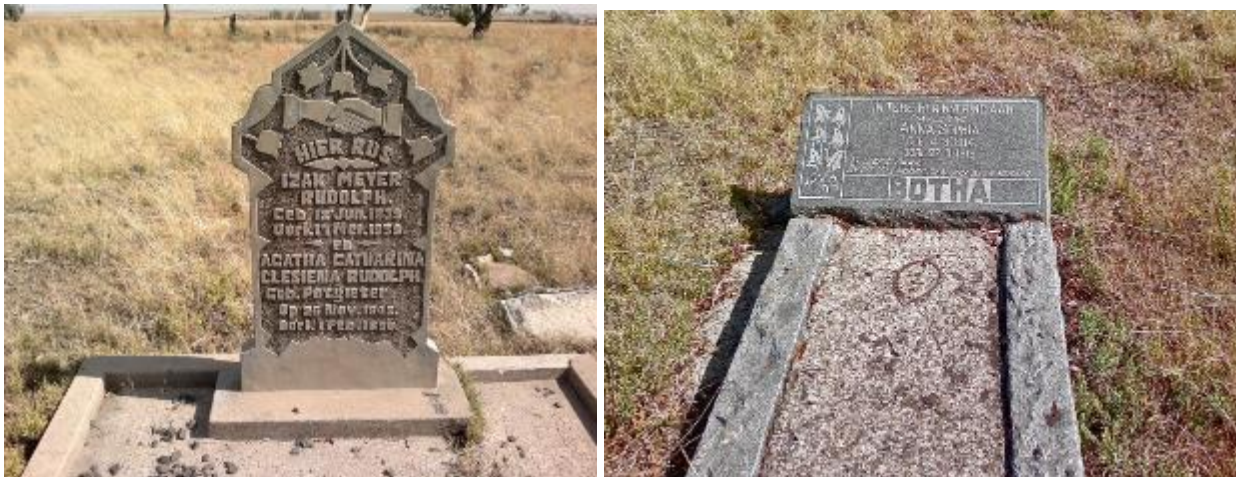
**Figure 4: Graves at substation site C**

Several graves were found in the south-west corner of the proposed substation site. These graves are well over 60 years old with the oldest death occurring in 1890 and the most recent in 1939. There is also a pile of rocks close to the graves without a headstone that could be a grave. The graves are situated at: S26°37'13.98", E29°09'43.64".

- If substation site C is selected as the substation site, it is recommended that location of the site is moved at least 300 m to the north to avoid the graves and structures that are currently situated in the footprint of the substation.

- If the location of substation site C cannot be moved, application will have to be made to the MPHRA for permission to destroy the structures found within the substation footprint.

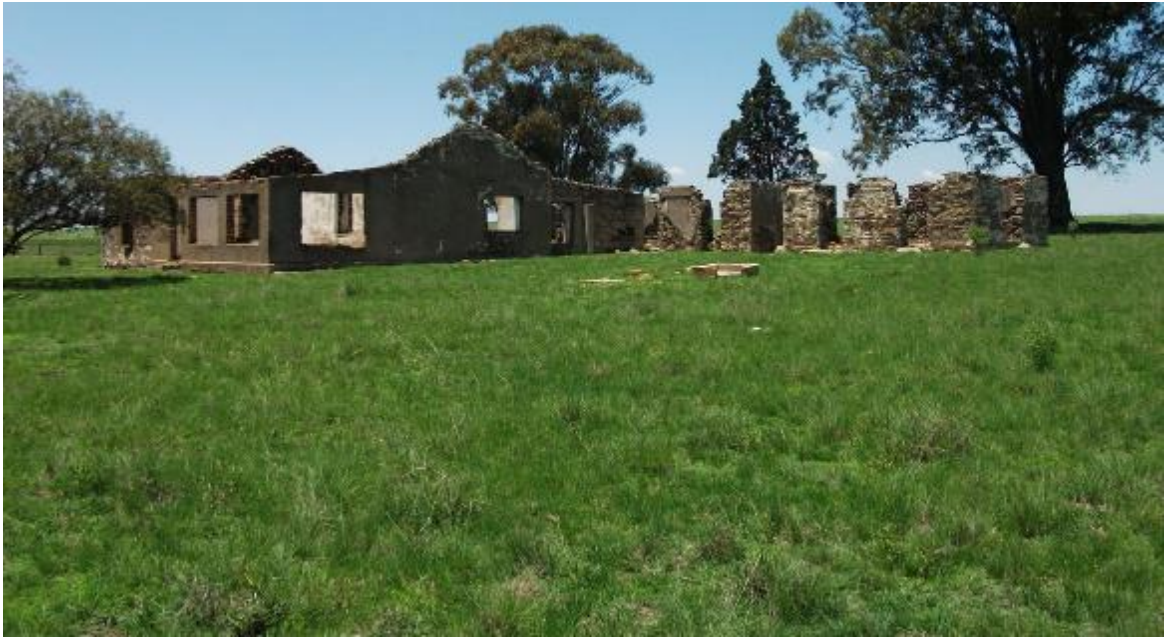
**Figure 5: Remains of house**

Approximately 320 m east of the above-mentioned graves, the remains of a house were found. These remains fall within the footprint of proposed substation site C. The walls of the house are still in place but the roof, windows, doors, etc, have been removed as can be seen in Figure 6 below. The structure is situated at: S26°37'12.89", E29°09'56.09".

The buildings, together with the, graves indicate a farm unit that has fallen into disrepair. All of the structures appear to be over 60 years old indicating that the structures are protected by section 34 (1) of the NHRA that states that no person may alter or demolish any structure or part of a structure which is older than 60 years without a permit issued by the relevant provincial heritage resources authority. It is recommended that if site C is selected as the substation site, then the position of the substation should be moved well away from the graves and the structures as described.

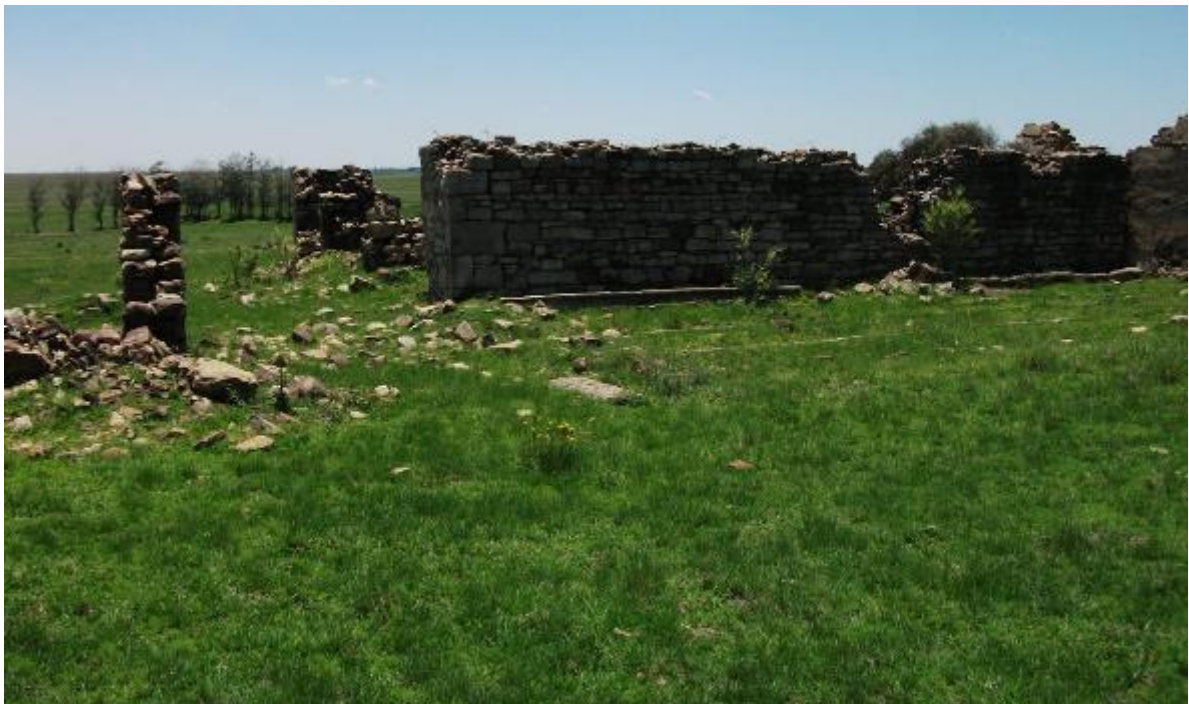
**Figure 6: Remains of other structures**

Close to the house are the remains of several buildings (S26°37'11.45", E29°09'52.78") and an area walled off with stone walling that has fallen into disrepair (S26°37'09.73", E29°09'55.73").

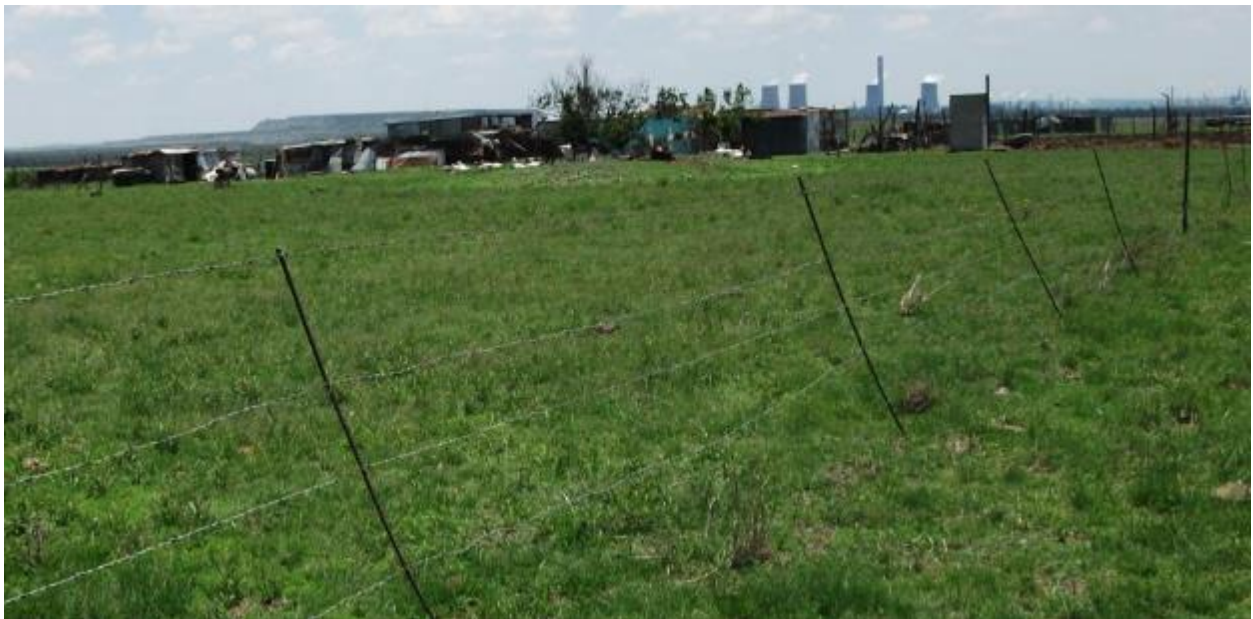
**Figure 8: Structures housing farm workers**

As the northern corridor lines exit substation site C, they cross several clusters of structures that house farm workers. The groups of structures are situated at: S26°37'07.74", E29°09'34.97" and S26°37'03.67", E29°09'35.64". The structures are made from brick and corrugated iron and most are in a state of disrepair. No graves were found during the site inspection but it is possible that there are unmarked graves that were missed during the inspection. It is recommended that before construction, the specialist walk down of the power lines is used confirm whether there are graves associated with these structures or not.

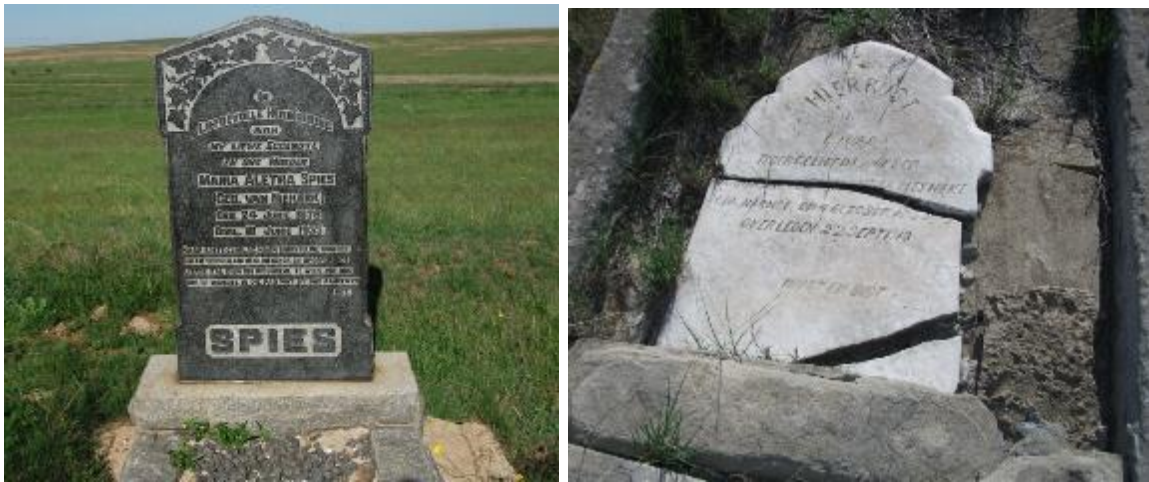
**Figure 9: Graves over 60 years of age**

After the R546 road, the northern corridors crosses property owned by Mr. L. Botha. There are two houses and some outbuildings as well as an iron ore mine and two graveyards. The iron ore mine and one graveyard are currently north of the proposed power lines. However, if the power lines are moved northwards to avoid the houses, then these two sites may be impacted especially the graveyard which is situated at: S26°36'59.73", E29°08'56.66". Those graves with headstones indicate that the graves are over 60 years of age with the individuals dying in 1910 and in 1933.

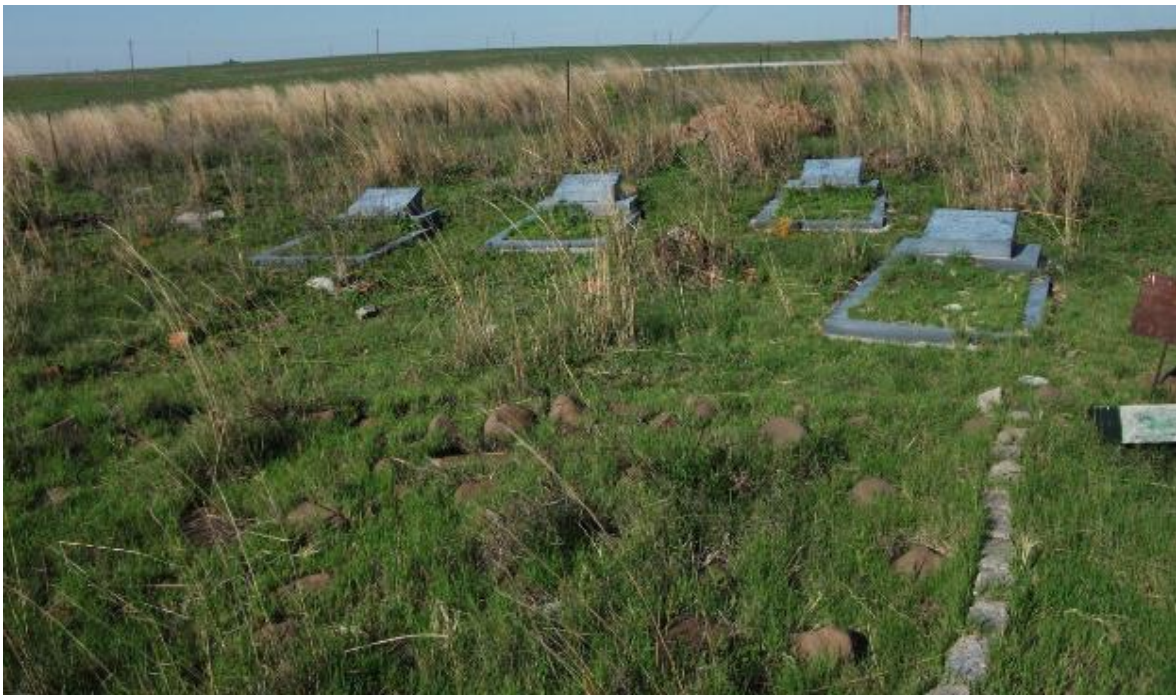
**Figure 10: Graveyard of farm workers**

The graveyard where farm workers are buried falls under the power lines in the northern corridor. The graveyard is situated at: S26°37'07.34", E29°08'31.28". A number of the graves are older than 60 years therefore the site is protected in terms of sub-sections (1) and (3) (a) (b) of section 36 of the NHRA. There are formal graves and mounds of stone that could indicate the site of a grave. The placement of pylons must be done in a way that they avoid the graves and a buffer is placed around the graves to avoid damage during the construction of the power lines.

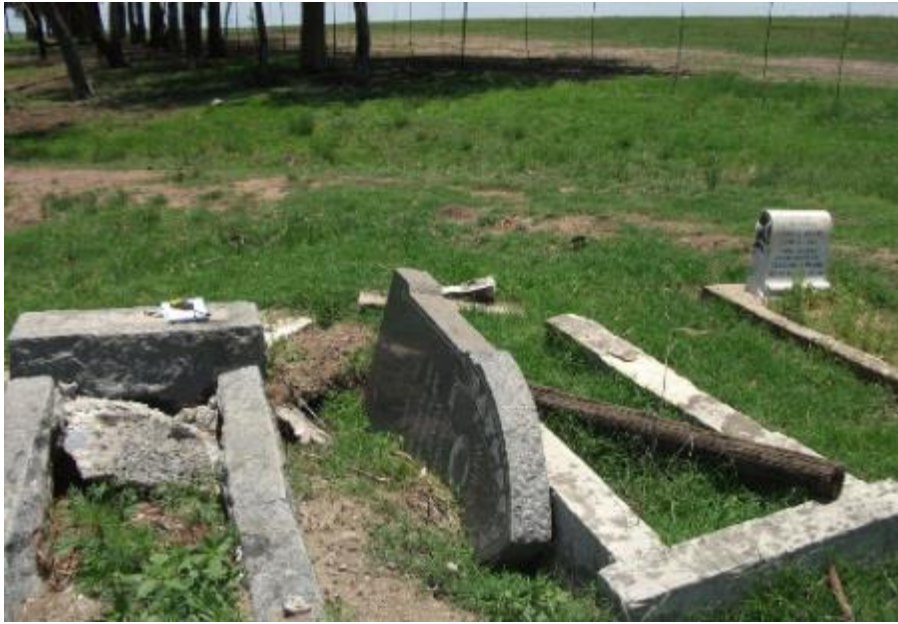
**Figure 11: Graves on Rhino Lodge property**

Further to the west on the property of Rhino Lodge, three graves were located at: S26°37'06.15", E29°07'04.08". All the graves are older than 60 years and are therefore protected by section 36 (3) (a) (b). The graves are not fenced and are unkept with broken headstones and graves that

are subsiding. The graves are situated below the northern corridor. A buffer must be placed around them to protect them from construction activities.

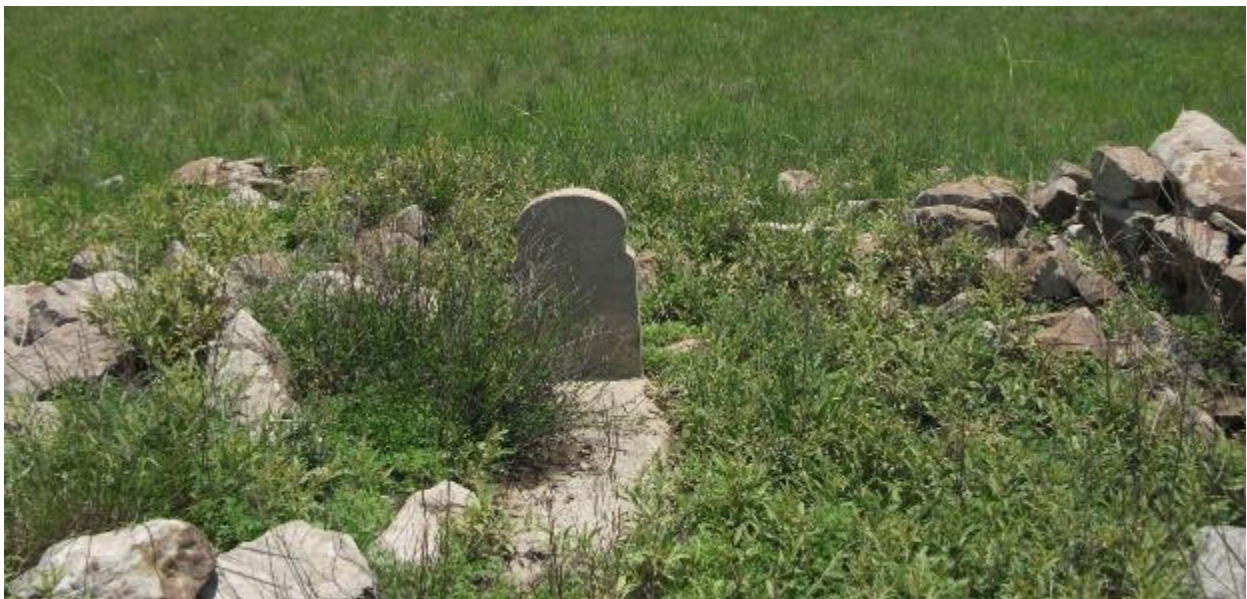
**Figure 12: Graveyard with single grave**

Further west along the northern corridor, a graveyard fenced with a dry stone wall was found at:  $S26^{\circ}37'20.06''$ ,  $E29^{\circ}06'43.84''$ . The grave yard contains a single grave with a headstone that had no inscription on it. The low stone wall is collapsing and in a state of disrepair. Although there is no date, the grave should not be disturbed as graves are important heritage resources and the disturbance of graves is not only illegal but a sensitive issue. The graveyard is situated about 15 m north of the southernmost power line and will fall within the servitude of this power line. A buffer must be placed around the graveyard to protect it from construction activities.

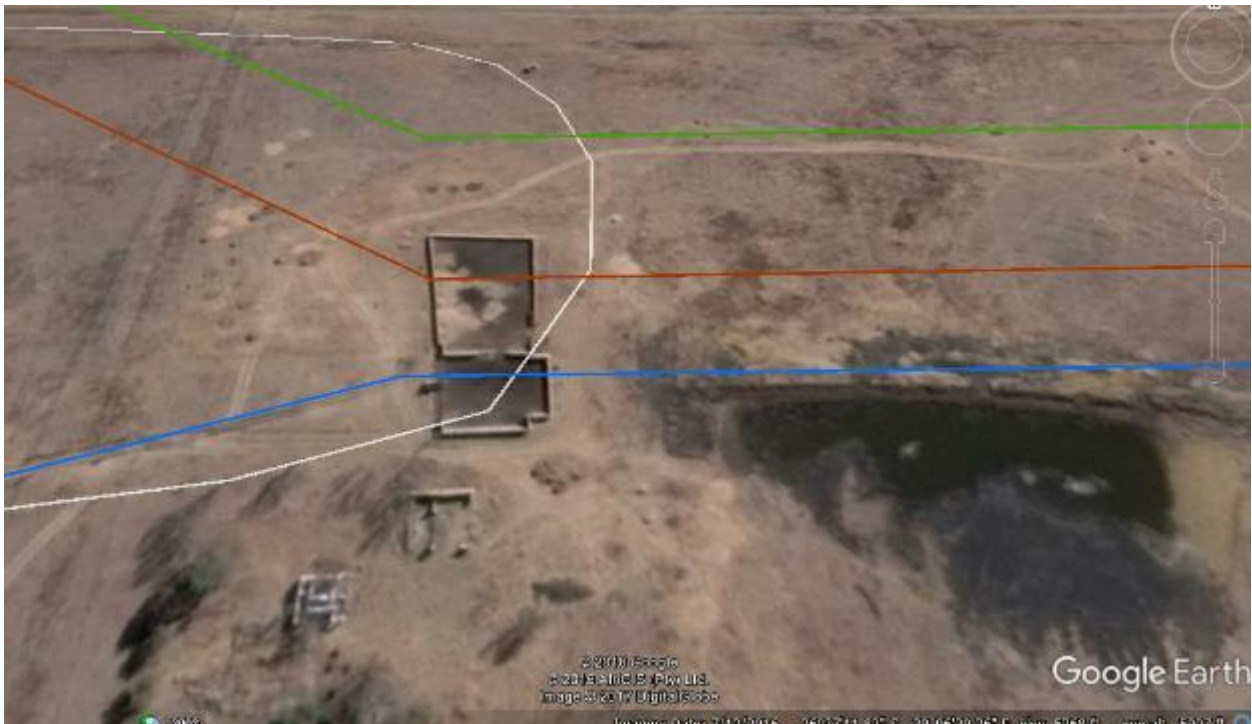
**Figure 13: Google Earth close-up of affected structures**

The grave may be linked to the remains of structures that are situated about 500 m north-west of the grave. The remains of a residence and outbuildings is still fenced and it appears to have been farm dwellings that are no longer used. A dam is situated within the complex and a number of water reservoirs. A boma or kraal used for game capture is situated on the fence line with the adjoining property close to the structures. No graves were noted during the site inspection but the site could not be accessed hence there is a possibility that graves may have been missed during the inspection. It is recommended that during the specialist walkdown of the power lines, the existence or not of graves be confirmed.

The date of the buildings could not be established hence the precautionary principle is applied with the assumption that some of the buildings are older than 60 years and are therefore protected by section 34 (1) of the NHRA. As can be seen in **Figure 13** below, the structures are situated at the point where the lines in the northern corridor turn to the north west and south west. The concern is that the bend towers will impact directly onto these buildings and it is recommended that the point where the lines turn is moved 40 m west to avoid placing the bend towers near the structures.

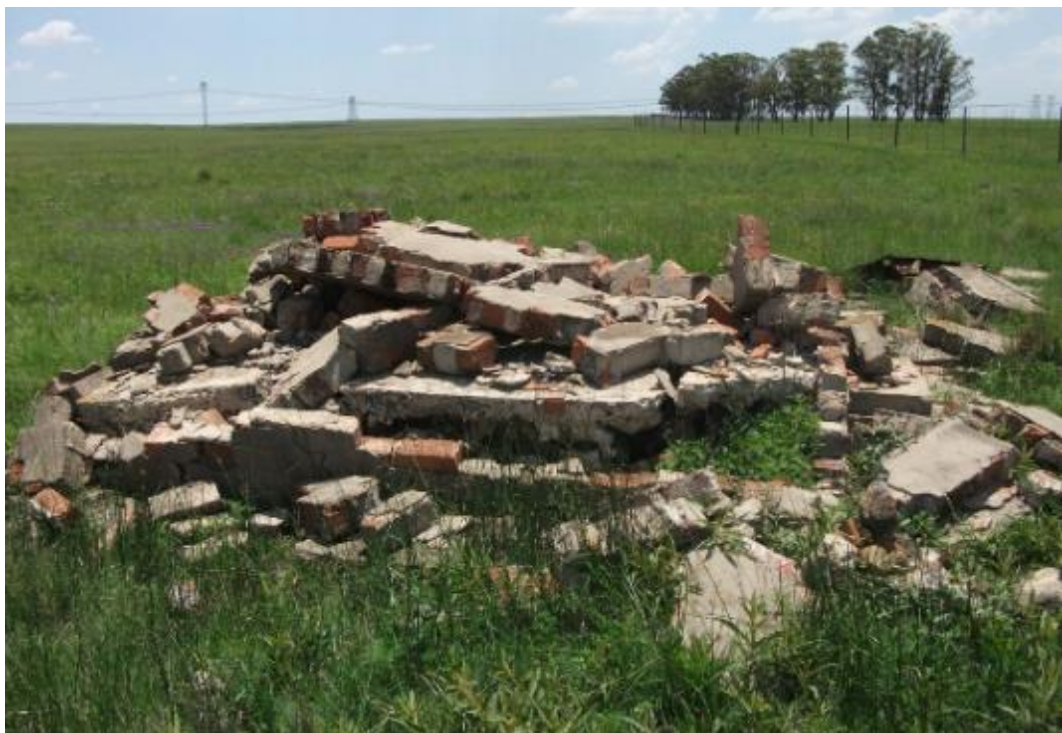
**Figure 15: Pile of rubble with existing power lines in background**

A heap of rubble was found to the south of the enclosed area discussed above. It appears to be broken down plastered wall/s. It is unclear what it was used for and is of no significance. It is situated at: S26°37'22.36", E29°06'30.93".

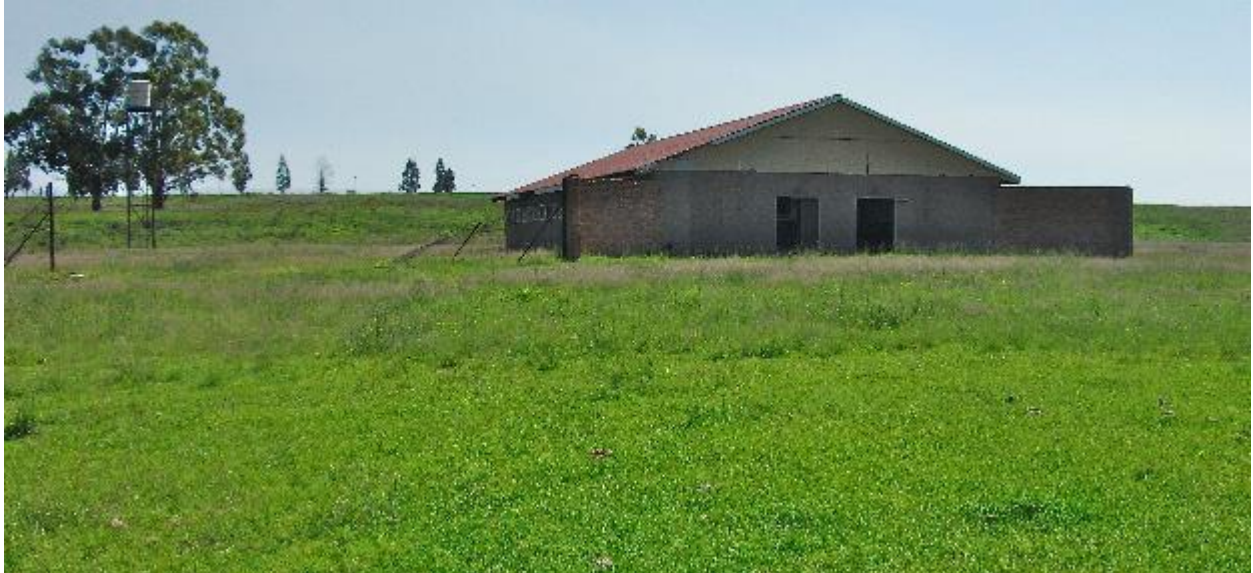
**Figure 16: Abandoned house Sasol wildlife area**

Where the alignment of the Sites B and C to Sasol 3 Line 1 route crosses the Sasol wildlife area, the proposed line is situated within 50 m of an abandoned structure at S26°35'52.70", E29°11'29.62". The Sasol representative who accompanied the specialist did not know what the structure had been used for. It is below 60 years of age and is of no heritage value.

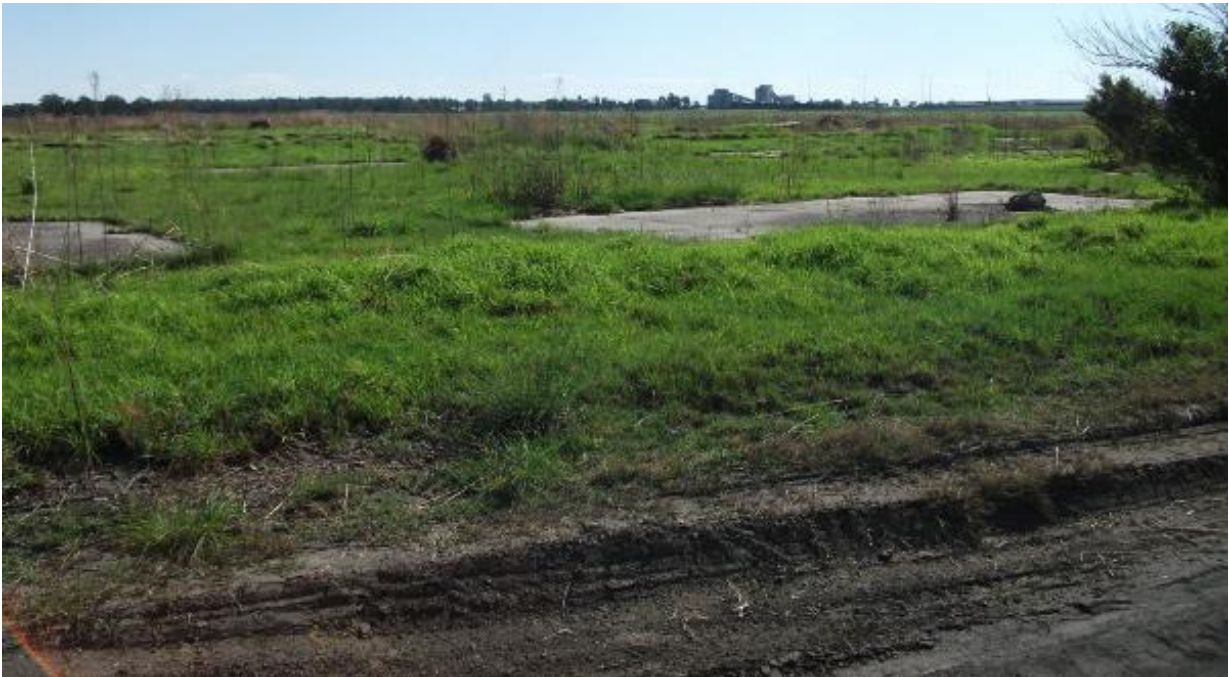
**Figure 18: Foundations of structures**

The proposed two 132kV lines that will join the Open Cycle Gas Turbine (OCGT) in the Sasol Refinery with the existing Sasol 3 substation do not impact on any heritage resources. They cross an area that is highly impacted by existing infrastructure including roads, existing power lines, etc. (see **Figures 18 and 19** below).
