## Sasol Sigma Defunct Colliery Surface Mitigation Project: Proposed River Diversion and Flood Protection Berms

### Heritage Assessment: Notification of Intent to Develop

SAS5250

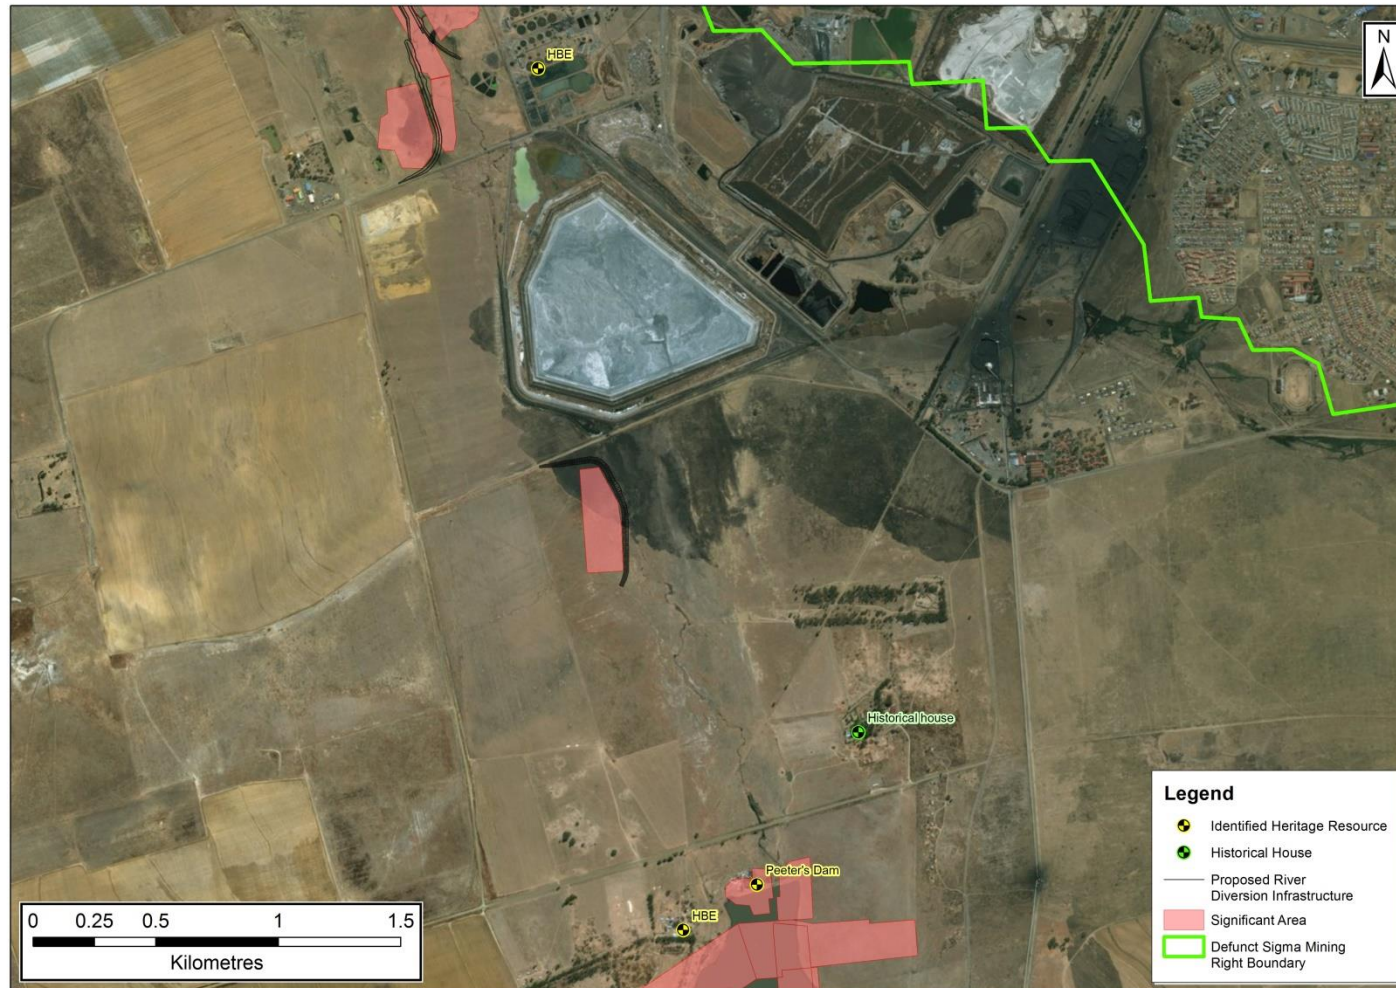
Figure 4-3: Historical imagery for the site-specific study area, showing potential heritage sites

The landowners of the farm Saltberry 422 (Portion 1 and 2 and RE) informed the geomorphology specialist that their house was constructed in 1903. The landowners said their house had been described in records written by Reitz (1929). This document is an autobiography of Reitz's time in the South African War (referred to as the Boer War). Reitz (1929) describes structures in this area which were used to supply and refresh horses during the South African War. This structure was not assessed by the heritage specialist as it is situated outside of the development footprint. The structure is shown in green in Figure 4-3 and is labelled "Historic House".

Several structures<sup>8</sup> were identified on the historical imagery, including Peeters Dam. These are presented in Figure 4-3. These structures are prescribed a relative age of at least 57 years through the aerial imagery, but have a high likelihood of being older than 60 years. To ensure compliance with the NHRA, these structures are considered to be generally protected under Section 34 of the Act.
