MDINA TOWNSHIP DEVELOPMENT

PRELIMINARY SHALLOW SOIL ENGINEERING GEOLOGICAL INVESTIGATION FOR PLANNING PURPOSES, MDINA VILLAGE, UMTATA REGION, EASTERN CAPE PROVINCE

Basic Shallow Soil Investigation for Residential Planning

Project number: WF14066

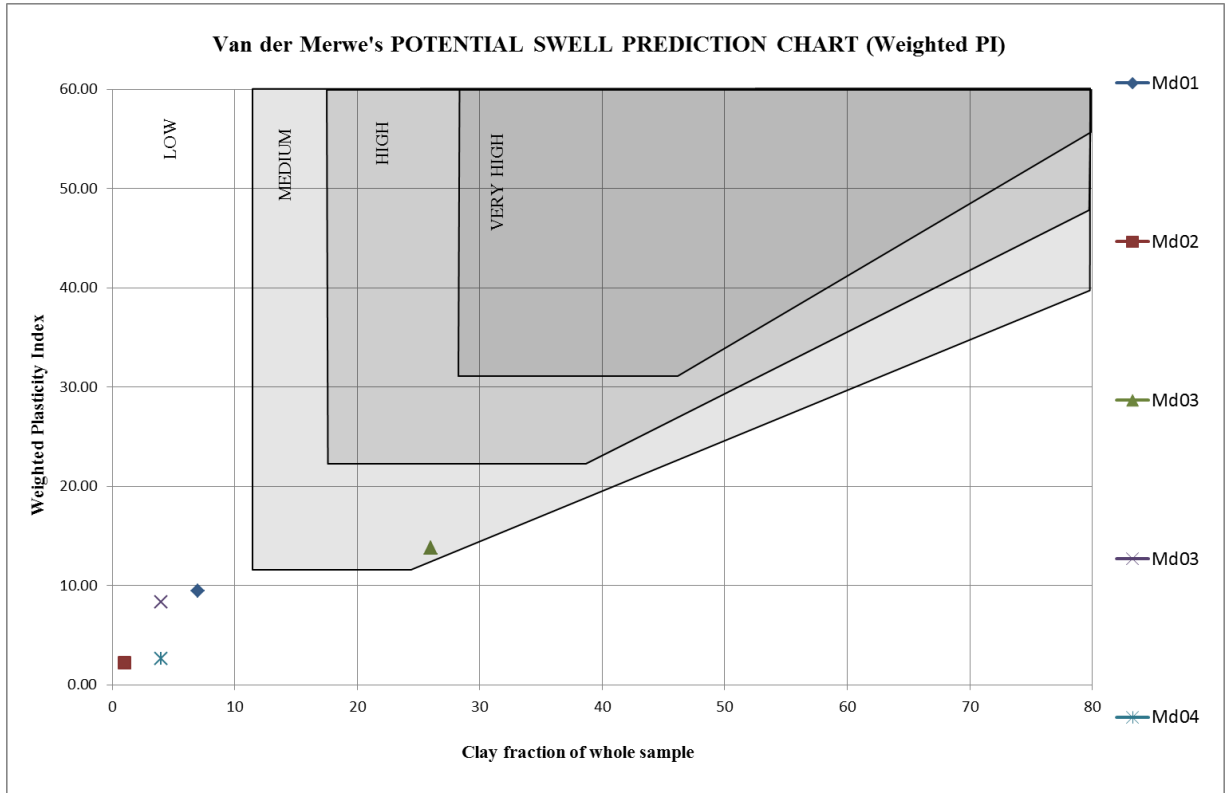
CHART 1: Swell Prediction Chart (Weighted PI and Clay Fraction of whole sample)

The indicator test results conducted on all the materials sampled indicate that the residual shale soil tested from MD03 at 1.00-1.40 m has a “Medium” heave potential which confirms the visual interpretations taking into consideration the clay content and soil structure. The test results indicate that the colluvium and completely to highly weathered shale has a “Low” heave potential with very little amount of clay present.

The potential expansiveness of the material was evaluated based on the indicative laboratory test results and field observations. This included using the Plasticity Index and Linear Shrinkage of the material, Van der Merwe’s Method and the material structure to evaluate the potential heave of the material. The potential expansiveness of the materials is visually depicted in Chart 1.

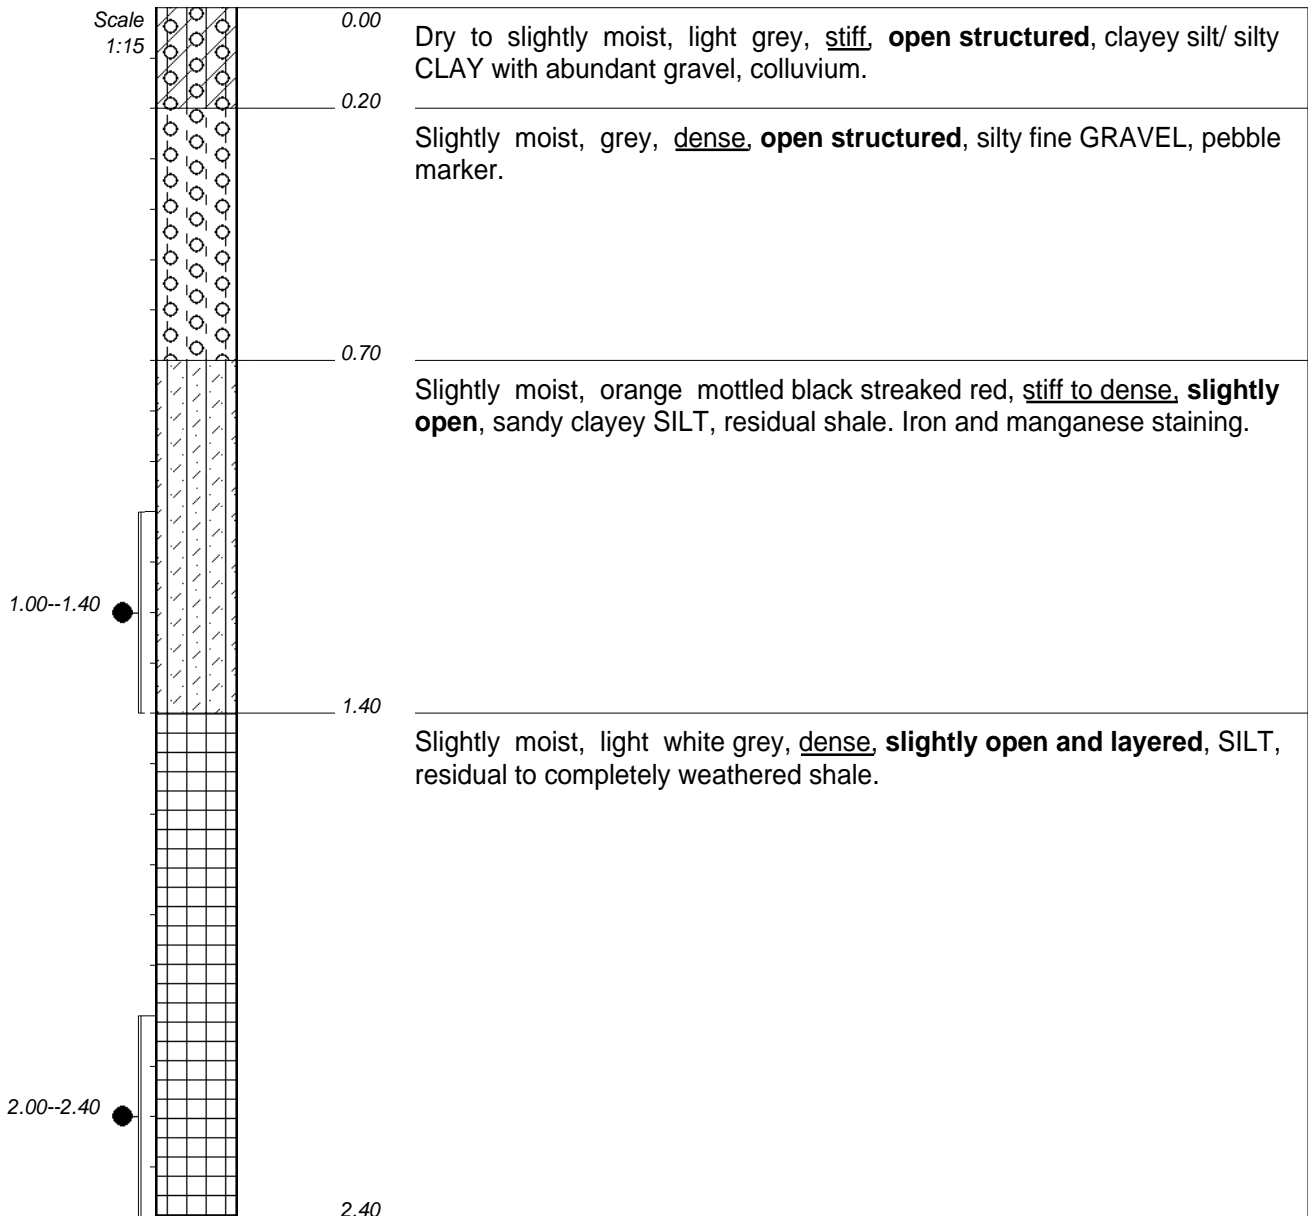
- 1) Progressive Refusal, TLB confined excavation.
- 2) Sample: 1.00--1.40 m and 2.00--2.40 m.
- 3) No seepage.
- 4) Hole stable during investigation.

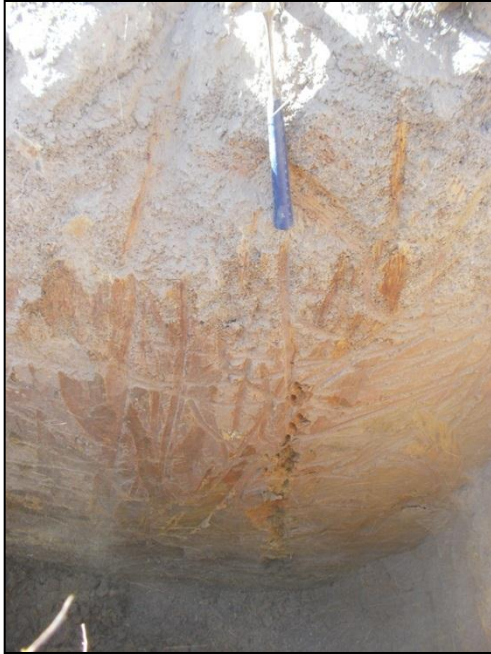
Test Pit number: TP01

Note: Progressive refusal of TLB.

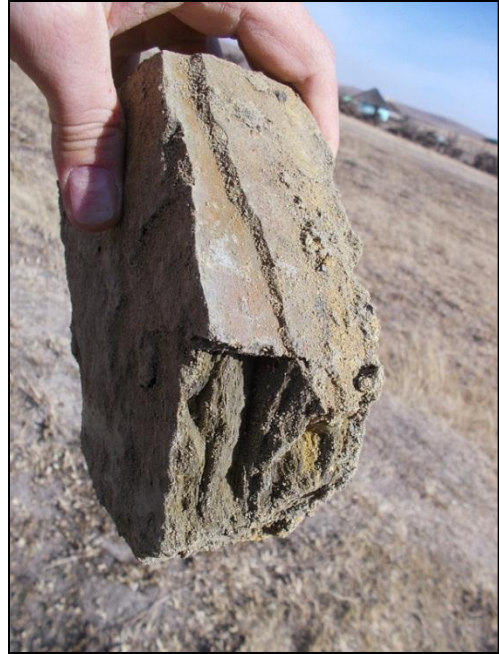
Test Pit number: TP01

Note: Highly weathered shale fragment.

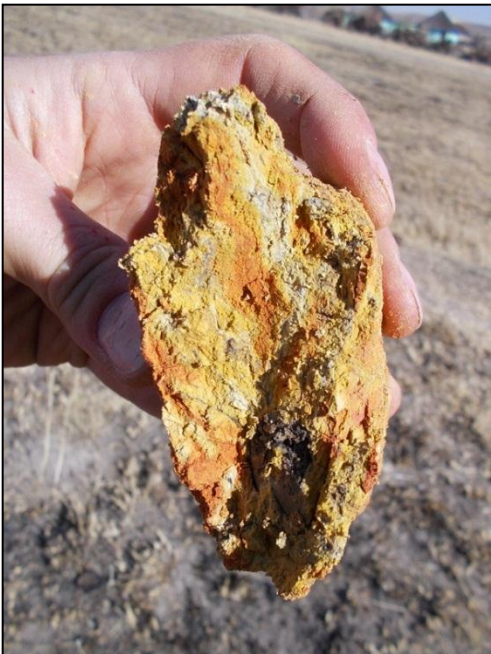
Test Pit number: TP01

Note: Clayey silty residual shale.

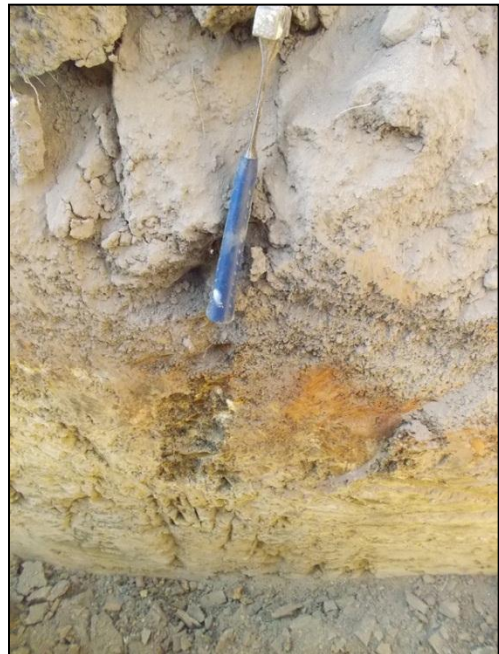
Test Pit number: TP02

Note: Refusal of TLB.

Refusal conditions were encountered in two of the test pits within highly weathered shale in test pit MD02 and MD04 at 1.25 m and 1.00 m bngl respectively. Hard excavation conditions were encountered at these termination depths where refusal conditions were experienced on jointed and layered soft rock shale.

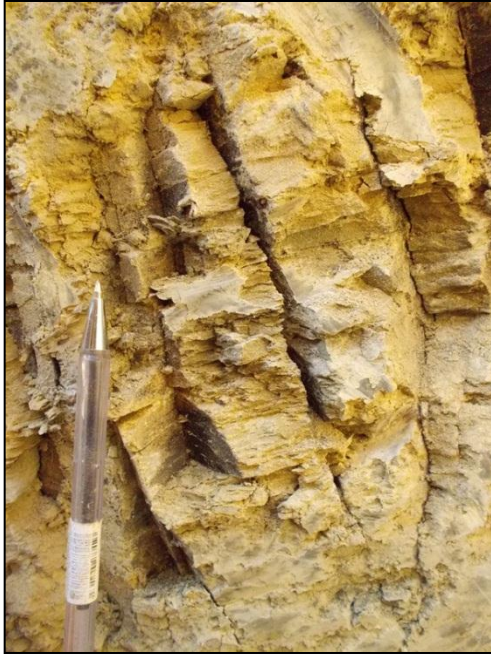
Test Pit number: TP02

Note: Jointed and layered structure in highly weathered shale.

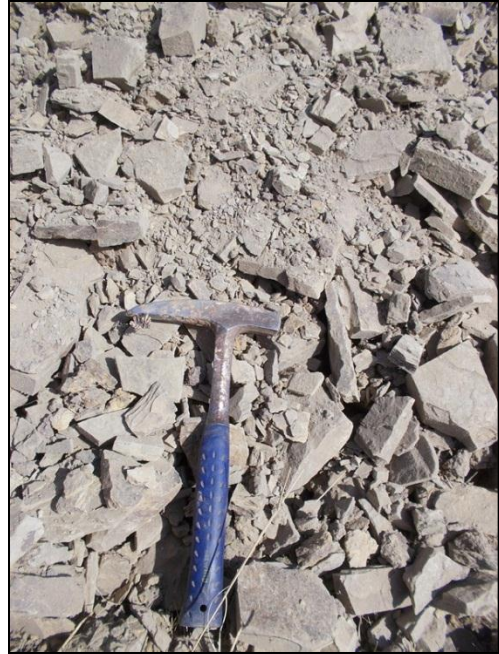
Test Pit number: TP02

Note: Highly weathered shale fragments excavated.

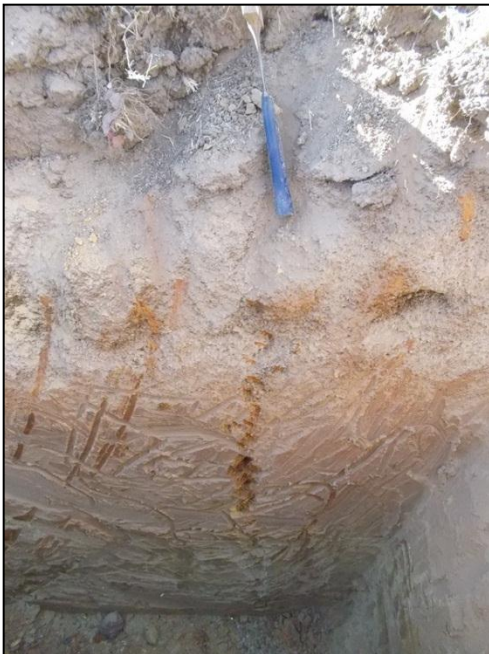
Test Pit number: TP03

Note: Progressive refusal of TLB.

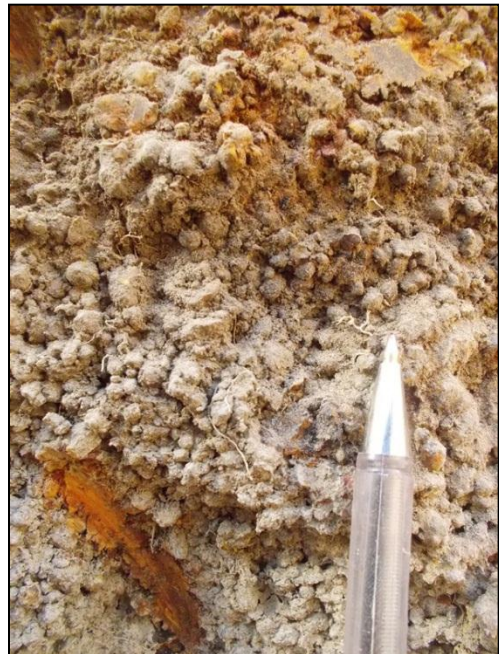
Test Pit number: TP03

Note: Open gravelly pebble marker.

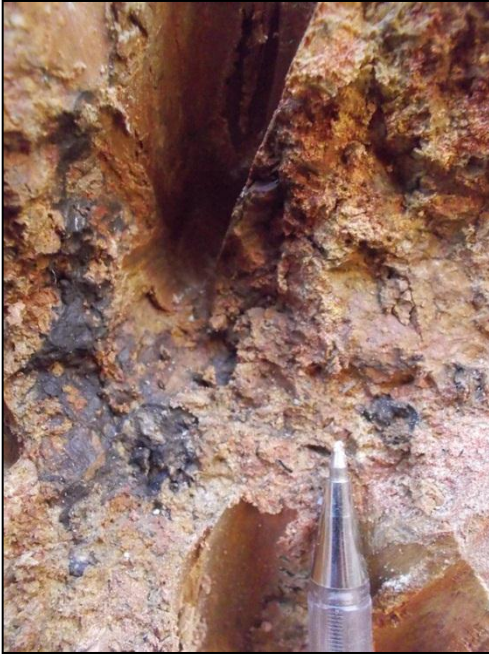
Test Pit number: TP03

Note: Iron and manganese staining.

Signs of seasonal shallow seepage water conditions are evident in the soil profiles excavated. Severe shallow seasonal seepage water are expected, water is expected to occur on the shallow completely to highly weathered shale. Concentration of flow will be from the top center of the village down slope to the sides of the village area towards the drainage features located in the lower lying areas especially towards the Mdina river north-east to north-west.

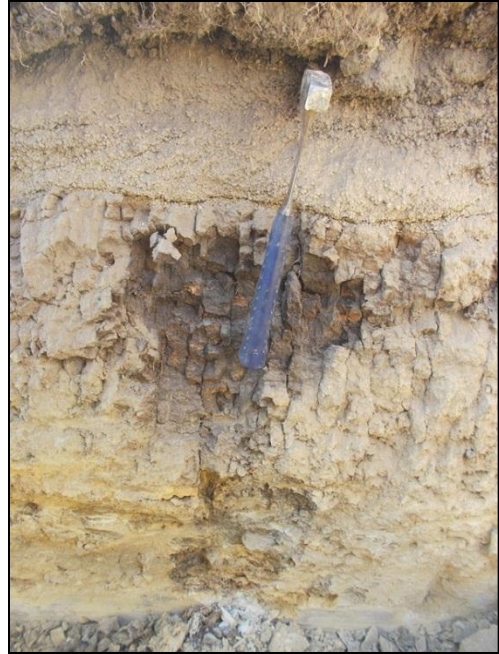
Test Pit number: TP04

Note: TLB refusal on soft rock shale.

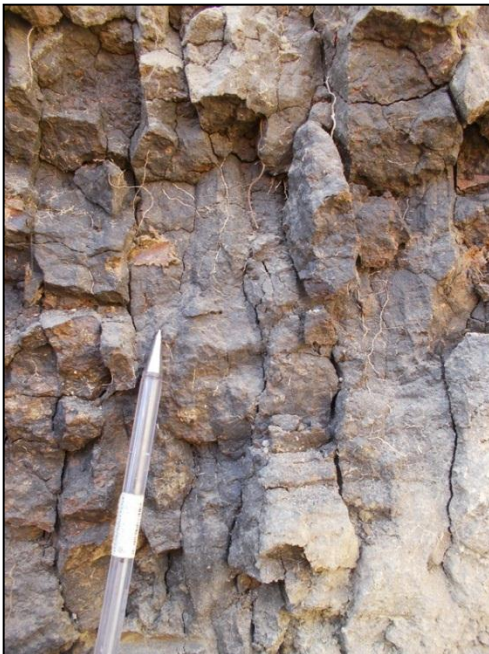
Test Pit number: TP04

Note: Desiccation cracks in silty clay horizon.

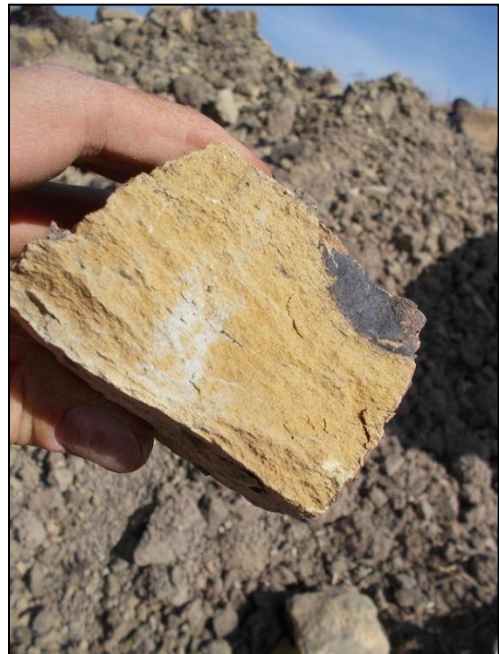
Test Pit number: TP04

Note: Highly weathered shale fragment.

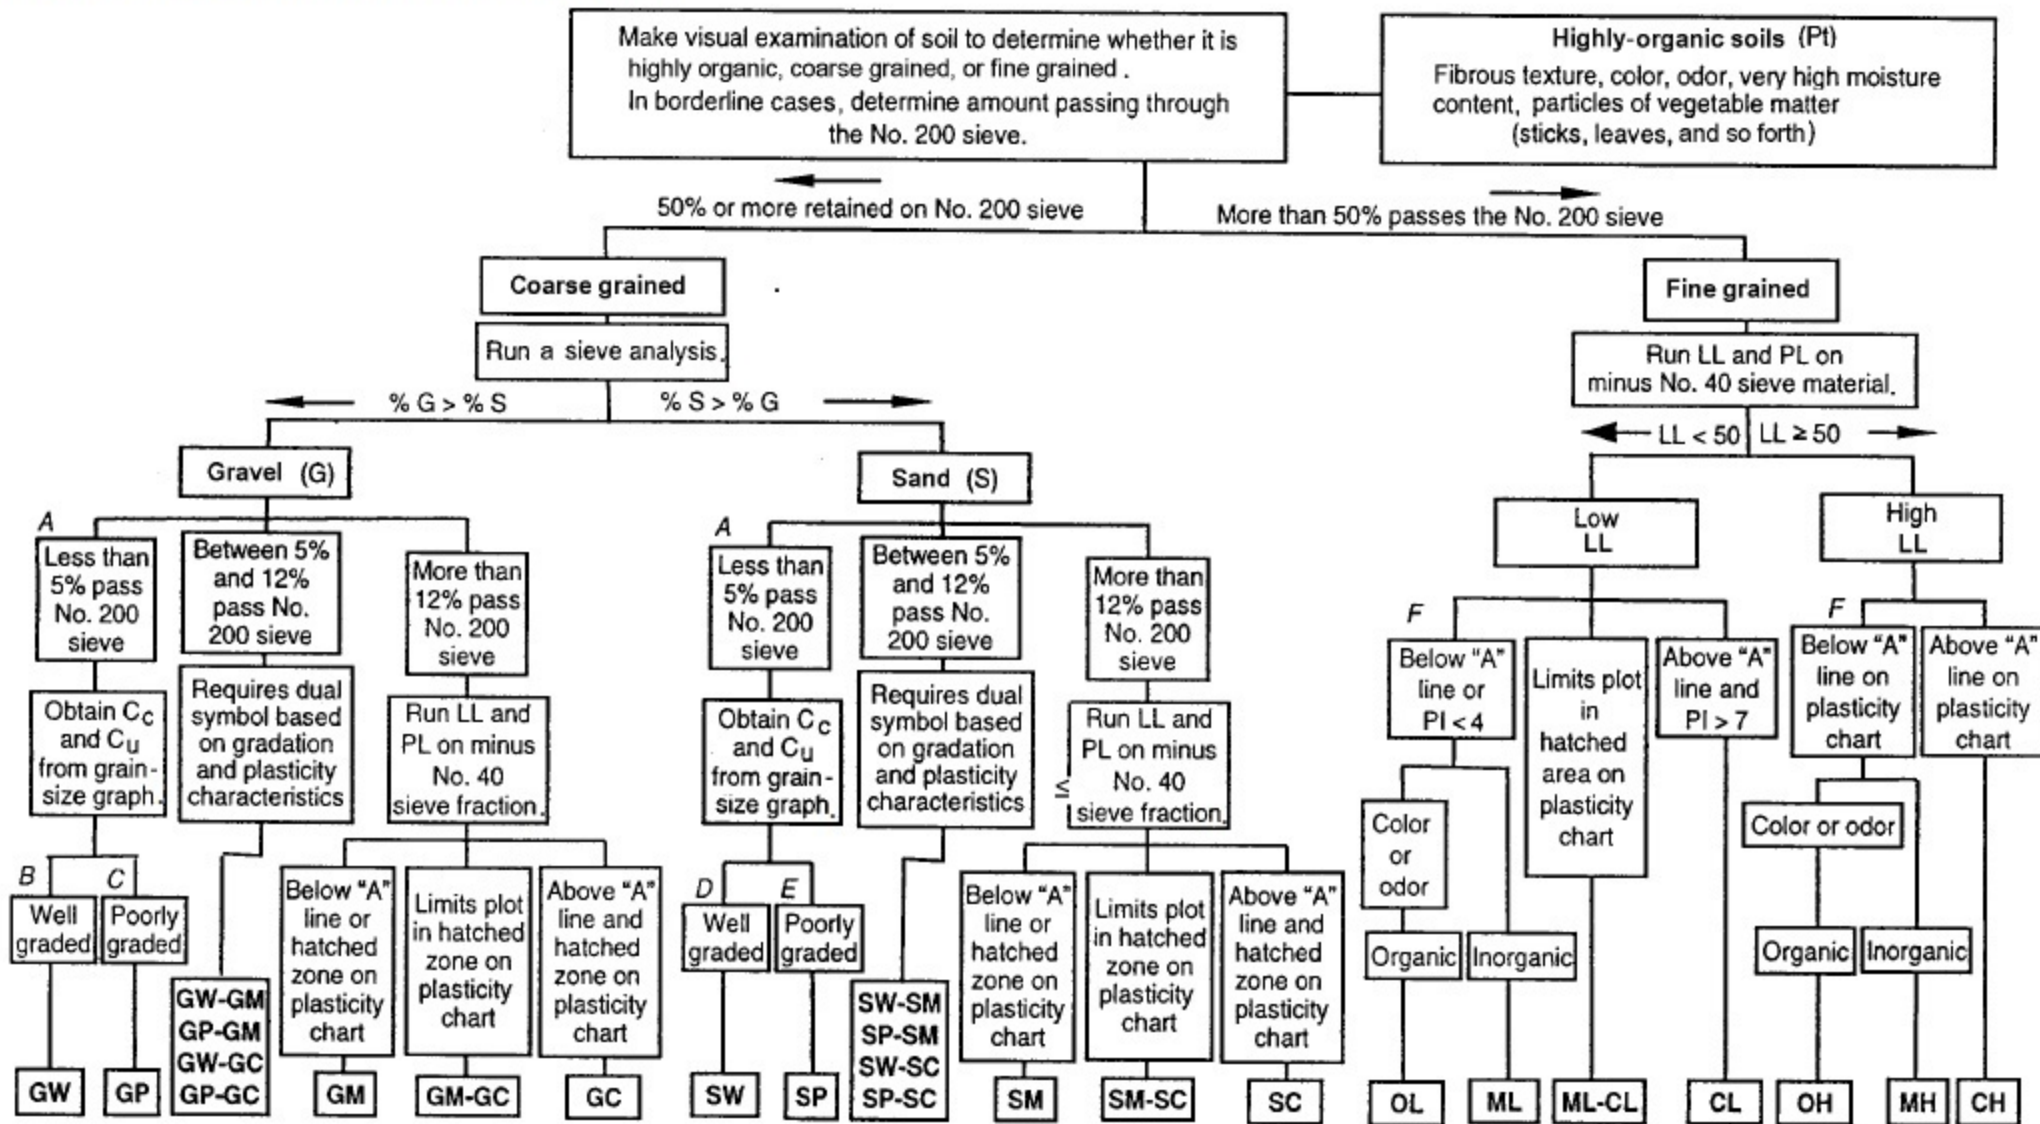
CHART C2: USCS DESIGNATION FLOW CHART

A If fines interfere with free-draining properties, use a double symbol such as GW-GM.

B For well-graded gravel, the C_u must be > 4 and the C_c must be ≥ 1 and ≤ 3 .
