THE “BARREL WRECK”: A PRELIMINARY ASSESSMENT OF ITS HULL REMAINS

By Wendy van Duivenvoorde

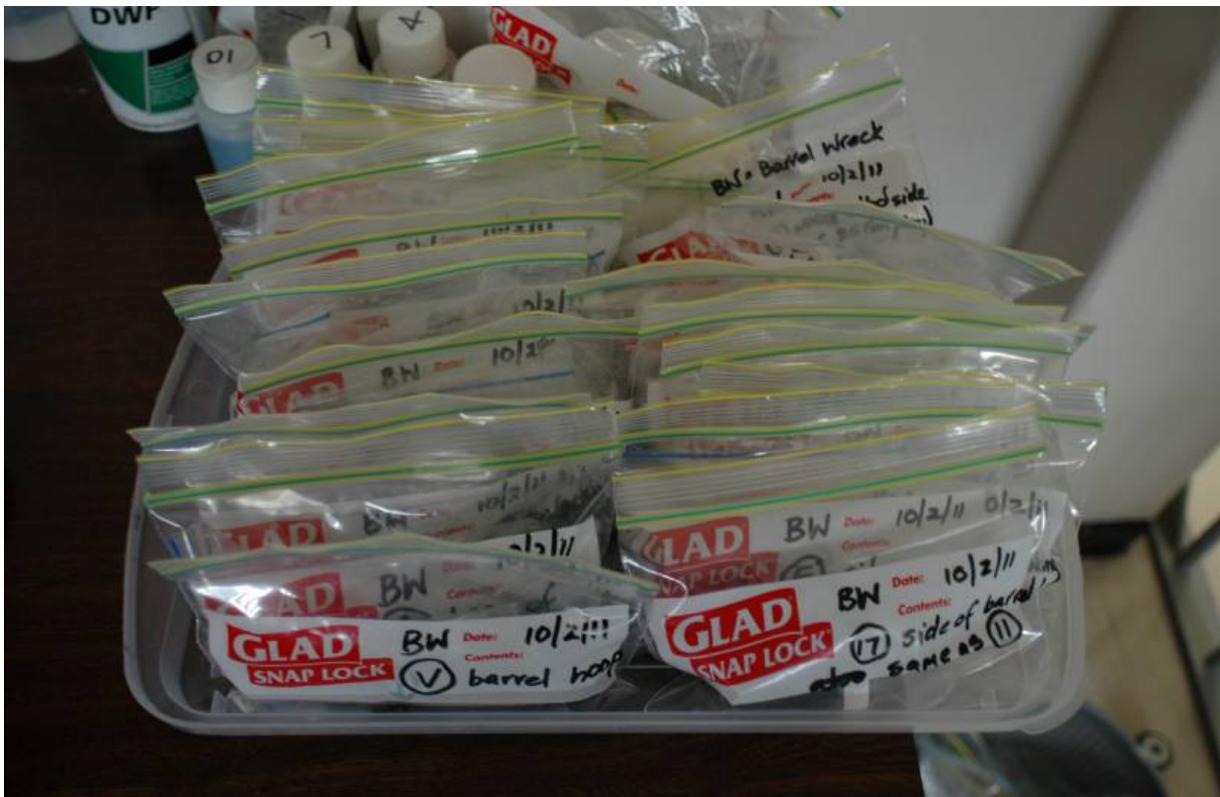
Fig. 1 Wood, resinous substance, and hair samples taken from the Barrel Wreck.
Photograph: Jon Carpenter.

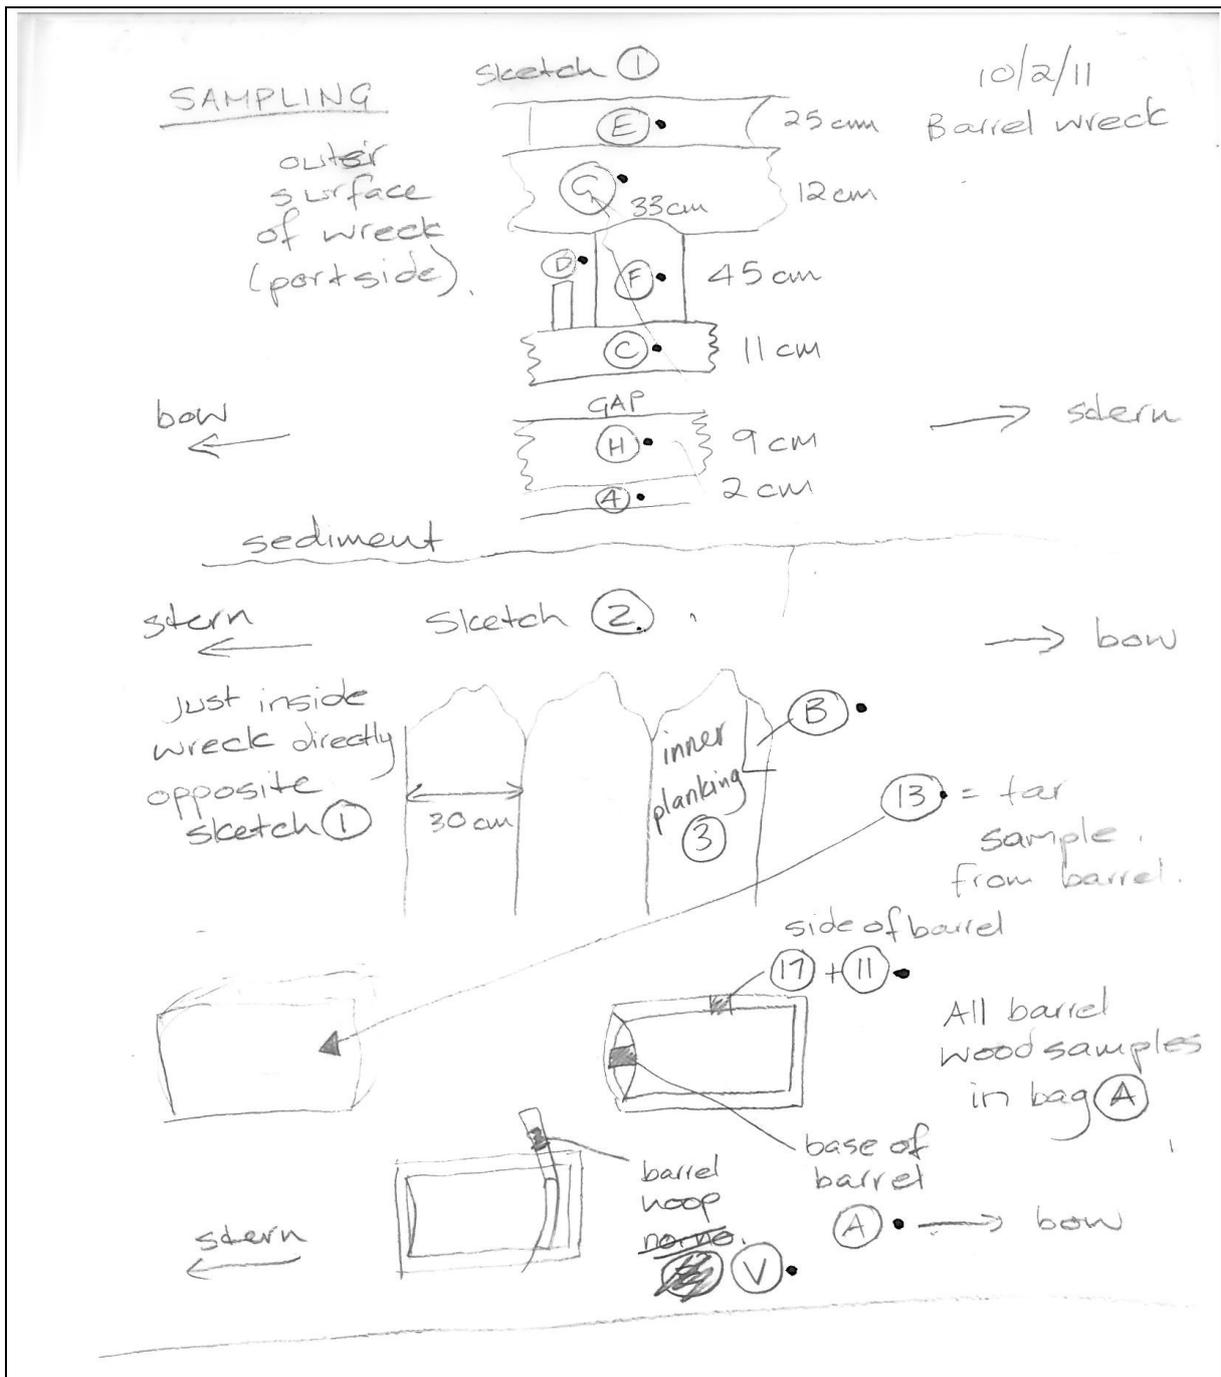
Although no assertions can be made on the Barrel Wreck's construction method, its hull remains seem to indicate that the ship was built with two thick layers of oak hull planking (Table 1); the outer layer measuring 9 cm and the inner layer 11 cm in thickness (Fig. 2).

Fig. 2 Location of wood samples taken from exposed timbers. Sketch: Vicki Richards.

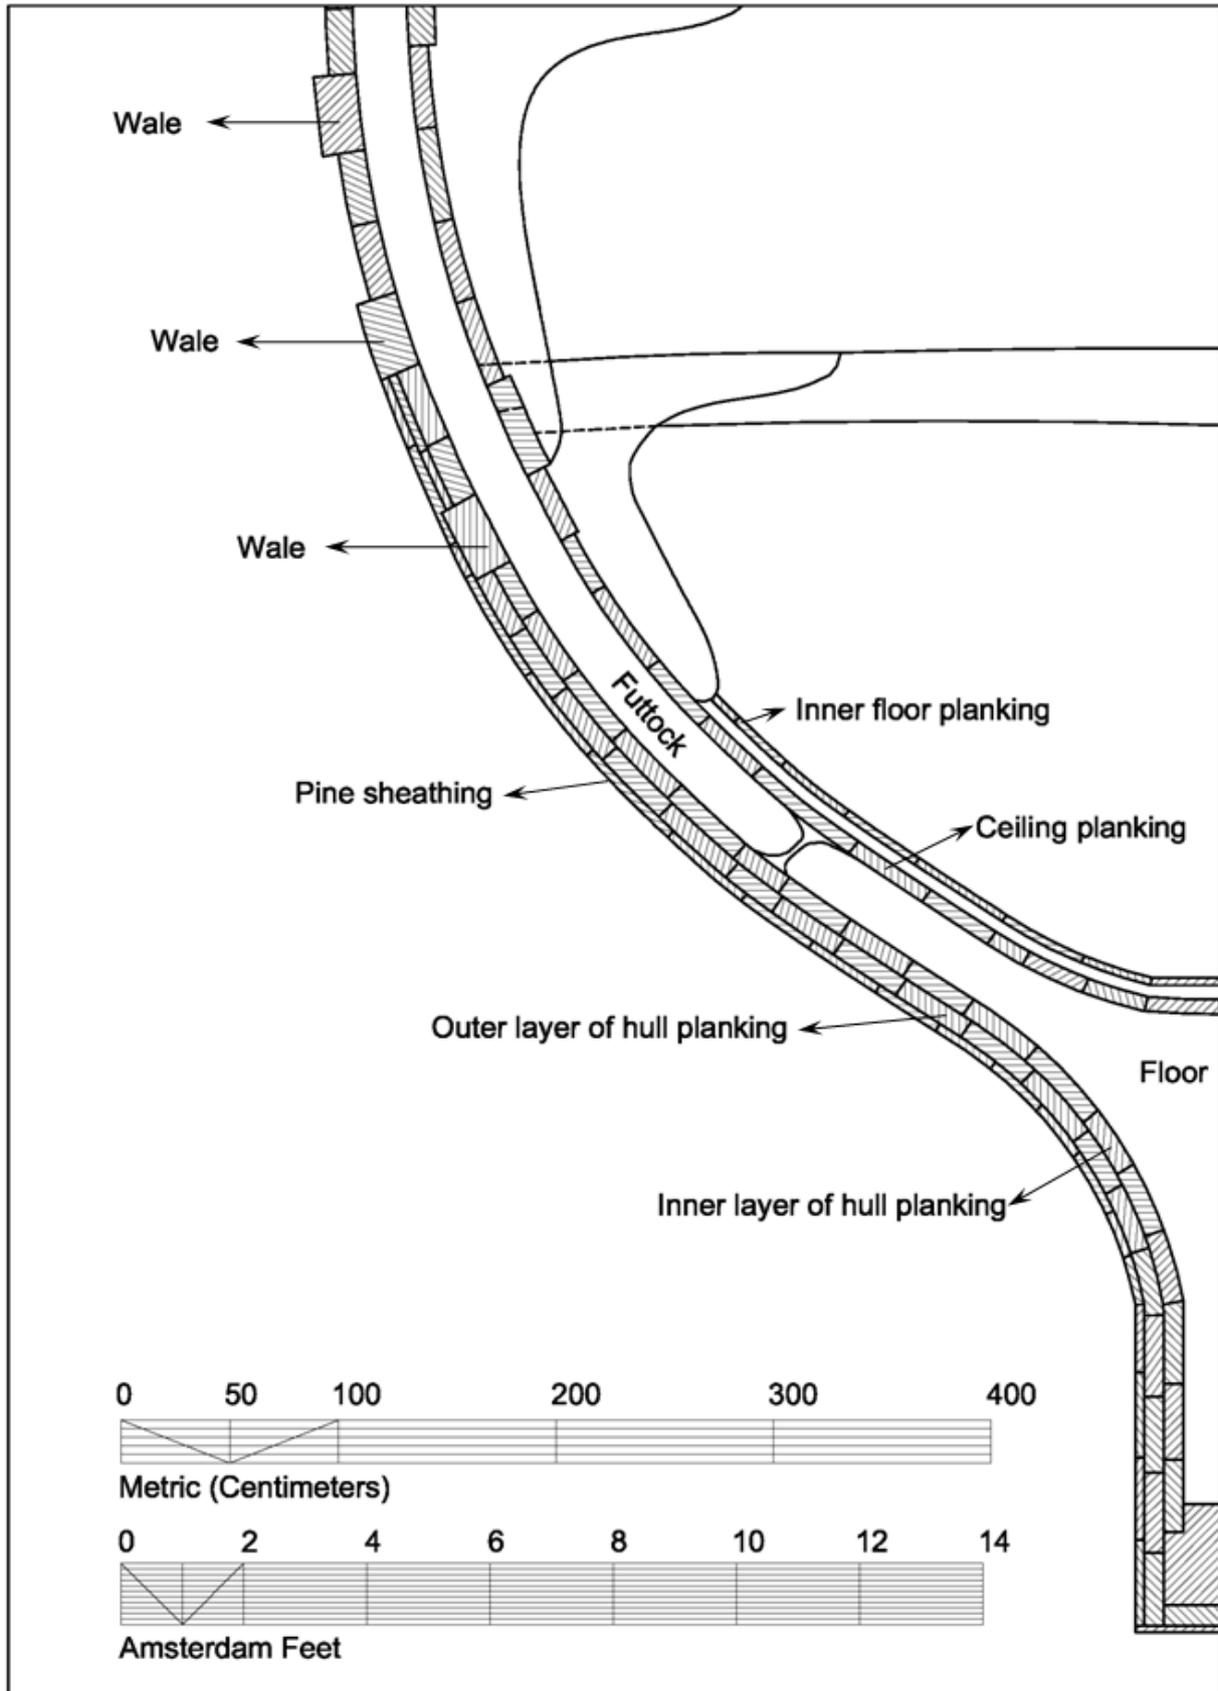
Fig. 3 Cross-section of *Batavia*'s hull showing all layers of planking and frame timbers. Illustration: Wendy van Duivenvoorde.

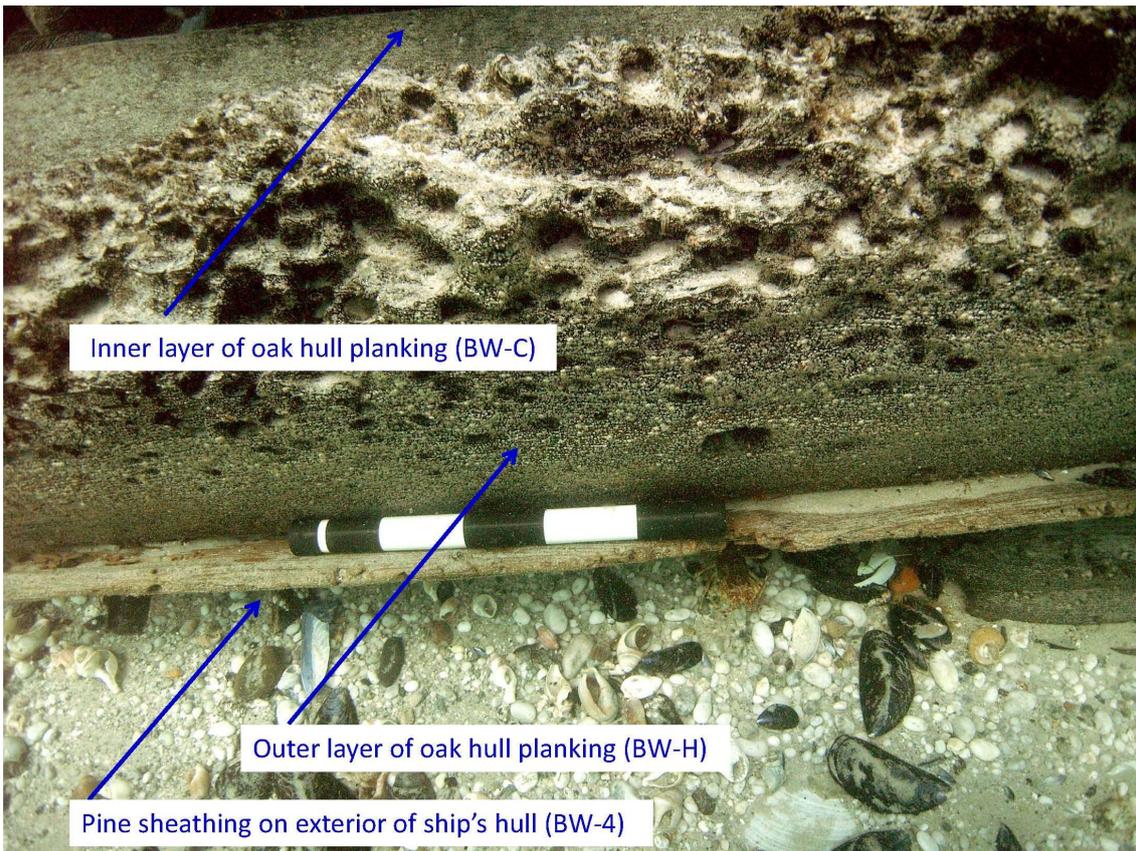
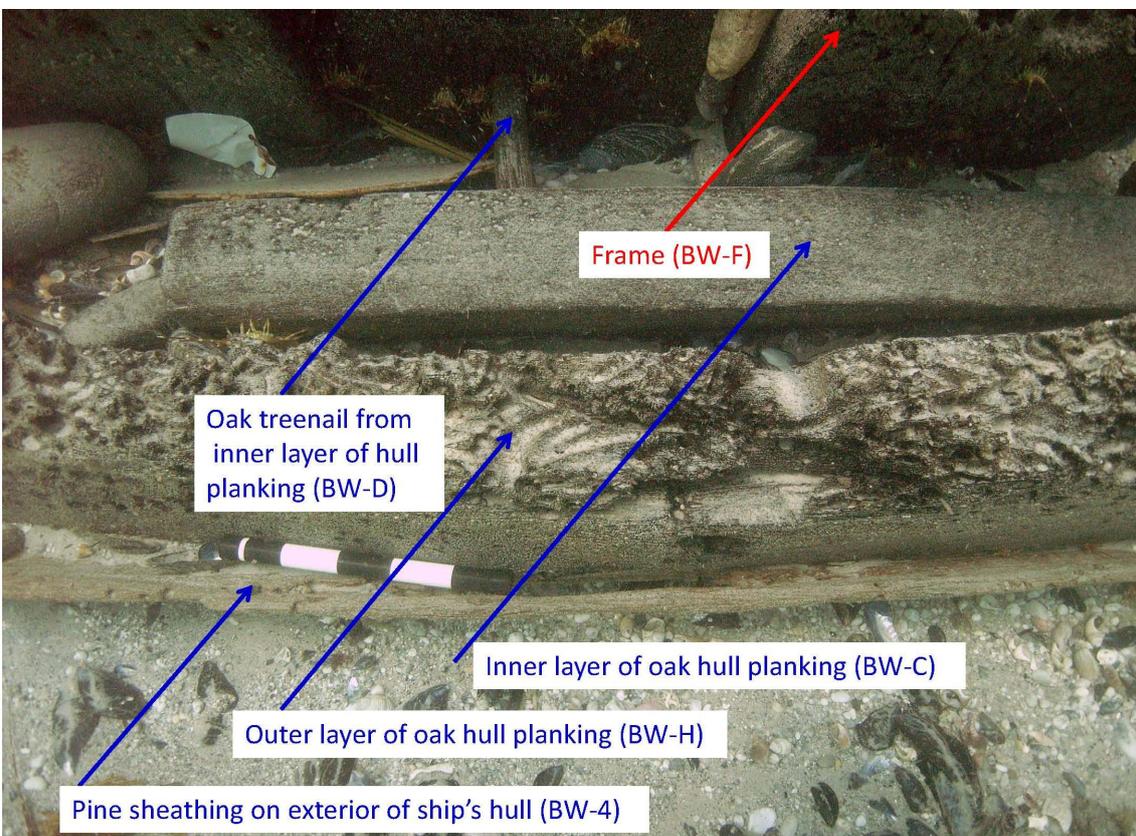
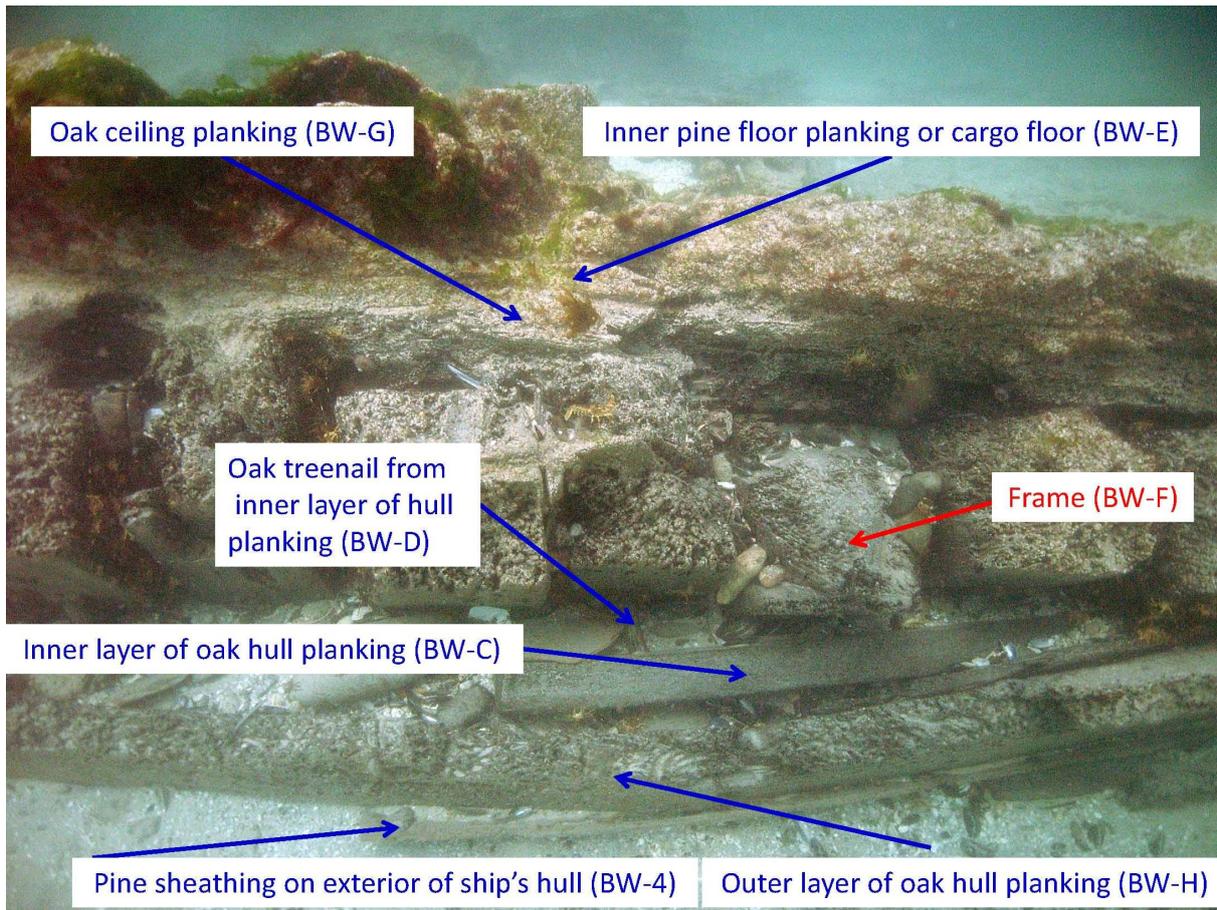
In addition to double planking the hulls, the Dutch East India Company—and India company shipbuilders in other European nations, such as England, Denmark, and Sweden—often outfitted its ships with an additional layer of pine sheathing to protect the hull from the ravages of marine borers. This sacrificial sheathing was fastened with iron nails to the outer layer of hull planking, with the nails closely spaced in order to create a layer of iron rust to provide additional protection against marine organisms. This method became a standard worm-protection measure throughout the 17th and 18th centuries.

Fig. 4 Two layers of oak hull planking and a sacrificial layer of pine sheathing, Barrel Wreck. Photograph: Jon Carpenter.

Fig. 5 Two layers of oak hull planking and a sacrificial layer of pine sheathing, Barrel Wreck. Photograph: Jon Carpenter.

Fig. 6 Two layers of oak hull planking and a sacrificial layer of pine sheathing, Barrel Wreck. Photograph: Jon Carpenter.

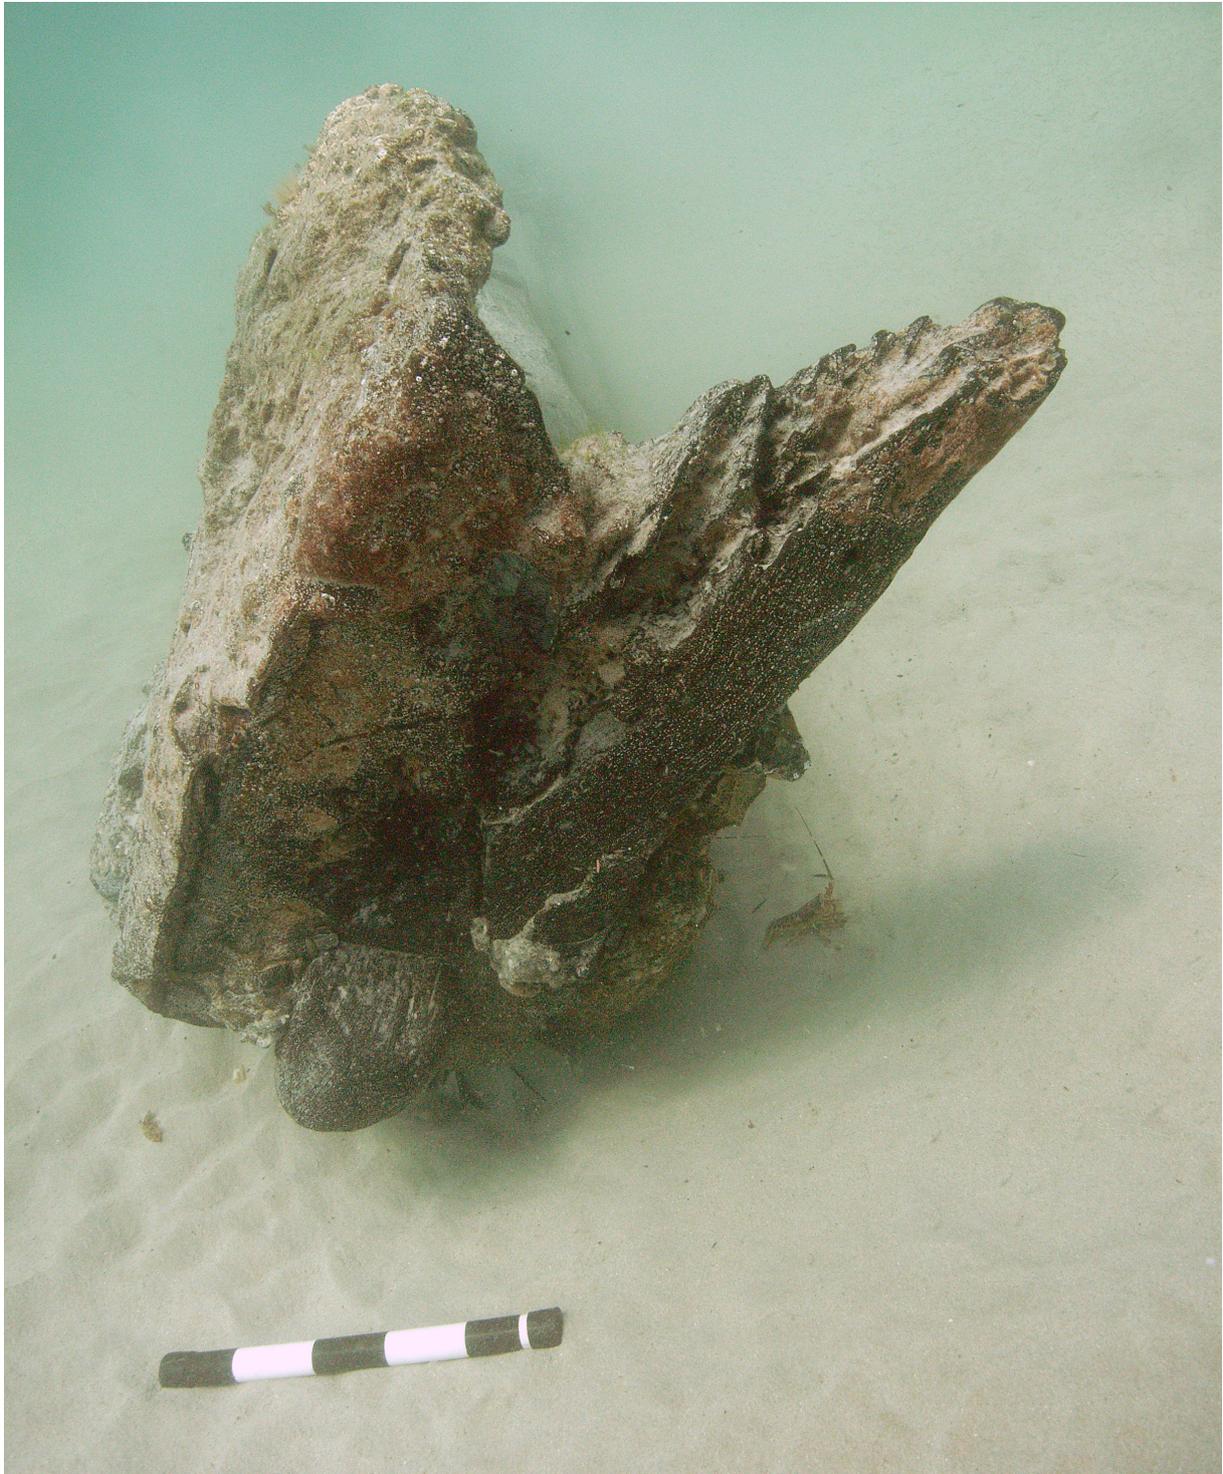
Fig. 7 Lead sheathing at aftermost end of the sternpost, Barrel Wreck. Photograph: Jon Carpenter.

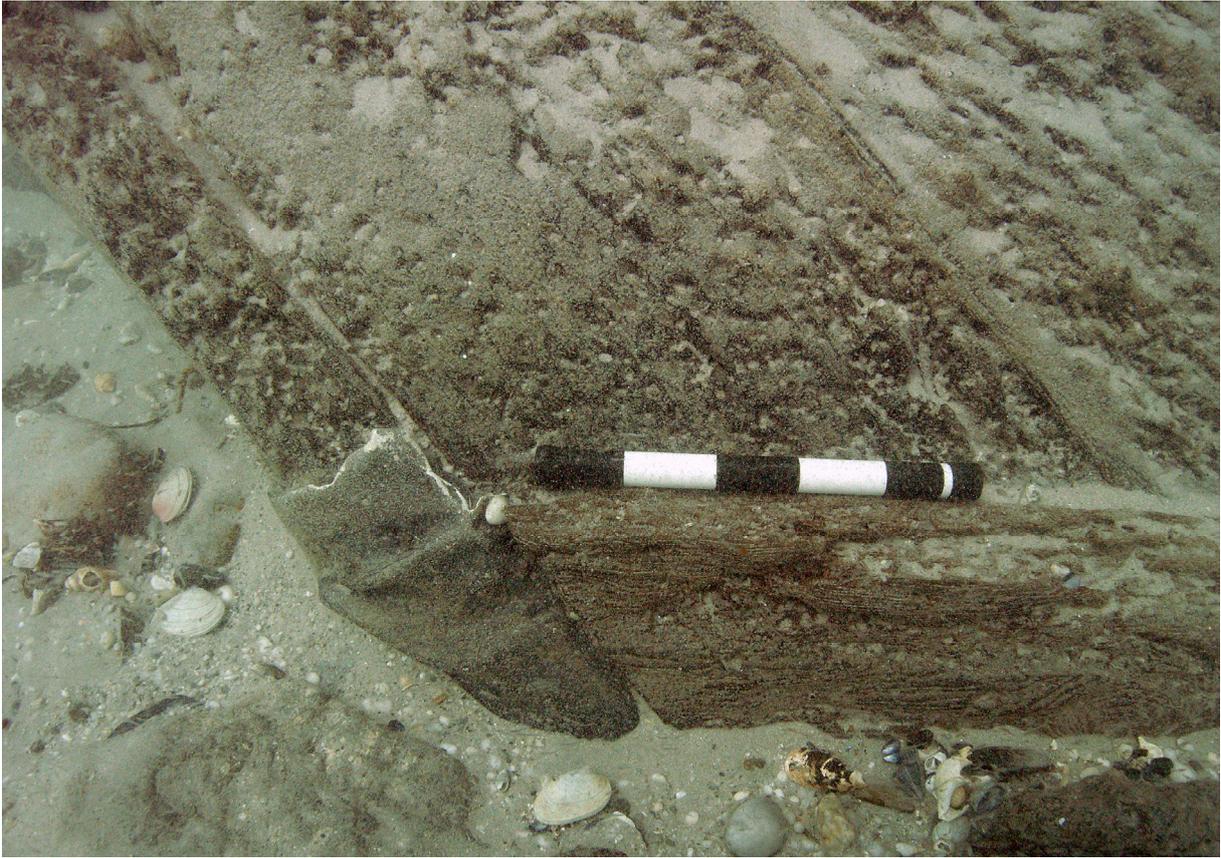
Fig. 8 Lead sheathing on the stem, Barrel Wreck. Photograph: Jon Carpenter.

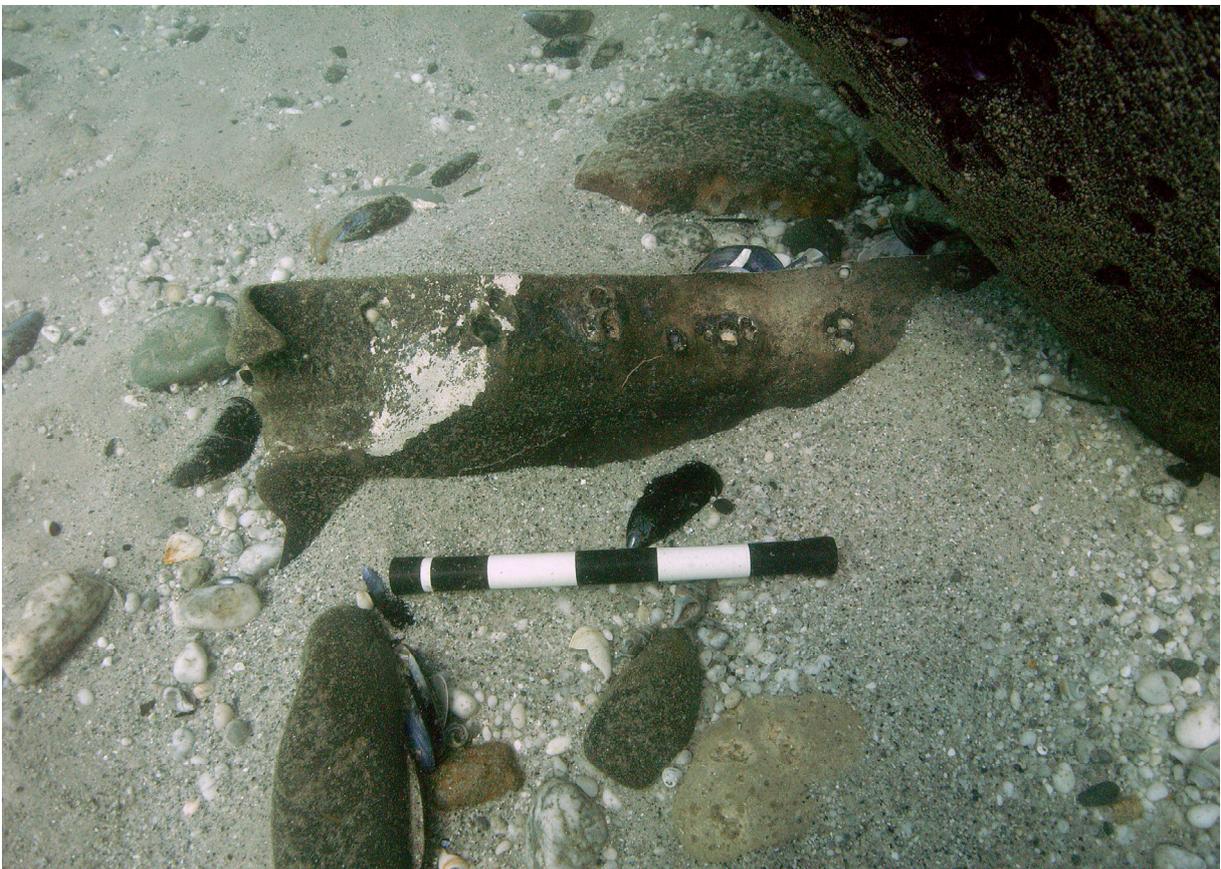
Fig. 9 Metal sheathing detached from the ship's hull, Barrel Wreck. Photograph: Jon Carpenter.

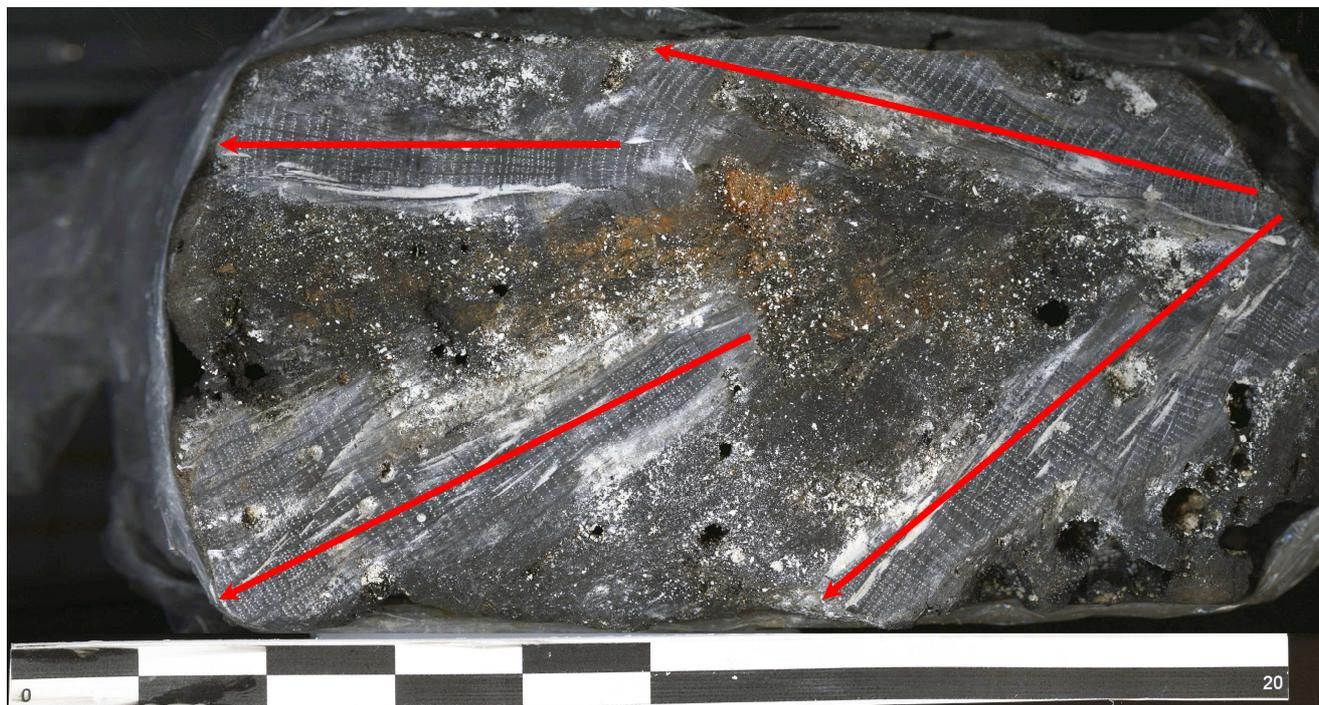
Appendix 1. Transversal section of the sample

After cleaning several rays in the transversal surface of the sample (from the pith to the outermost visible ring as indicated in Figure 1, Appendix 1), we obtained a continuous tree-ring series containing 130 rings. The comparison of this tree-ring series with the master chronologies of oak available at the Ring Foundation (see <http://www.noaa.nl/content/hst03/h3.1.4.2.htm#143>) resulted in the absolute dating of the sample, with the most recent ring dating in AD 1742 (see Table 1 in Appendix 2, and Figure 2 in Appendix 3).

Figure 1. Transversal surface of the sample, showing the cleaned areas where the ring-widths have been measured. The red arrows point at the direction of the measurements, from the inner to the outer rings.

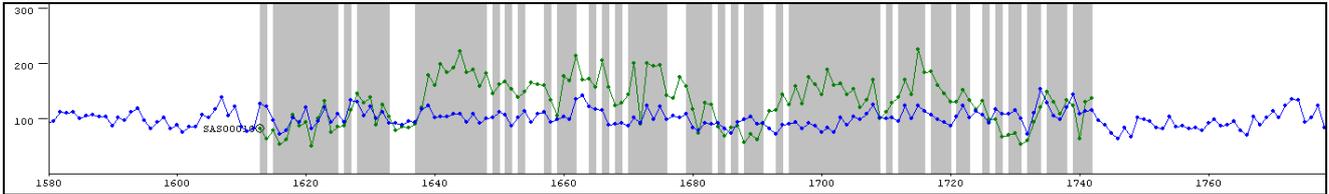
Appendix 3. Visual synchronisation of the tree-ring series with the master chronology

Figure 2. Green: tree-ring series from the sample SAS00010 (the circle indicates that the pith is present in the sample); blue: master chronology NLNSA502. Y-axis: tree-ring widths in $\text{mm} \cdot 10^{-2}$; X-axis: calendar year. The grey area indicates the percentage of parallel variation (%PV) between the overlapping part of the sample and the master chronology.
