230 CURRIE RD DARD REPAIRS & RENOVATIONS DURBAN

DESIGN, PROJECT MANAGEMENT & CONSTRUCTION OF DEPARTMENT OF AGRICULTURE & RURAL DEVELOPMENT RESTORATION PROJECT

SITE INSPECTION REPORT

CIVIL AND STRUCTURAL WORKS

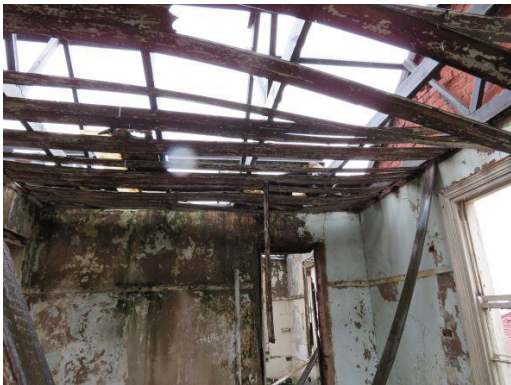
The roof coverings for the building are non-existent leaving the entire structure exposed to inclement weather for extended period of time. Timber roof structures are collapsing due to decay and rotting of the timber. See photos 25 to 28.

Photo 27: Collapsing Roof and Ceiling Structure

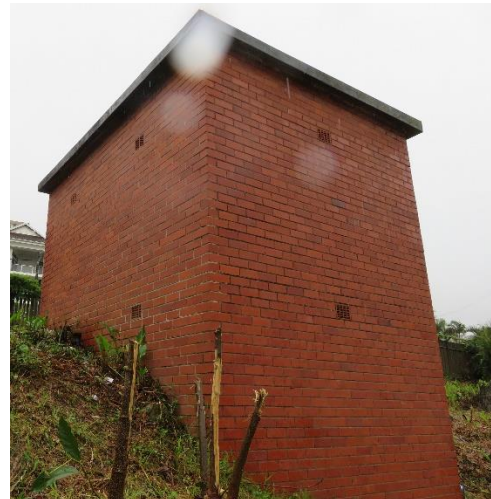
This is the only building that is in a fairly good condition on this site. See photos 51 to 54. The only defects noted related to roof slab waterproofing problems and a damaged lintel beam above the main door opening.

Photo 52: Typical Brick Wall Condition

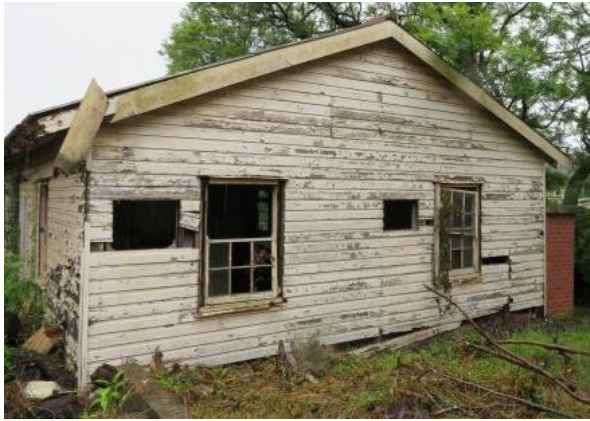
This is a temporary timber structure that is also in a very poor condition. See photos 55 to 60. The defects mainly relate to decay and rotting of the timber. The roof covering is of asbestos material hence a health hazard.

Photo 55: Side View of Building

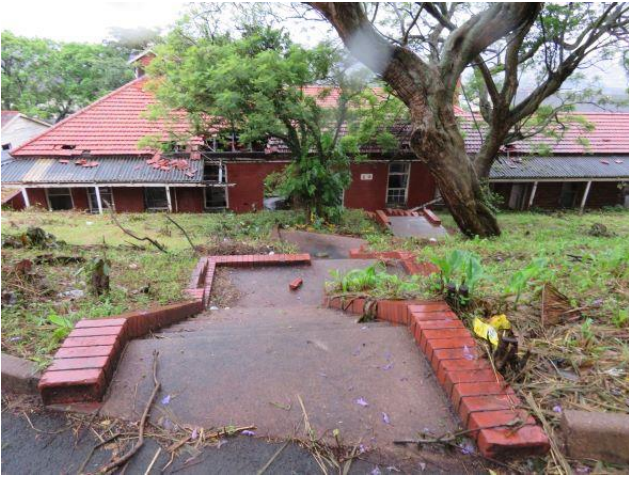
The numerous walkways around the site are in a fairly good condition apart from some minor cracks on the slabs. See photos 67 to 68.

Photo 67: View of main steps to Block A from parking

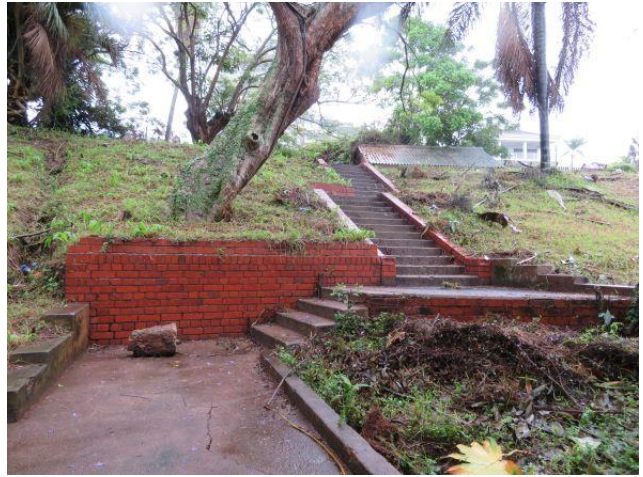
Photo 68: View of main steps to Block A
