SKOENMAKERS RIVER REHABILITATION ASSESSMENT
 ZONE 1

Date:	08/02/2016	Compiled by:	PAUJ
Project No.	472748	Scale	1:7,369

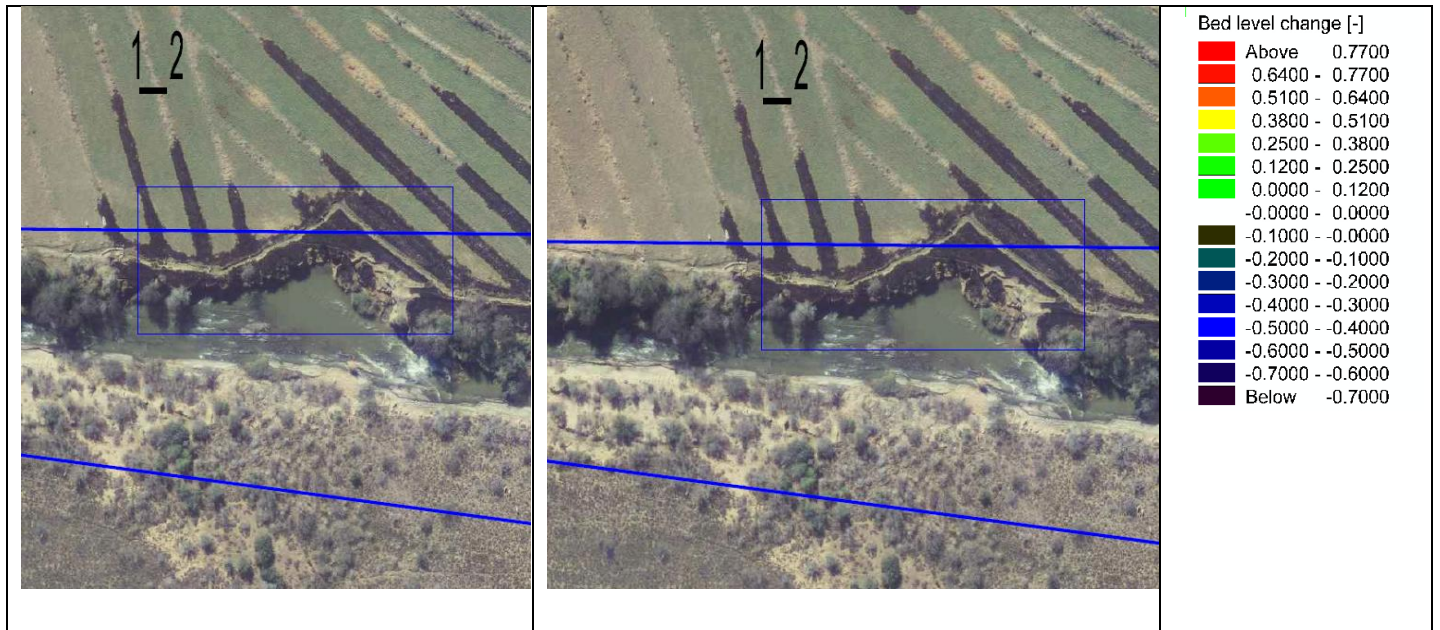
Zone 1_2

This area is within the servitude and has unstable banks. Due to the bedrock at the location, the banks do not need protection and the servitude seems incorrect.

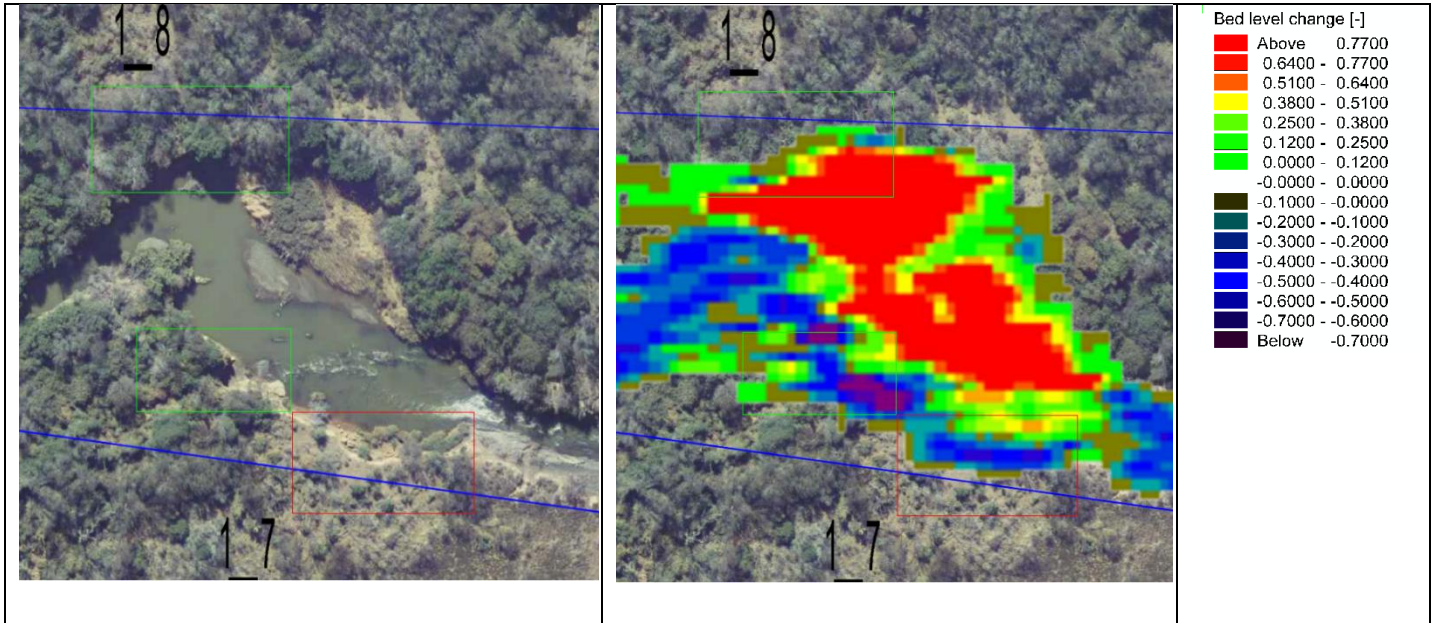
Zone 1_8

This area has banks partially crossing the servitude.

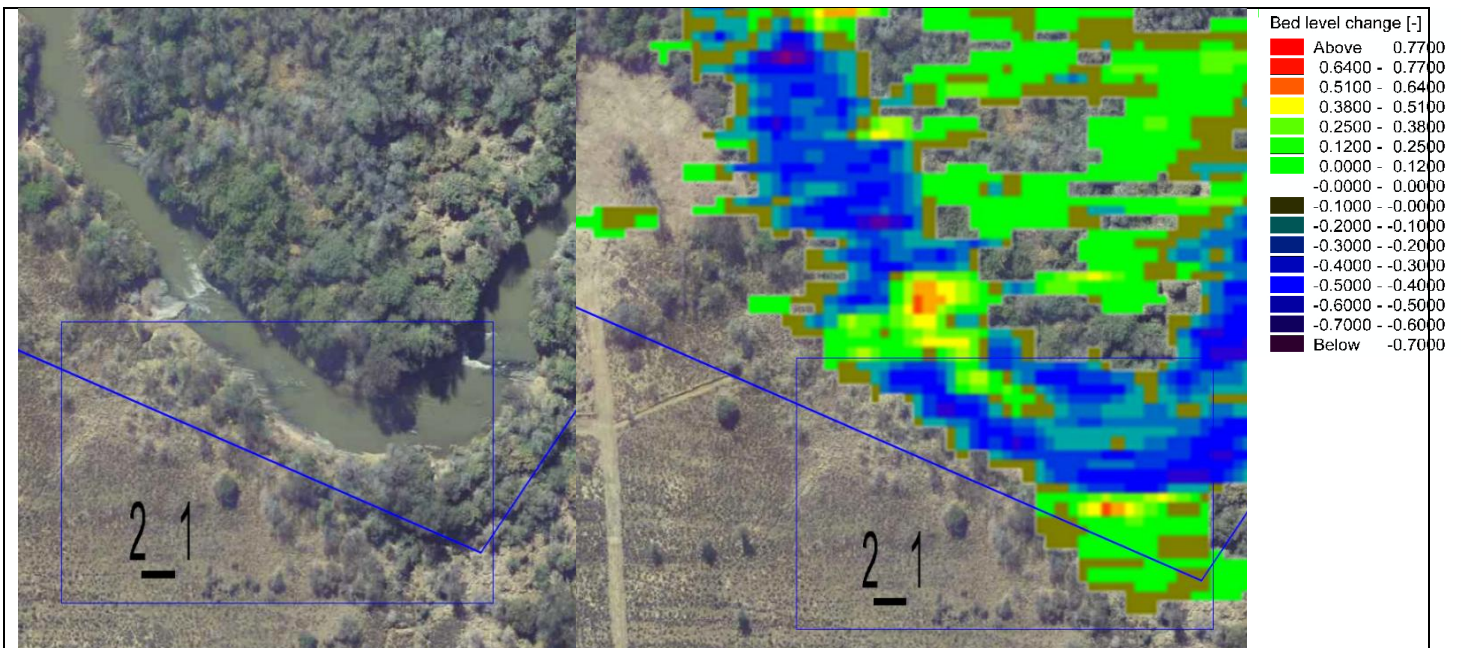
Zone 2_1

The banks are encroaching the servitude but protection does not seem necessary.

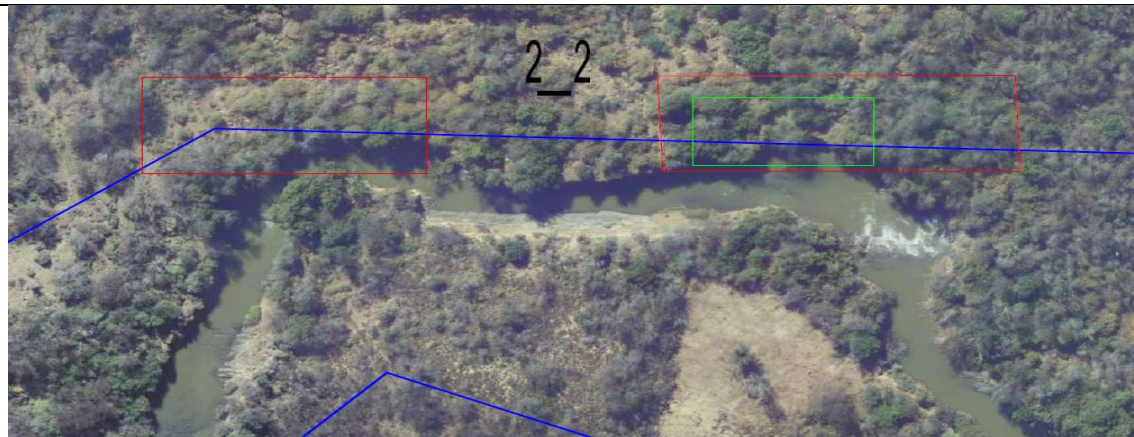
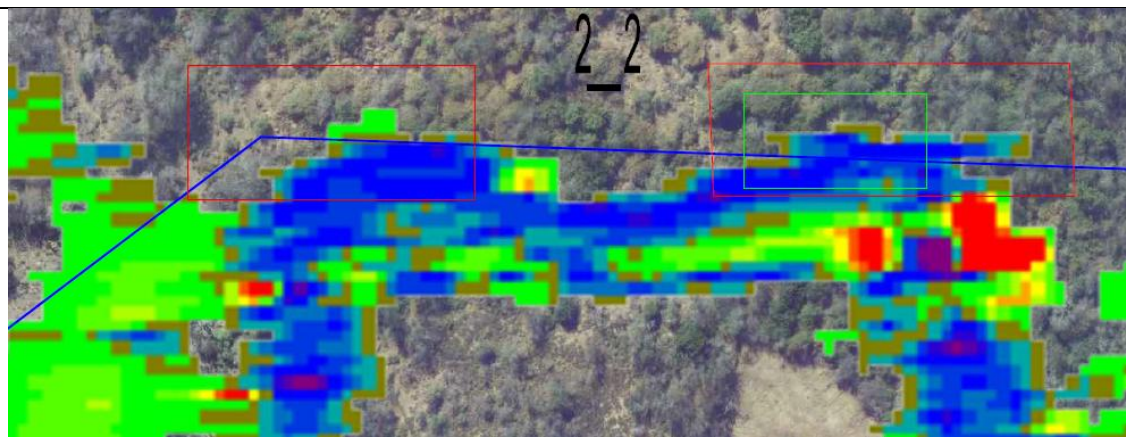
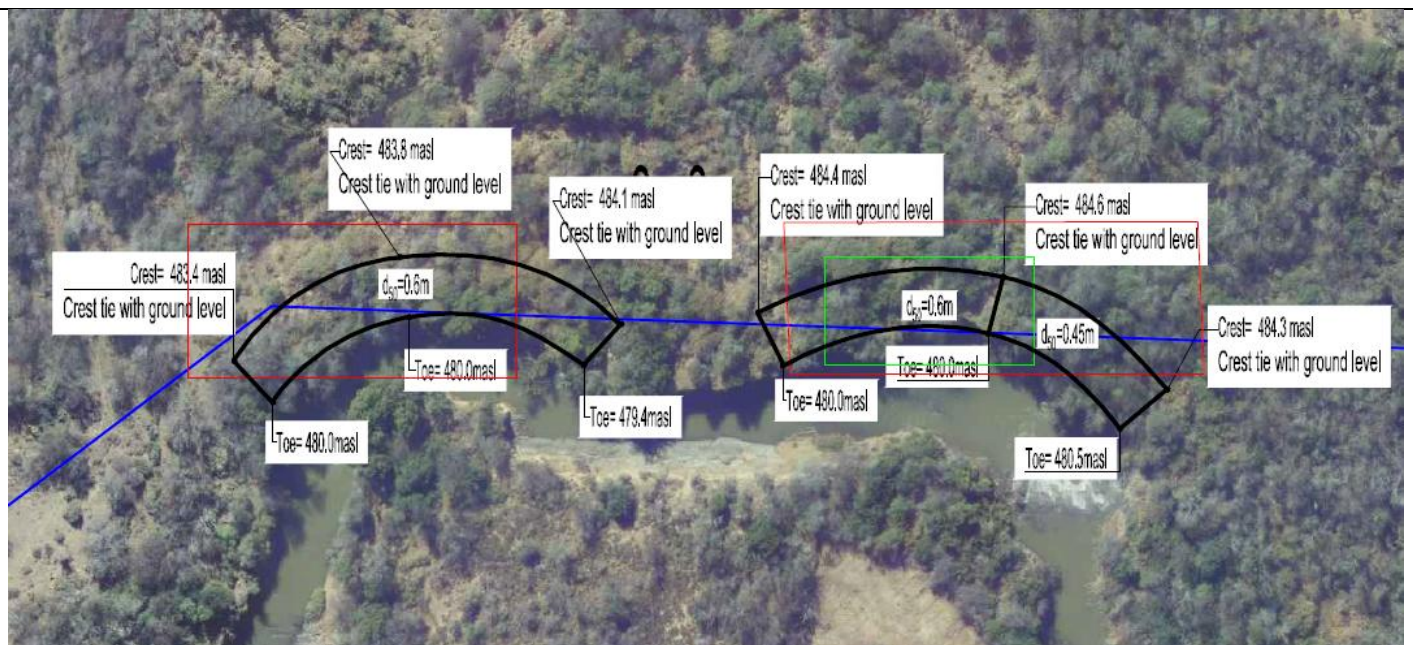
Zone 2_2

This area has unstable banks crossing the servitude.

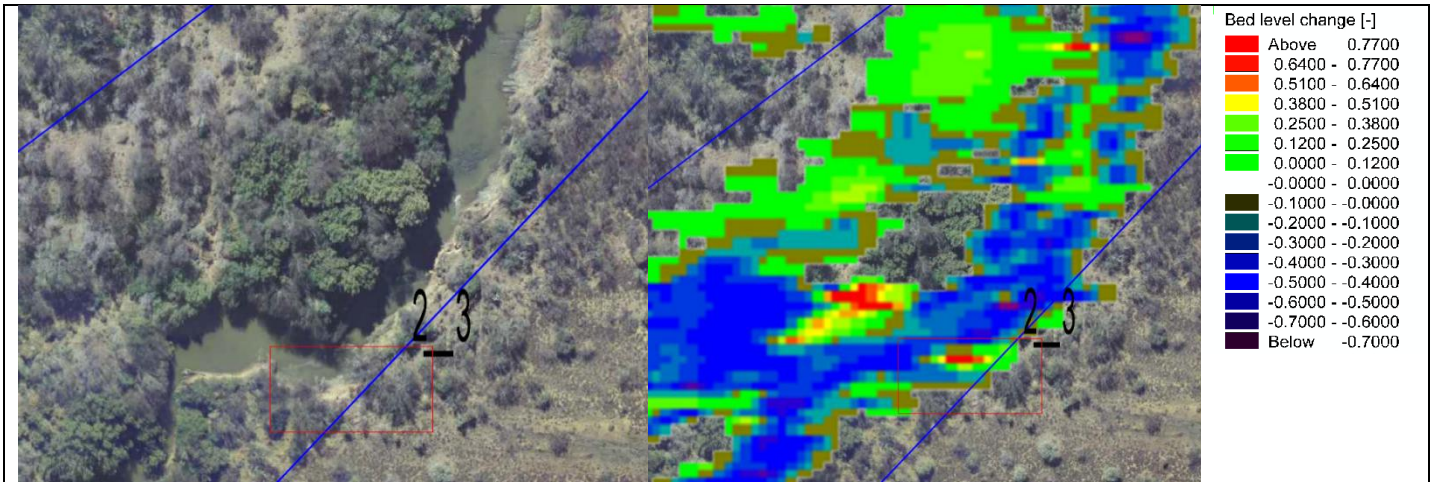
Zone 2_3

This area has unstable banks are encroaching on the servitude.

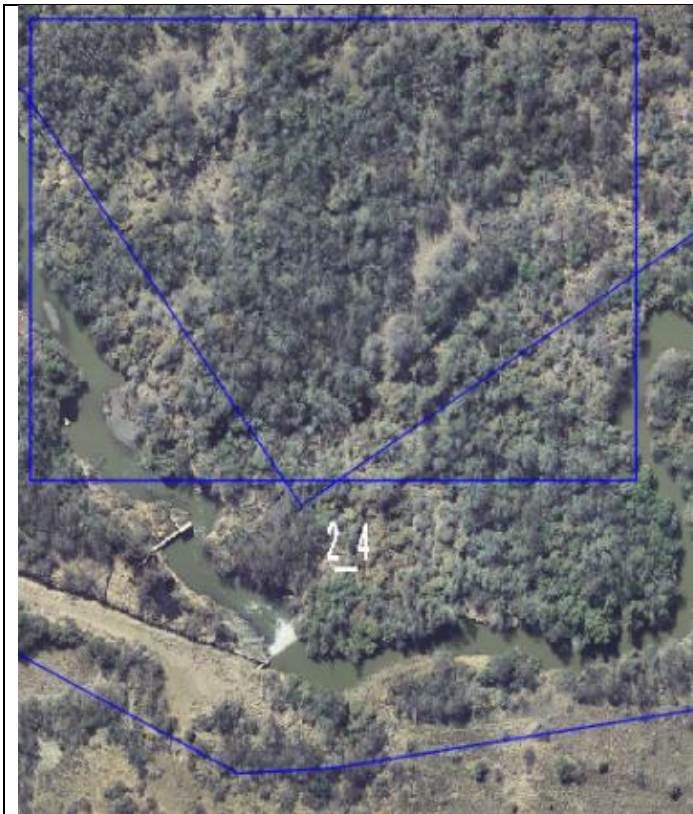
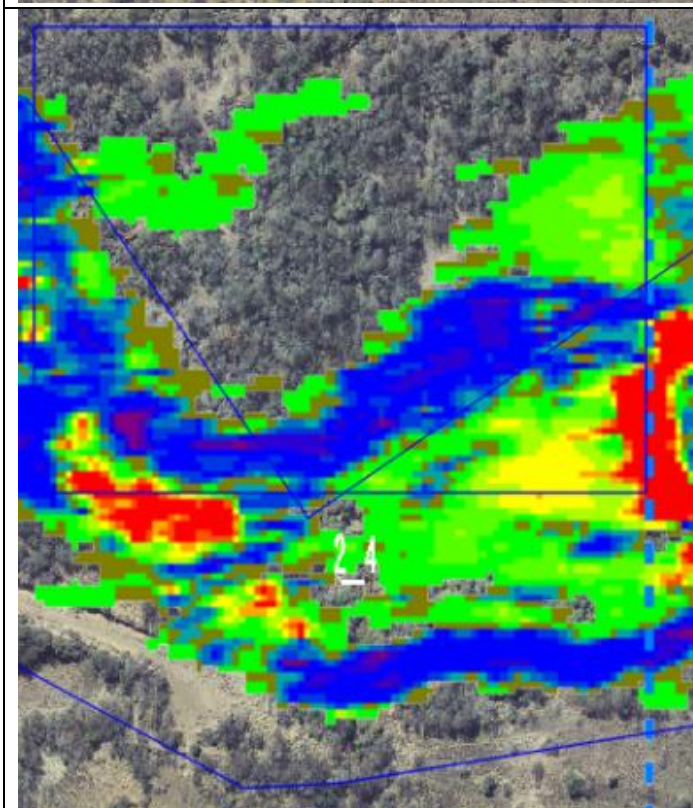
Zone 2_4

This area crosses the servitude but due the wide flood plain flow, protection is not viable

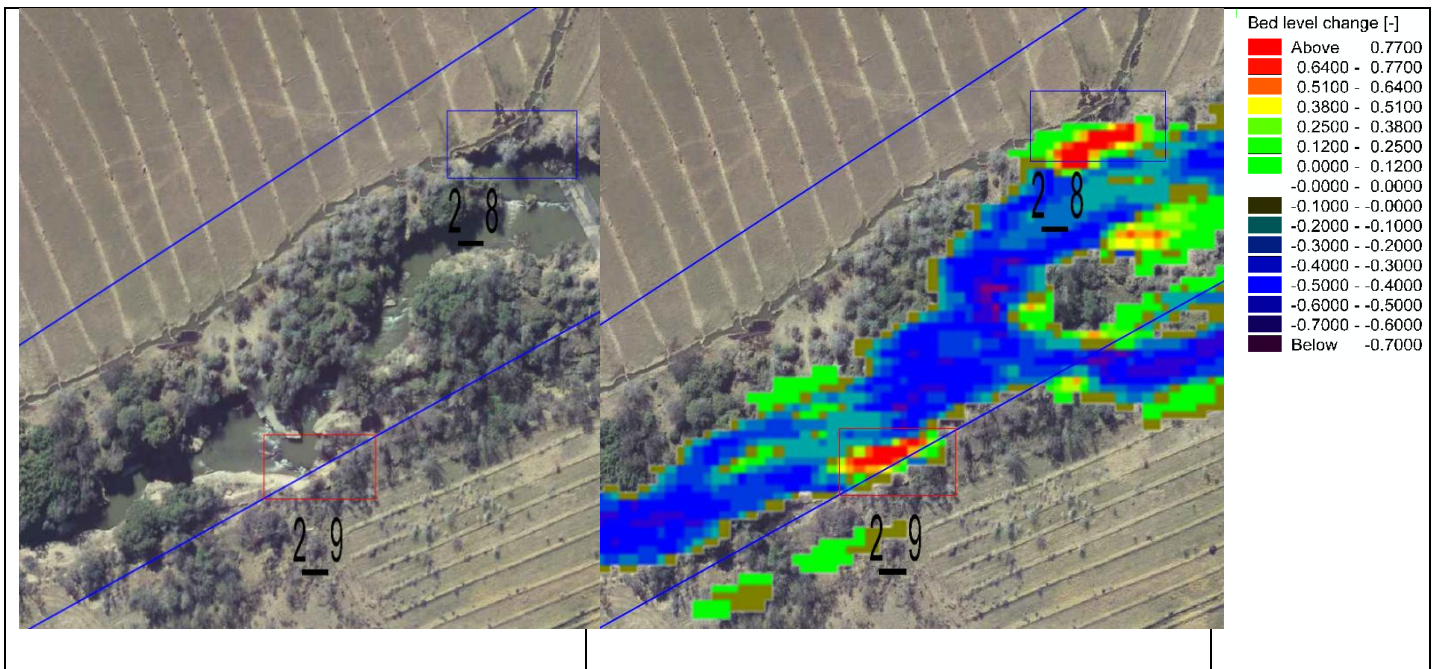
Zone 2_8 and 2_9

The banks are encroaching the servitude and farmland

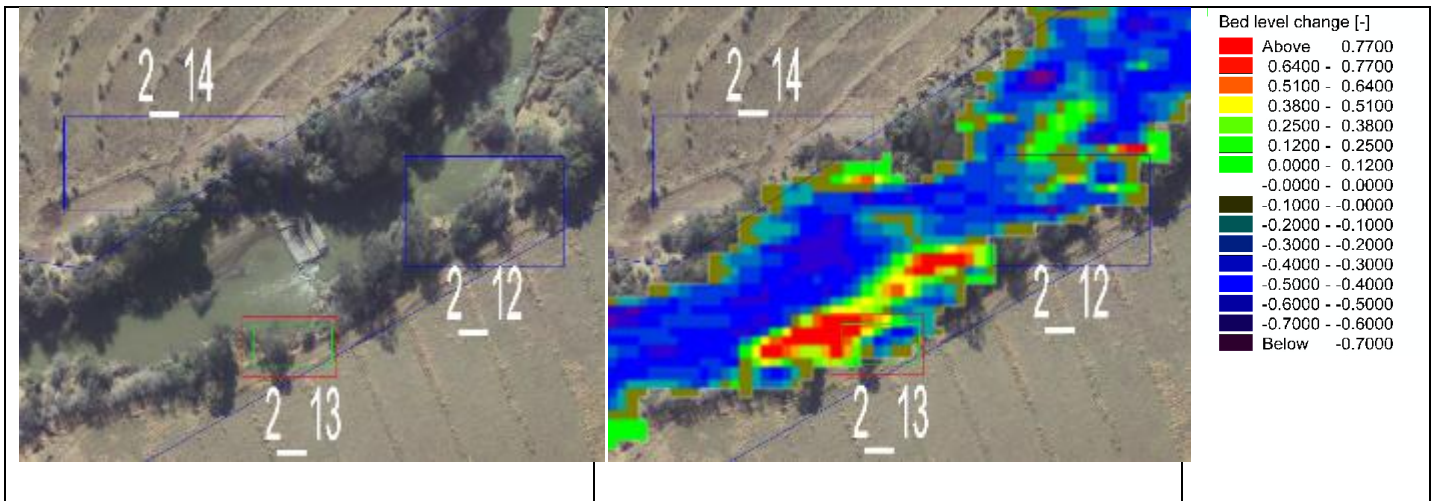
Zone 2_13

The unstable banks are encroaching the servitude and farmland.

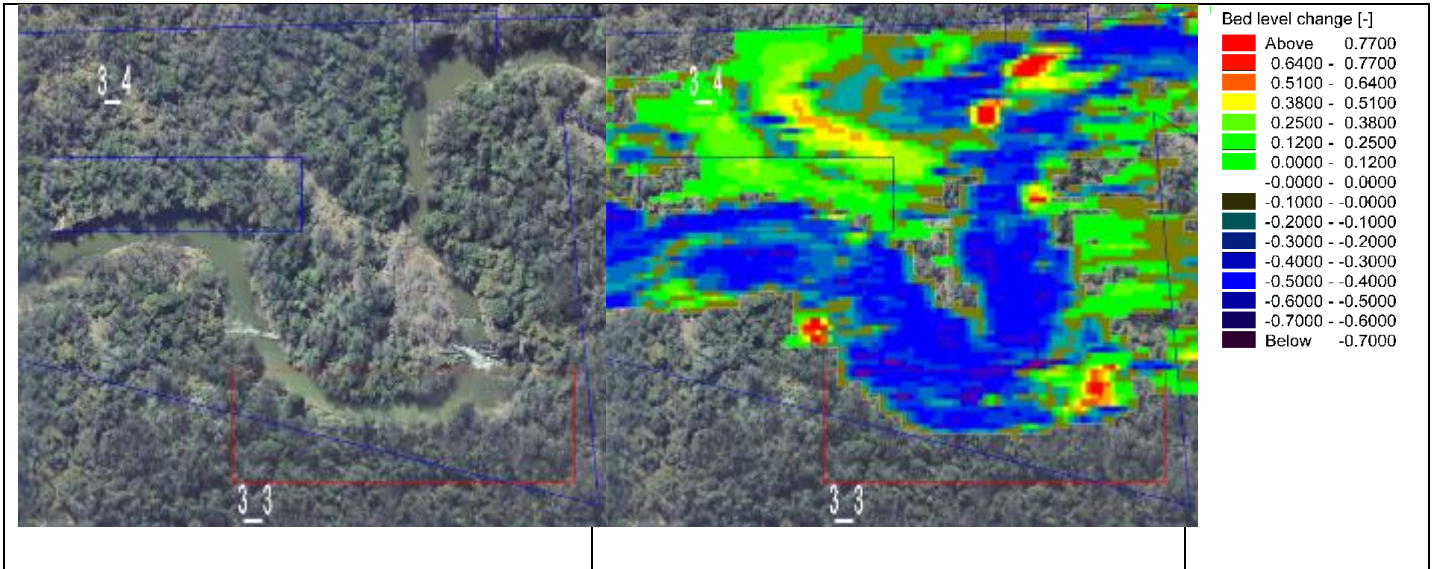
Zone 3_4

Flow in this area is in a wide floodplain and protection is not necessary.

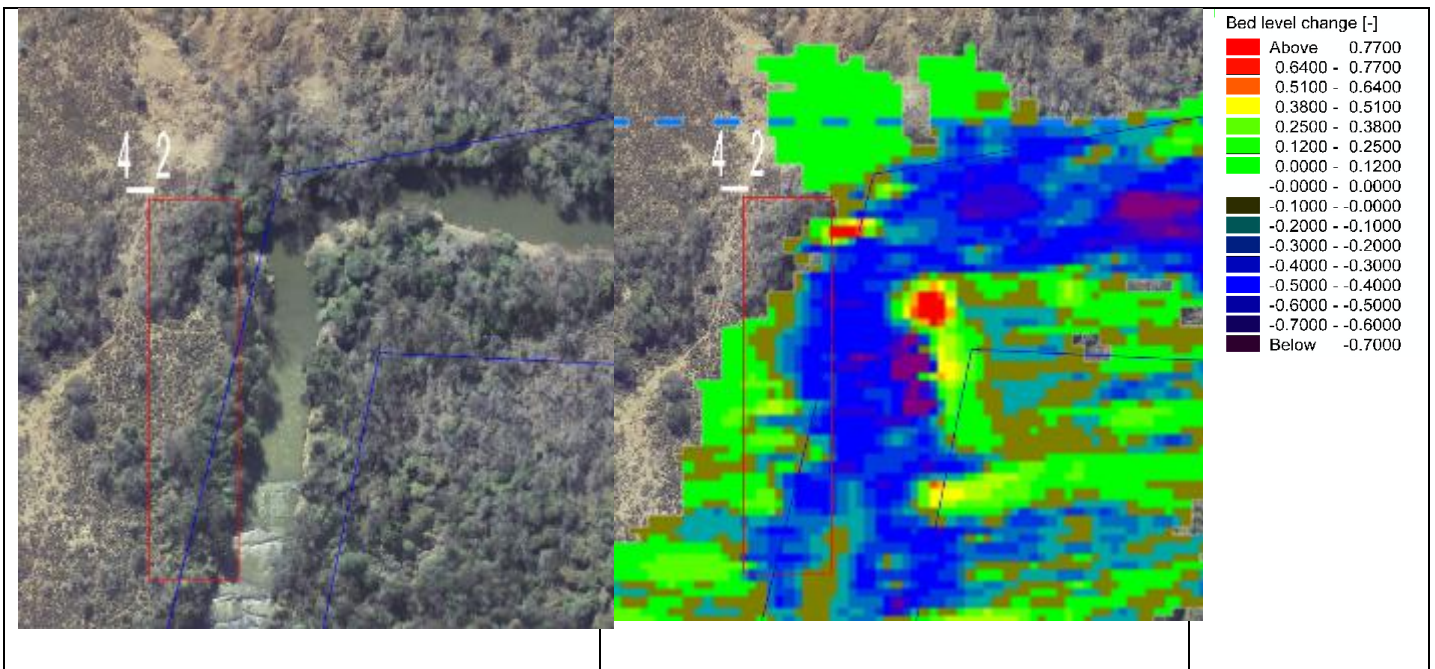
Zone 4_2

The zone has unstable banks crossing the servitude and encroaching the road.

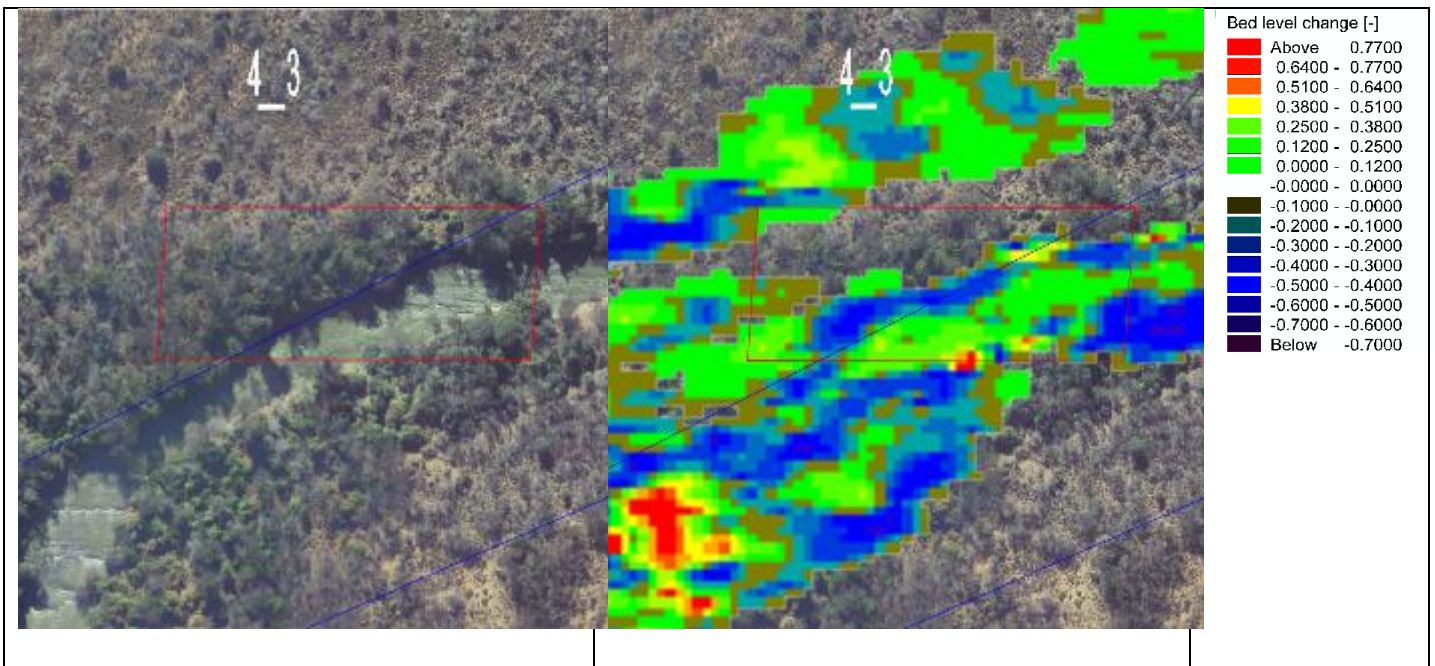
Zone 4_3

The zone has unstable banks crossing the servitude.

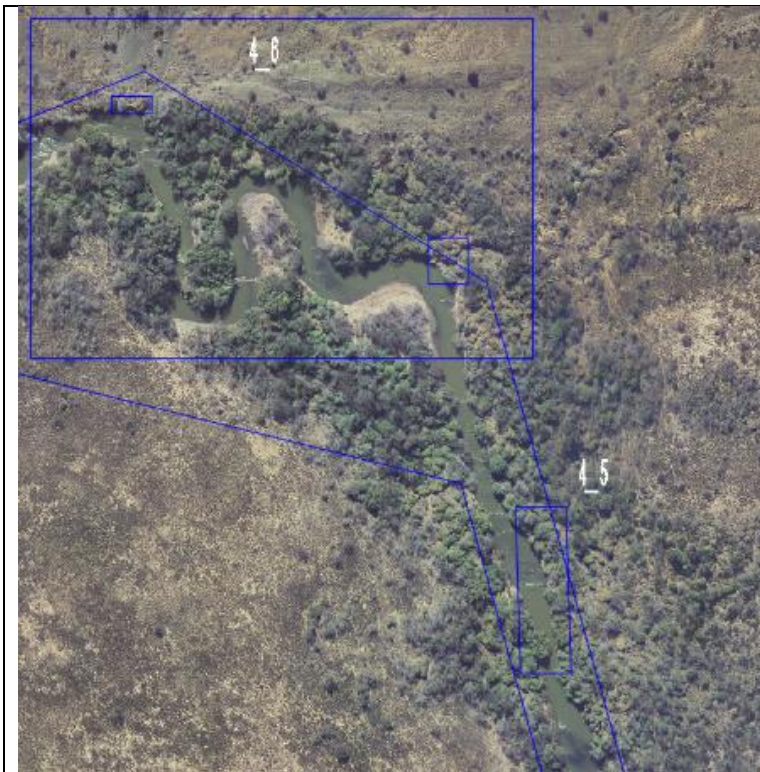
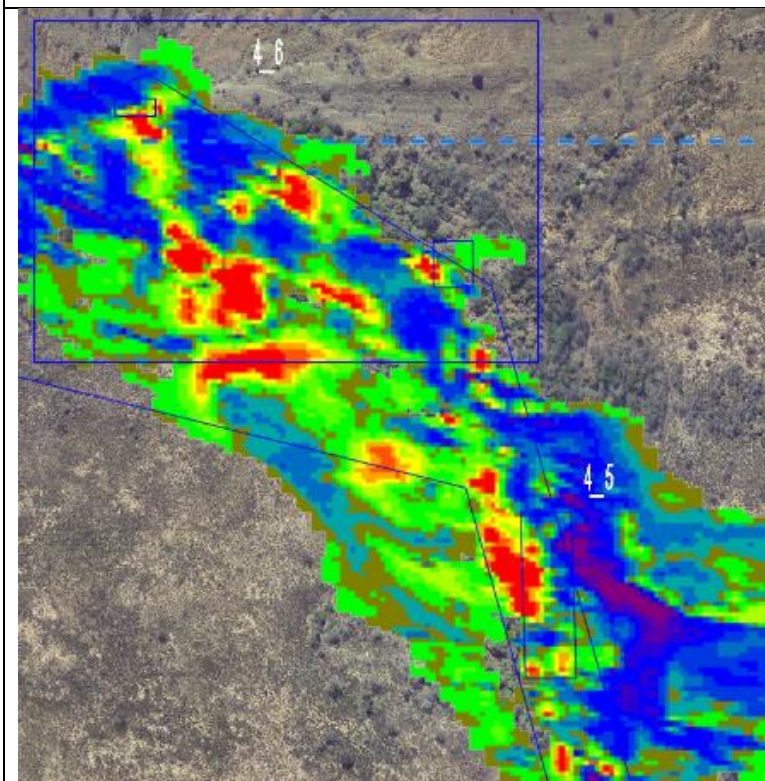
Zone 4_5 and 4_6

Flow in this area is on a wide floodplain and erosion induced by a tributary thus protection is deemed not necessary.

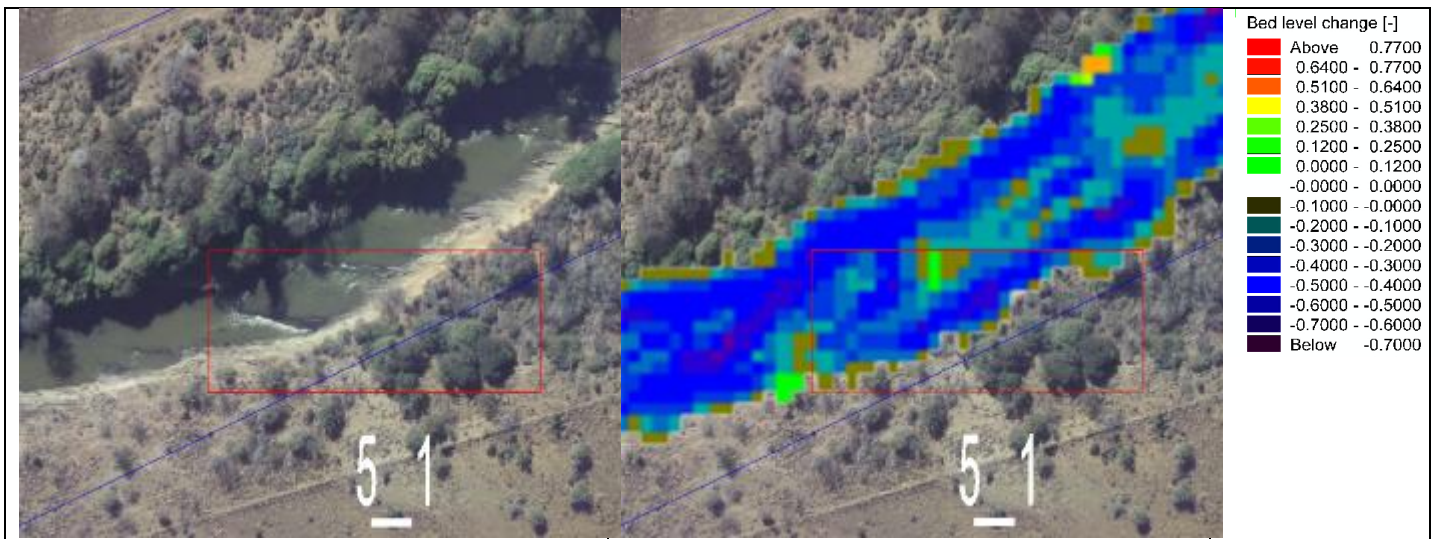
Zone 5_1

The zone has banks encroaching the servitude.

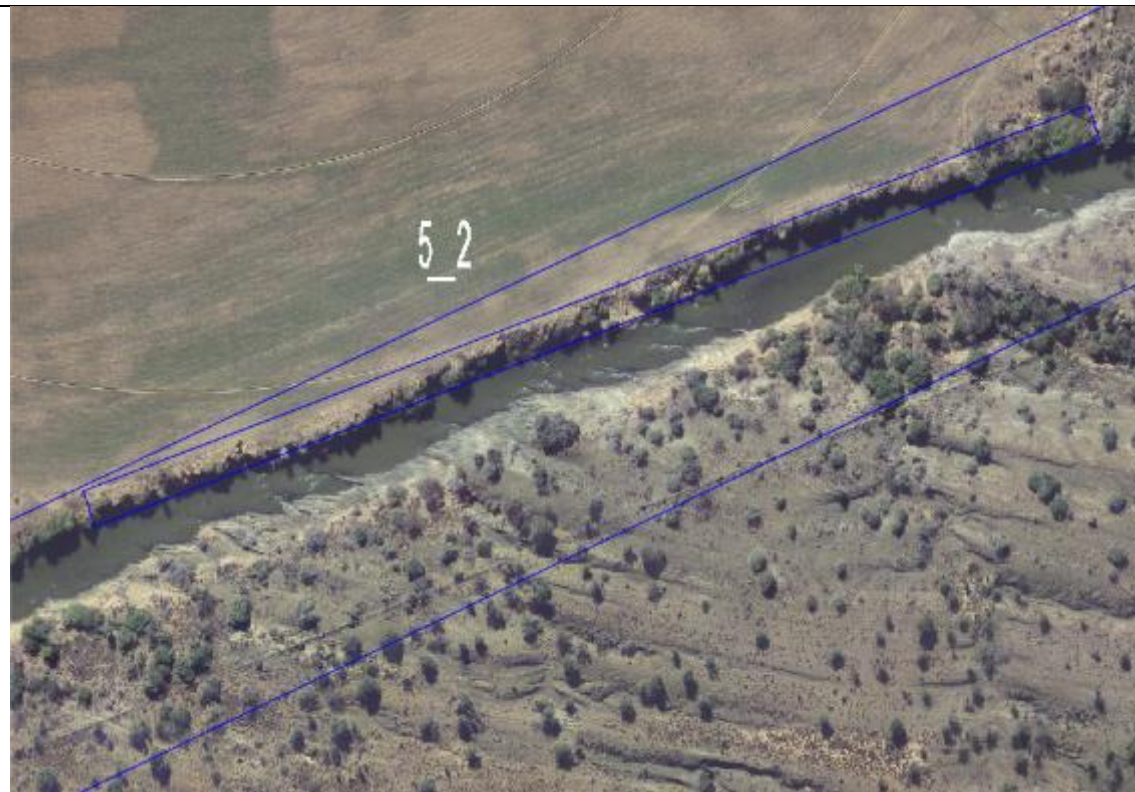
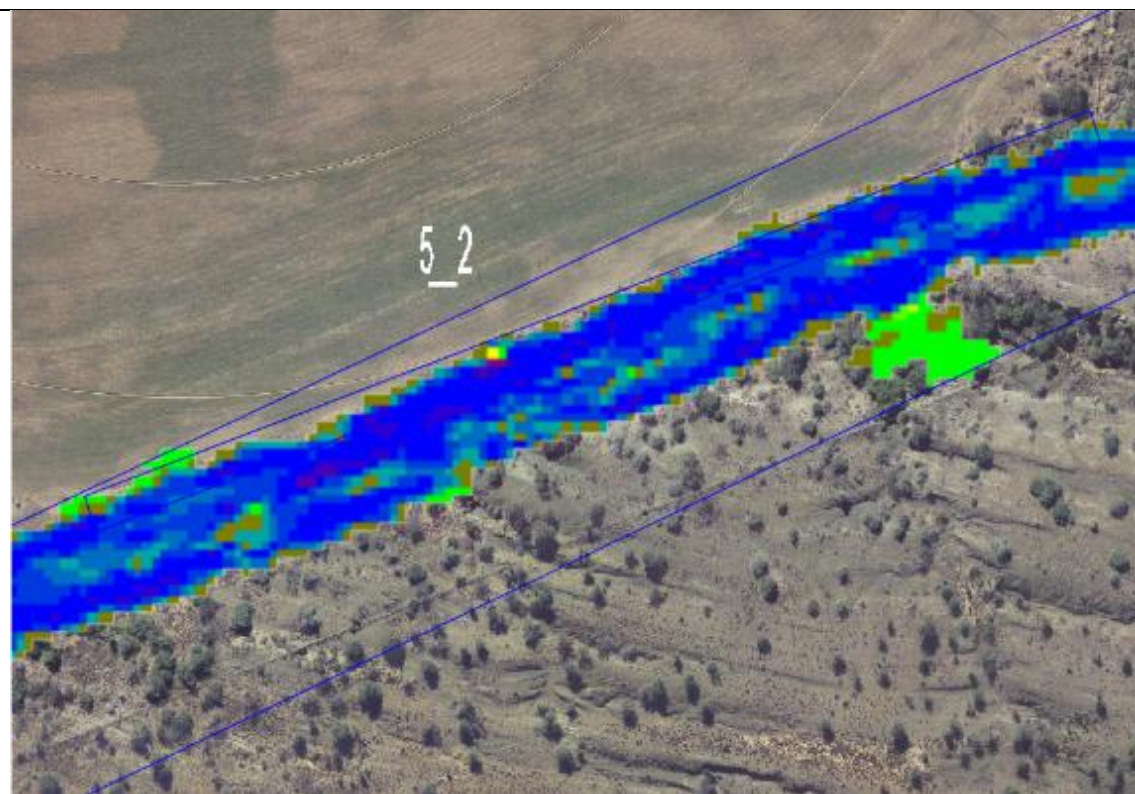
Zone 5_2

The zone has unstable banks encroaching servitude and farmland. Protection in this zone does not seem necessary.

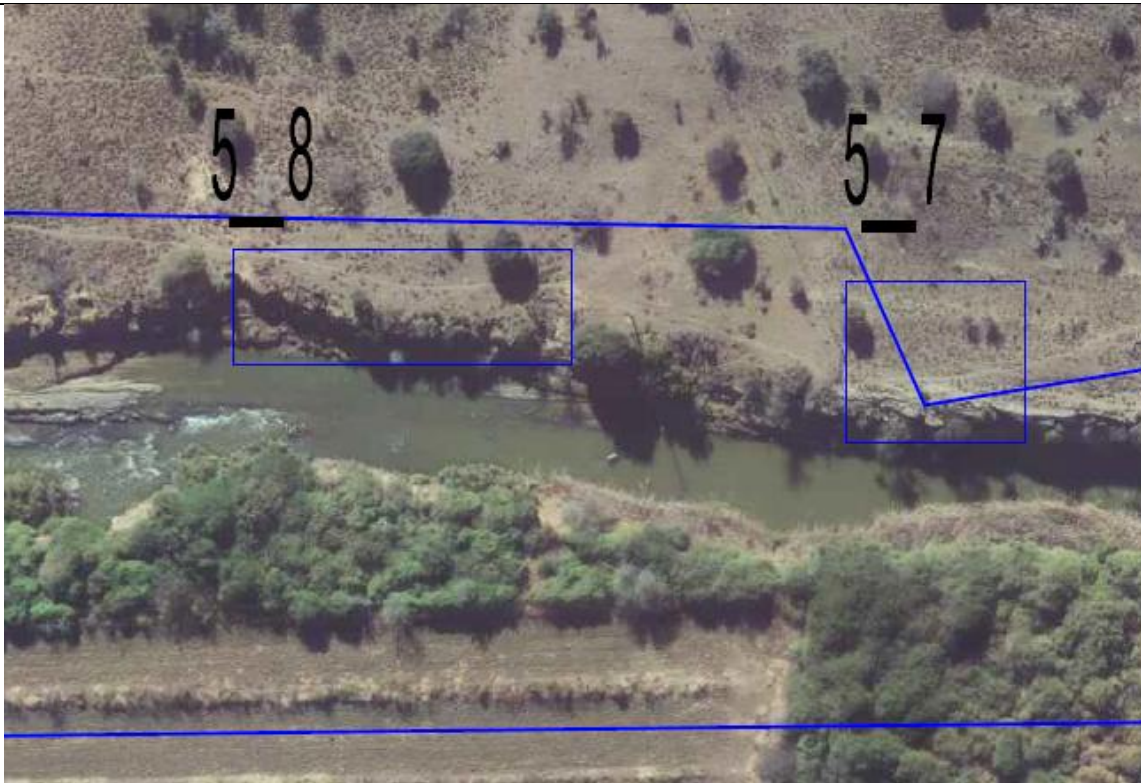
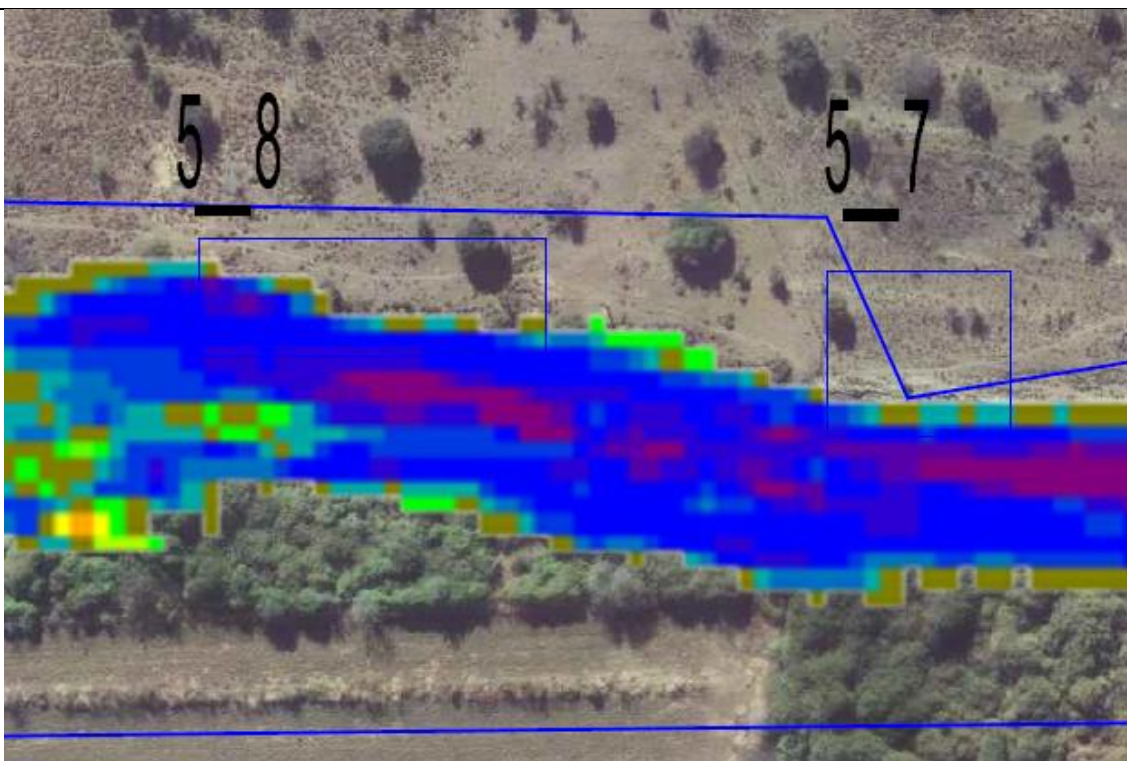
Zone 5_7and 5_8

Unstable banks within the servitude. The servitude seems to be incorrect and protection is deemed not necessary.

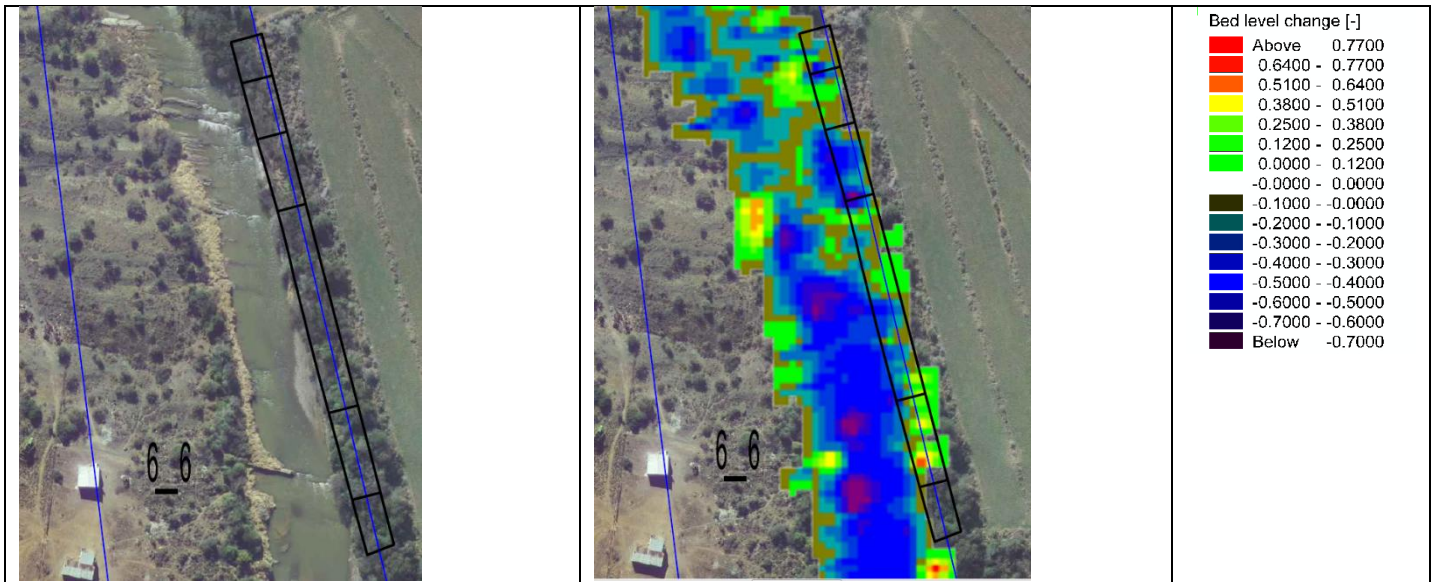
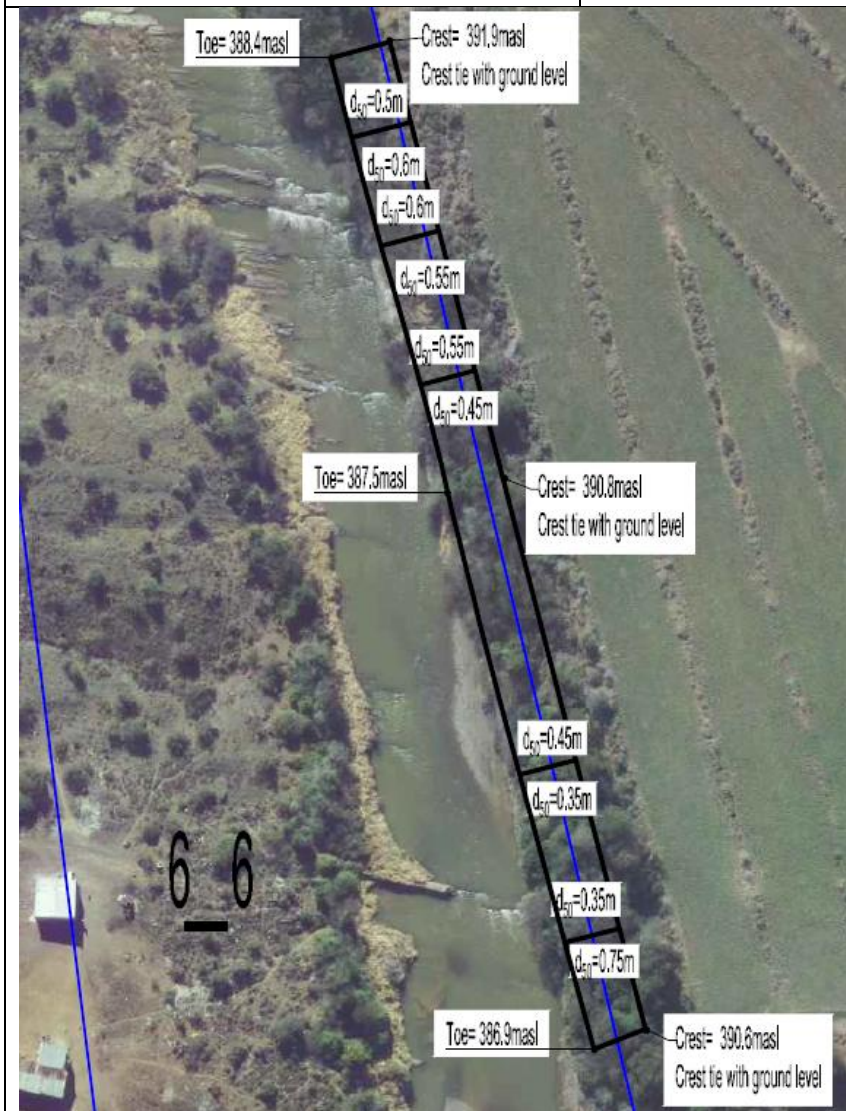
Zone 6_6

The zone has banks crossing the servitude and encroaching farmland

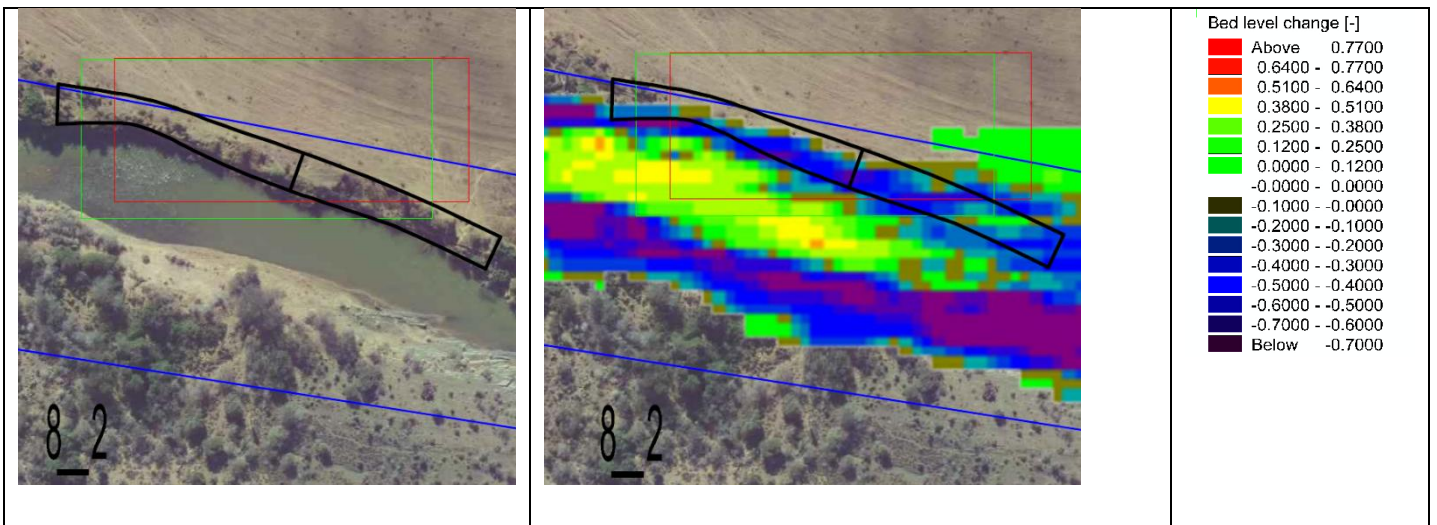
Zone 8_2

The zone has unstable banks crossing the servitude and encroaching onto farm land

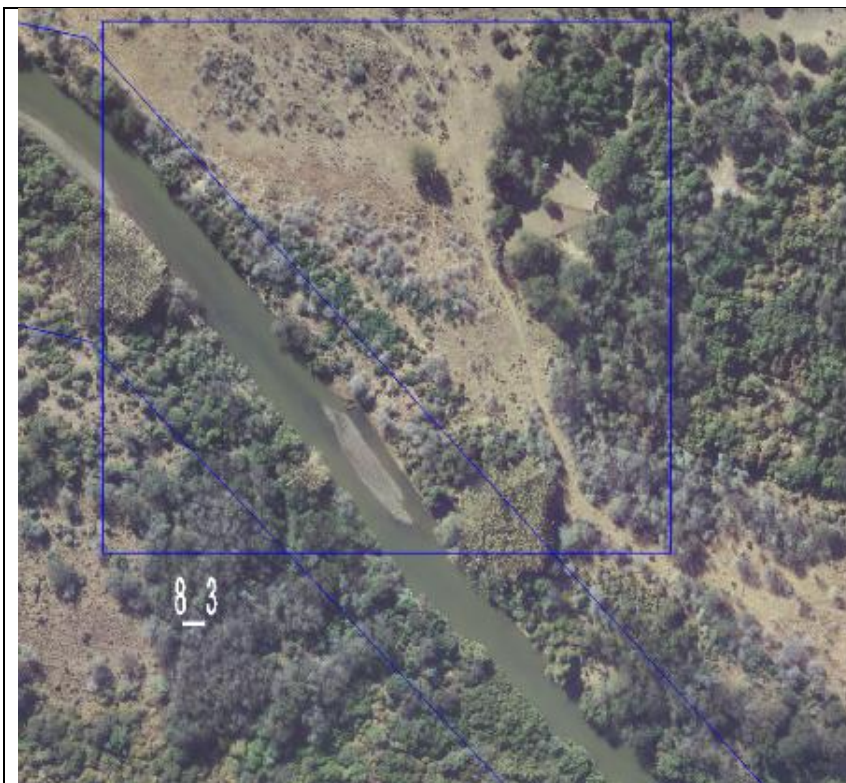
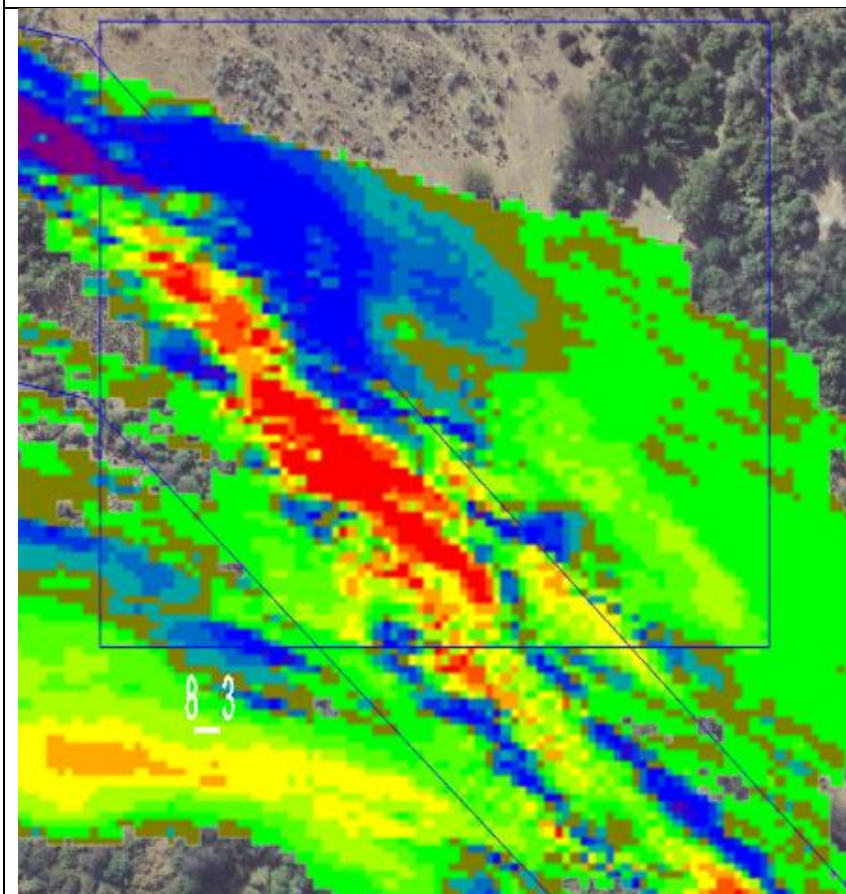
Zone 8_3

Flow in this region is on a wide floodplain and protection will constrict the flow further, thus not necessary.

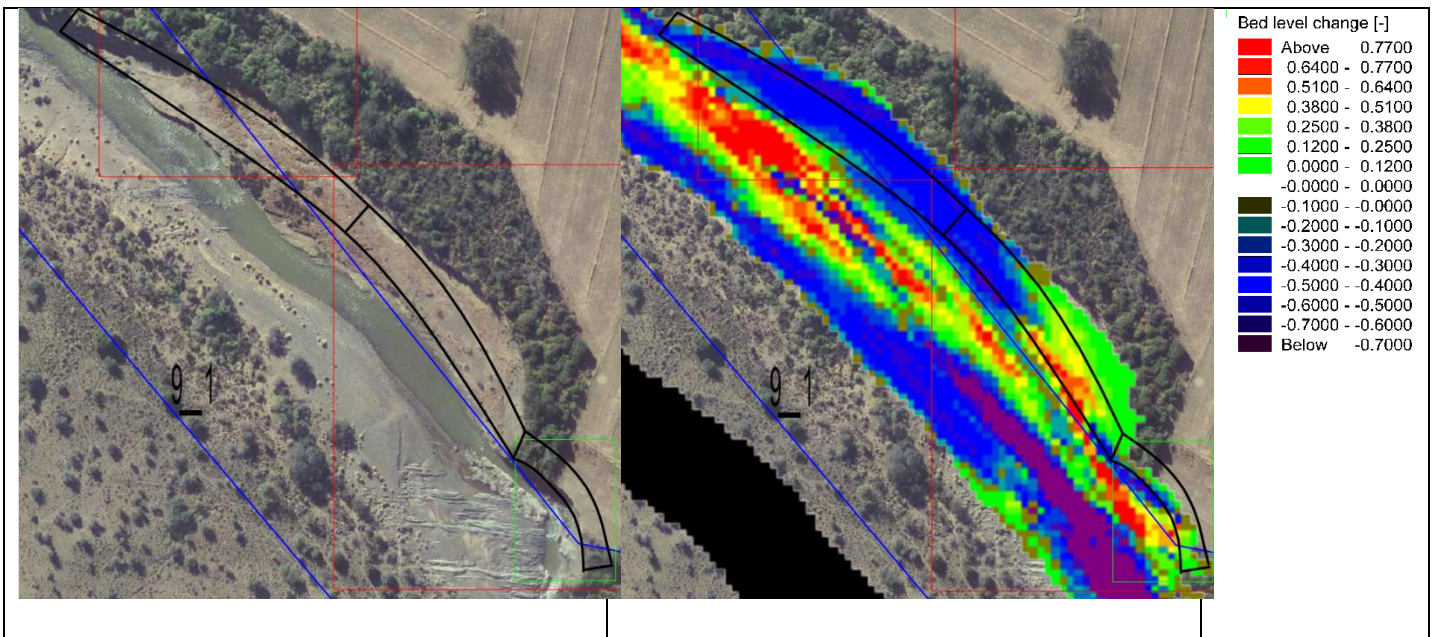
Zone 9_1

The zone has unstable banks crossing the servitude and encroaching onto farm land.

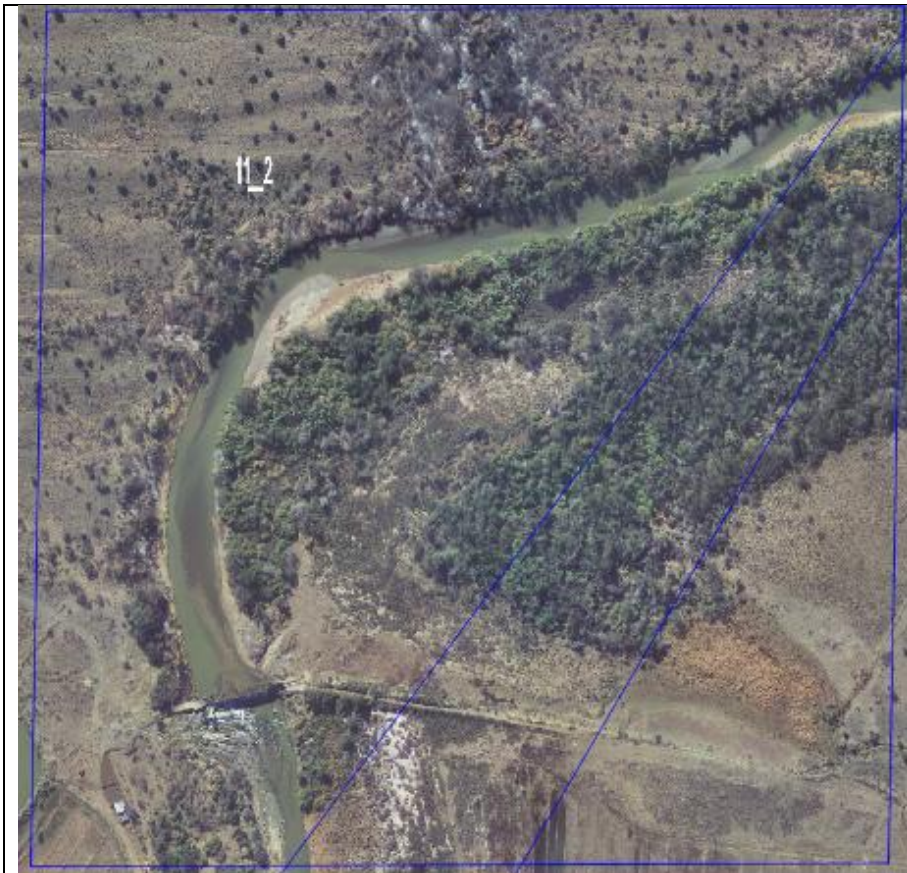
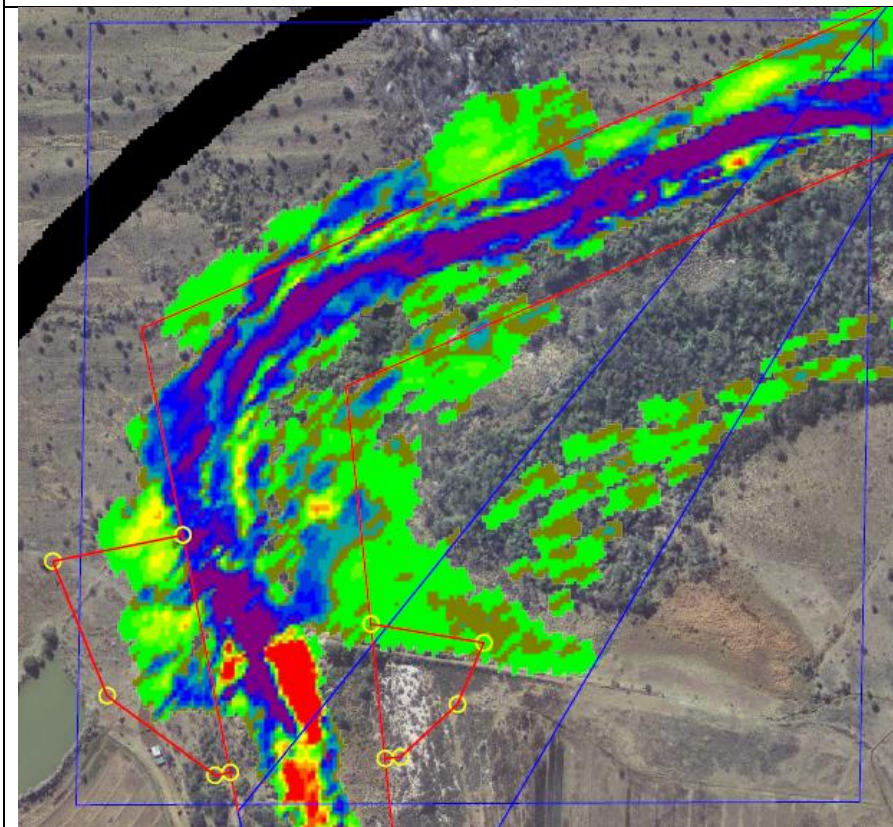
Zone 11_2

The area river servitude is inaccurate
