APMH HERITAGE SITE AND CONSERVATION MANAGEMENT PLAN

ROBBEN ISLAND HOUSE NUMBER 85

COURSE CODE: MHS724

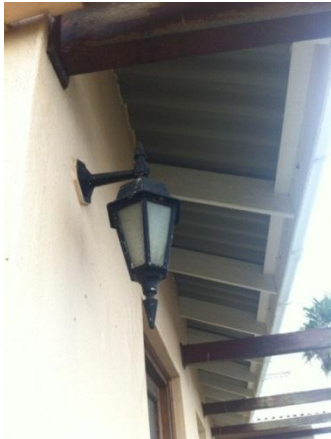
lighting

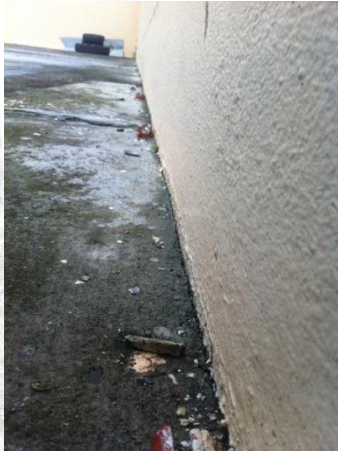
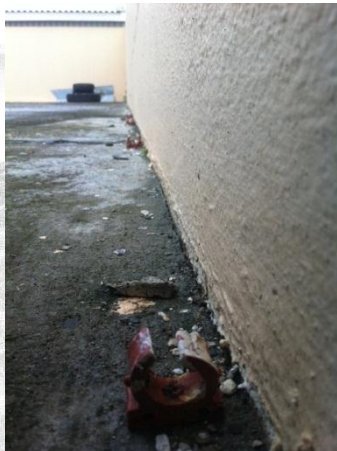
Signs of piping that ran along the wall
