Client: **Ngodwana Mill - SAPPI Paper and Paper Packaging
SAPPI Southern Africa Ltd**

Project Description: **2019 ANNUAL DAM SAFETY INSPECTION**

Date: **30 September 2019**

NGODWANA DAM ANNUAL DAM SAFETY REPORT 30 September 2019

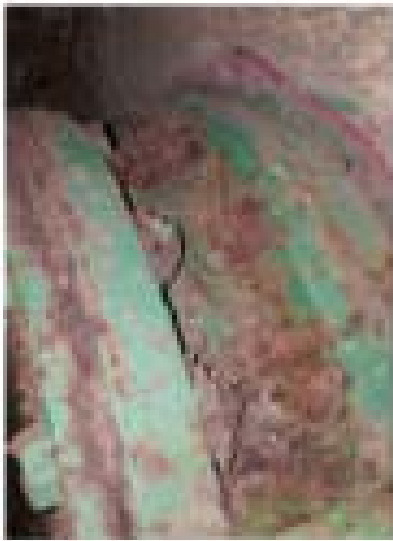
10

Bolts and nuts are badly corroded on drain valves at the bottom of the tower [*Photo – B1/A2//B2/A10/B10*].

- Corrosion protection system on drain valves to be re-applied
- Scour valve drainage area be improved to ensure water does not flow back into the tunnel.

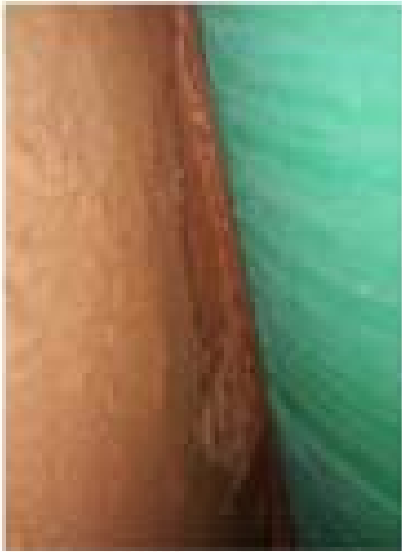
13

Most of the piping corrosion protection system is in a good condition requiring spot repairs in some areas [Photo-A1/B3], with the exception of a section of the 1000mm pipe where exposed to water [Photo-A13/B13/C12].

Water is damming up below the 1000mm pipe, this is leading to severe corrosion of the pipe supports and bottom of the pipe in this area.

- Repair and replace steel pipe supports
- Corrosion protection system on all pipe supports to be re-applied
- Improve drainage on area where water is damming up below the 1000mm pipe to ensure the pipe is not submerged in water.
- Annual schedule be put in place to ensure no water damming which exposes pipe and pipe supports to corrosion.
- Included piping below the dam when thickness tests are done.

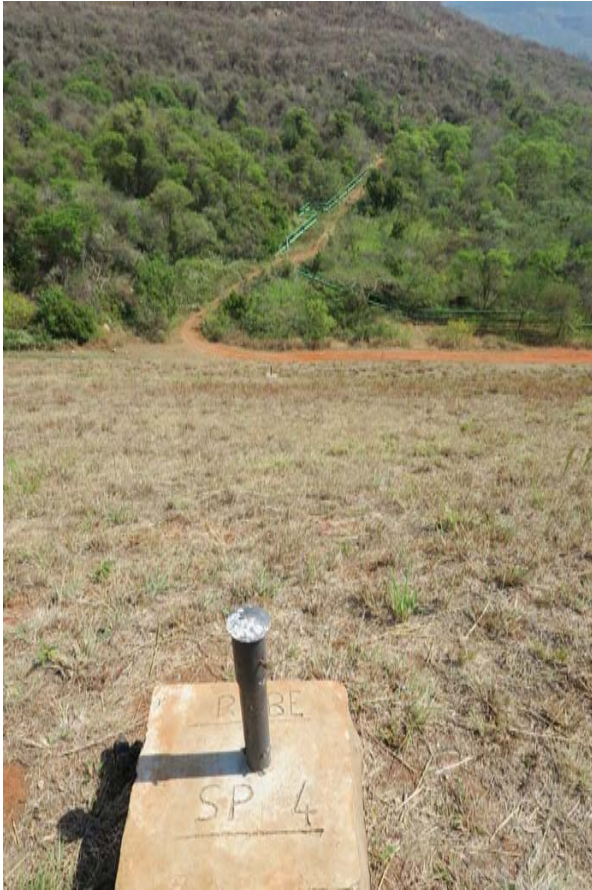
PLATE 3:- Standpipe piezometers SP4-7 along “riverbed” section

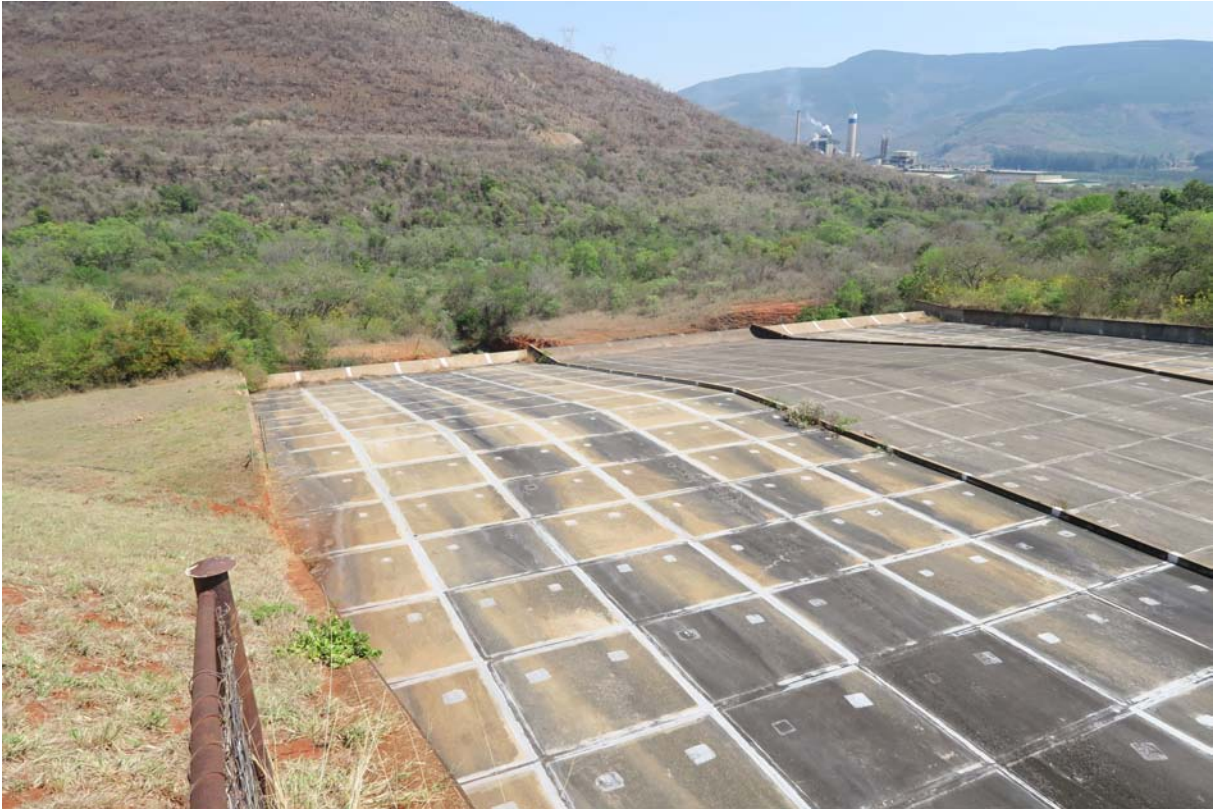
OGEE Condition	Good – some grass growing in Ogee construction joints. See Appendix F - Photographic Record - Plates 8 & 9.
Return Channel Condition	Good - joint sealants between cill slabs of spillway discharge chute were repaired. See Appendix F – Photographic Record, Plates 6-8.
Flank Walls Condition	Retaining wall on left flank displayed movements as evidenced by opening joints – probable cause is foundation settlement, but no cause for stability concern. See Appendix D – Structural Report.
Emergency Spillway Condition	Good

PLATE 7:- Spillway return channel
