Client: **SAPPI Southern Africa Ltd - Ngodwana Mill**
Ref #: **Order # PO 2105-052852**
Project Description: **NGODWANA DAM – SAFETY INSPECTION**
Date: **9 September 2016**

**NGODWANA DAM
COMPULSORY 7-YEARLY DAM SAFETY REPORT
9 September 2016**

Title: **SAPPI Southern Africa Ltd - Ngodwana Mill**
Order # PO PO 2105-052852
Ngodwana Dam:- Compulsory 7-Yearly Dam Safety
Report – 9 September 2016

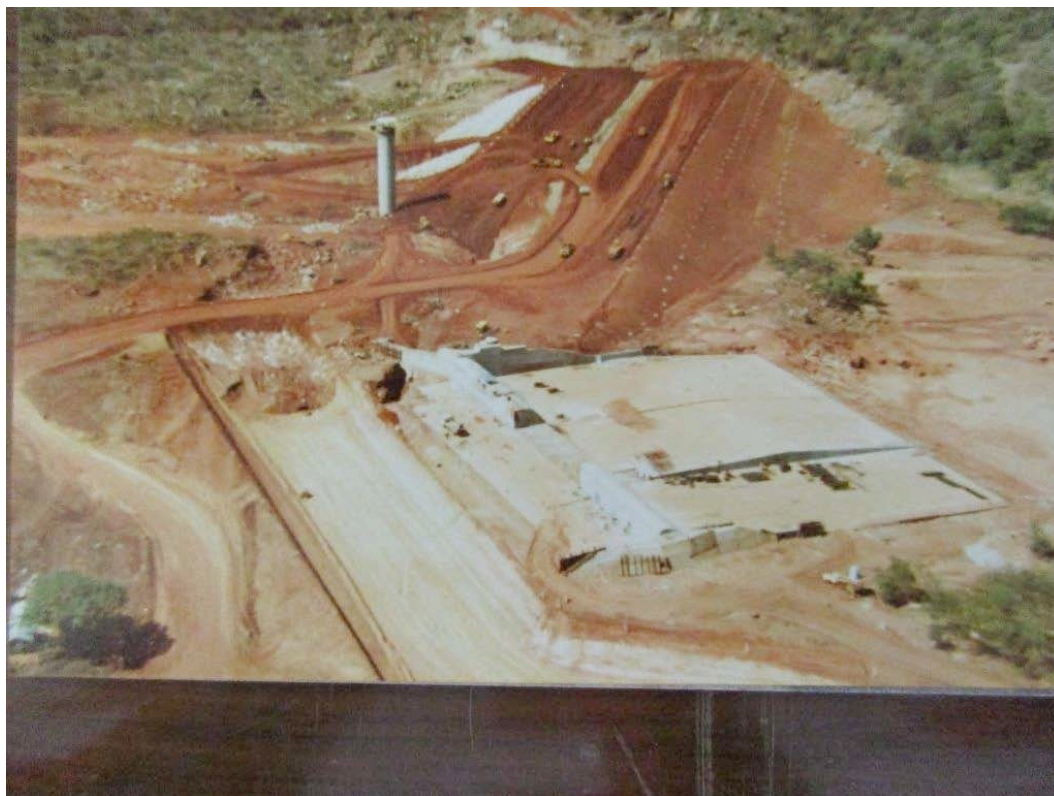
Plate 1:- View from right bank across service spillway in foreground. Note filter drain (light-coloured strip of material) along centre of embankment.
