Specialist basic assessment report: Tshatane/Lesego project

Dr Wynand Vlok (BioAssets)

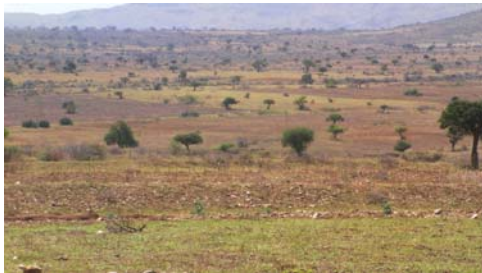
Figure 9: View towards sub Alternative 2 – many impacts visible, some *Boscia albitrunca* present.

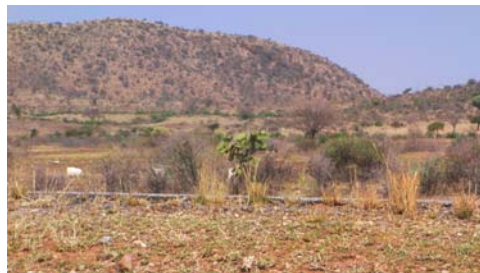
Figure 10: Site 2 – impacts are grazing, wood collection and cultivation resulting in high erosion potential on slopes.

From an ecological perspective, Alternative 1 is the preferred site for the new proposed Tshatane substation. The reason is its close proximity to the existing road. The route to Alternative 2 crosses steep slopes and the stream in the valley bottom, resulting in more opportunities for erosion in future. In both cases some *Boscia albitrunca* is present and once the final position for the substation is determined, all protected trees must be mapped (GPS) and permits for cutting or trimming obtained before clearing and construction can commence.

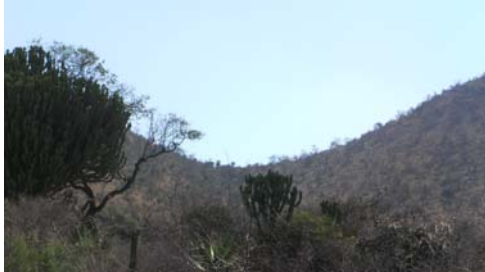
Figure 13: View to the east of hills, facing towards the new Tshatane sub.

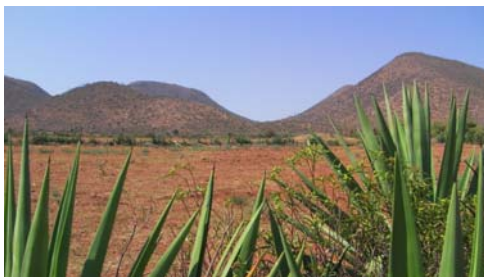
Figure 20: View across the cultivated lands towards the hills.

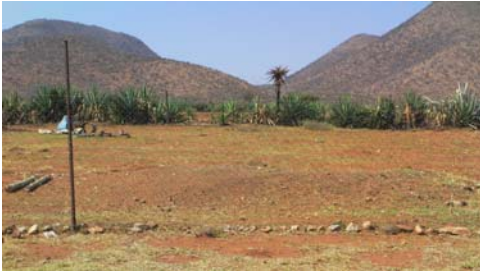
Figure 23: Grazing and cultivation on slopes aggravates erosion problems.

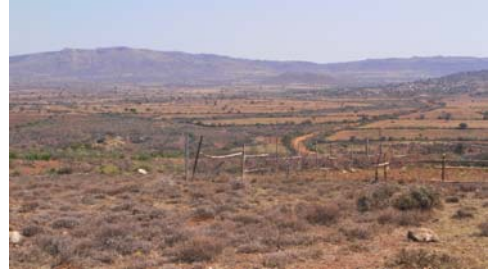
Figure 24: Natural vegetation severely modified due to land use practices.

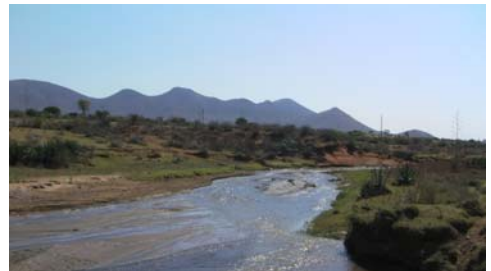
Figure 26: View of proposed crossing point of the new power line over the Lepellane River.

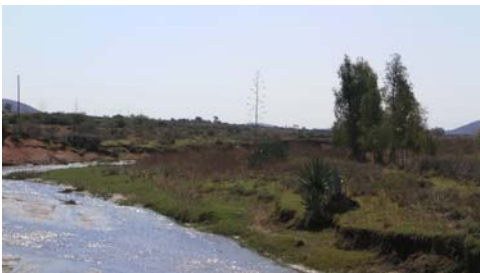
Figure 27: Riparian vegetation totally modified and erosion visible on the river banks.

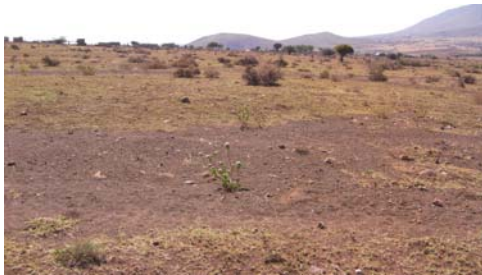
Figure 31: Over grazing evident in the area.

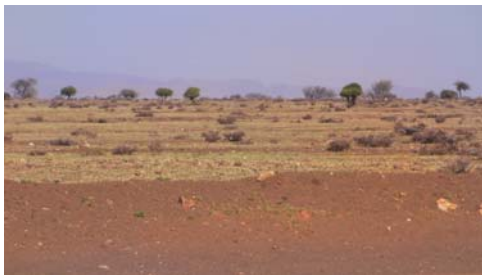
Figure 33: Natural vegetation modified in the area.

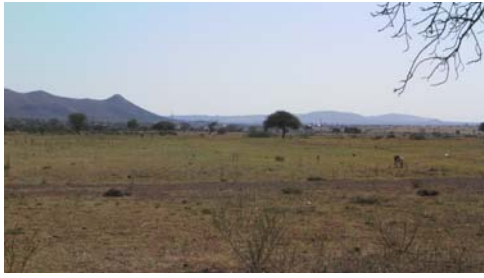
Figure 35: Grazing and cultivation modified the natural vegetation.

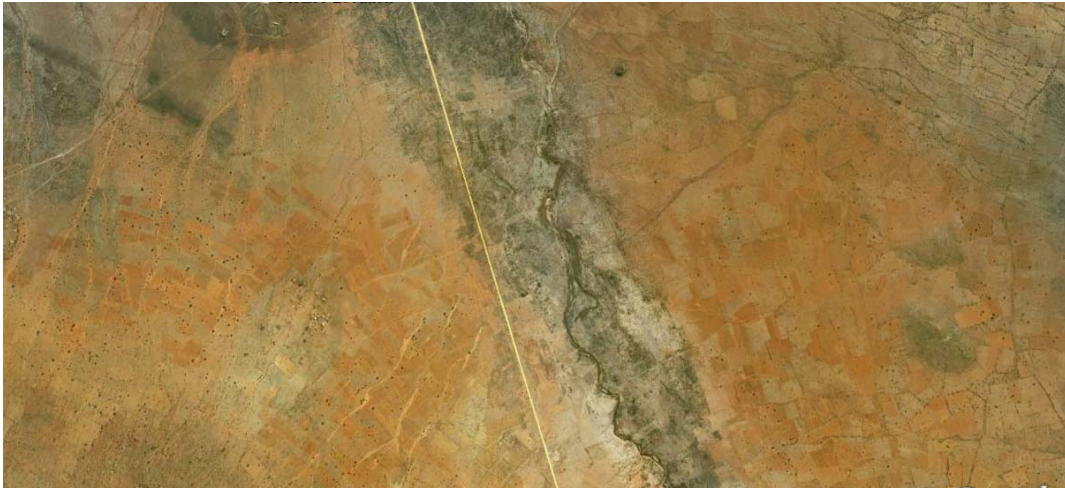
Figure 44: Aerial view of route – note high impacts from grazing and cultivation.

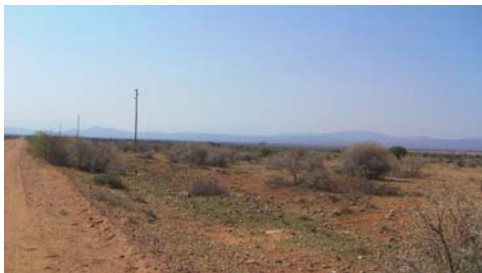
Figure 47: Modified natural vegetation along the D4200.

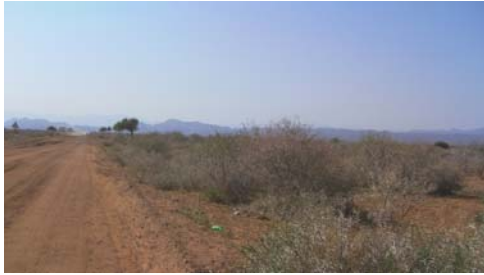
Figure 50: Few large trees present – natural vegetation dominated by low shrubs, mostly *Acacia spp.*

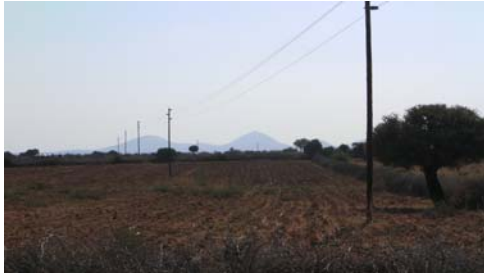
Figure 56: Cultivation present over a large area.

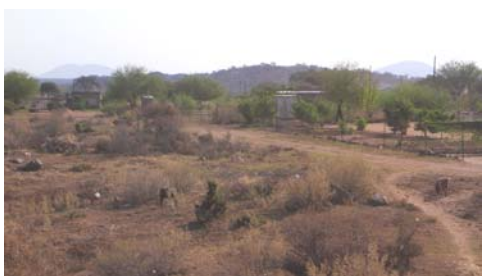
Figure 58: View of corridor to the west of the village near D4250.

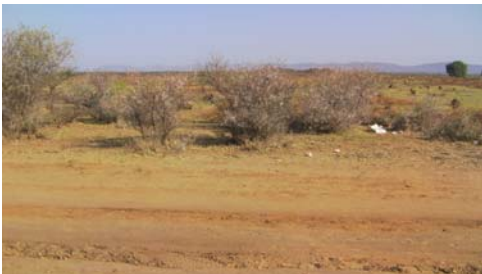
Figure 63: Low *Acacia* shrubs (acting as pioneer species) dominate the landscape in areas.

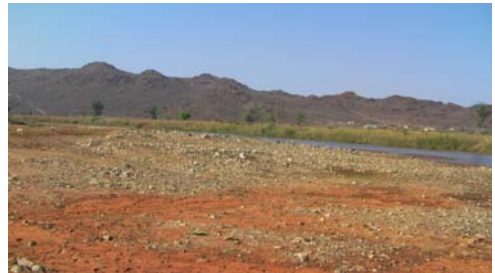
Figure 64: Possible crossing point over the Olifants River.

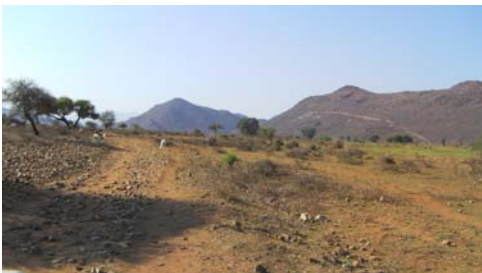
Figure 65: Corridor to the east of Mabokotswane.

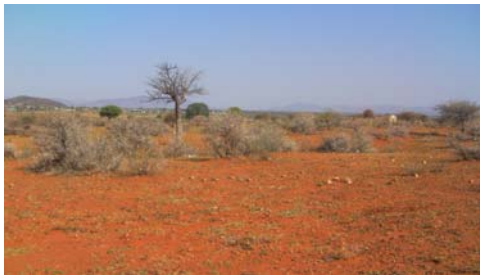
Figure 70: Modified natural vegetation – some coppiced *Sclerocarya birrea* present.

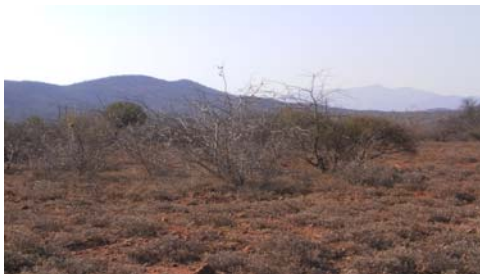
Figure 72: Encroachment of *Acacia mellifera* present.

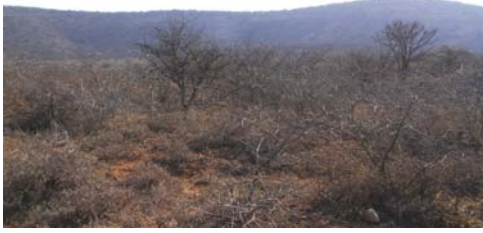
Figure 73: View of the proposed Lesego substation sites.

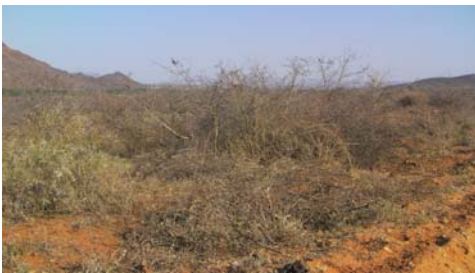
Figure 75: Modified natural vegetation on Lesego substation sites present.

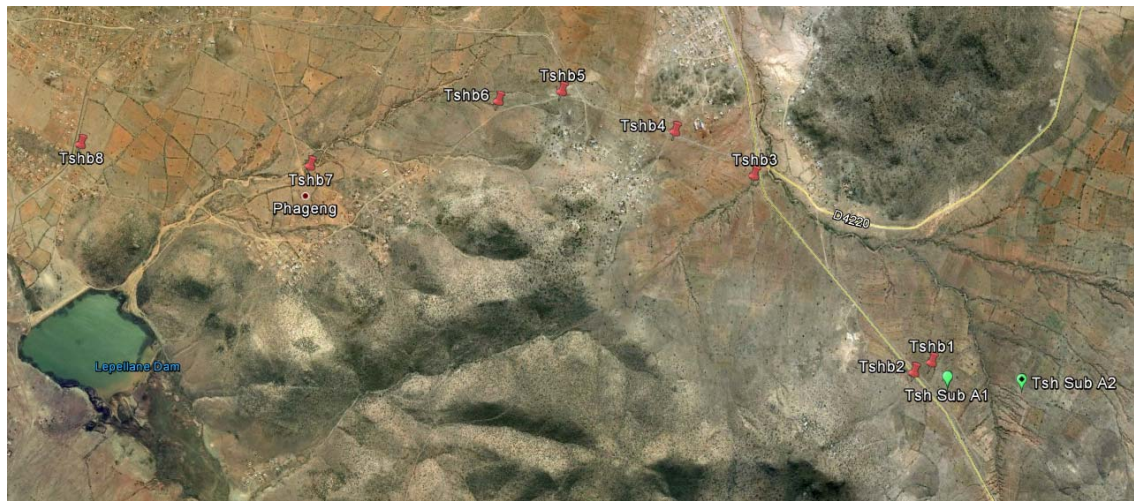
Figure 79: Aerial image of sector – note land use and modified natural vegetation.

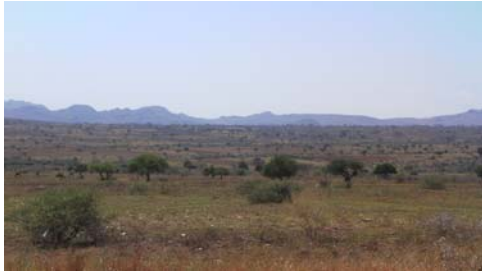
Figure 80: View of substation and exit of power line.

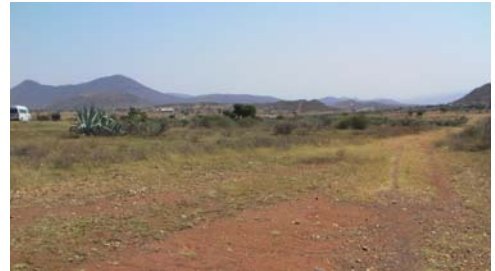
Figure 81: View of corridor along the road towards the junction with the D4220.

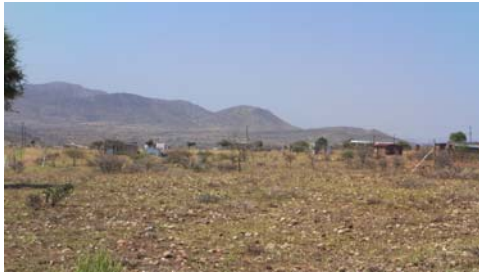
Figure 85: Natural vegetation modified – some *Boscia albitrunca* present.

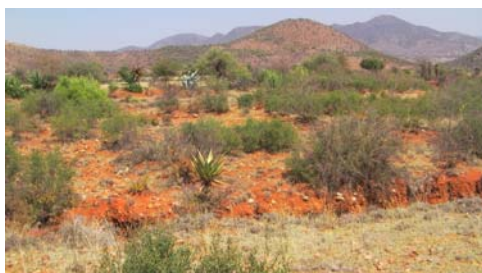
Figure 88: Erosion potential high in the area.

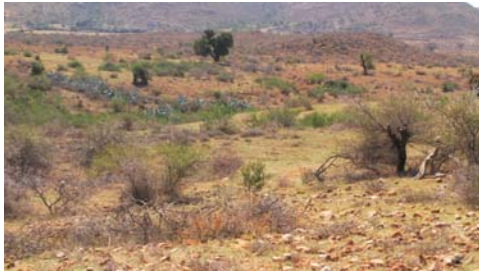
Figure 89: Exposed slopes around streams with high erosion potential.

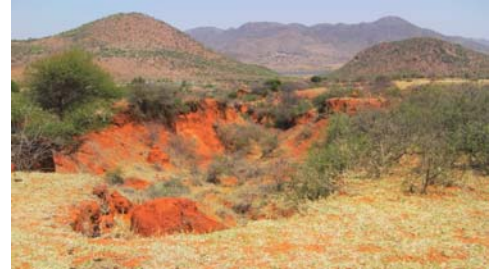
Figure 90: Example of erosion along the corridor.

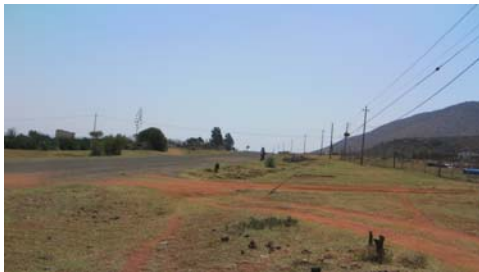
Figure 91: Possible corridor along the existing road.

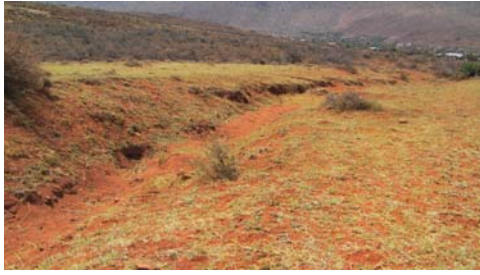
Figure 98: Small streams susceptible to erosion.

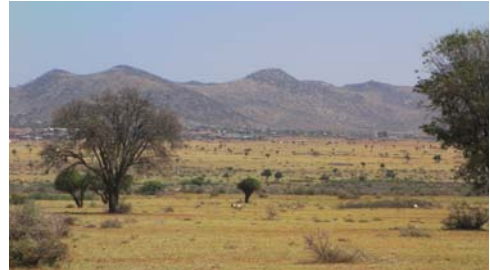
Figure 99: Crossing of the Lepellane River a sensitive area – no vehicles to drive through it.

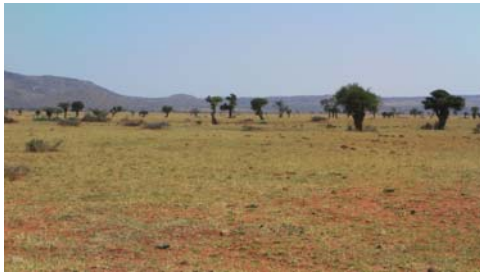
Figure 100: Protected trees in the area include *Boscia albitrunca* and *Sclerocarya birrea*.
