County of Pembroke

Shipwreck Report

Vanessa Maitland

**Port of Ngqura
Eastern Cape
South Africa**

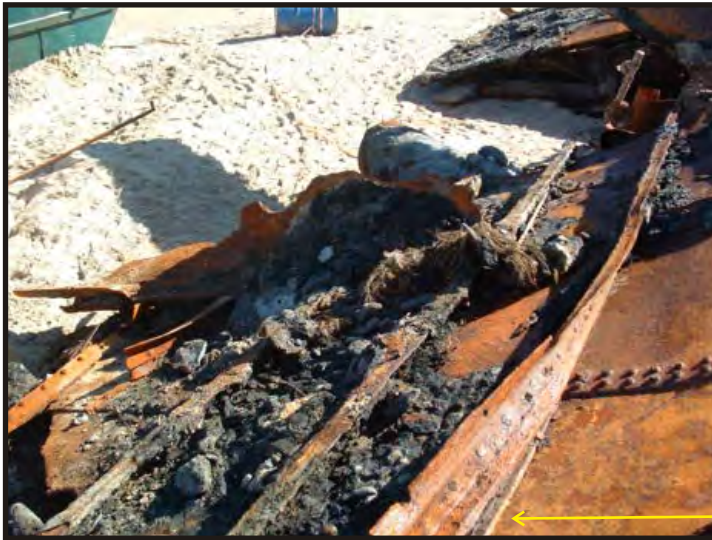
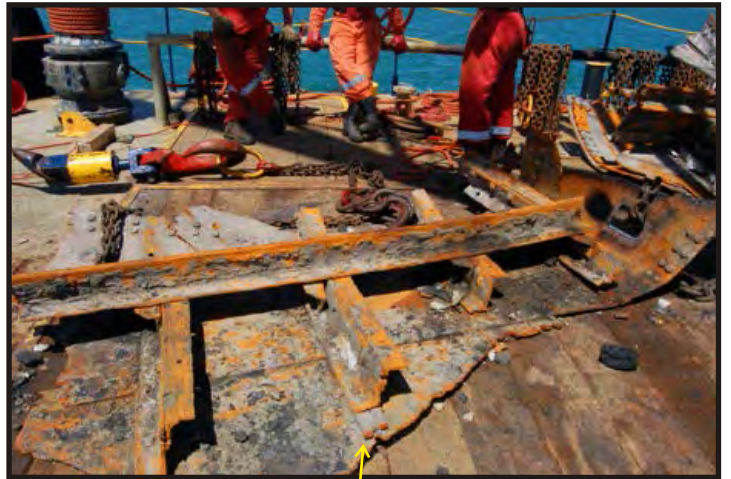
Figure 113 - 114: Frames on the side plating. A liner had to be fitted under the frames to ensure a proper connection between the out stakes and frames. (Photo V. Maitland)

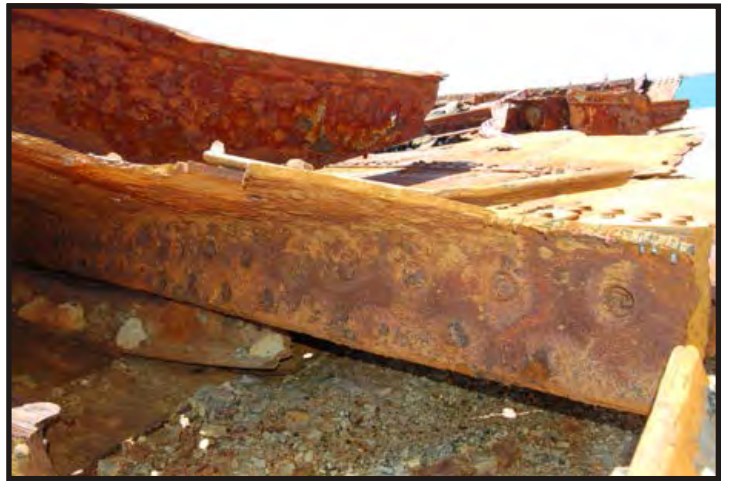
Figure 123: Zig-zag riveting on the keel. (Photo V. Maitland)

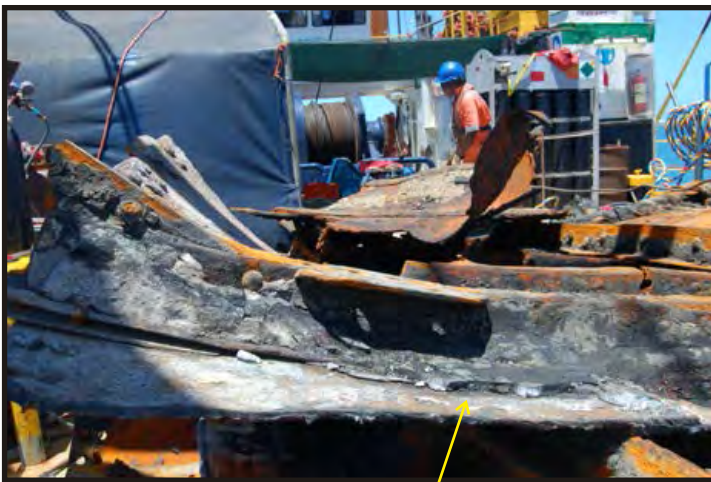
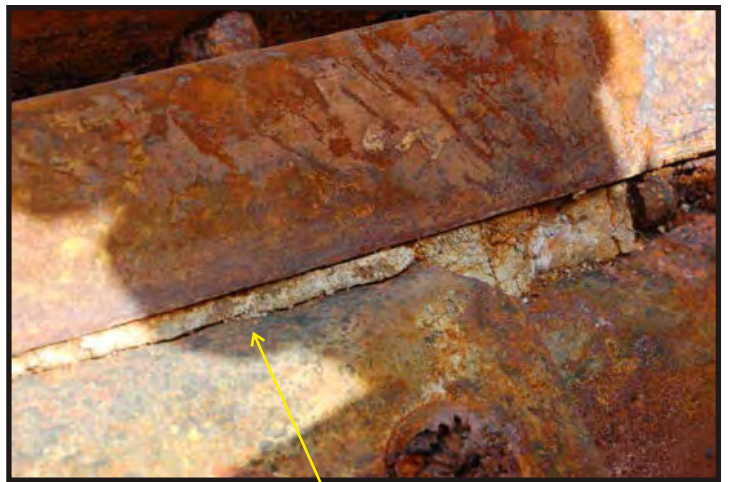
Figure 124 - 125: The Lloyds' Survey of 1881 states that the inside surfaces of the barque were protected from oxidation by cement and paint. Joints in the keel were usually caulked, this operation had to be carefully done. If the caulking was pushed too far into the joint it could cause it to separate, and if not pushed in enough, would not provide a watertight seal. (Pursey 1942:16) The cement caulking can be seen covering the web frame in Figure 124 and in the join of the bar keel to the garboard strake in Figure 125. (Photos V. Maitland)

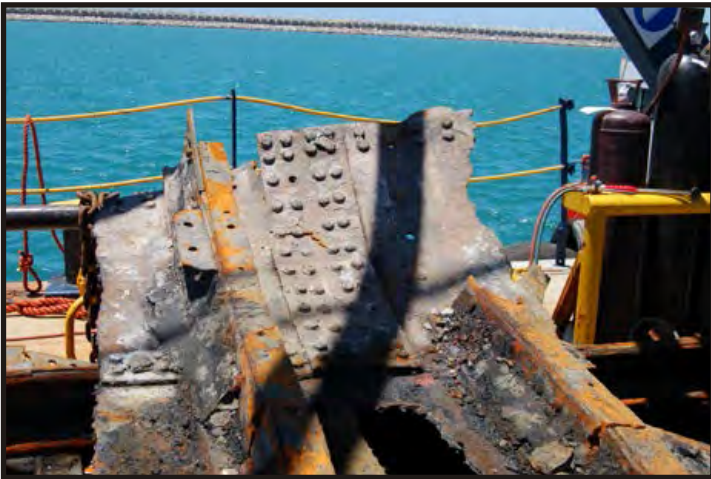
Figure 133: Turn of the bilge and floor head. (Photo V. Maitland)

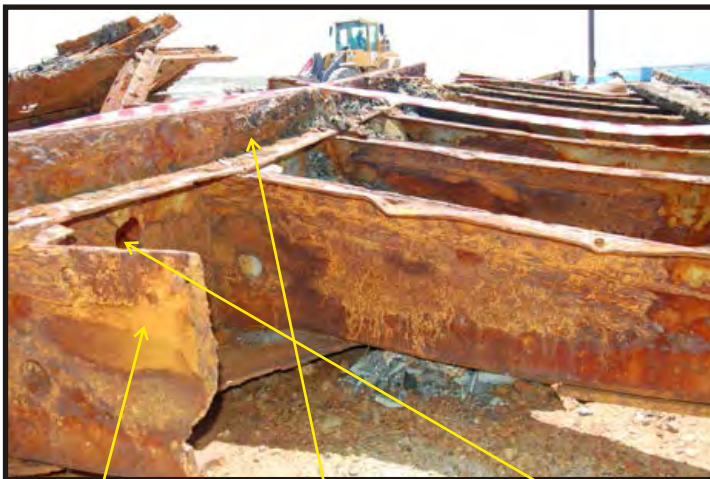
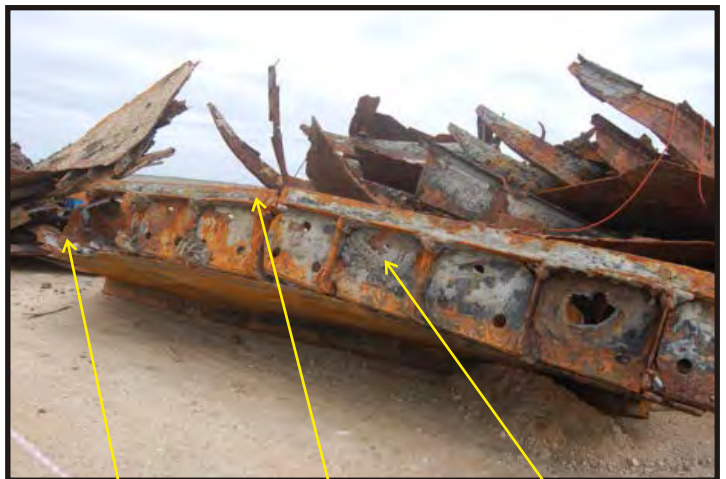
Figure 138 - 139: Note web frames and side keelson. Under the side keelsons there are strengthening intercostal plates. (Photo V. Maitland)

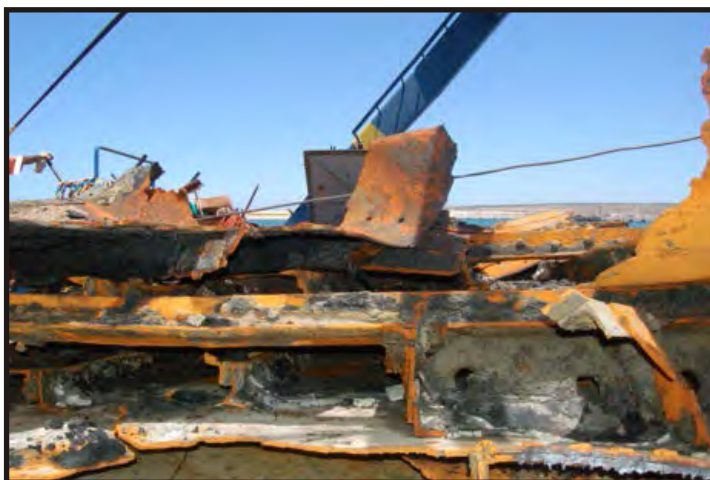
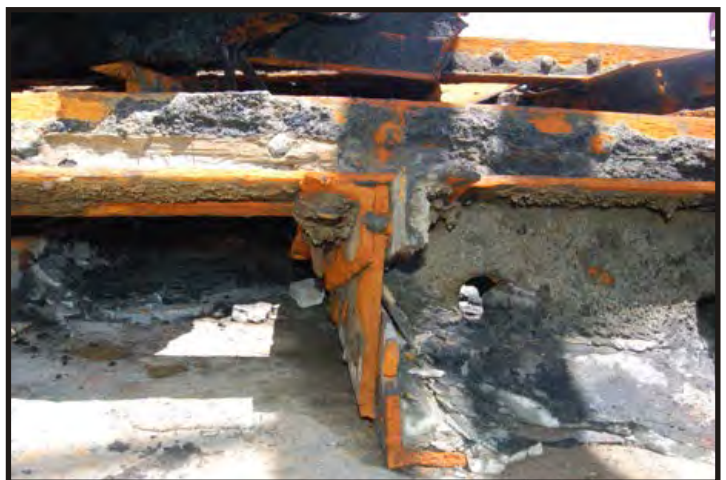
Figure 140 - 141: Seen from the top of the side plating looking down along the frames. The frame and reverse system can be seen. Intercostal plates under certain stringers are also visible. (Photo V. Maitland)

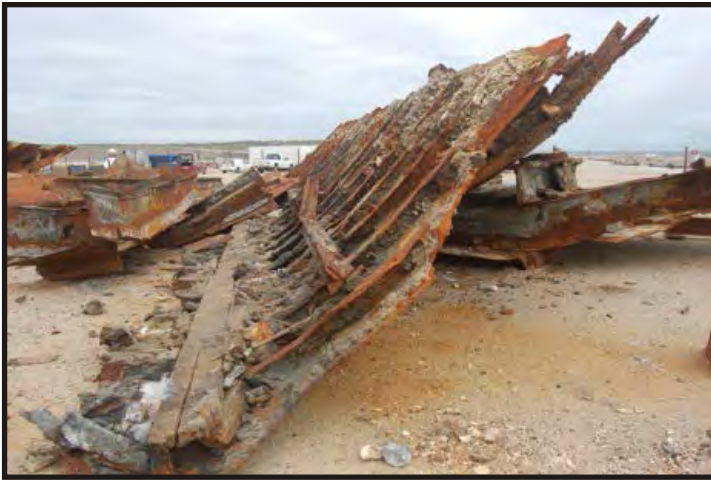
Figure 142: Side stringers add longitudinal strength to the hull. (Photo V. Maitland)

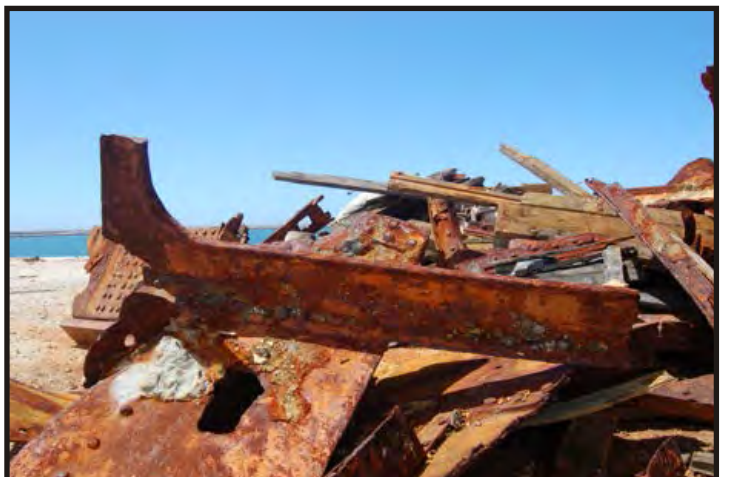
Figure 146: Beam knee, a turned knee with a bulb. (Photo V. Maitland)

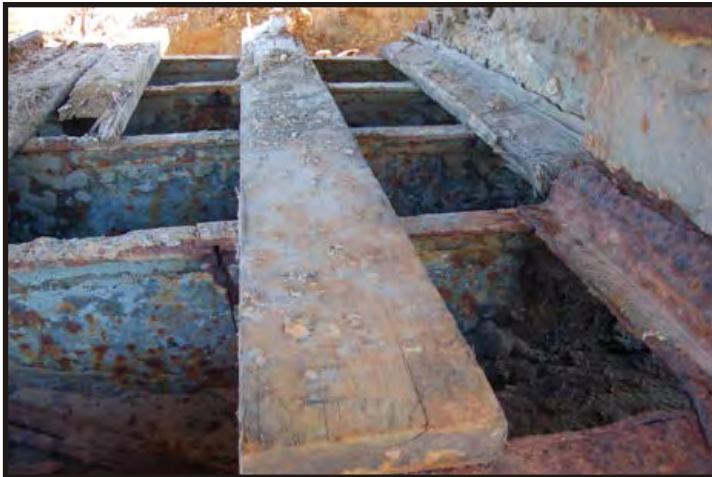
Figure 154: Hold ceiling with markings. (Photo V. Maitland)

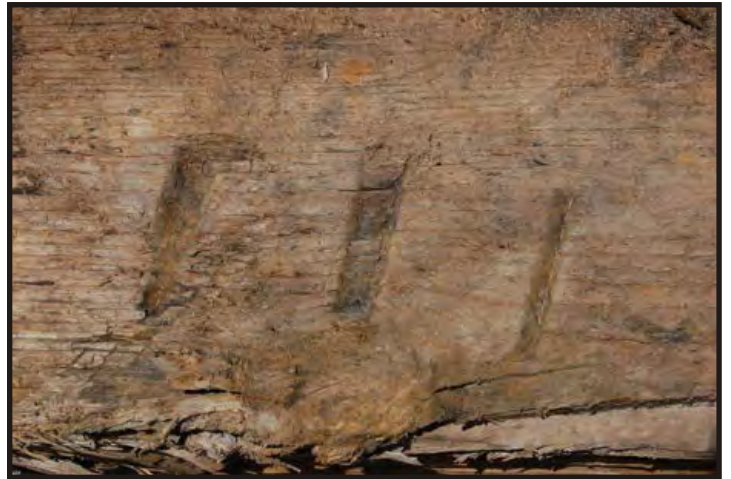
Figure 161: Hold markings, on recovered ceiling. Roman numerals DII. (Photo V. Maitland)

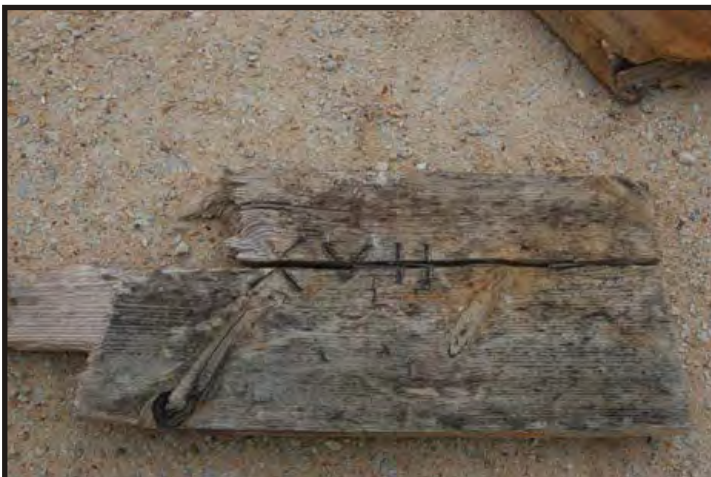
Figure 162: Dunnage, Roman numerals XVII. (Photo V. Maitland)

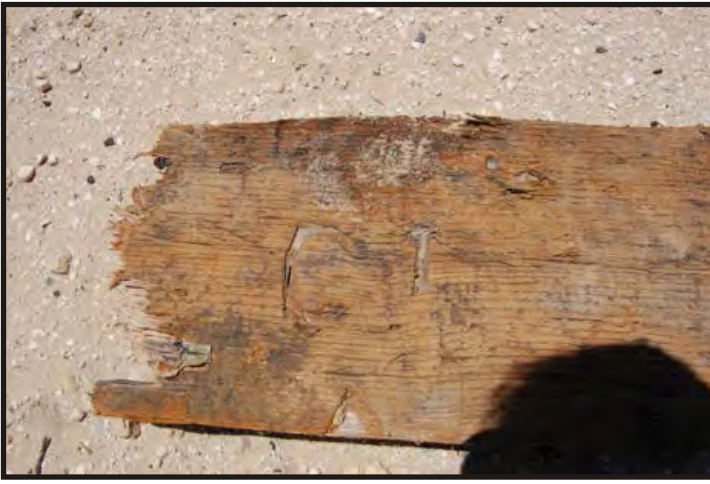
Figure 163: Dunnage, Roman numerals XXX and VIII. (Photo V. Maitland)

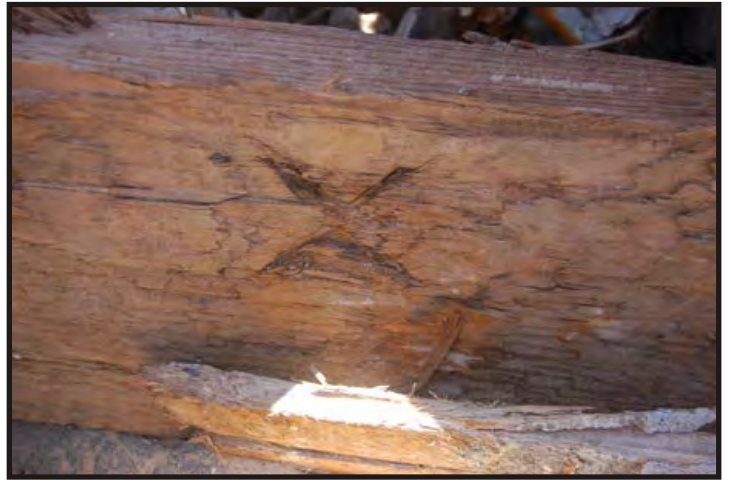
Figure 164: Dunnage, Roman numerals CI and upside down V. (Photo V. Maitland)

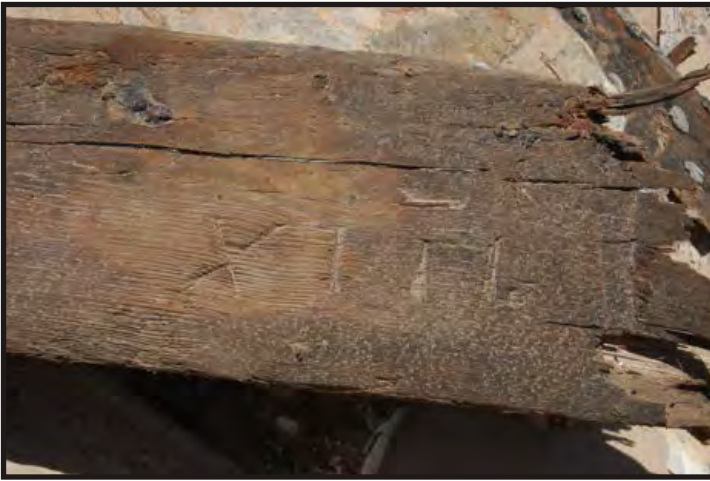
Figure 165: Dunnage, Roman numeral X. (Photo V. Maitland)

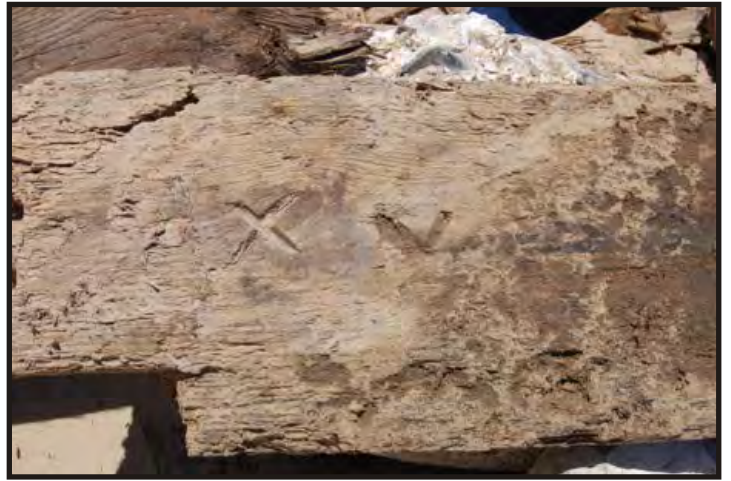
Figure 166: Dunnage, Roman numerals XIII. (Photo V. Maitland)

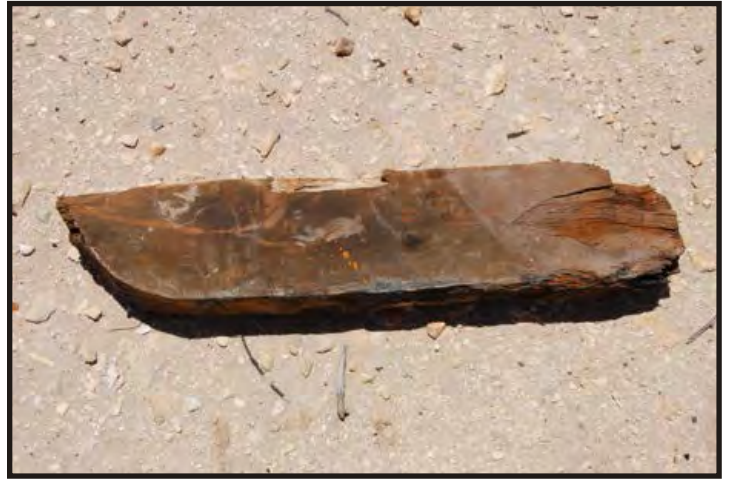
Figure 172: Side plates and frames. Shaped blocks of wood were wedged between the frames, they may have served the dual purpose of absorbing moisture and acting as intercostal support. (Photo V. Maitland)

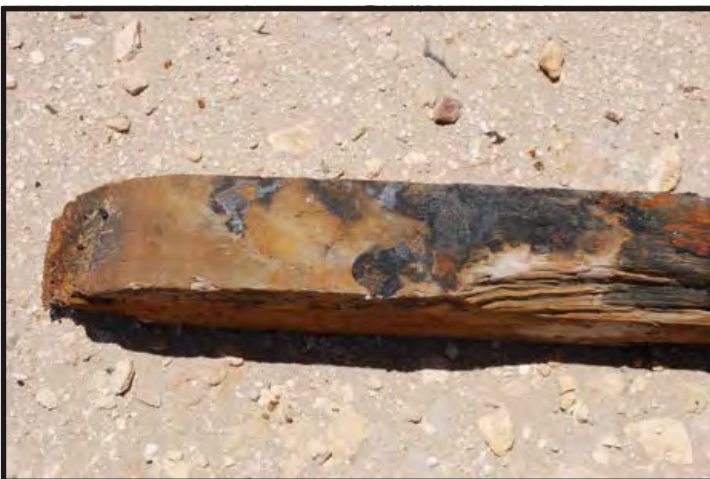
Figure 173: Intercostal block, shaped to fit between the frames. (Photo V. Maitland)

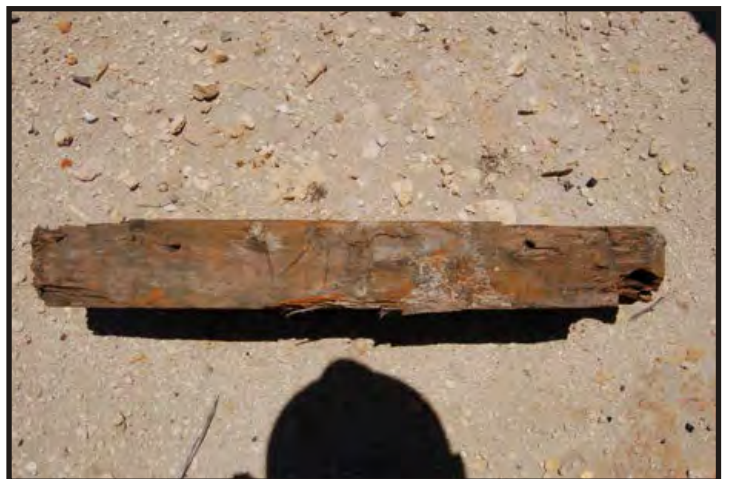
Figure 174: Intercostal block, shaped to fit between the frames. (Photo V. Maitland)

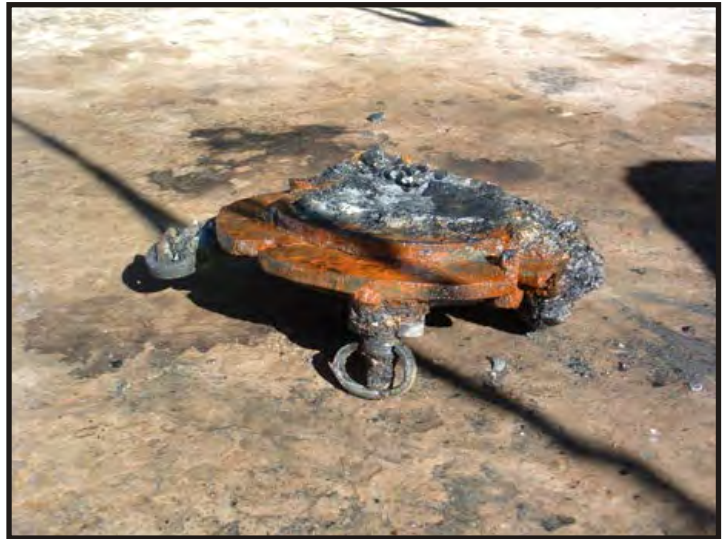
Figure 202: Back of the porthole. (Photo V. Maitland)

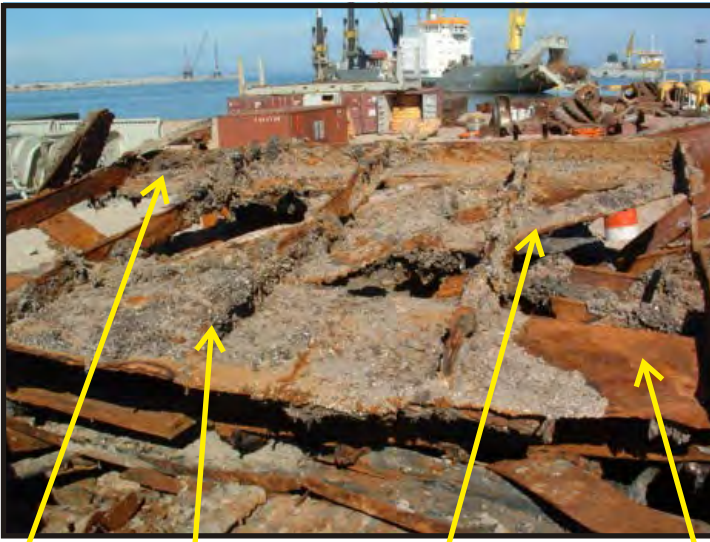
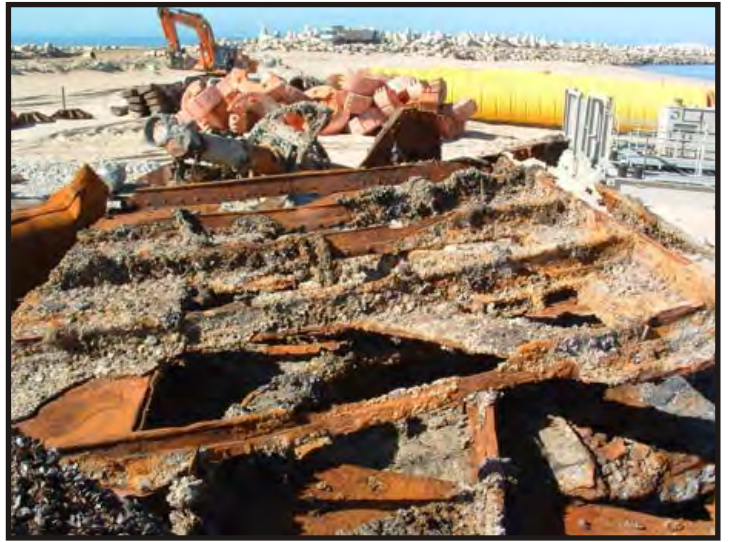
Figure 204 - 205: Two different views of the underneath of part of a deck girder. (Photo V. Maitland)

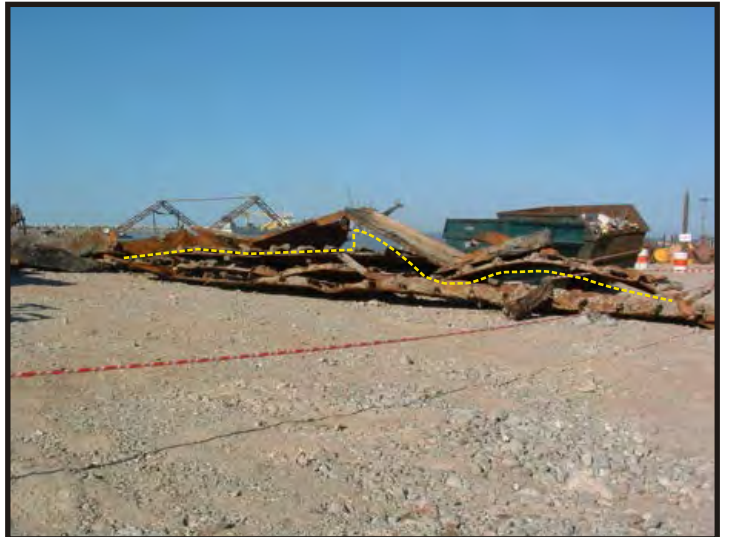
Figure 219: Long section of the bulwark removed in 2004. The supporting angle of the gunwale is towards us. (Photo V. Maitland)

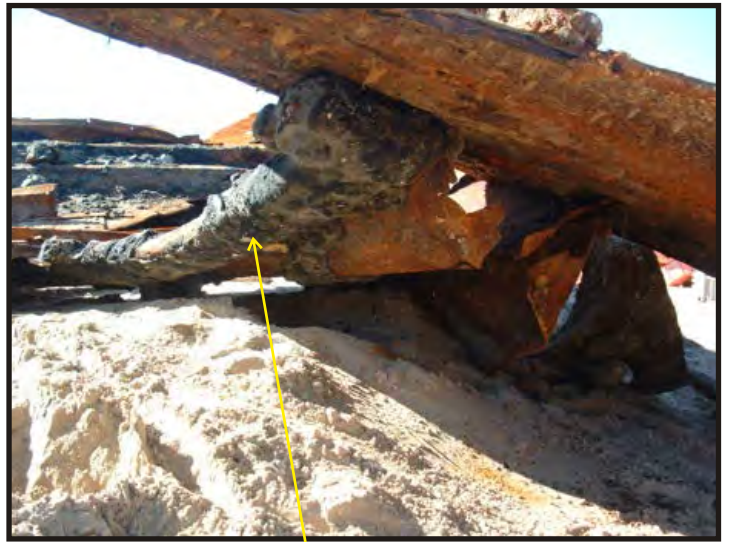
Lettering residue

Figure 246: Upper section of the bow where the outline of the vessel's name was found. (Photo V. Maitland)

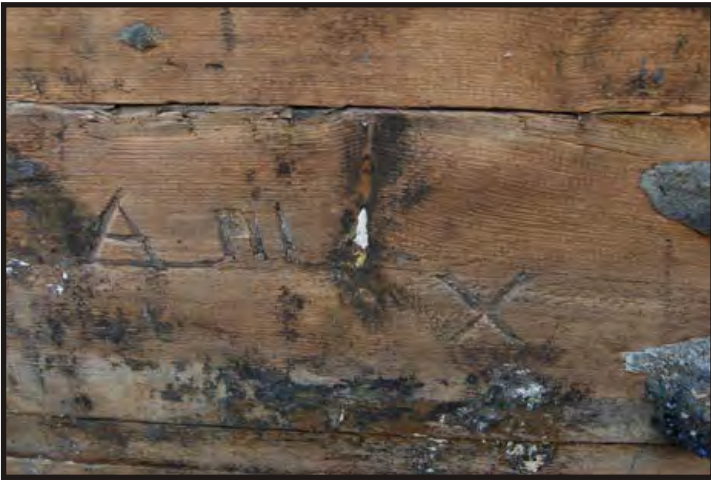
Figure 289: Ceiling marking - A III
X
(Photo V. Maitland)

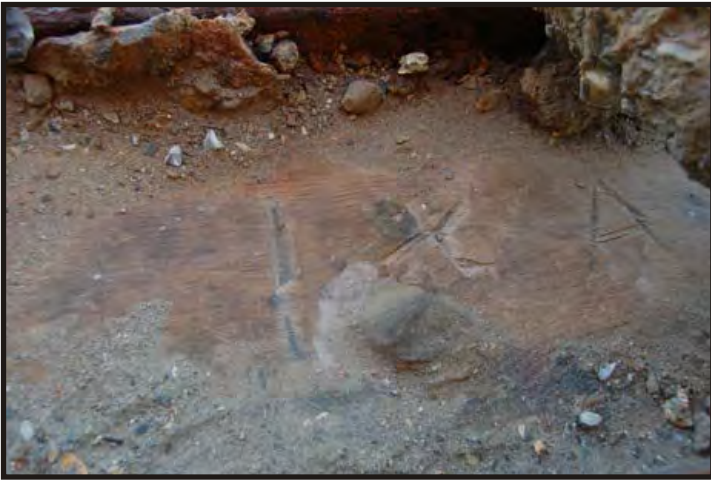
Figure 295: Ceiling marking - I X All (Photo V. Maitland)

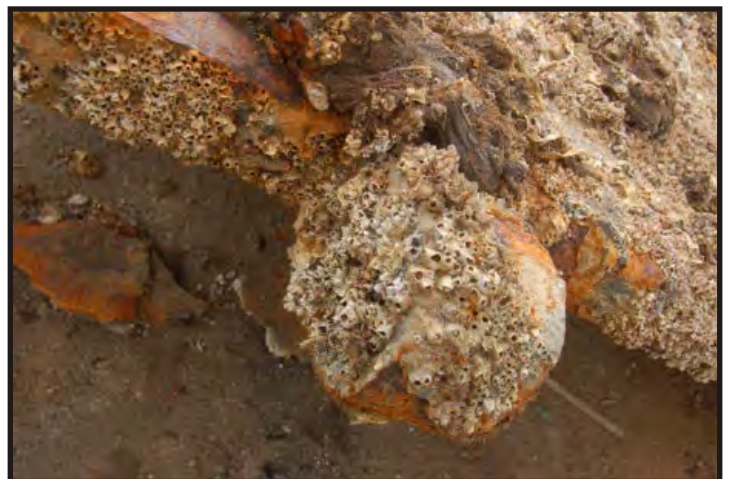
Figure 310: Close-up of the gudgeon, encrusted with barnacles. (Photo V. Maitland)

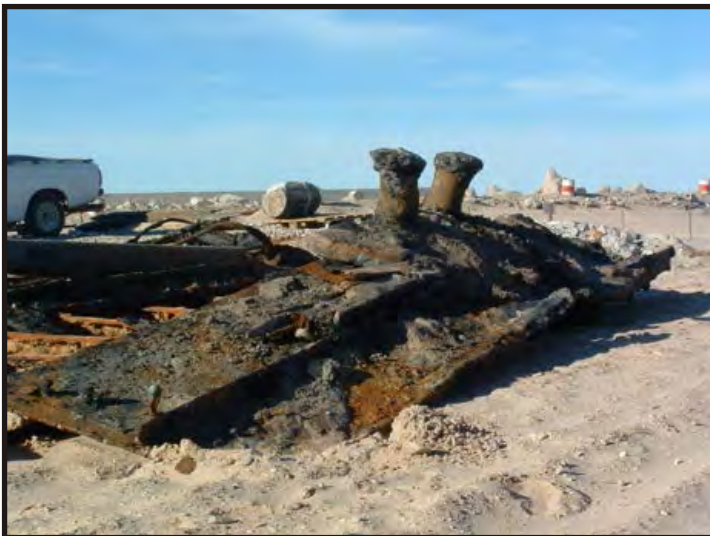
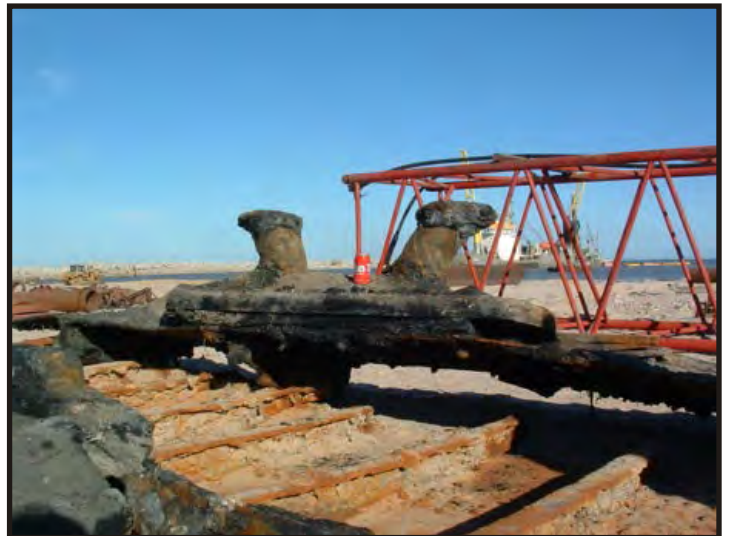
Figure 312 - 313: Bollards are stout vertical posts used for securing the lines when a ship is moored. They usually appear in pairs sharing the same base, which is fixed to the vessel rather than being an integral part of the vessel as are the bitts, which are often used for the same purpose (Blackburn 1981:44). These bollards were made of cast iron and they attached to a shaped wooden piece; this in turn was attached to the deck planking, which was attached to the rider plate. (Photos . V. Maitland)

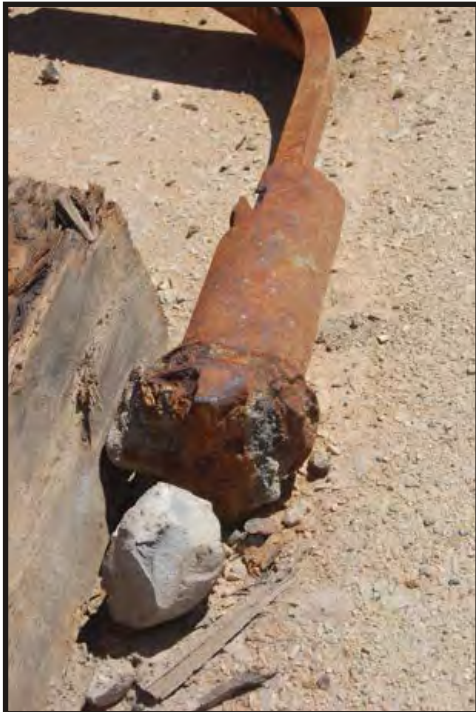
Figure 324: Cog of the windlass. (Photo V. Maitland)

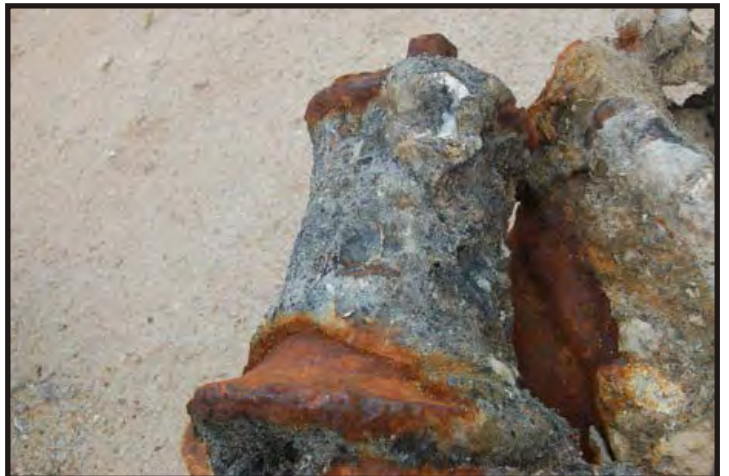
Figure 325: Close-up of the drum end of windlass. (Photo V. Maitland)

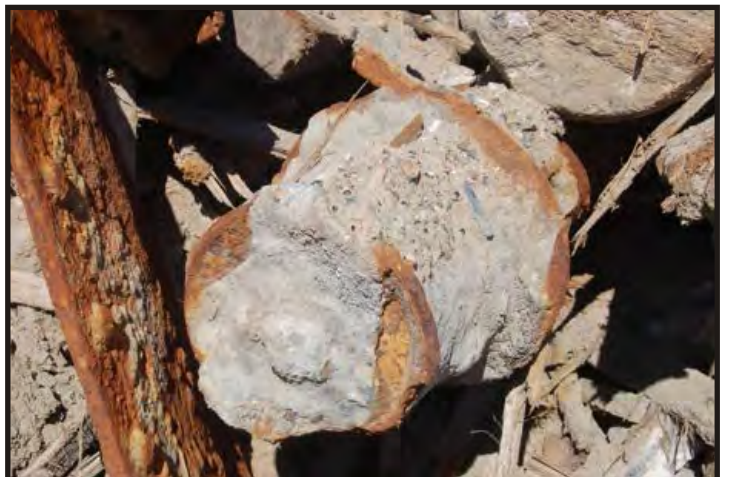
Figure 327: Top view of windlass drum end. (Photo V. Maitland)

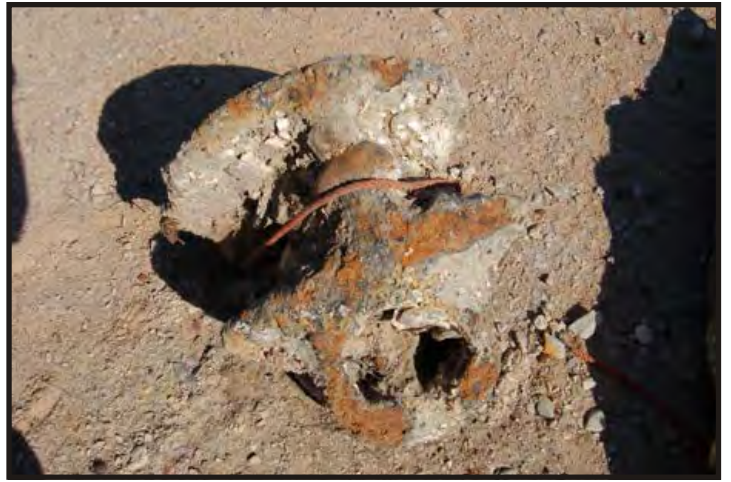
Figure 329: Close-up of gypsy, part of the windlass. (Photo V. Maitland)

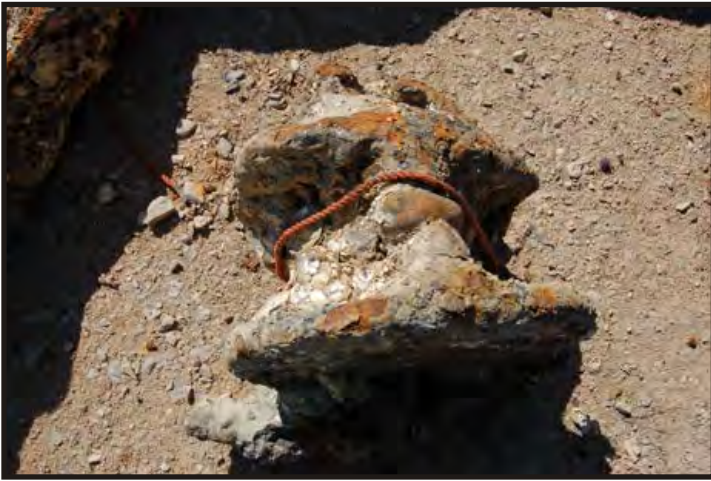
Figure 330: View of the bottom of the gypsy. (Photo V. Maitland)

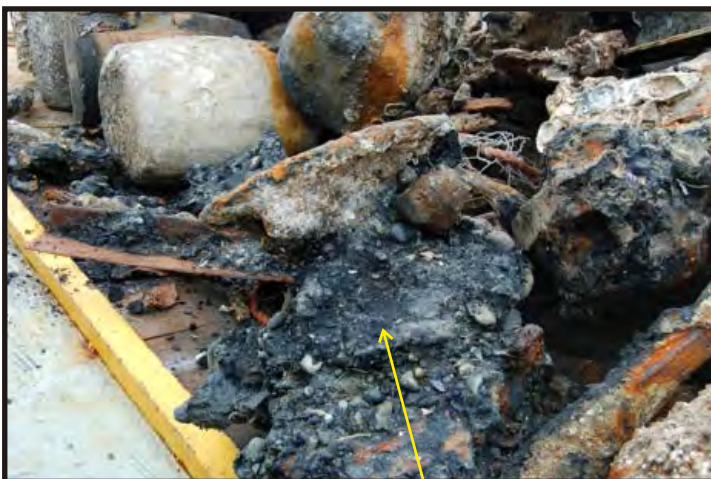
Figure 332: Side view of the possible gypsy. (Photo V. Maitland)

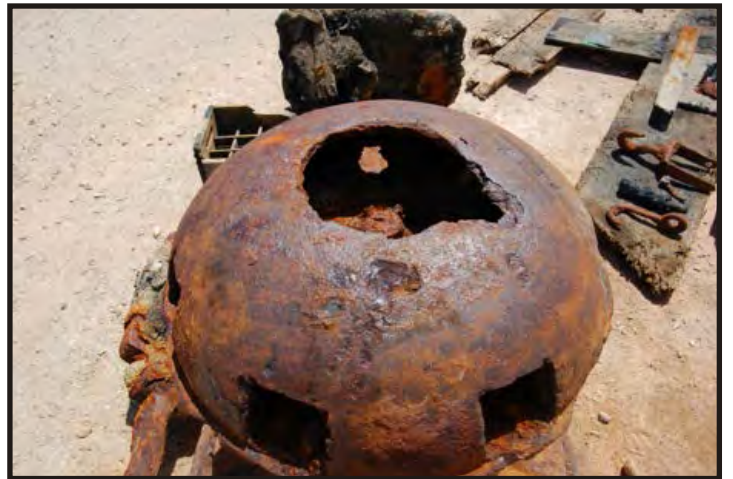
Figure 338: Capstan drum head. (Photo V. Maitland)

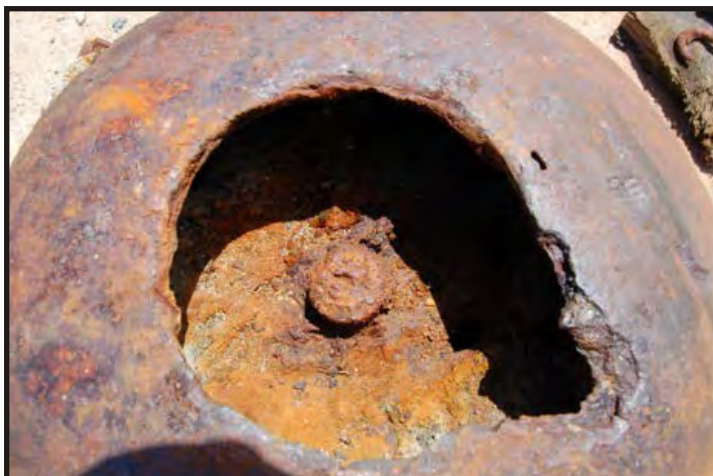
Figure 339: Close-up of drum head. (Photo V. Maitland)

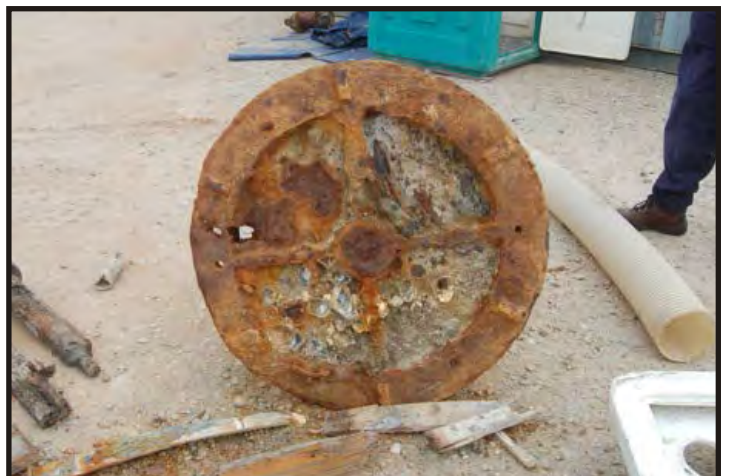
Figure 340: Bottom of capstan. (Photo V. Maitland)

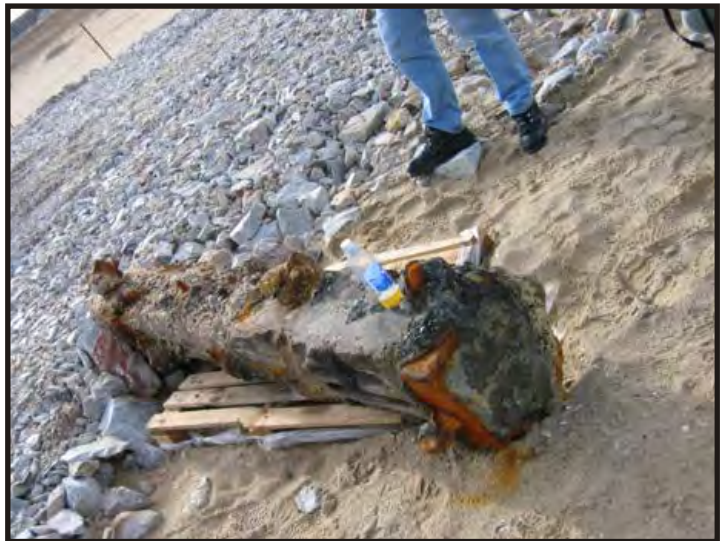
Figure 342: Cathead from the *County of Pembroke*, recovered in 2004. (Photo V. Maitland)

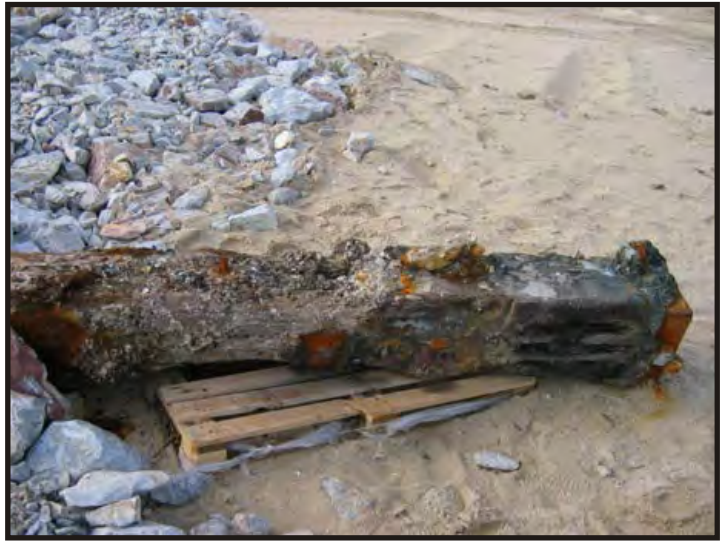
Figure 344: View from the top of the cathead, sheaves are visible on the right. (Photo V. Maitland)

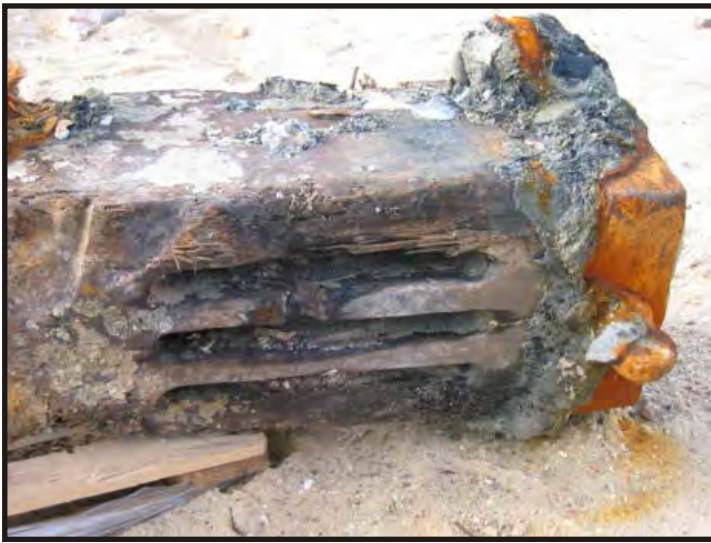
Figure 345: Close-up of cathead sheaves. (Photo V. Maitland)

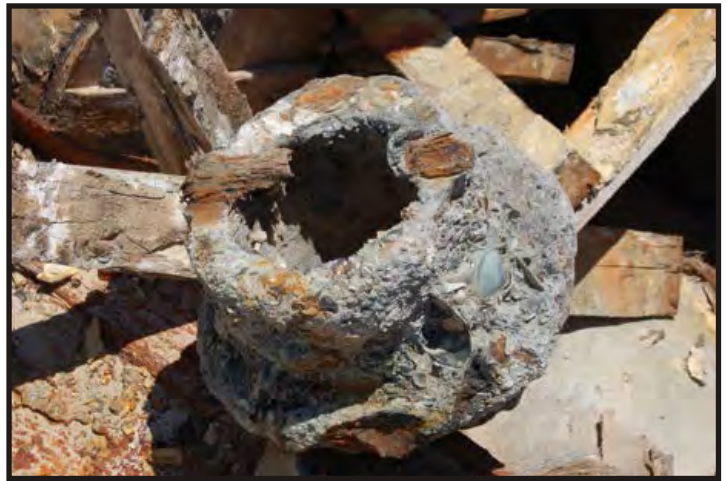
Figure 346: This cast iron fitting is very different from the hawseholes and I believe it's a spurling gate leading to the spurling pipe, which leads to the chain lockers, where the anchor chains were stored. Pieces of the deck are attached to the underside. (Photo V. Maitland)

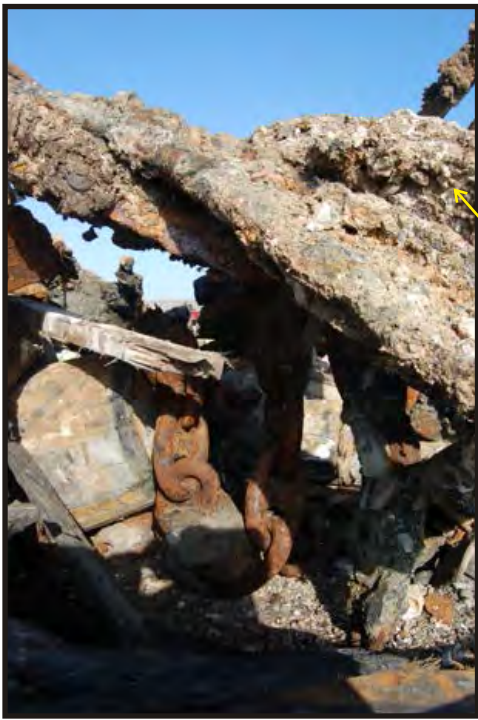
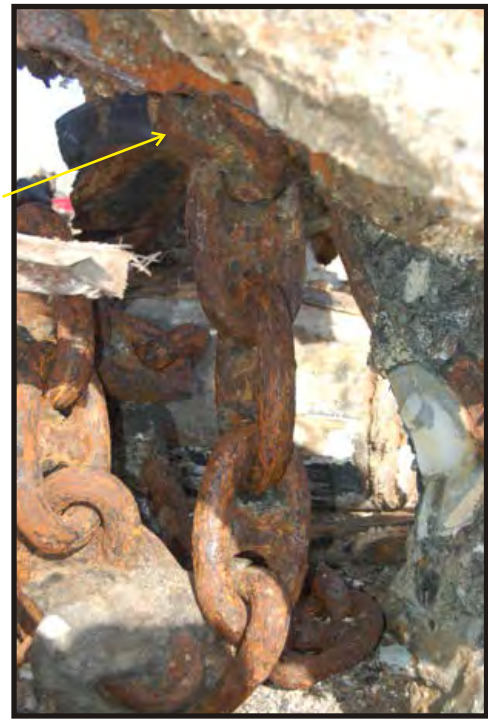
Figure 349 - 350: Bower cable. According to the Lloyds' Survey of 1881, the *County of Pembroke* had 270 fathoms of 1¾" chain. The *Eastern Province Herald* (27-11-1903), states the *County of Pembroke* had two chains of 135 fathoms each and 1¾ inches in thickness, this tallies with the Lloyds' Survey. In Figure 349, it appears that there is a hawse pipe or a spurling pipe above where the chain is attached to the beam. Figure 350 is a close-up of the beam attachment. (Photos V. Maitland)

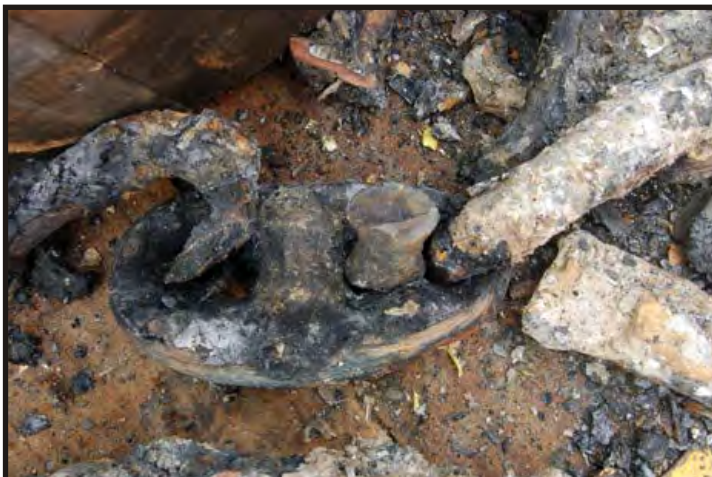
Figure 353: Chain links with a stud in the links. (Photo V. Maitland)

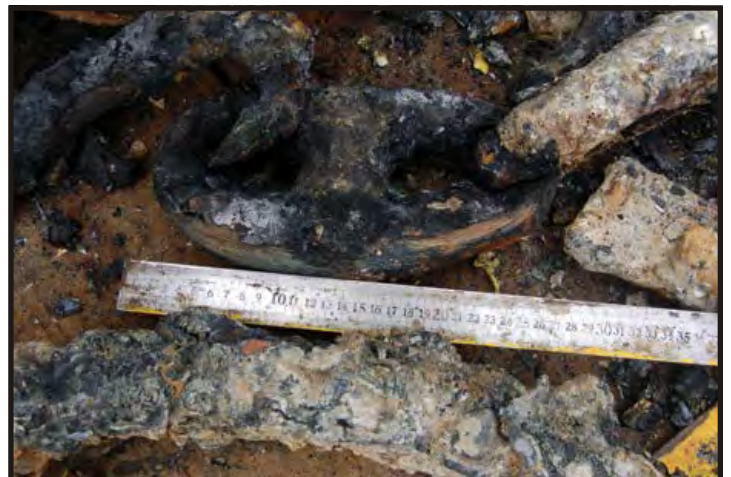
Figure 354: Chain links, after the stud was removed. (Photo V. Maitland)

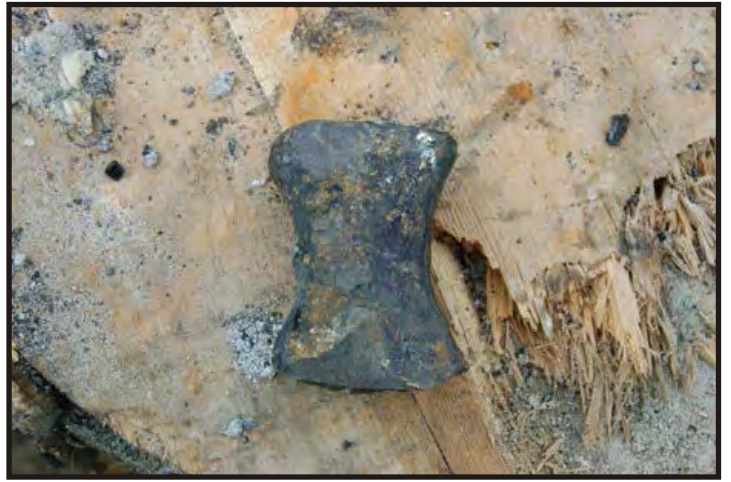
Figure 356: Close-up of the side of the chain stud. (Photo V. Maitland)

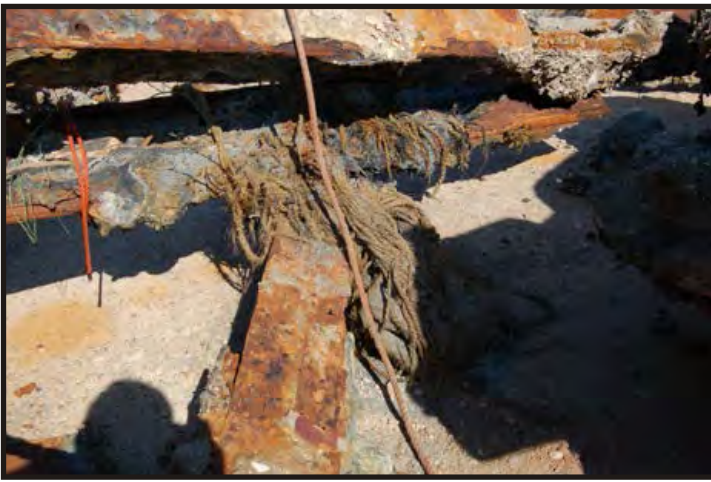
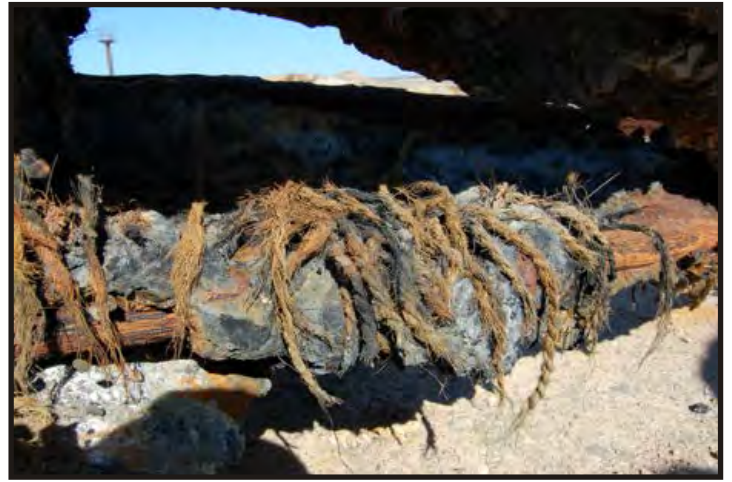
Figure 359 - 360: Strands, ropes and cables were wrapped and lashed on various parts of the wreck. I don't know which were pre-wreck and which were used during the 1904 salvage operation. According to Bisset (1958:93), during quiet times onboard the crew blacked down the rigging. This involved rubbing tar into the rope rigging in order to preserve the manilla (Blackburn 1982:39). (Photo: V. Maitland)

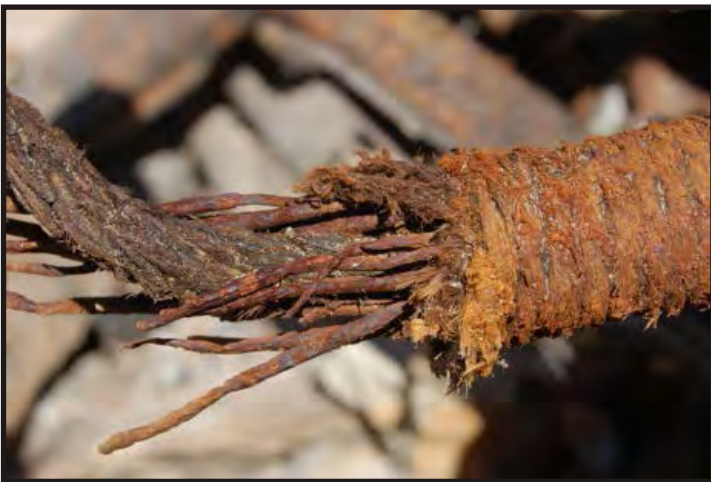
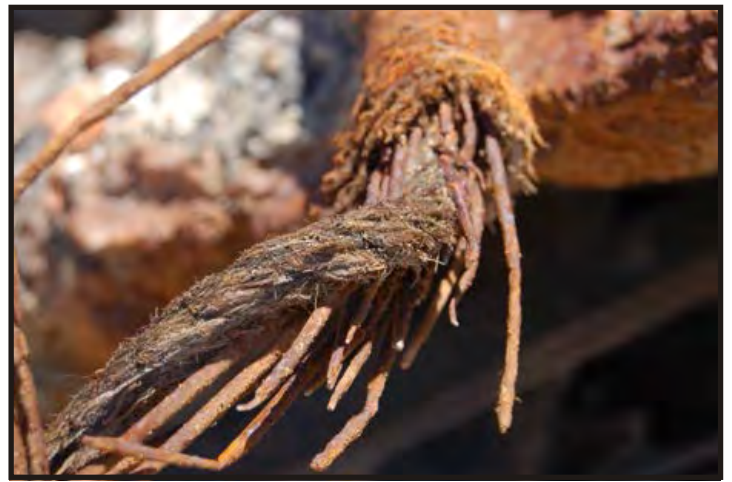
Figure 361 - 362: Wire rope. According to the Manual of Seamanship (1951:89), wire rope consists of many small wires extending continuously throughout its length, these are twisted into strands; the strands are twisted around a jute or hemp heart. The wire ropes from the *County of Pembroke* were wrapped with manilla, hemp or jute. The heart acts as a cushion into which the strands bed, giving the rope more flexibility. The heart and covering absorbs the oils with which the ropes are treated. As the ropes are stretched or flexed, the oils are squeezed between the wires lubricating them and reducing friction. According to Bisset (1956: 214) slush was mixed with Stockholm tar for greasing down the rigging, masts and for splicing ropes. (Photos V. Maitland)

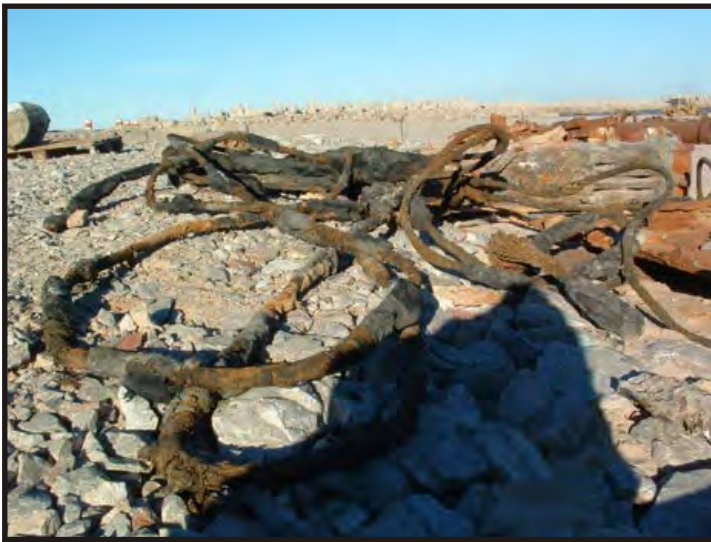
Figure 365: Manilla covered wire rope. (Photo V. Maitland)

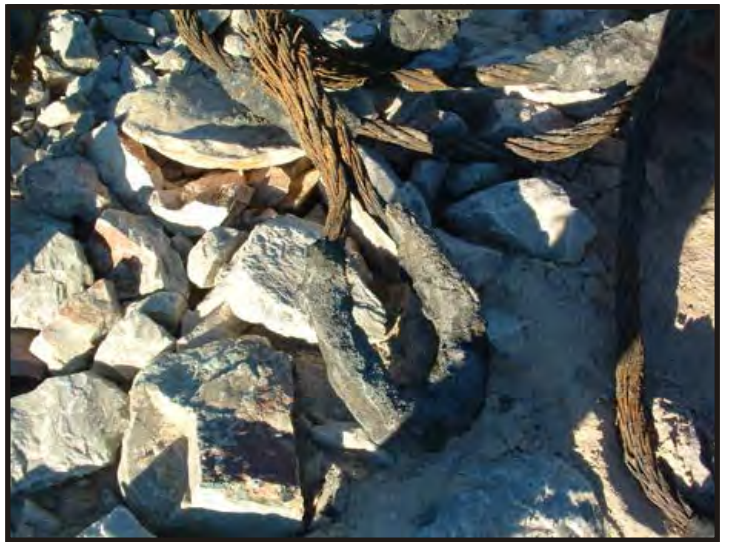
Figure 366: Spliced thimble. (Photo V. Maitland)

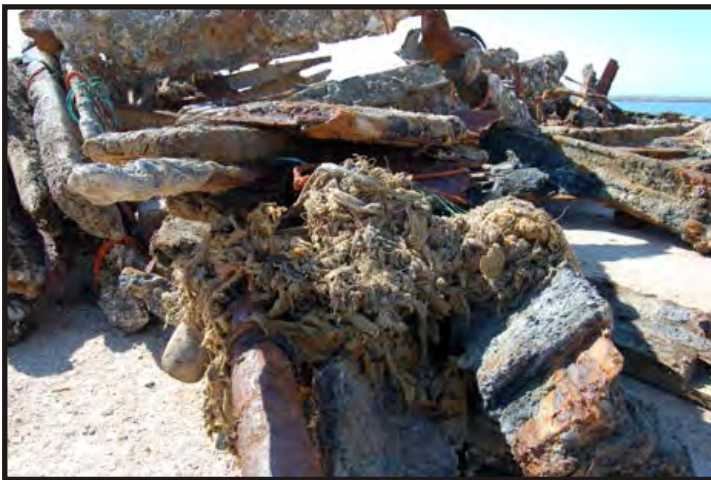
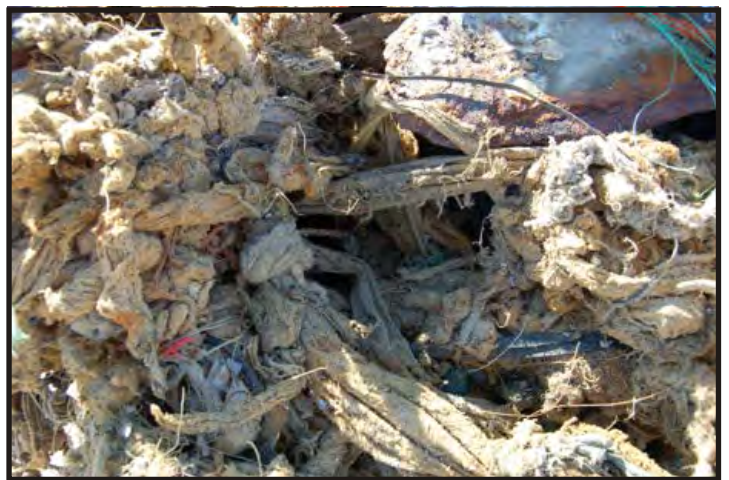
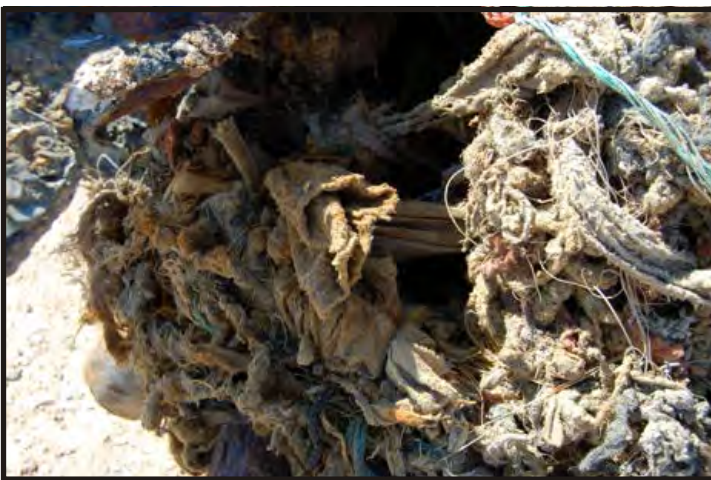
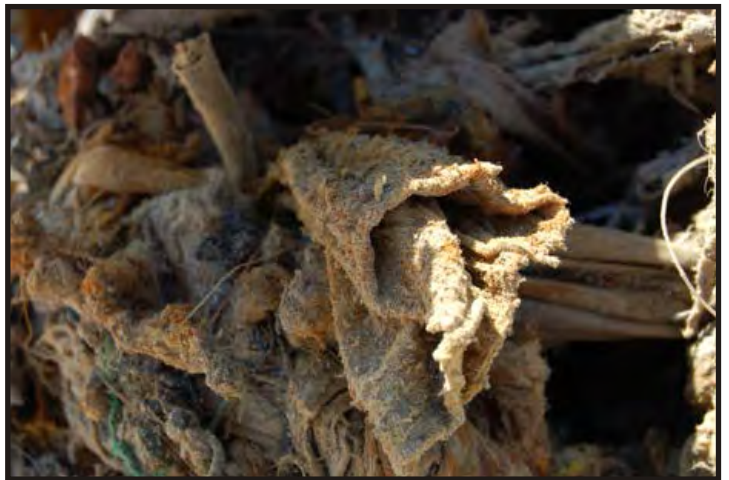
Figure 367 - 370: Numerous bundles of these knotted rags were found throughout the upper areas of the wreck. There are three possible explanations for these artefacts:
