County of Pembroke

Shipwreck Report

Vanessa Maitland

**Port of Ngqura
Eastern Cape
South Africa**

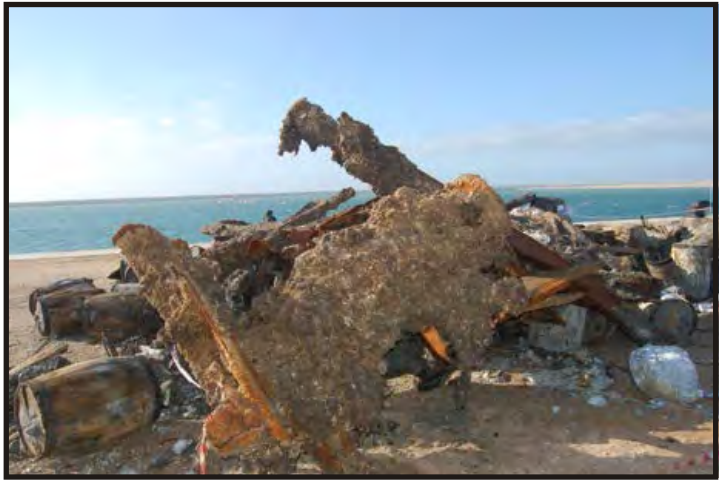
Figure 384: Unknown piece of deck equipment, heavily encrusted. (Photo V. Maitland)

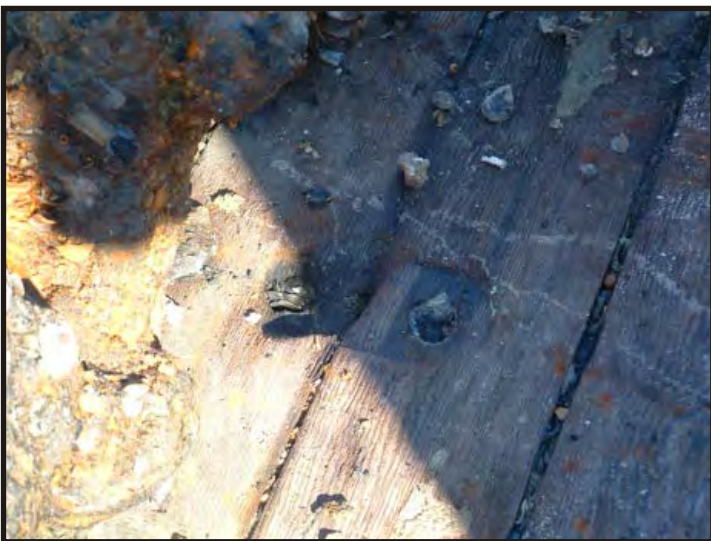
Figure 387: Imprint and bolts of deck rigging or equipment. (Photo V. Maitland)

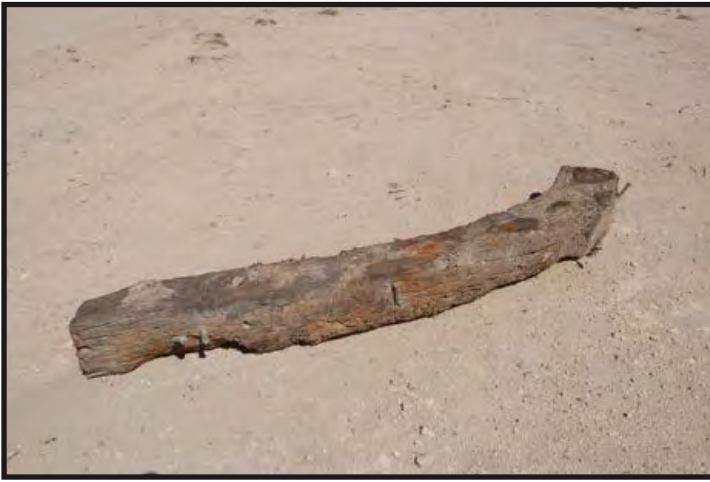
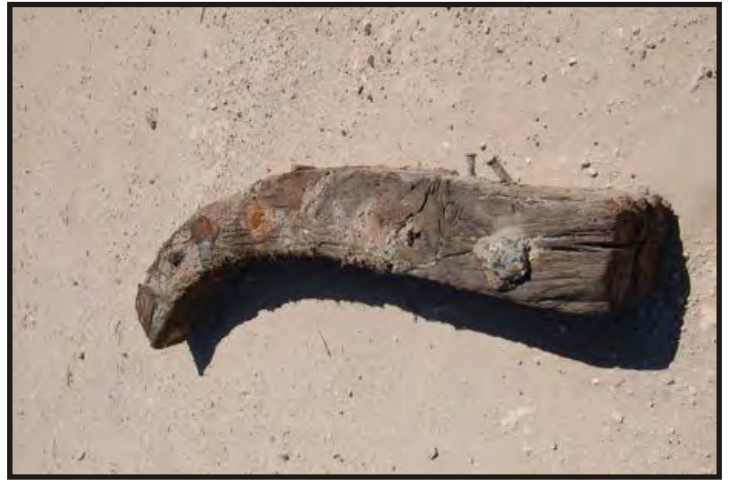
Figure 401 - 402: This curved wood has brass bolts inserted. The *County of Pembroke* had four boats. One was used by the crew to get ashore and the *Eastern Province Herald* (05-02-1904) advertised salvaged boats from the *County of Pembroke*, but not how many. This may be a bow or stern section from one of the barque's boats. (Photos V. Maitland)

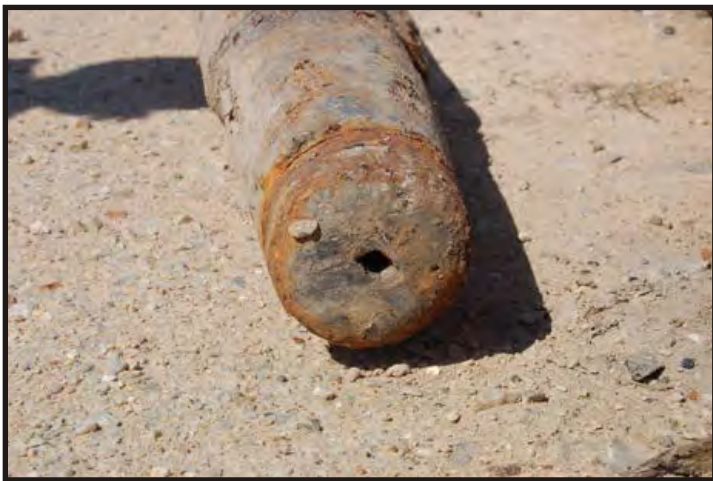
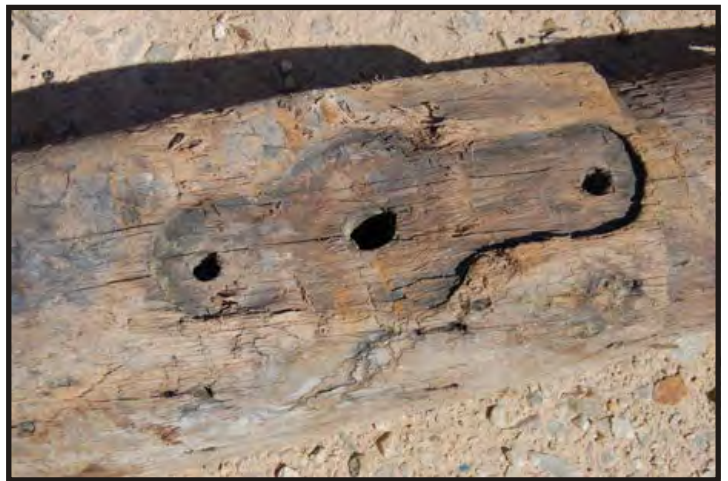
Figure 407: Close-up of the end where the metal band was. **Figure 408:** Close-up of the routed area. (Photo V. Maitland)
(Photo V. Maitland)

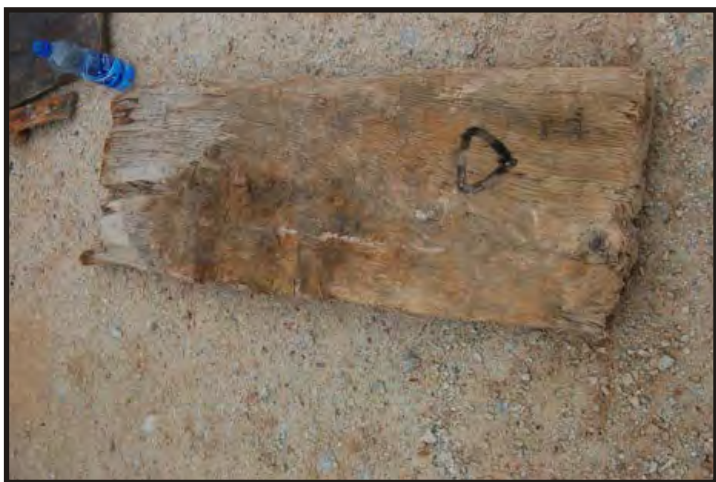
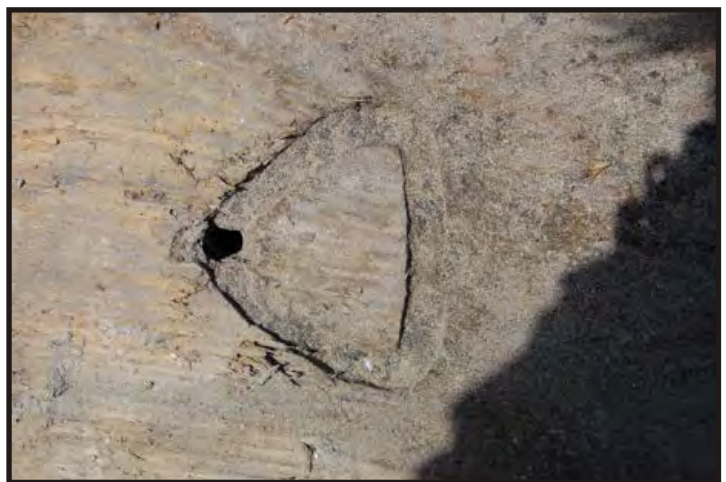
Figure 409 - 410: Possible locker lid; the ring is missing. (Photo V. Maitland) A locker is a small cupboard, generally with a lid on top, used for keeping small articles on board. A locker ring is a loose ring held in a plate, mounted flush with the surface but is always free, and easy to get hold of (Blackburn 1981:199).

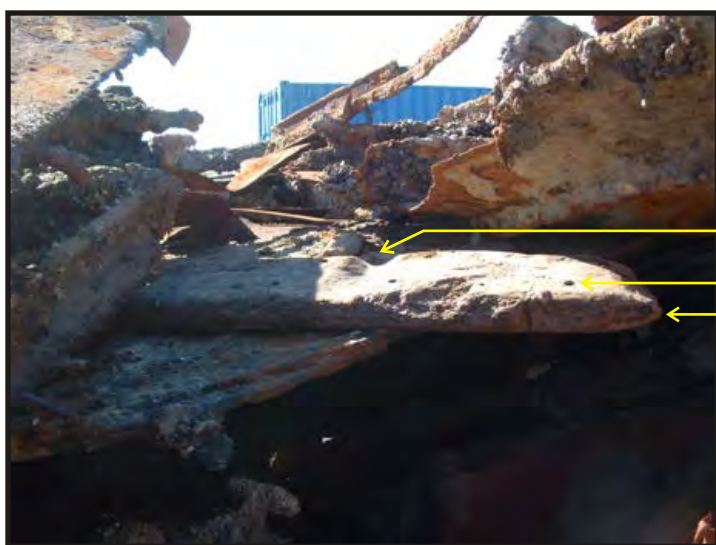
Wear from gear
Brass attaching nails
Bolster

Figure 411: Bolster. (Photo V. Maitland) This is a piece of wood that is attached as needed to prevent damage from the chafing of moving parts (Blackburn 1981:44).

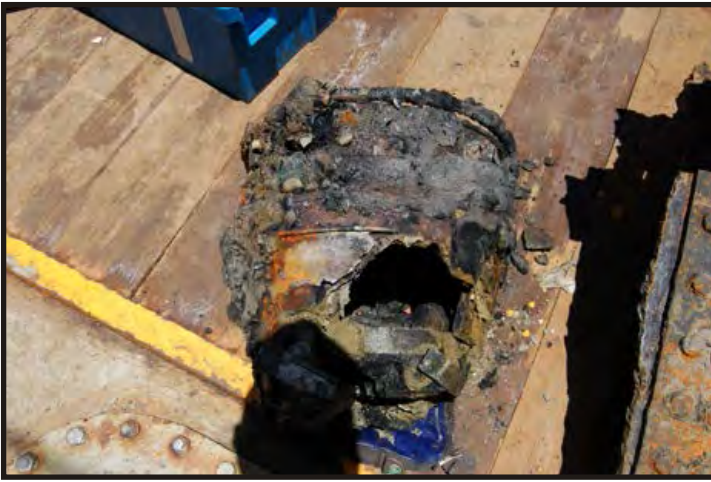
Figure 418 - 419: Metal buckets corroded together. (Photo V. Maitland) Bisset (1958:201) discusses the *County of Pembroke's* buckets in the following extract, "...the hold was filled to the deckhead, with 1,000 tons of guano, rammed into every corner and packed tightly around the two iron fresh water tanks. These, as in all sailing vessels, were set amidships in the hold, abaft the mainmast, and water was drawn from them into buckets by a hand pump on deck, for our whack of three quarts per man per day."

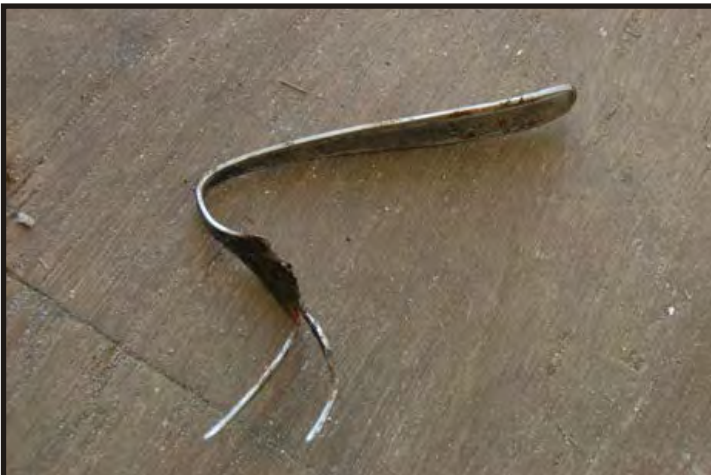
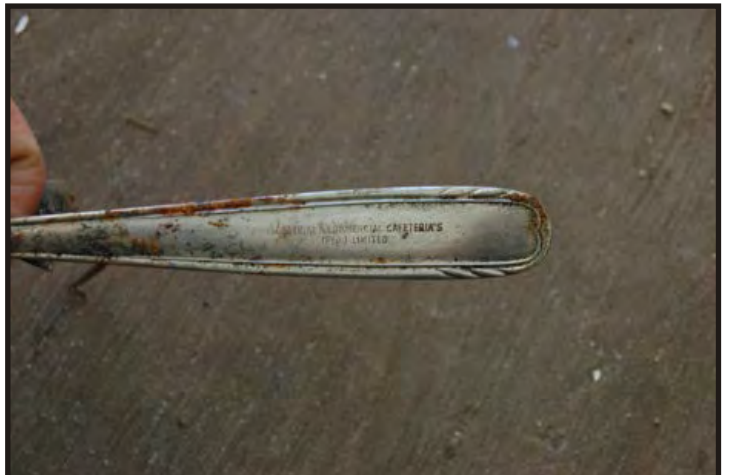
Figure 432 - 433: Metal fork, the stamp on it states "Industrial & Commercial Cafeterias (Pty.) Limited". (Photos V. Maitland)

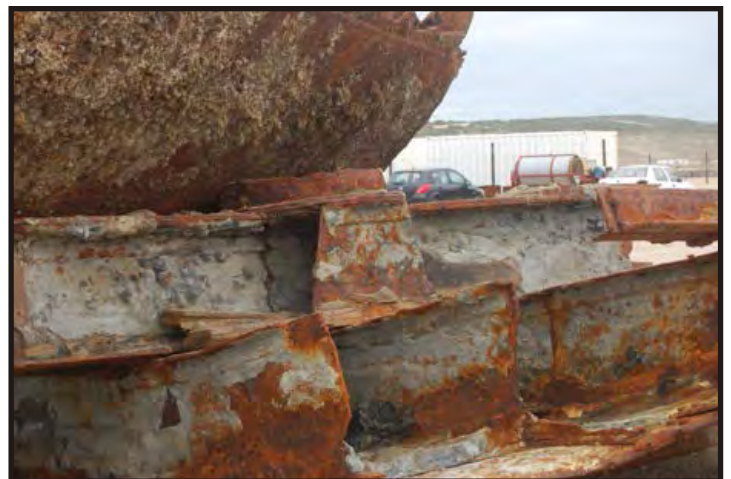
Figure 442: Centre keelson and mast step from the side. (Photo V. Maitland)

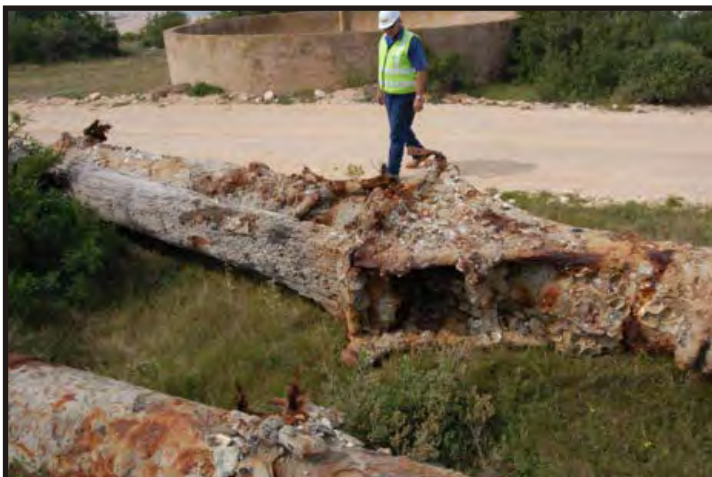
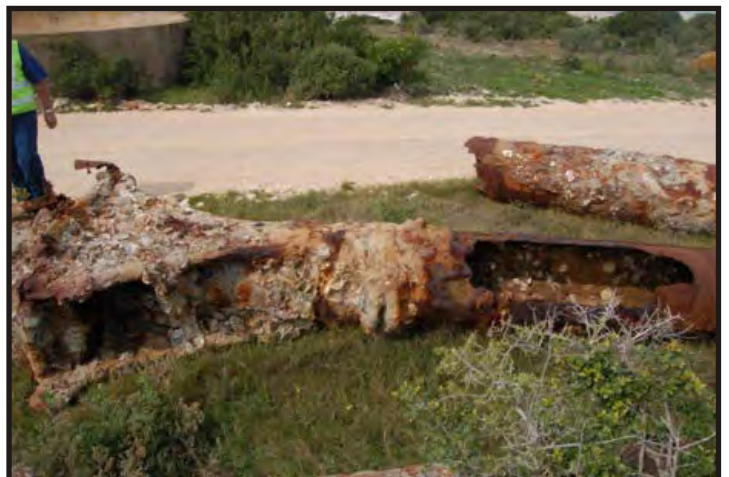
Figures 453 - 454: Two different views of the trestle trees and doubling of the mast. (Photo V. Maitland)

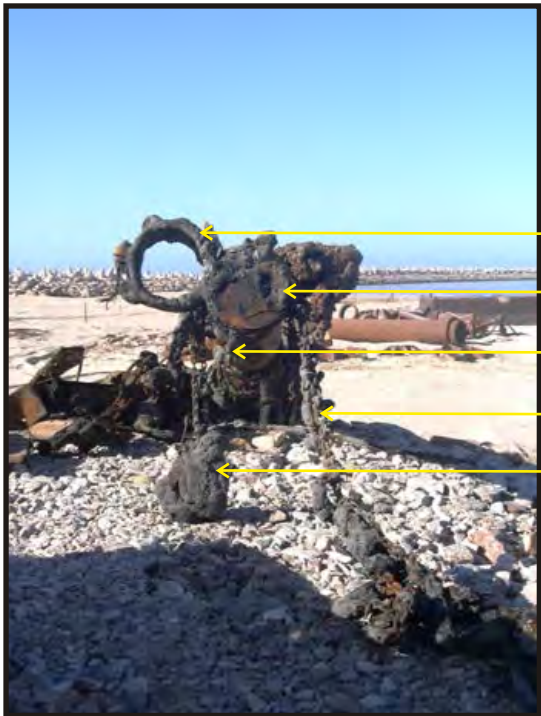
- Trunnion hoop
- Lower mast cap
- Funnel with eyes for the stays
- Chains for the lower yards
- Double block

Figure 469: View of the trunnion hoop of the lower main mast and its parts. (Photo V. Maitland)

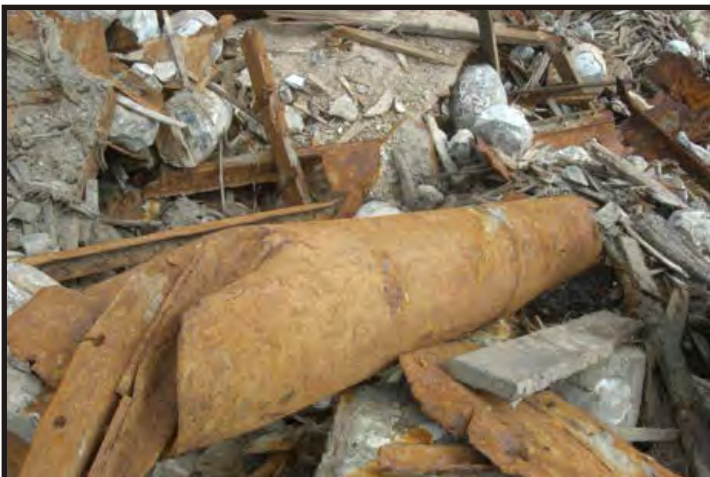
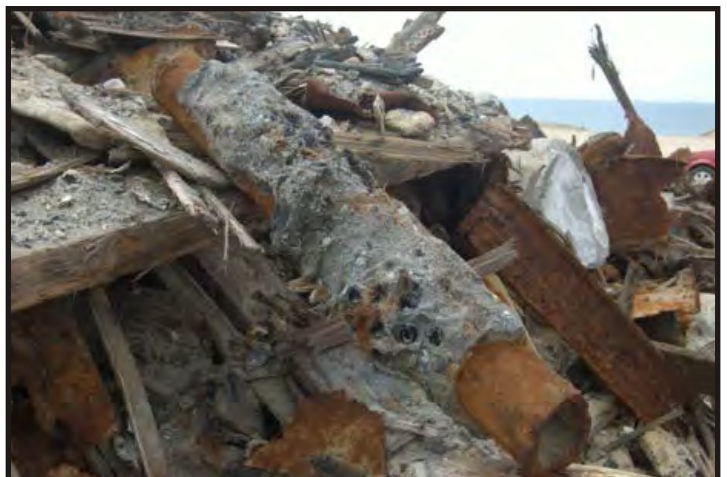
Figure 481 - 482: These round metal pieces, too narrow to be masts, may be yards. (Photos V. Maitland)

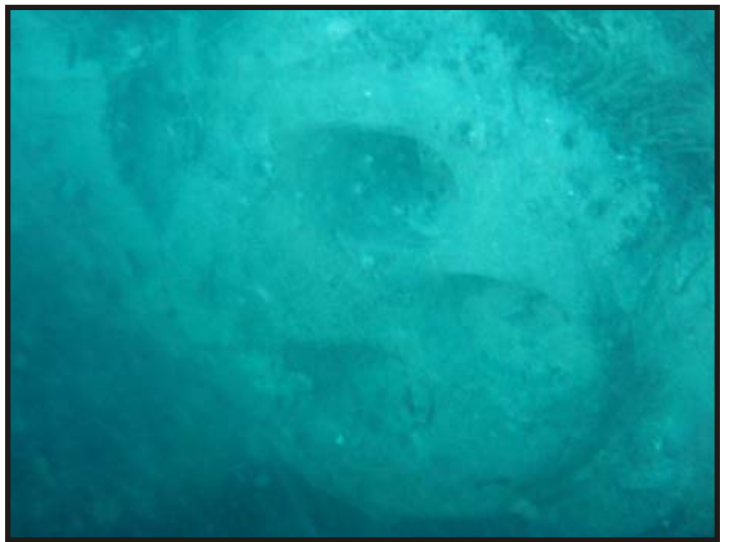
Figure 486: In-situ dead-eye. (Photo Subtech)

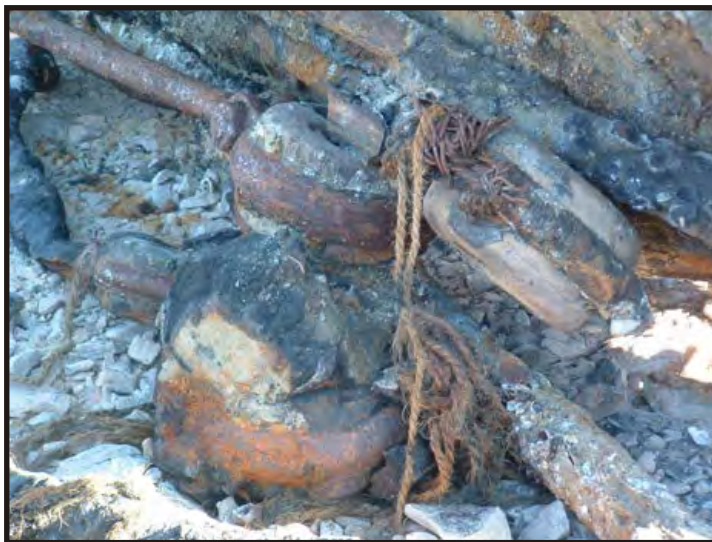
Figure 487: Dead-eyes in the channel on the bulwarks. (Photo V. Maitland)

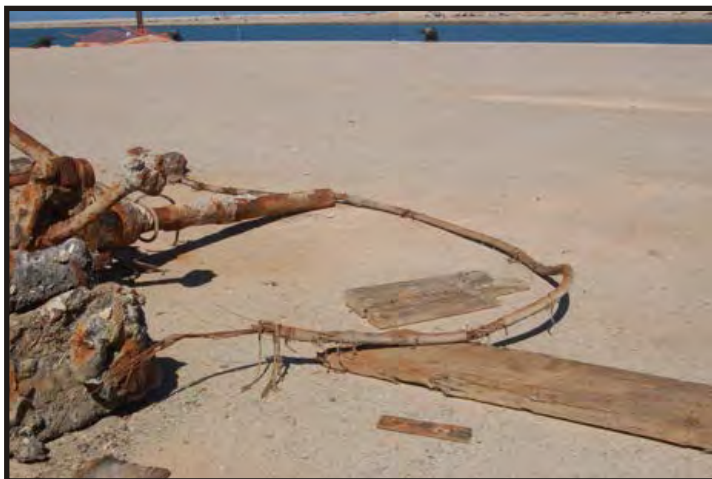
Figure 489: Dead-eye still attached to iron wire rope or standing rigging. (Photo V. Maitland)

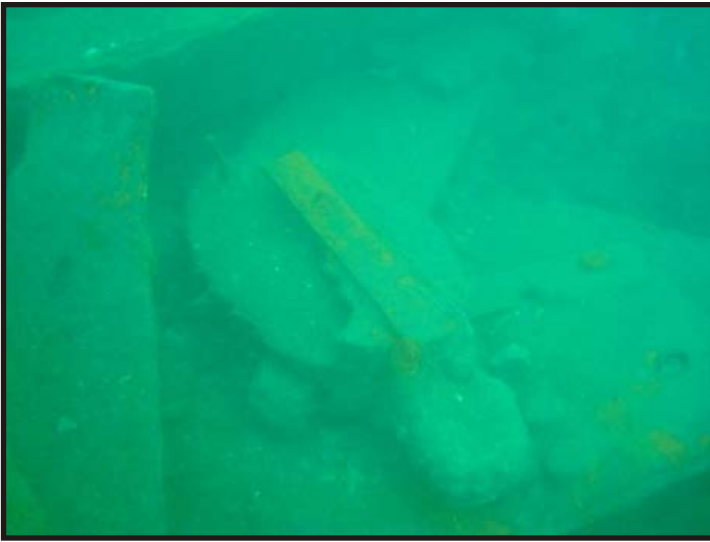
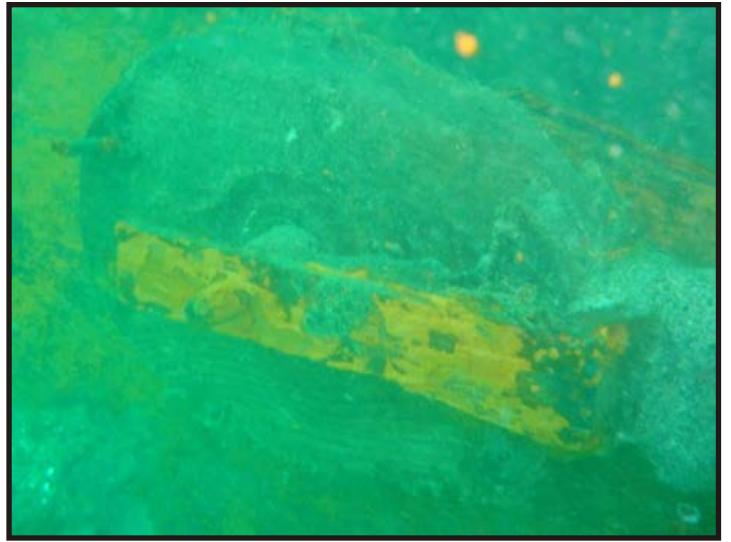
Figure 491 - 492: Two in-situ views of an iron strapped block. It appears the shell has rotted away. (Photo V. Maitland)

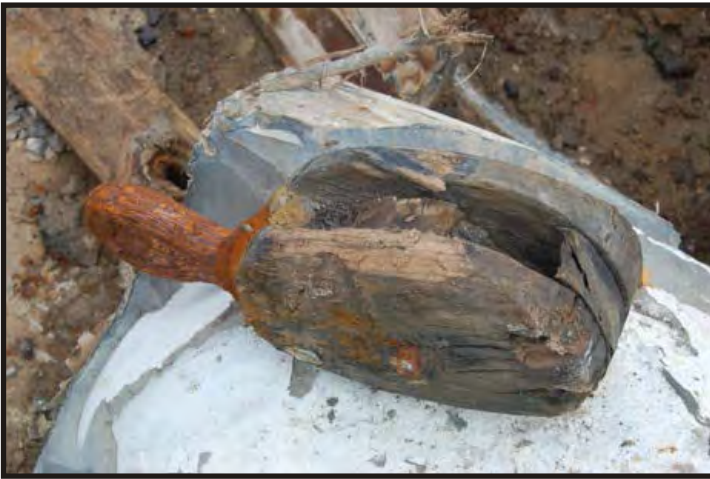
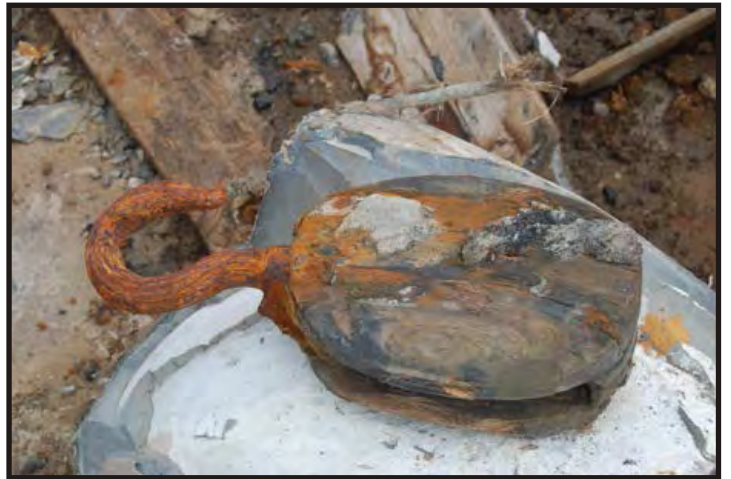
Figure 493 - 494: Two views of a large, single, iron-bound block with a fixed hook. The iron strap has disappeared, but its attaching pin and sheave are still largely intact; iron bolts for attaching the strap are also visible. (Luce 1891:66; Photos V. Maitland)

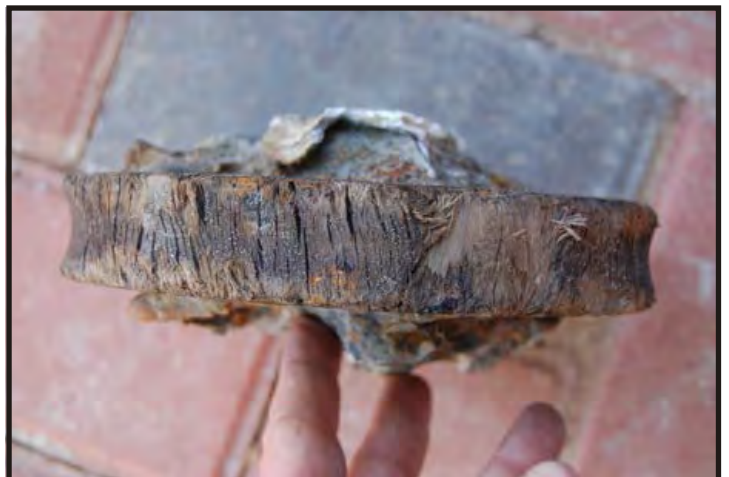
Figure 502: Sheave from a block. (Photo V. Maitland)
