**HERITAGE IMPACT ASSESSMENT:**  
**PROPOSED DEVELOPMENT OF THE SPRINGHAAS SOLAR PV FACILITIES**  
**CONSISTING OF SEVEN NEW SOLAR PV FACILITIES AND ASSOCIATED**  
**INFRASTRUCTURE NEAR DEALESVILLE IN THE FREE STATE PROVINCE**

Required under Section 38(8) of the National Heritage Resources Act (No. 25 of 1999)  
as part of a Heritage Impact Assessment.

**Dr Jayson Orton**  
**ASHA Consulting (Pty) Ltd**  
23 Dover Road, Muizenberg, 7945  
Tel: (021) 788 1025 | 083 272 3225  
Email: [jayson@asha-consulting.co.za](mailto:jayson@asha-consulting.co.za)

Final report: 12 April 2022

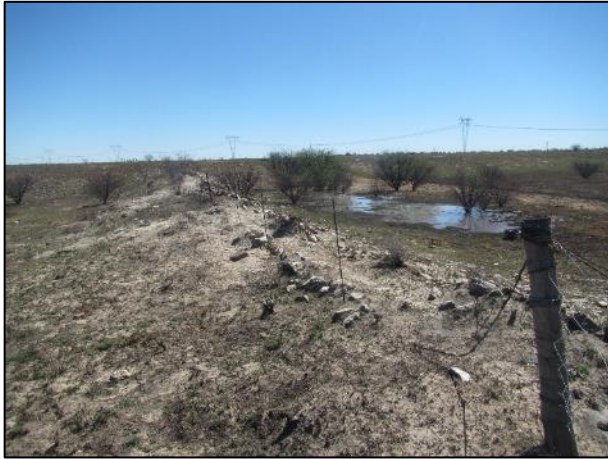
More commonly encountered were historical archaeological sites. Surprisingly, artefacts were almost entirely absent from these sites. One site to reveal some historical glass and ceramics was an unexpected one. A historical earthen-walled dam has an animal burrow in it and this burrow has pulled artefacts out (Figures 22 & 23). The dam was across an inlet to a large pan and from aerial photography it is evident that a large area drains into this inlet. A number of ephemeral remains of older structures were also seen. These varied in nature but all would have related to the earlier farm complexes of the area. Most are likely 19<sup>th</sup> century in age, but it is possible that some might be from

**Figure 22:** A historical dam wall at waypoints 315-6.

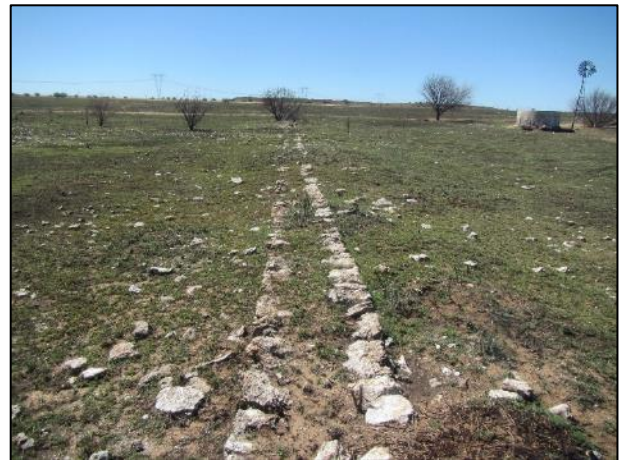
the early 20<sup>th</sup> century. Figure 24 shows a stone mound of unknown function but it is a historical feature (its orientation is incorrect for a grave and it lacks any other grave features). Figure 25 shows an example of a remnant calcrete foundation from which the entire wall has been removed. Smaller fragments of calcrete that would have been placed between the larger stones are lying on the ground but the larger rocks have all been robbed for reuse elsewhere – this is a common practice due to the high labour cost of obtaining new stones.

**Figure 25:** Foundation stones of a structure at waypoints 318-321.

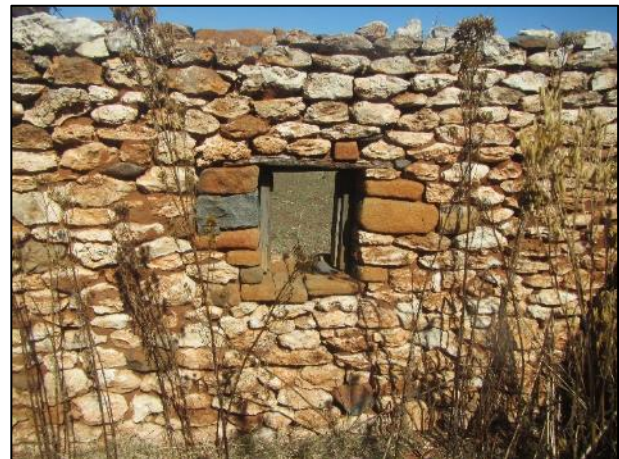
Several historical farm complexes were seen in varying states of repair, with a few of the structures perhaps better suited to reporting as built environment features. However, to keep them together, they will all be discussed together here. These are undoubtedly the most significant archaeological remains in the study area and illustrate the traditional building techniques and styles of the 19<sup>th</sup> and early 20<sup>th</sup> century. Figure 30 shows a small cottage at waypoint 293 built with the typical double skin method. Interestingly, while the outer skin is made almost entirely from dolerite cobbles with rare calcrete inclusions, the inner skin is the reverse pattern (Figure 31). This may have been due to the availability of stone but, given that calcrete does appear in the outer skin of this and a number of other ruins, it seems more likely to have been a stylistic decision. The door frame is missing but the wooden window frame survives. The flat roof is entirely missing.

**Figure 31:** *Detail at waypoint 293.*

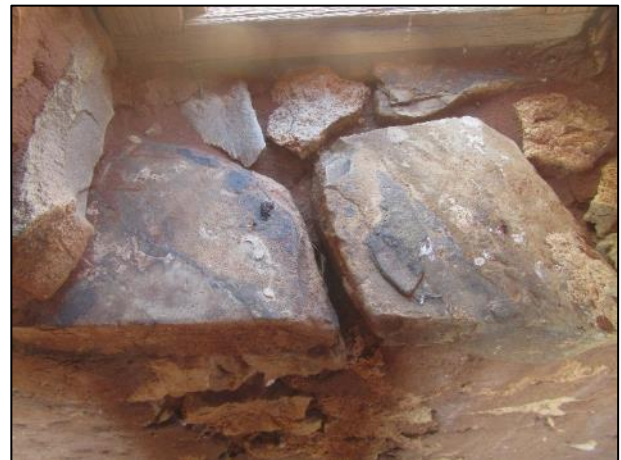
**Figure 33:** Windowsill in the cottage at waypoint 294.

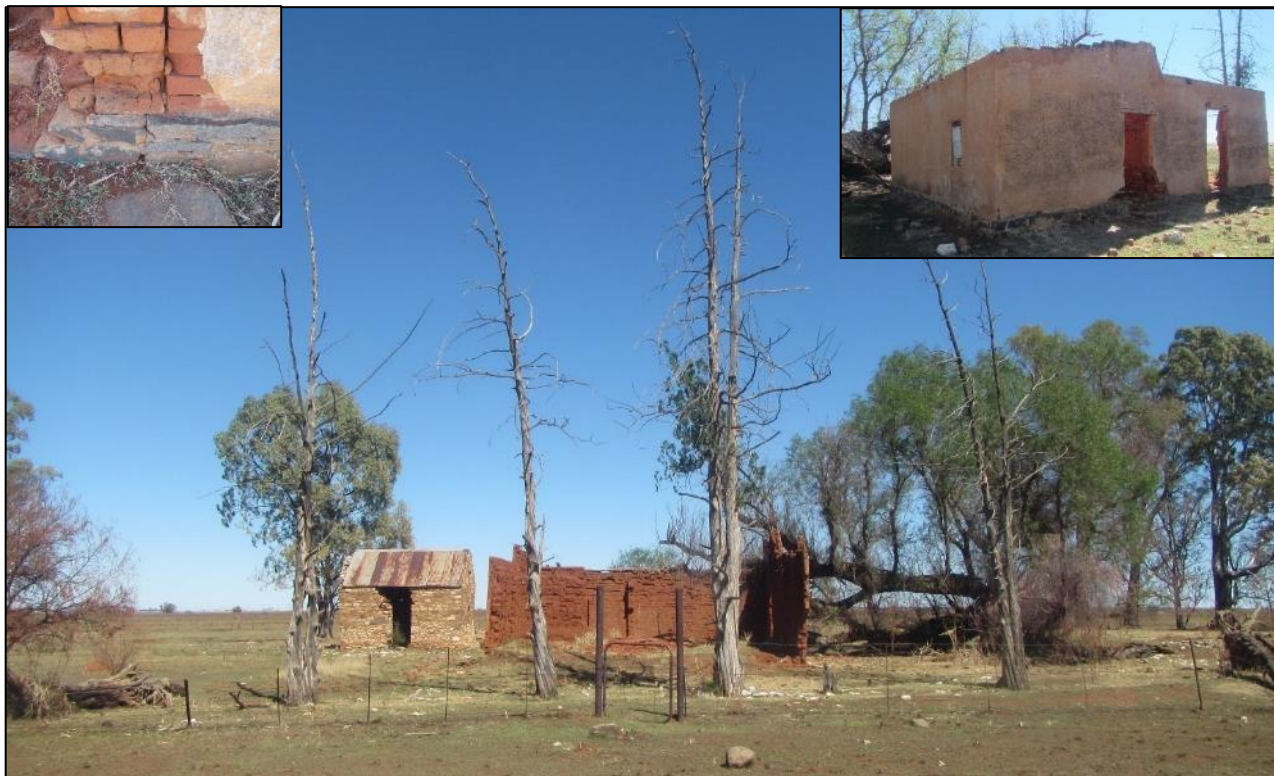
**Figure 34:** View of the farm complex with associated trees at waypoint 294 (roofed ruin) and 295 (red brick ruin). A line of cypress trees stands in the foreground, just behind the fence. Left inset: Brick wall on stone plinth. Right inset: southwest corner of house.

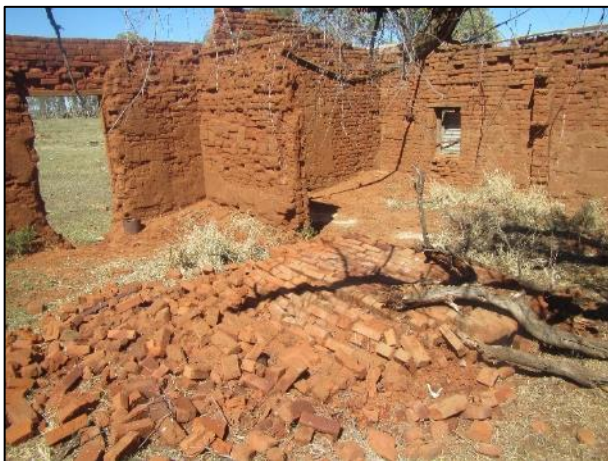
**Figure 36:** Interior of the brick house at waypoint 295.

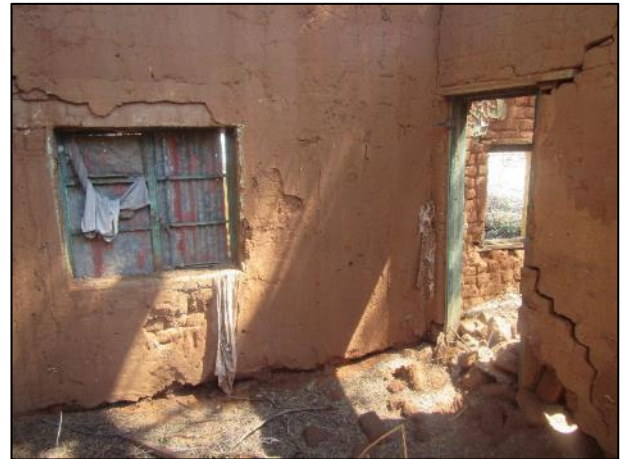
**Figure 40:** North end wall (left) and newer bathroom addition (right) at waypoint 301.

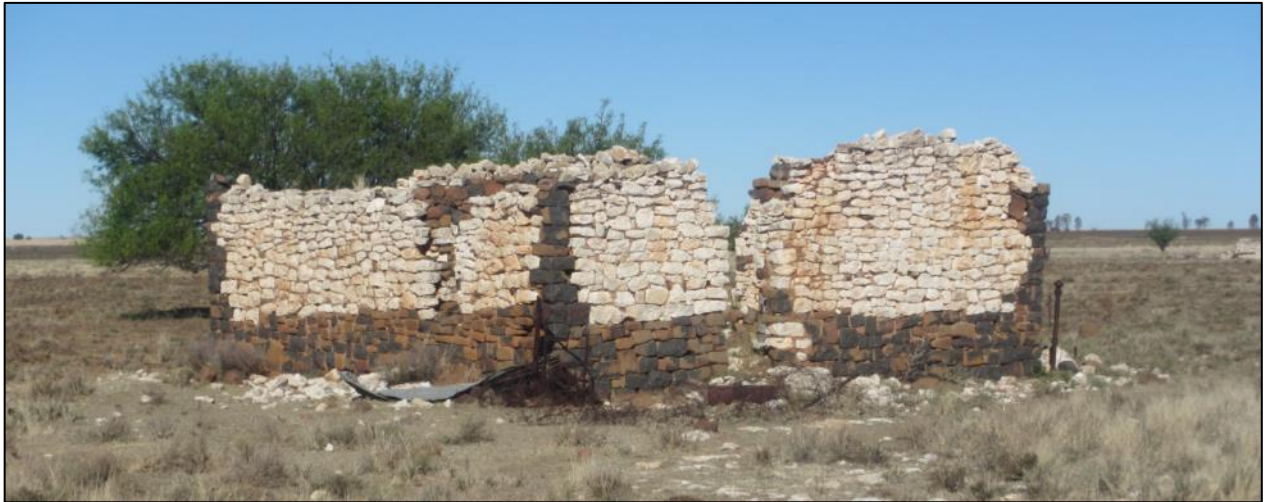
Another complex in the west contained a ruin with further evidence of stylistic influence in stone choice. While the outside has dolerite at the bottom and up the corners and calcrete above (waypoint 368; Figure 43), the inner walls have a mix but with calcrete and dolerite in clusters (Figure 44). The end result, especially on the outside, is very striking. A shallow water well lies nearby (waypoint 369; Figure 45). Although only 1.5 m deep now, this well might have been deeper originally. Wells often had rubbish disposed of in them and can prove to be valuable repositories of archaeological information.

**Figure 43:** *Calcrete- and dolerite-walled ruin at waypoint 368.*

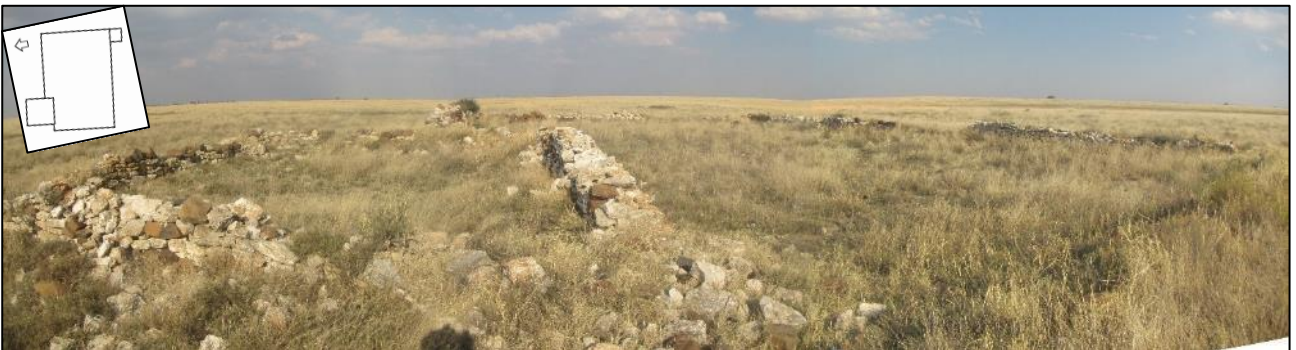
Another very poorly preserved complex lies just north of the pan in the western part of the study area. Three structures appear to have been present here, with two of them (waypoints 398 & 399) built in the same alignment. Figure 46 shows one of these two and is assumed to have been a house. Just to their south lies a kraal that has a main enclosure and two smaller ones (waypoint 401; Figure 47).

**Figure 47:** Remains of a stone-walled kraal at waypoint 401. The main enclosure stretches to the right in this view. Inset: Plan view rotated to match the orientation of the photograph.

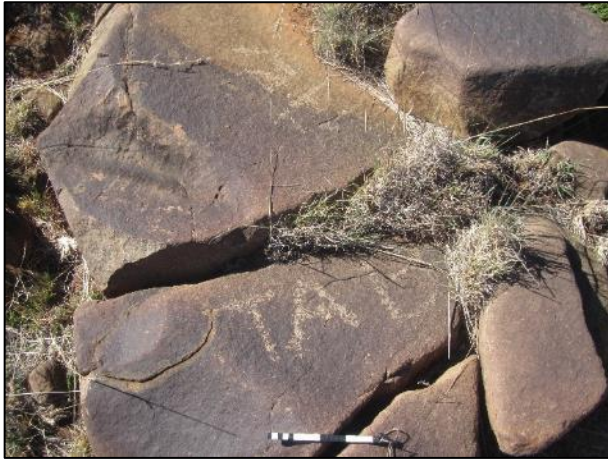
The last aspect of historical archaeology to consider is the various engravings/graffiti that were located on the dolerite ridge. Whether these are related to the stone ruins there can never be known, but the spatial relationship makes this quite possible. The engravings include names (e.g. waypoints 343 & 344; Figures 50 & 51), initials (e.g. waypoint 348; Figure 52) and an indeterminate motif (waypoint 344; Figure 53). These engravings were made by either pecking or scratching. The age of these engravings is also unknown. If younger than 100 years – which seems quite possible – then they would not be archaeology under the NHRA.

**Figure 50:** Example of historical pecked graffiti at waypoint 343.

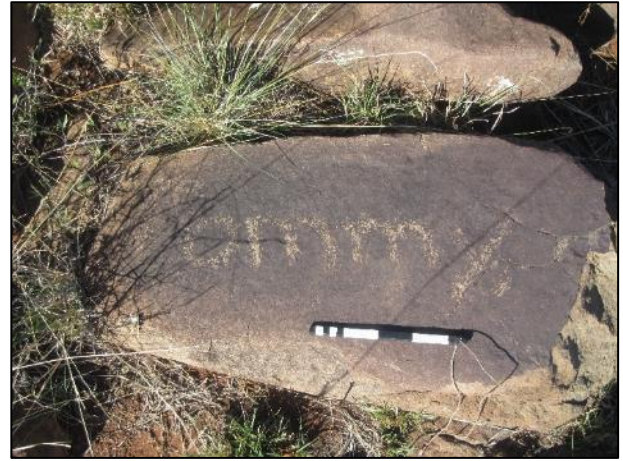
**Figure 51:** Example of historical pecked graffiti at waypoint 344.

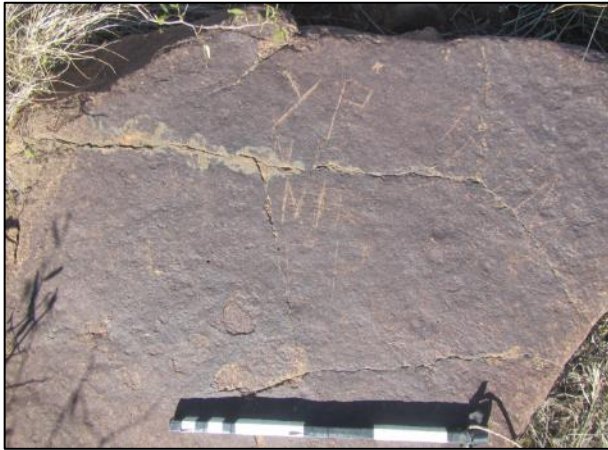
**Figure 52:** Historical scratched initials at waypoint 348. Scale in 1 and 5 cm intervals.

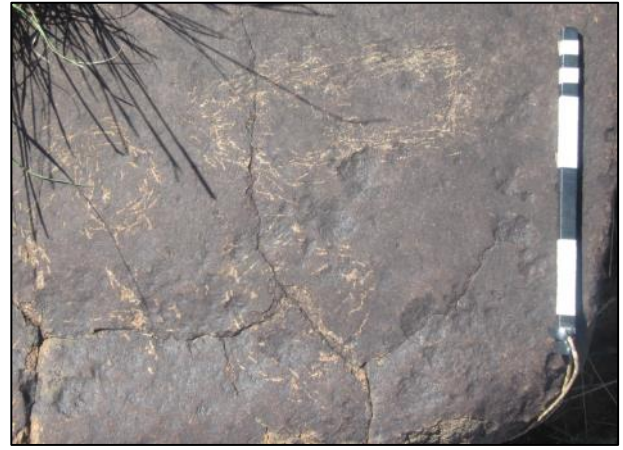
**Figure 53:** Indeterminate pecked motif at waypoint 344. Scale in 1 and 5 cm intervals.

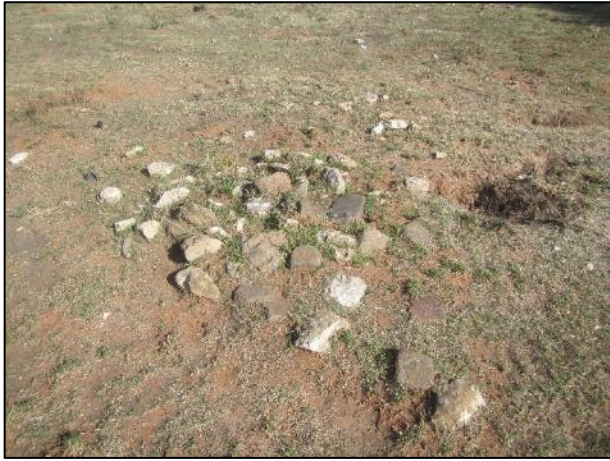
**Figure 54:** Possible grave at waypoint 384.

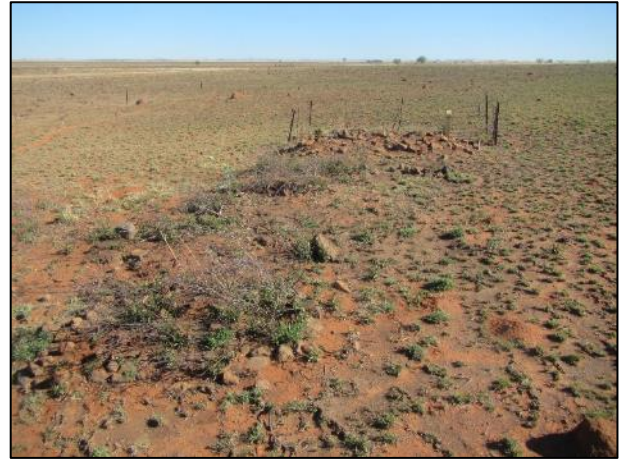
**Figure 55:** Graves at waypoint 362.

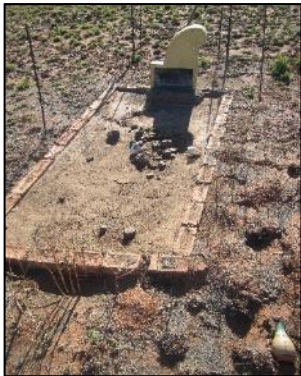
**Figure 56:** Grave at waypoint 362 with an illegible inscription.

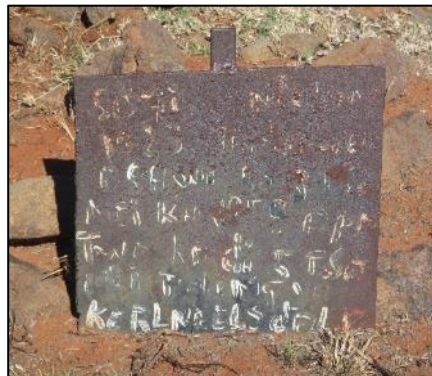
**Figure 57:** Grave at waypoint 362 possibly dated 1923.

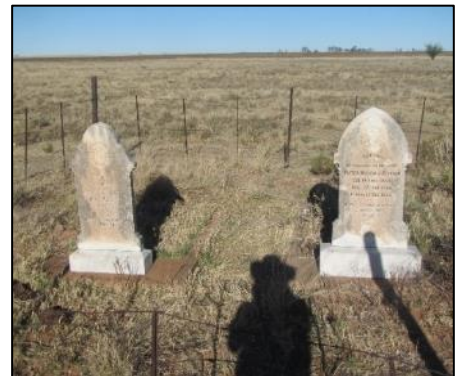
**Figure 58:** Graves at waypoint 376 with dates of 1935 & 1928.

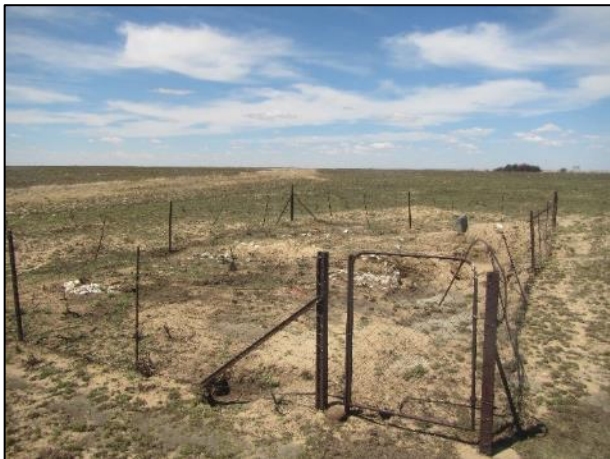
**Figure 59:** Graves at waypoint 381.

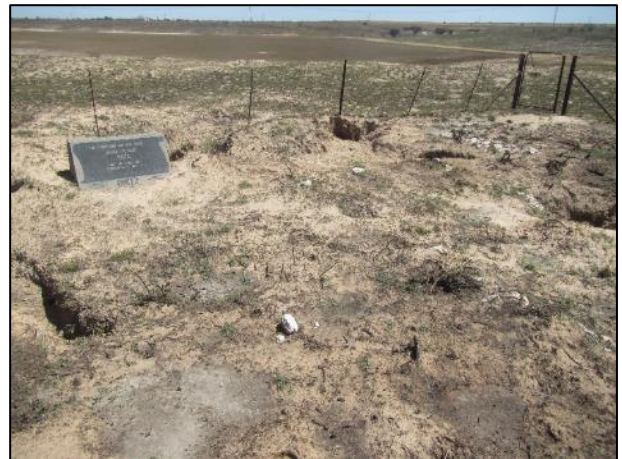
**Figure 60:** Grave at waypoint 381 dated 1914.

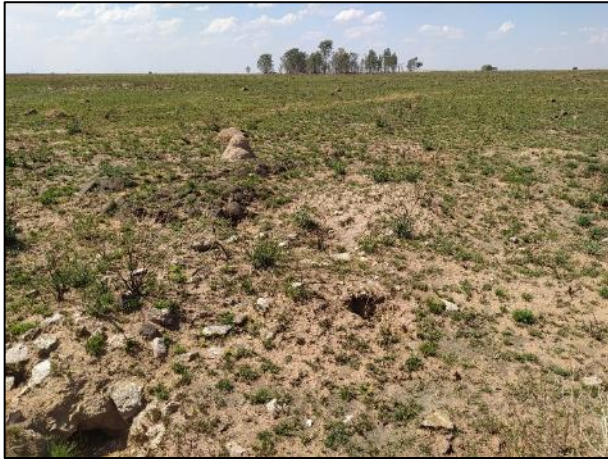
**Figure 61:** Poorly visible graves at waypoint 404.

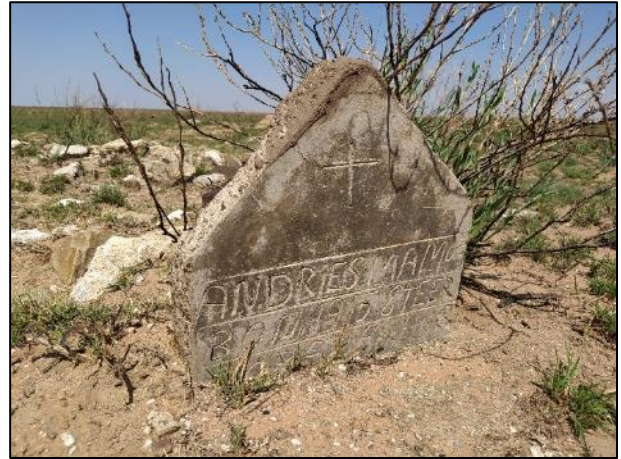
**Figure 62:** Grave at waypoint 404 dated 1915, but this may be a date of birth.

402	S28 48 23.6 E25 40 57.5	Very ephemeral background scatter of hornfels artefacts in an area of dolerite gravel exposure. Only three artefacts seen. Probably MSA.	Very low (GPC)
403	S28 48 32.3 E25 40 41.7	Piles of dolerite rocks have been removed from the old ploughed lands and dumped in the pan at this location. Not a heritage resource.	---
404	28 49 12.2 25 39 49.2	Set of graves found by another consultant. From the photographs, four graves appear to be present. Two have dolerite cappings and two calcrete with one of the latter also having a small cement headstone with a date of 1915 on it (this might be a birth date though).	IIIA

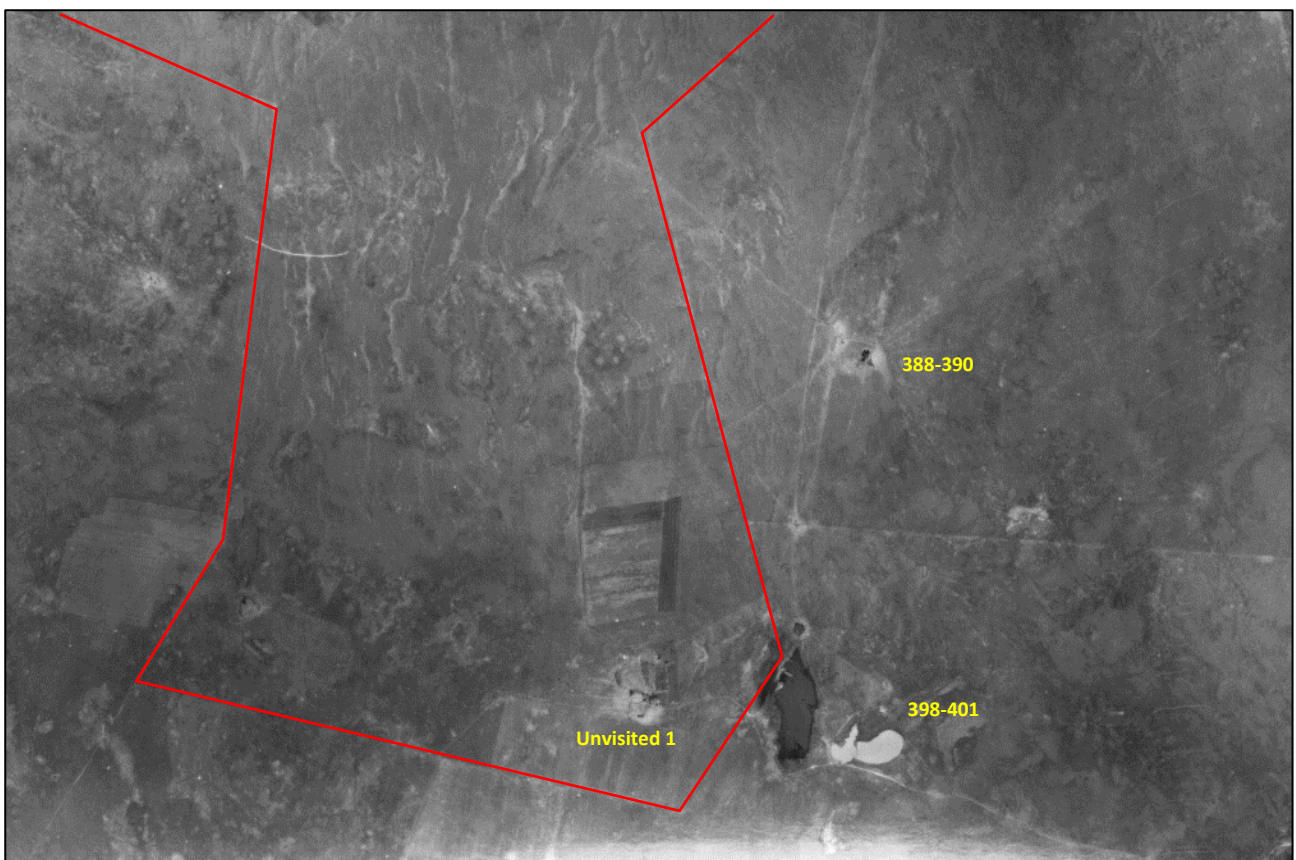
Figures 66 and 67 show aerial views of the study area from 1956. Some change is evident over the last 65 years. The ruin at waypoint 388 was still in use and the modern house and shed were not yet built. The waypoint 399-401 complex was already disused (as indicated by the lack of desire lines in the grass) and had probably already been in ruin for some time. The same applies to the one at waypoints 315-324, although its dam was still intact. The complexes at waypoints 368-377, 299-307 and 291-298 appear to have been still fully functional. All three of these are now completely ruined. The latter is shown as having had a single labourer's cottage to the west with another to the north and a third to the east. While a ruin marks the location of the eastern one, the other two have both been completely removed. The stone-walled features on the dolerite ridge are not at all visible on the 1956 imagery. It is evident from these images that structures built without cement can deteriorate very quickly once their roofs are removed. It is likely that joinery and rocks were frequently removed for reuse elsewhere which greatly exacerbates the degradation.

**Figure 66:** Aerial photograph from 1956 (377\_002\_05062) showing four farmsteads in the north-eastern part of the study area (waypoint numbers indicated).
