PARLIAMENTARY PRECINCT: OLD ASSEMBLY BUILDING: CAPE STORES: STRUCTURAL REPAIR WORK

C2567 / 31058-REP-001 REV 0

CONCEPT & VIABILITY REPORT

MAY 2016

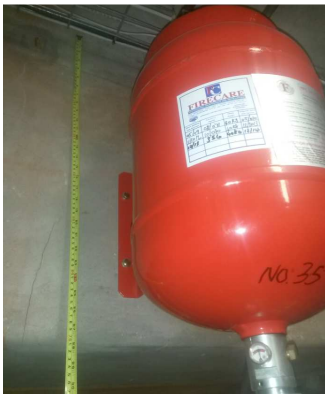
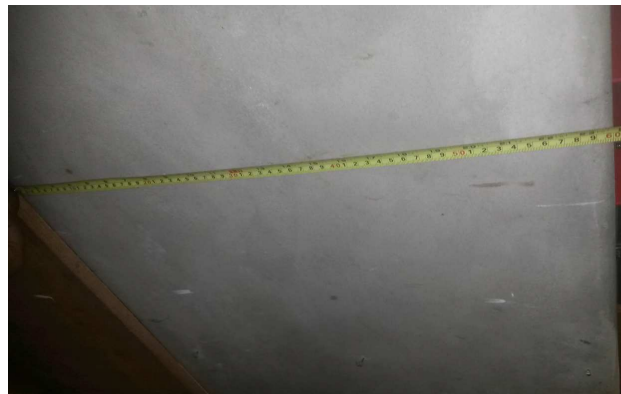
Photo 4.3.3 & 4.3.4: Downstand Reinforced Concrete Ring beam inside basement (700dp x 600 wide)

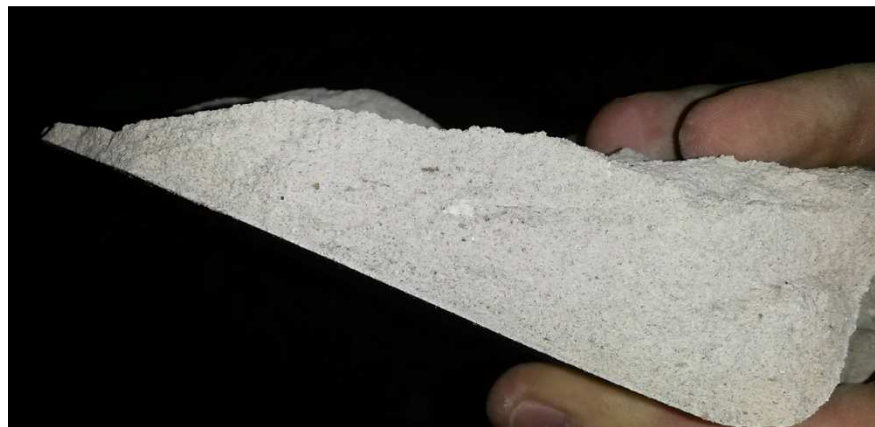
Photo 4.5.8 40mm thick cementitious plaster

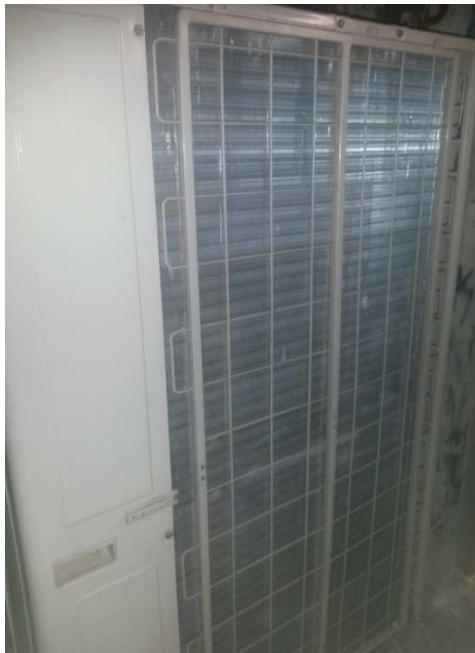
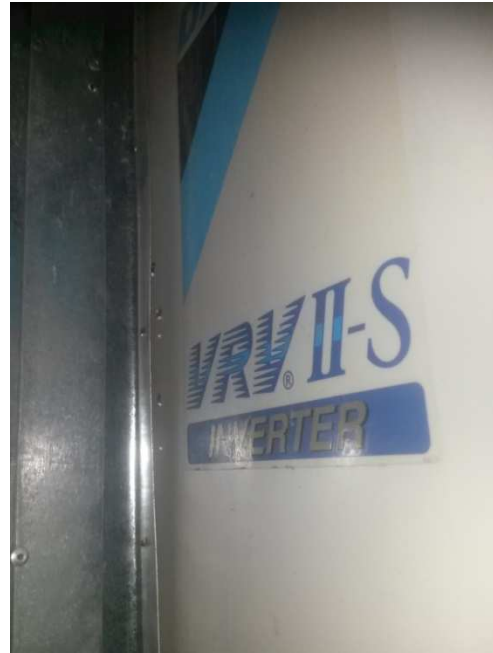
Photo 4.6.5 & 6: Passage 2 - Inverter at far end of basement underneath outside staircase clad with granite, servicing airconditioner units on the floor above the basement

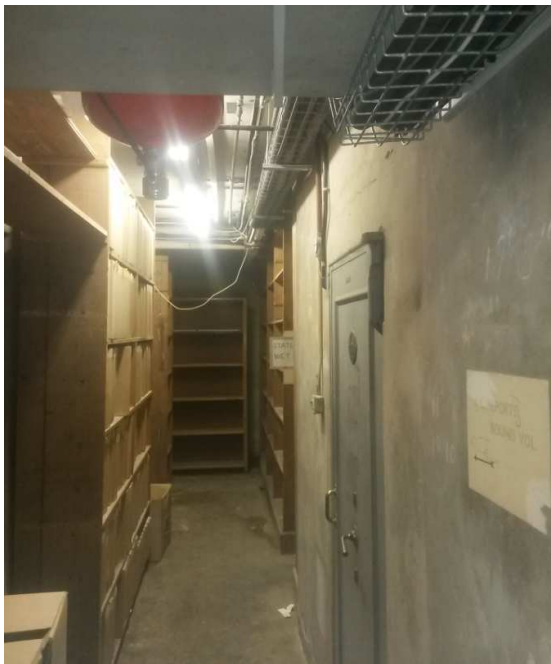
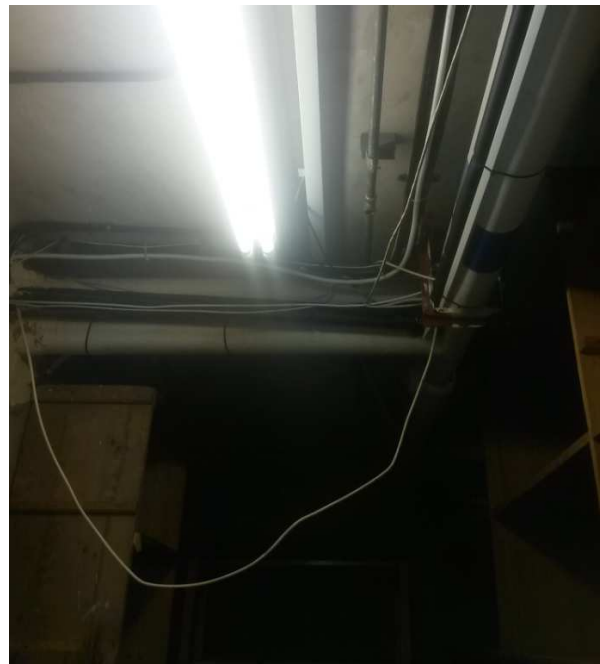
Photo 4.6.29 & 30: Basement safe area with overhead services

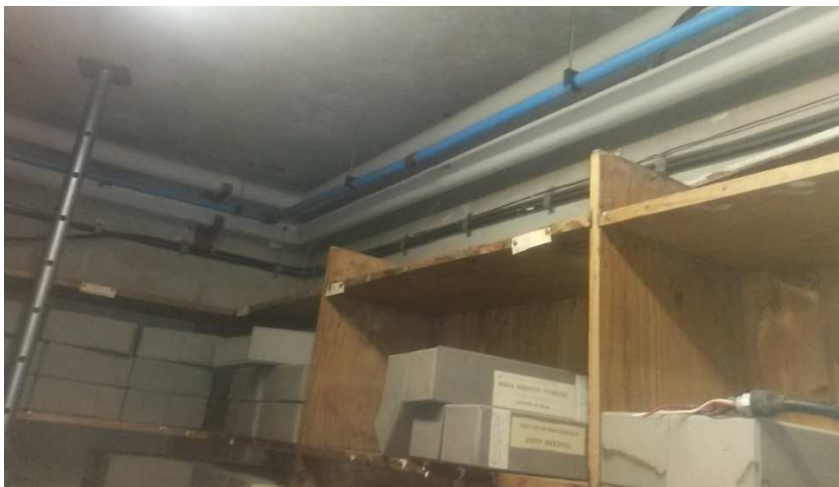
Photo 4.6.31 & 32: Services at far right corner of basement (close to safe)

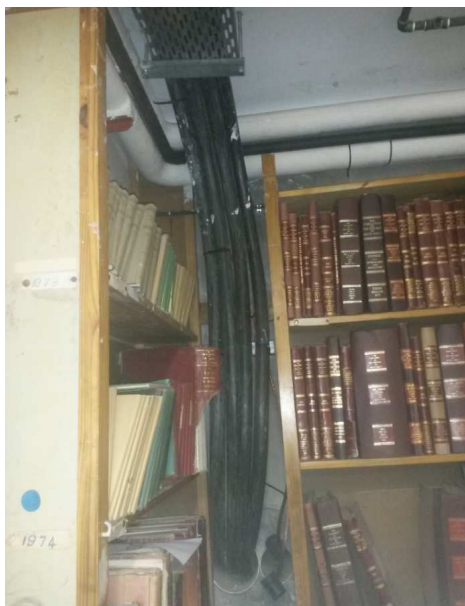
Photo 4.5.36 & 37: 4x Black PVC conduits entering the basement on the near left corner of the basement

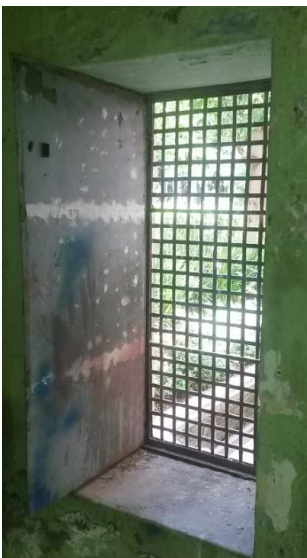
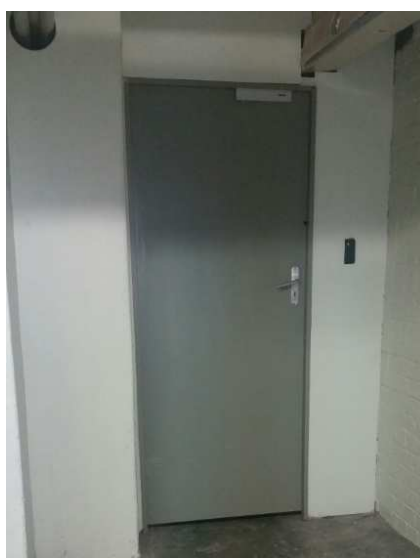
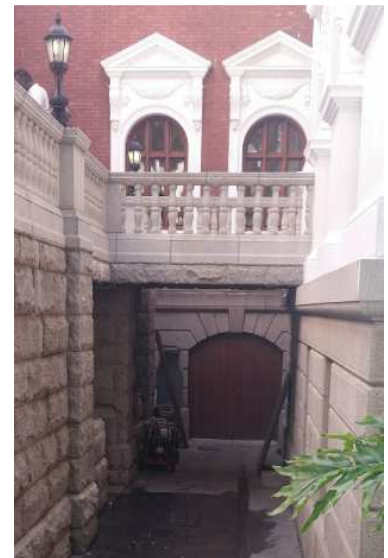
Photo 4.6.17, 18 & 19: Potential basement access points during the construction works
