Native Hostel (Compound)

5.3.2.2 Mine Area B

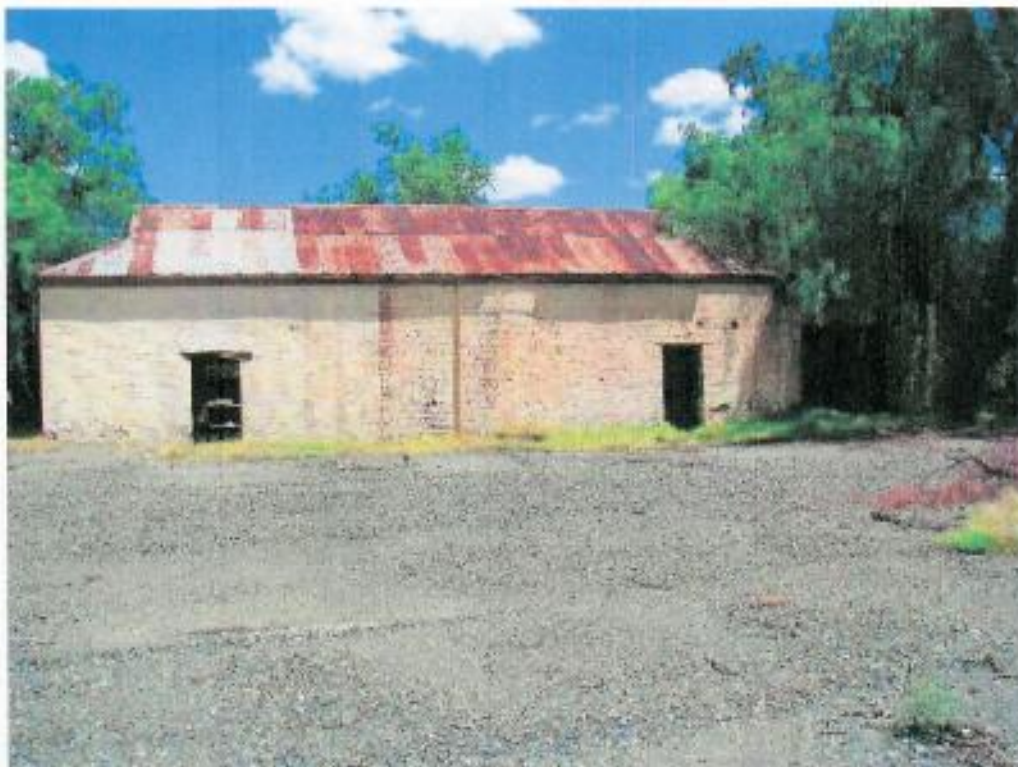
Figure 131: Northern view of Isolation Ward

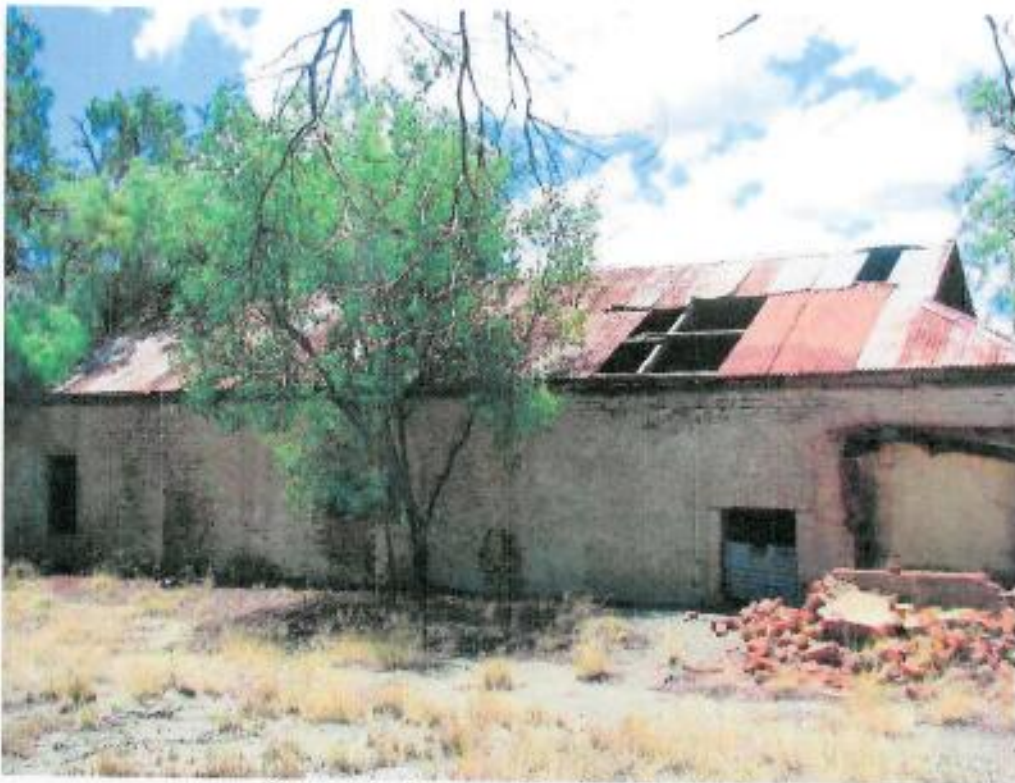
Figure 132: Southern side of Isolation Ward
