**Jagersfontein Heritage Impact Assessment
Structures: Mine Area b
31/03/2009**

5.3.2.3 Central Section

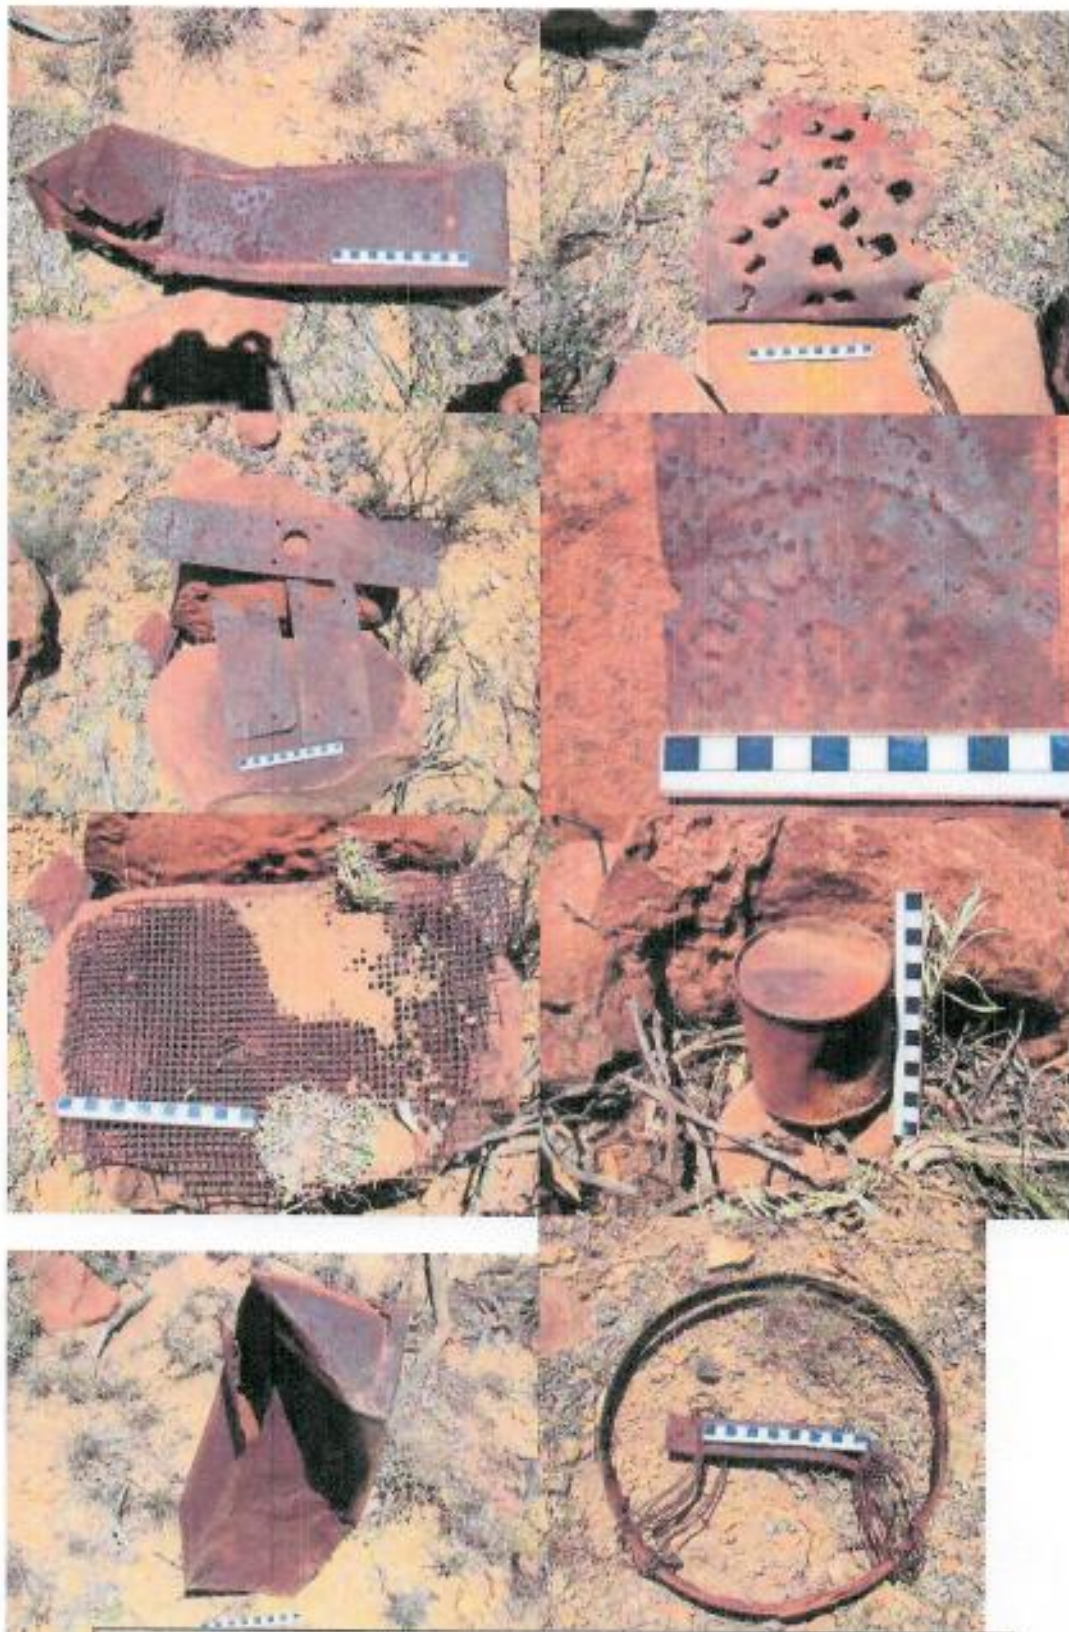
Figure 189 (group): Various items found in hill between dam and graveyard

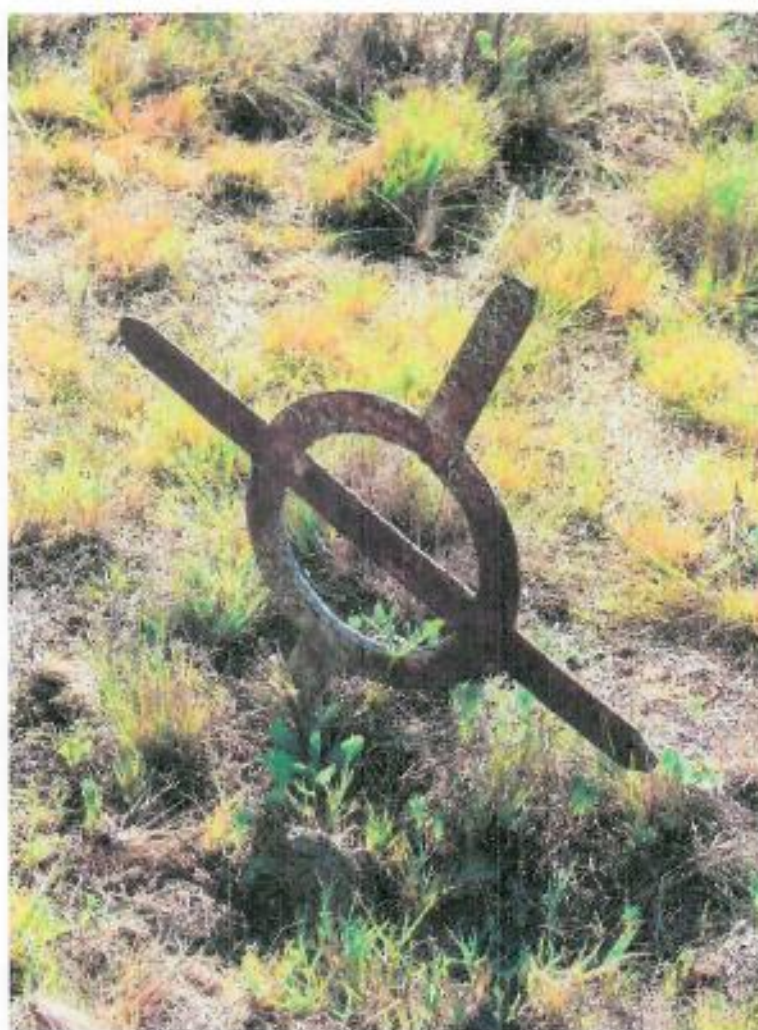
This entire burial area is in need of maintenance and repair and requires urgent attention.

Figure 190: Cross on grave in "formal" section

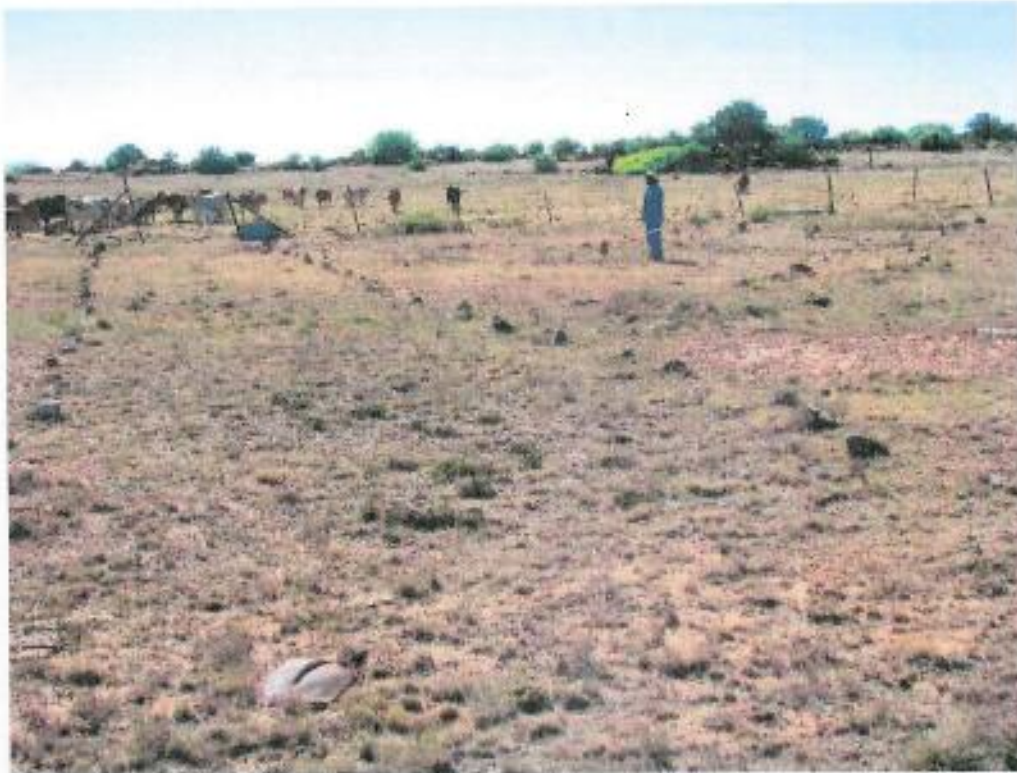
Figure 193: Path running north to south

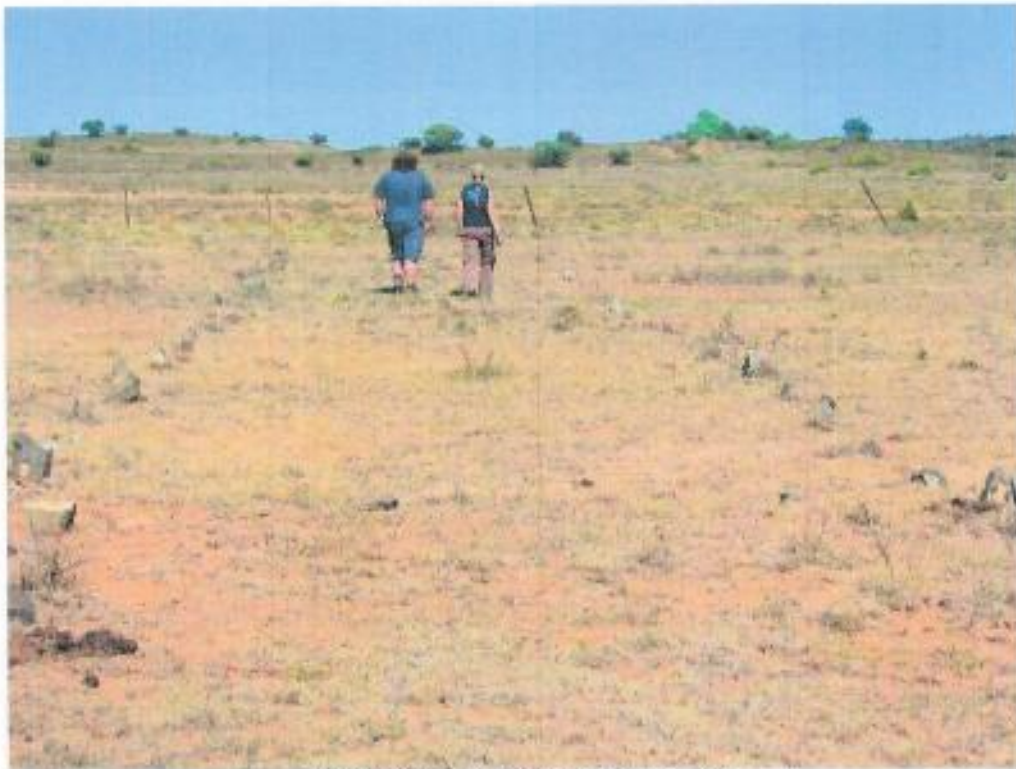
Figure 194: Path running east to west

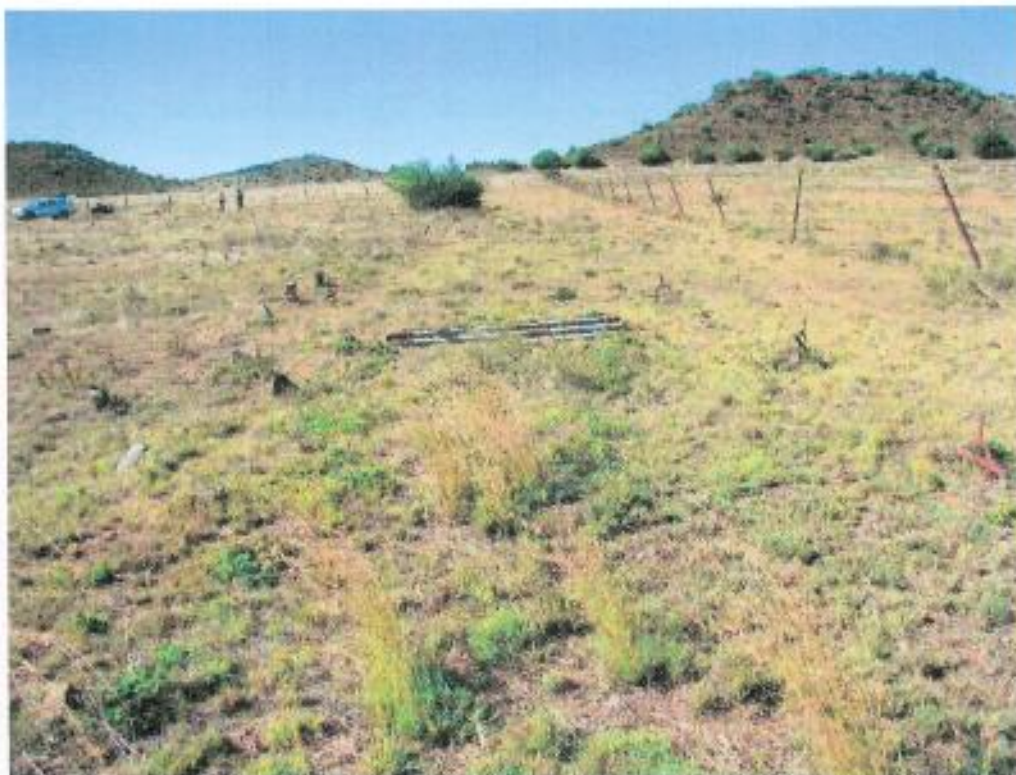
Figure 195: Formal section of burial area (orientation south)

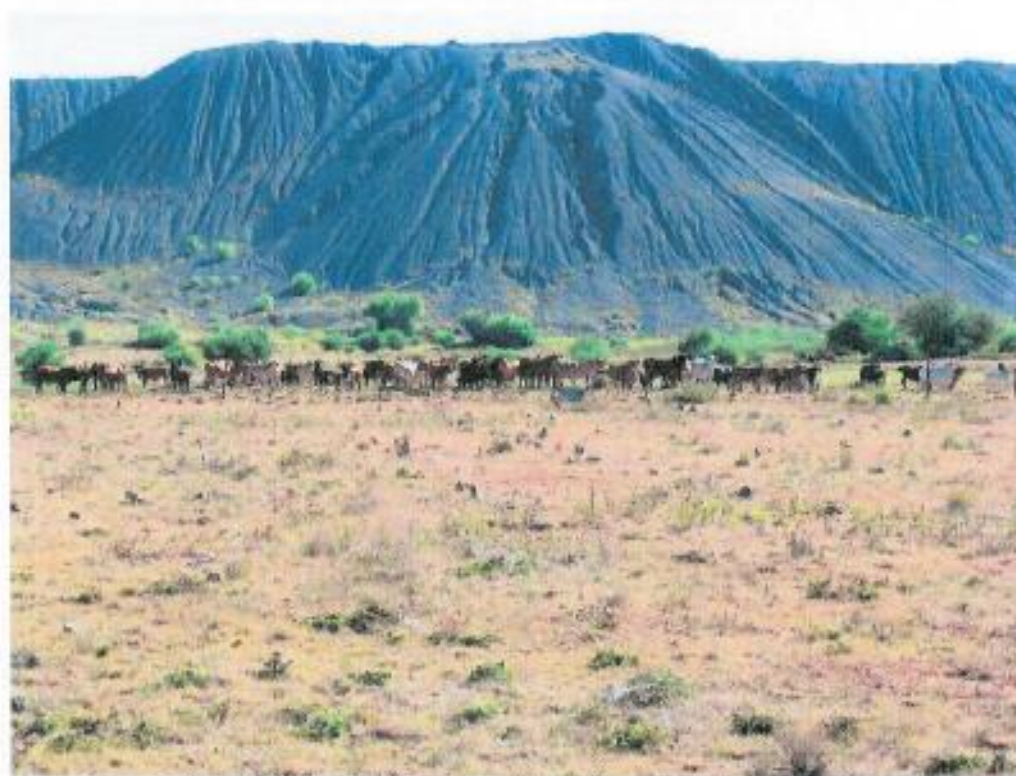
Figure 196: Informal section of burial area (orientation north)

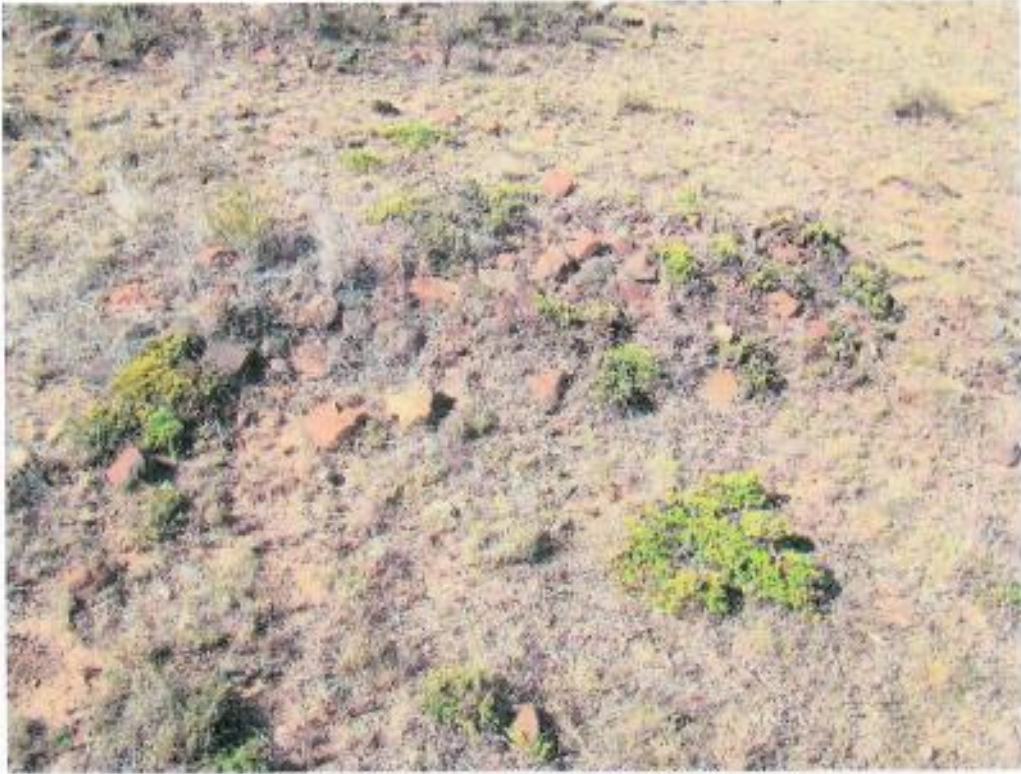
Figure197: Grave with packed stones (formal area)

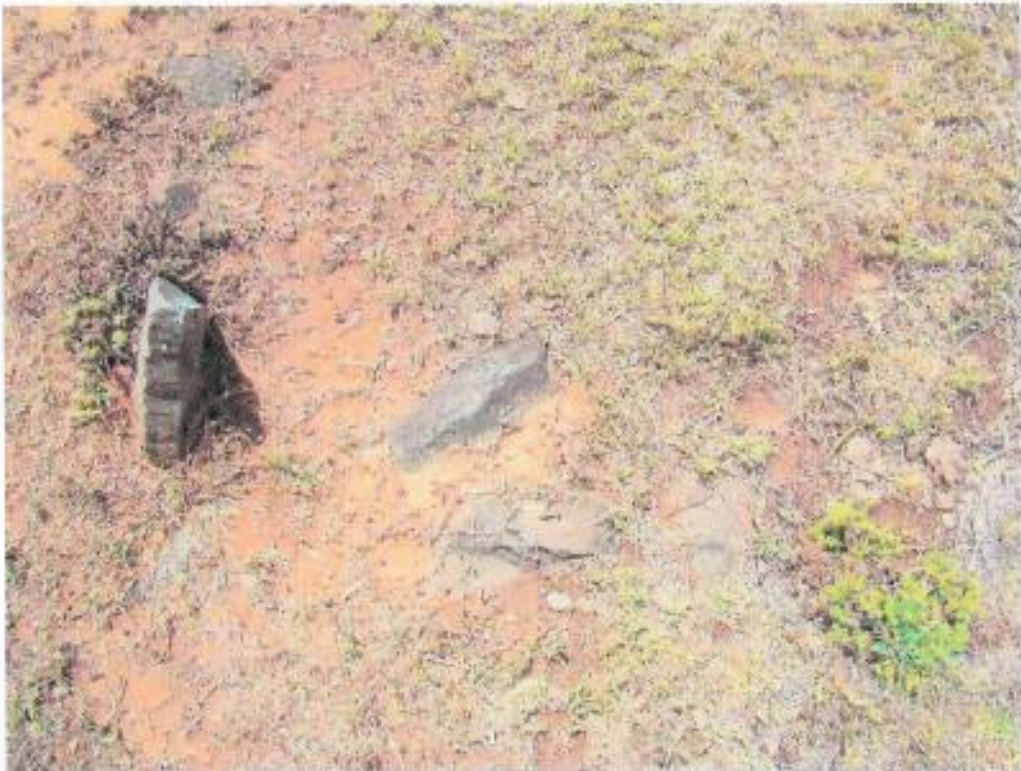
Figure 198: Grave with packed stones (informal area)

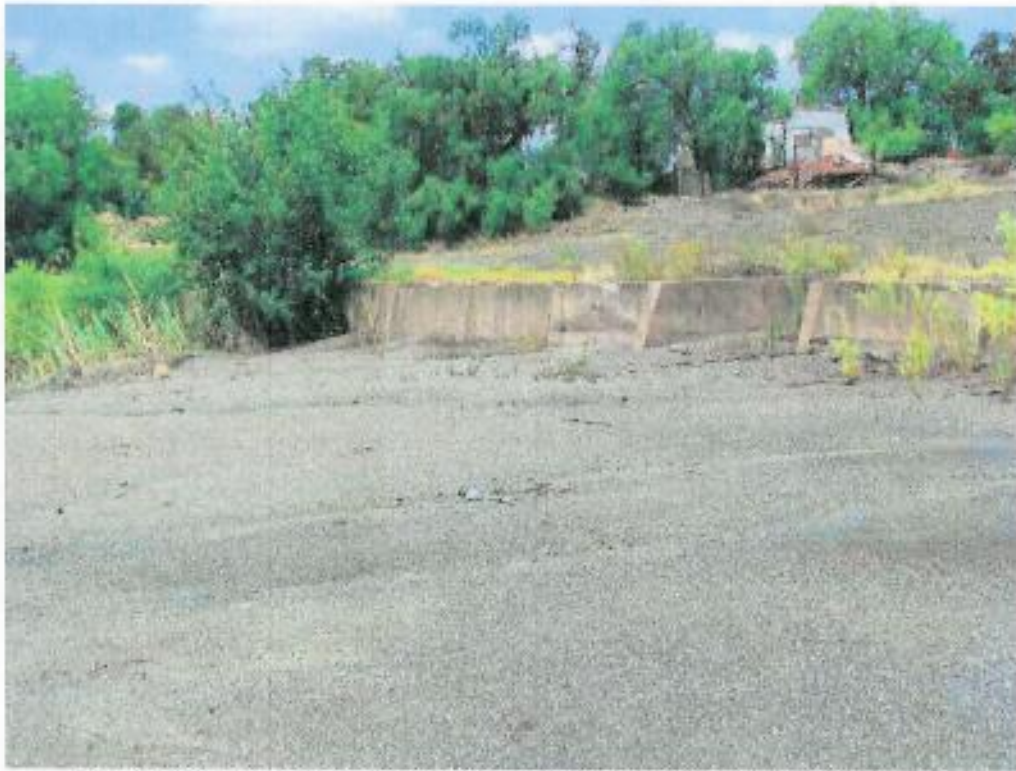
Figure 207: Remains of Power Station (remains of mine stores in background)

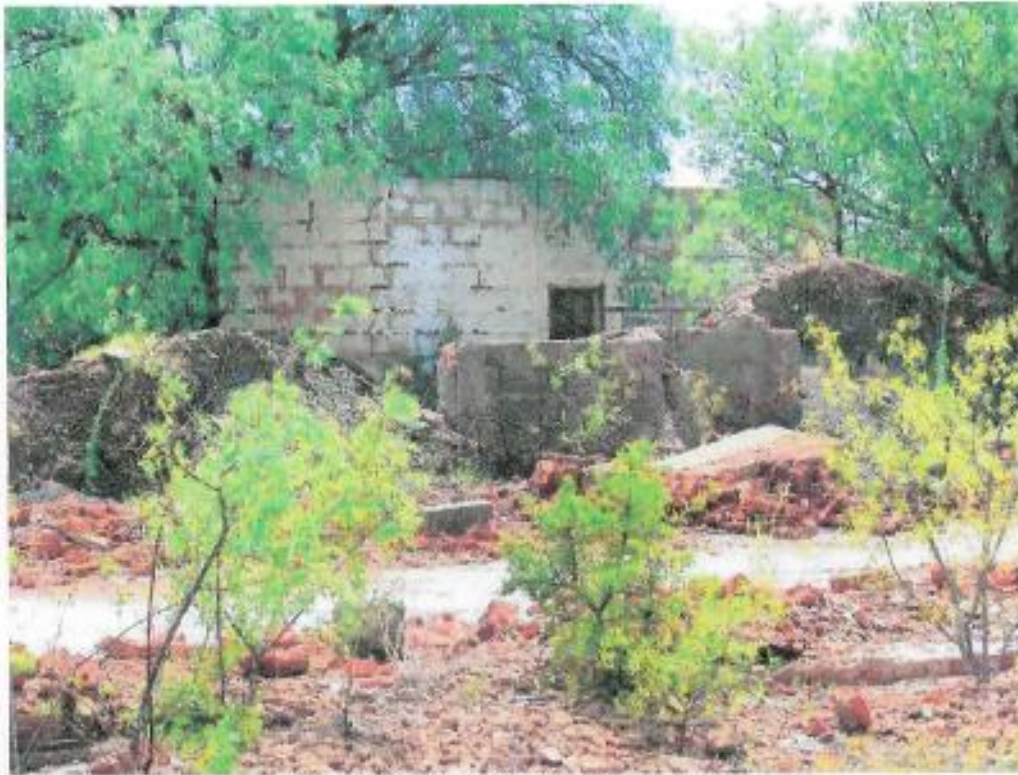
Figure 209: Remains of Mine Stores (1)

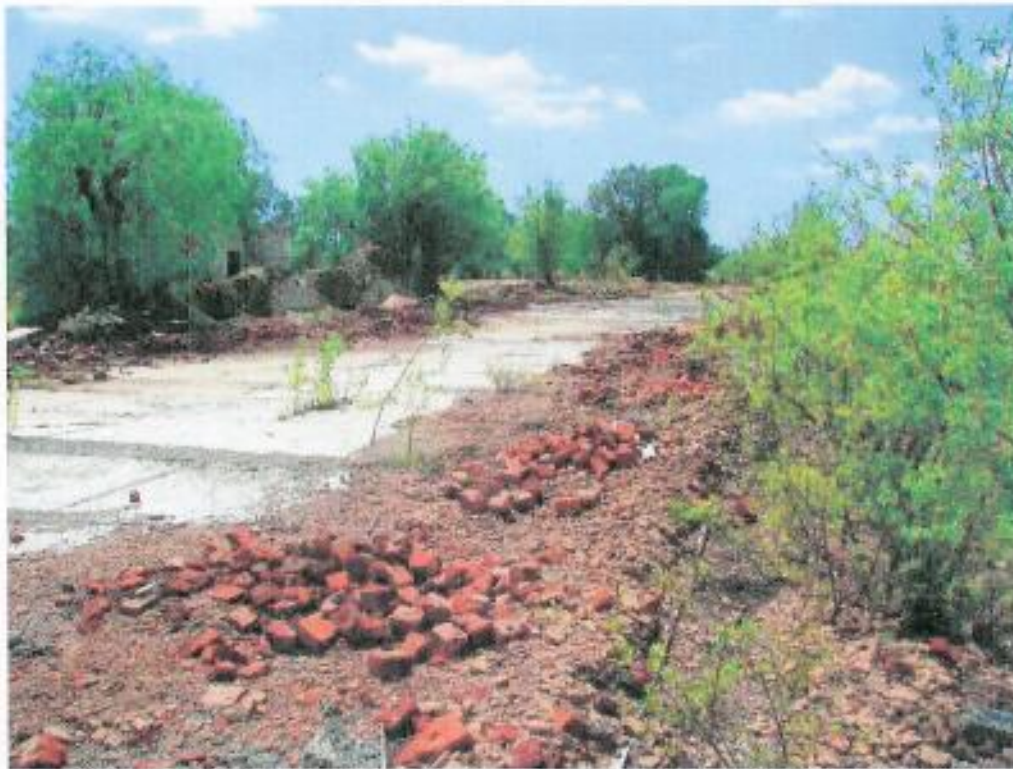
Figure 210: Remains of Mine Stores (2)

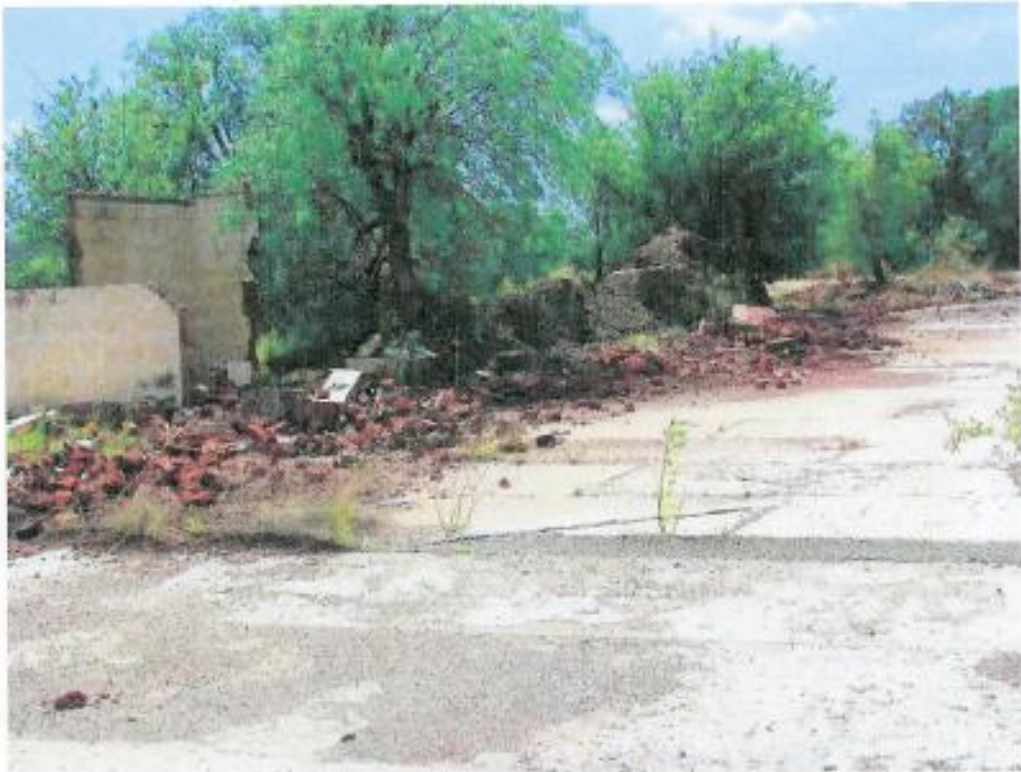
Figure 211: Remains of Mine Stores (3)

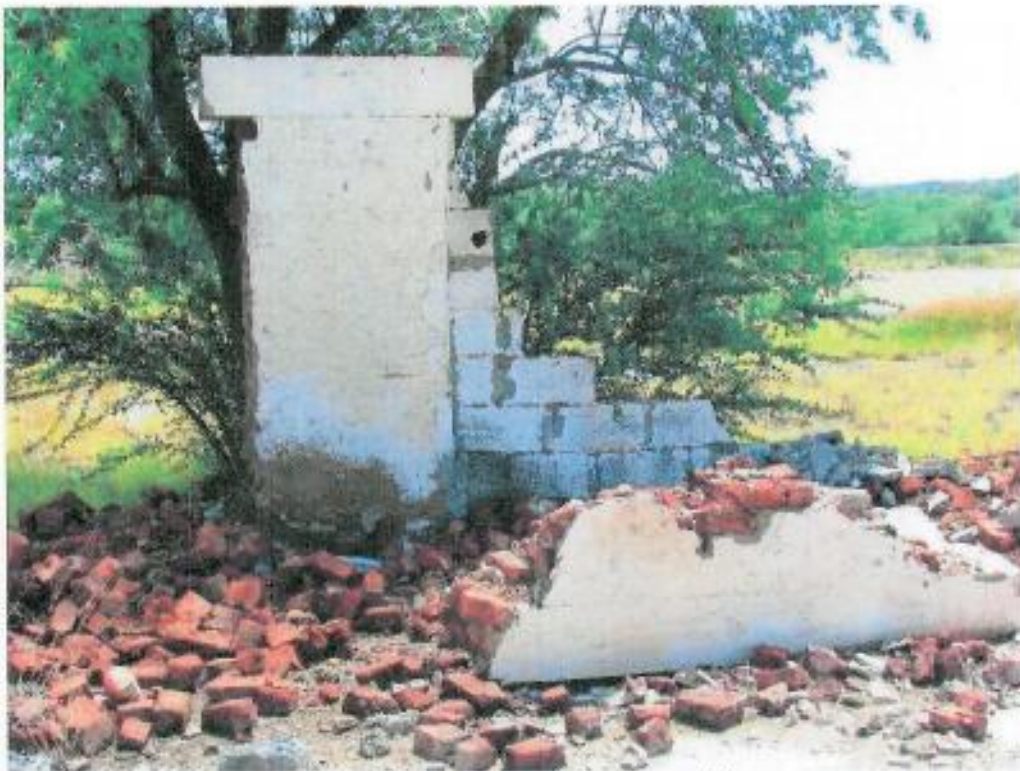
Figure 212: Remains of Mine Stores (4)

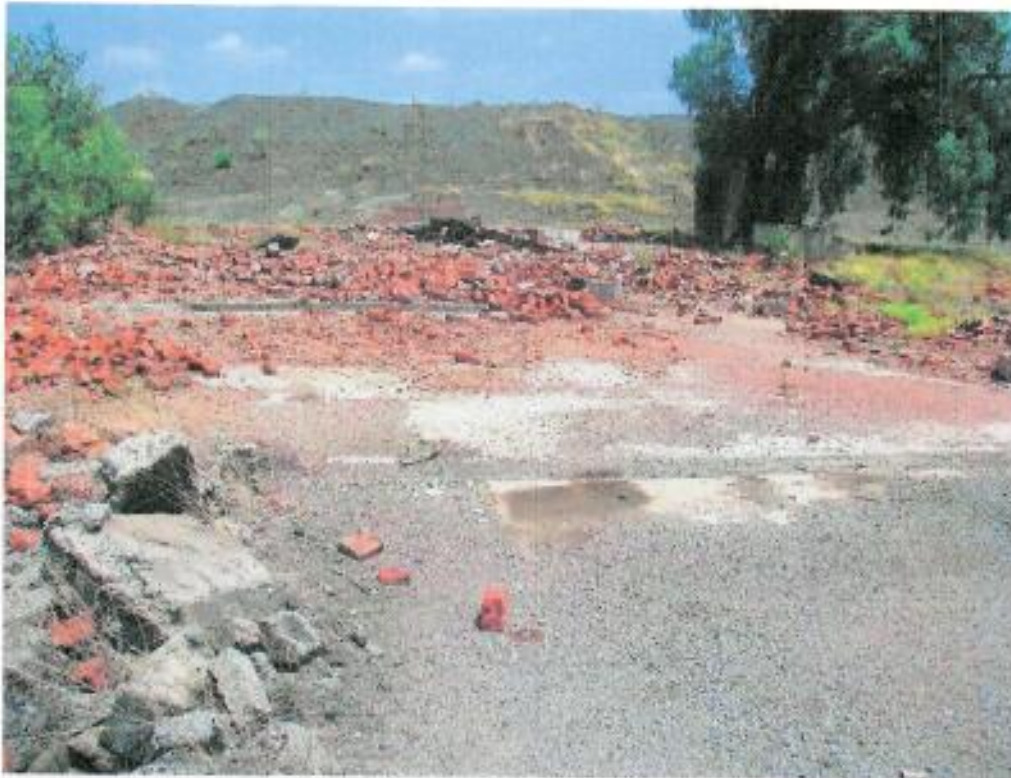
Figure 213: Remains of Mine Stores (5)

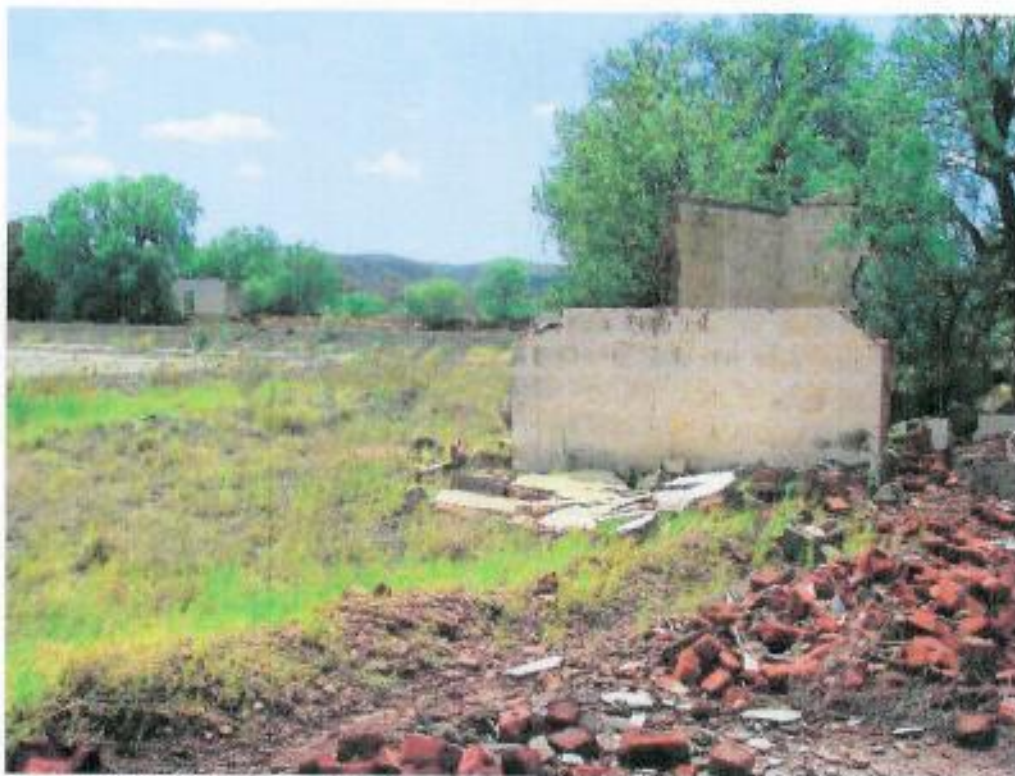
Figure 214: Remains of Mine Stores (6)

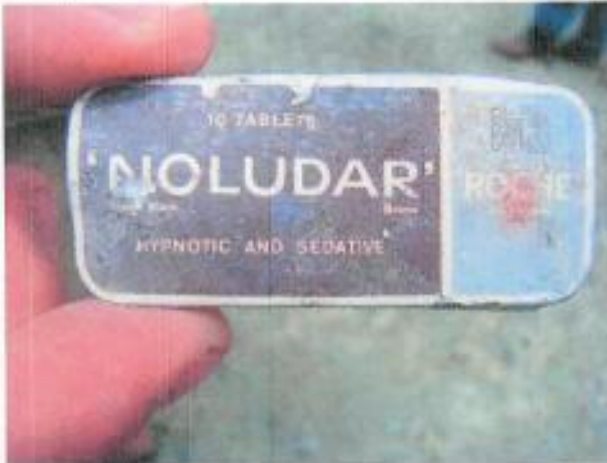
Figure 215: Container of "Noludar" found on rubbish dump.

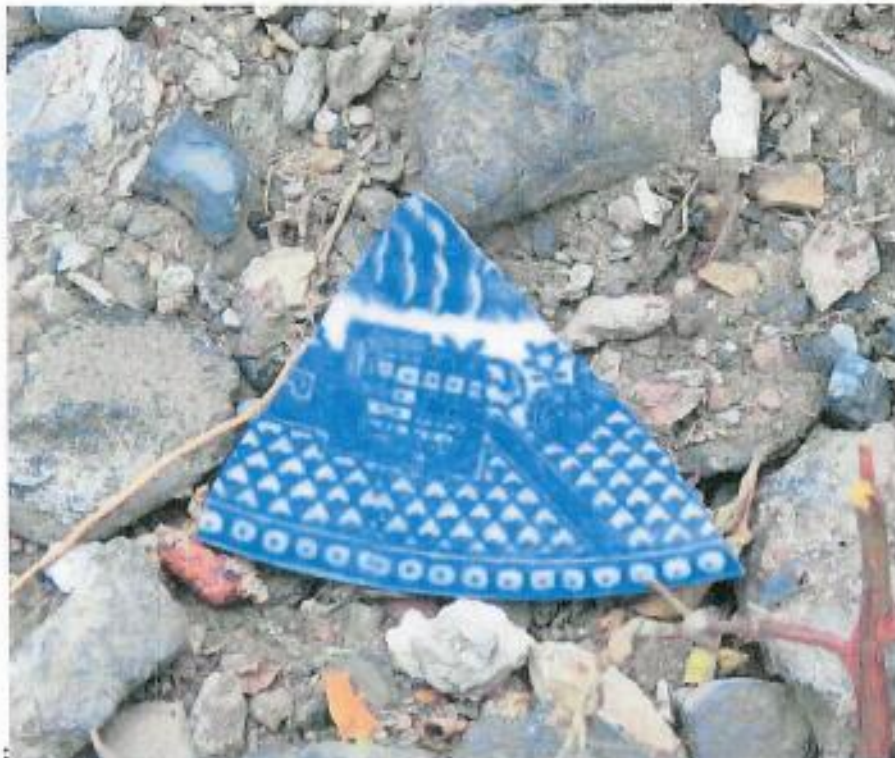
Figure 216: Ceramic sherd from rubbish dump

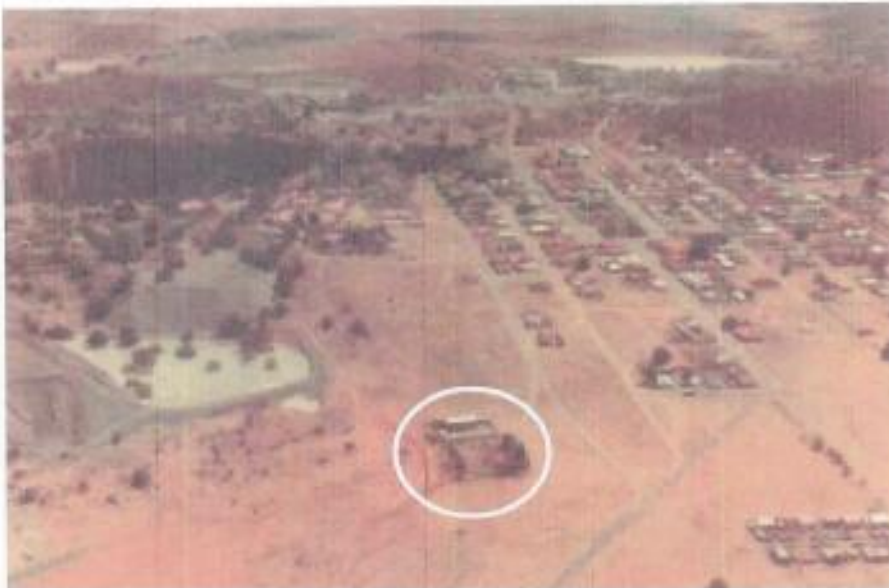
Figure 227: 1960's aerial photograph - encircled area is the "coal depot"

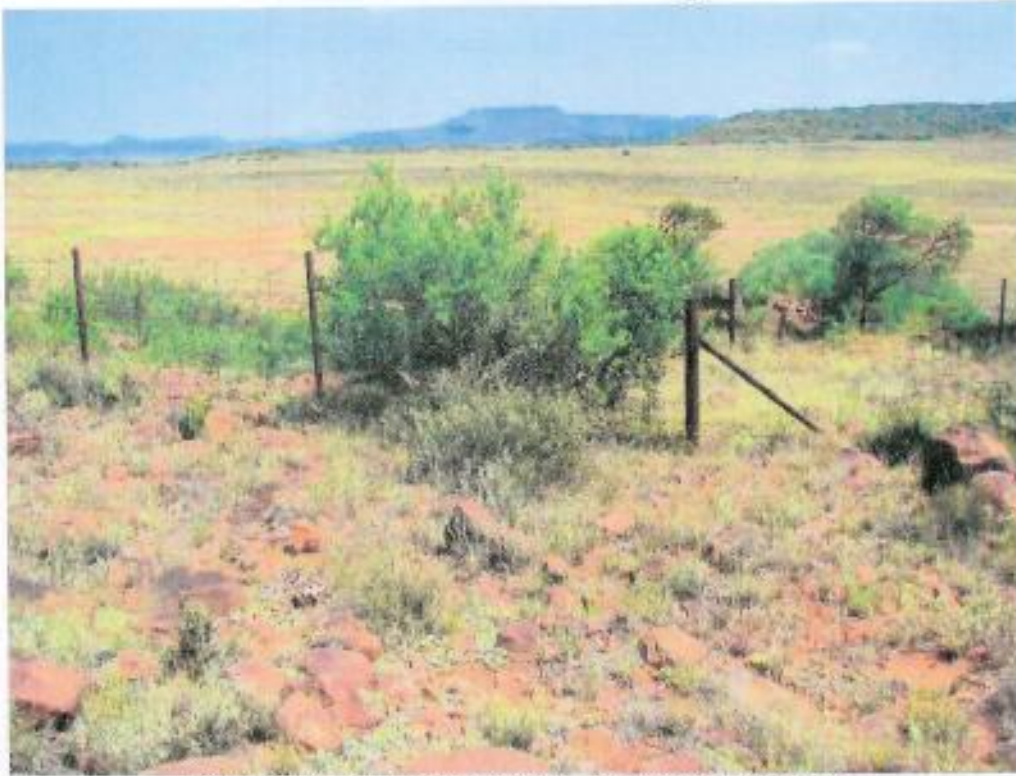
Figure 238: Small fenced off area - possibly an animal pen

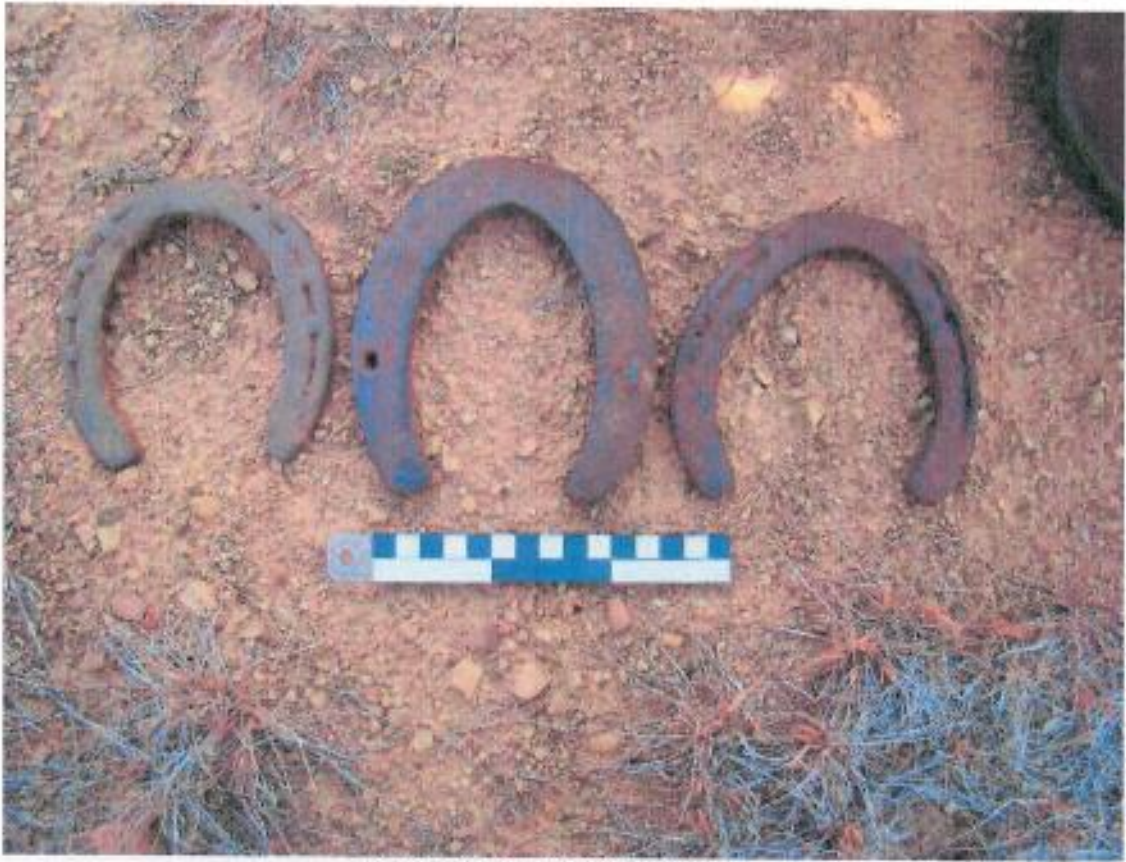
Figure 240: A variety of horseshoes

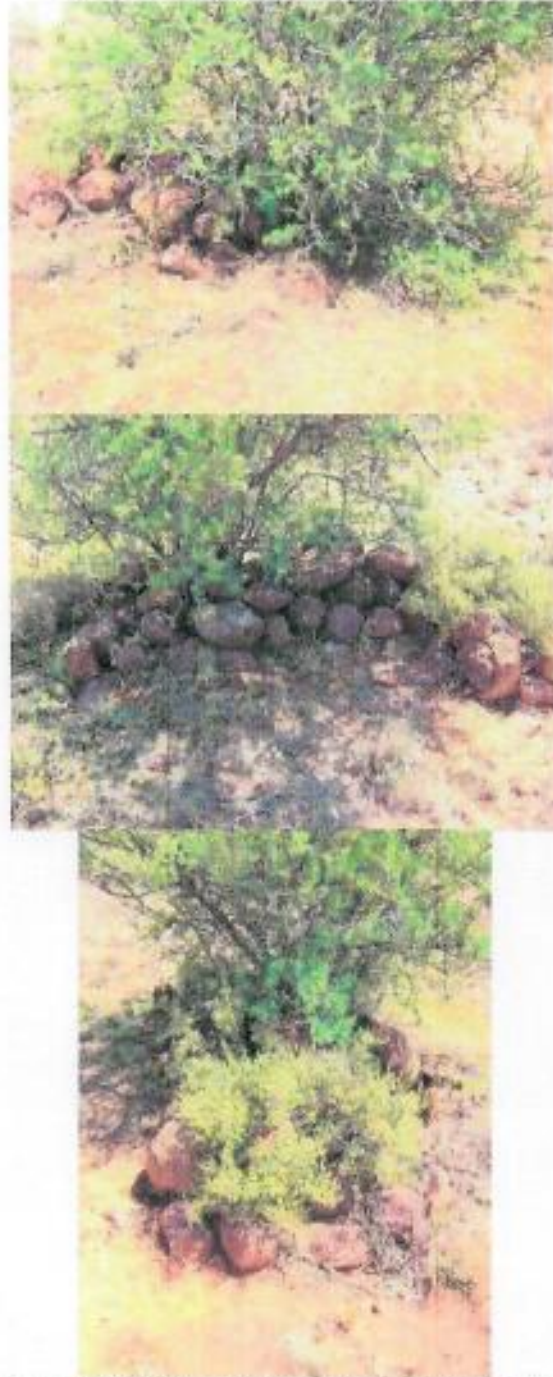
Possible grave

A single possible grave on the south-eastern side of the airfield strip might date to a much earlier period and not have any relation to the mine. Apart from evidence that cattle was kept on top of the ridges on the western side, a small animal pen from more recent type fencing was found on the ridges on the southern side.

Figure 241 (group): Single grave photographed from different sides

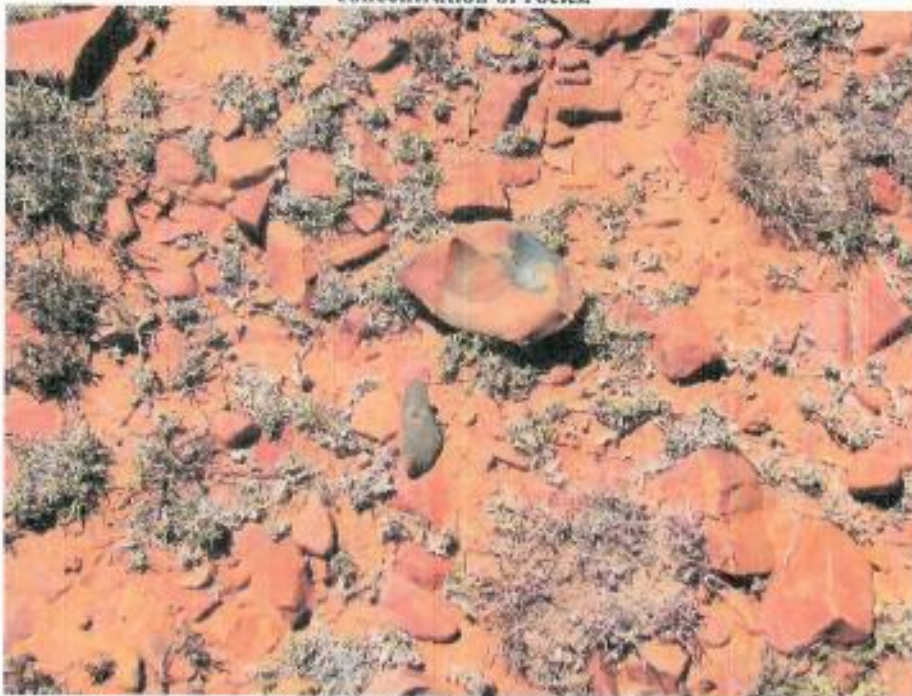
Figure 243: Core and flake

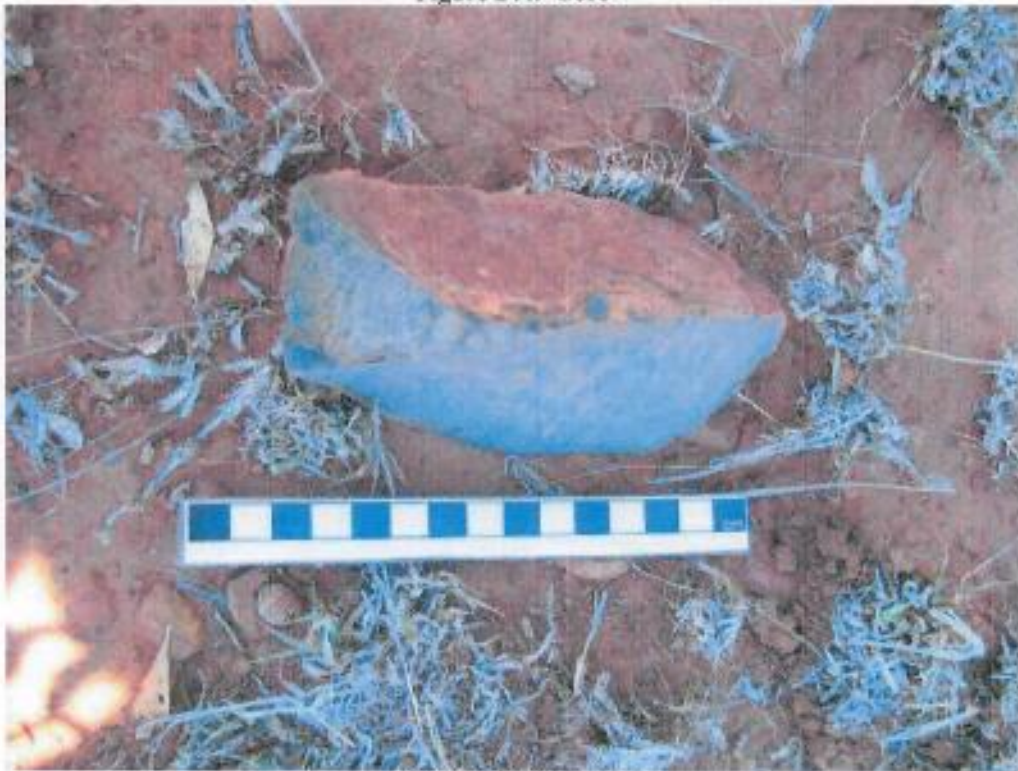
Figure 245: Core flake

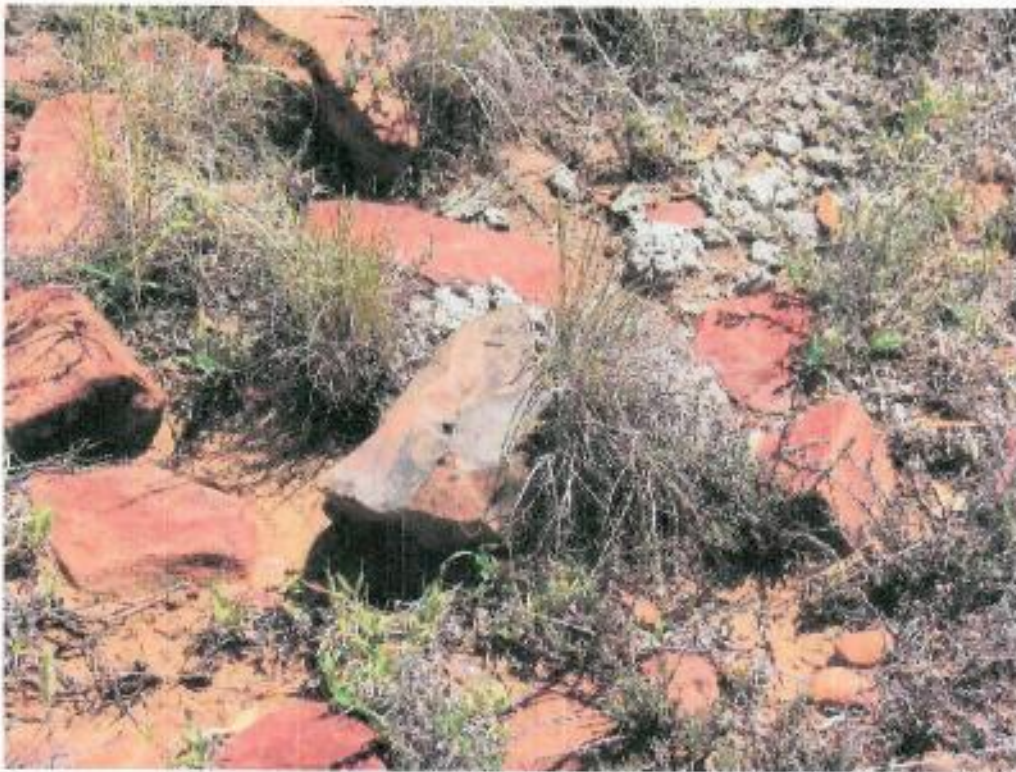
Figure 247: Core

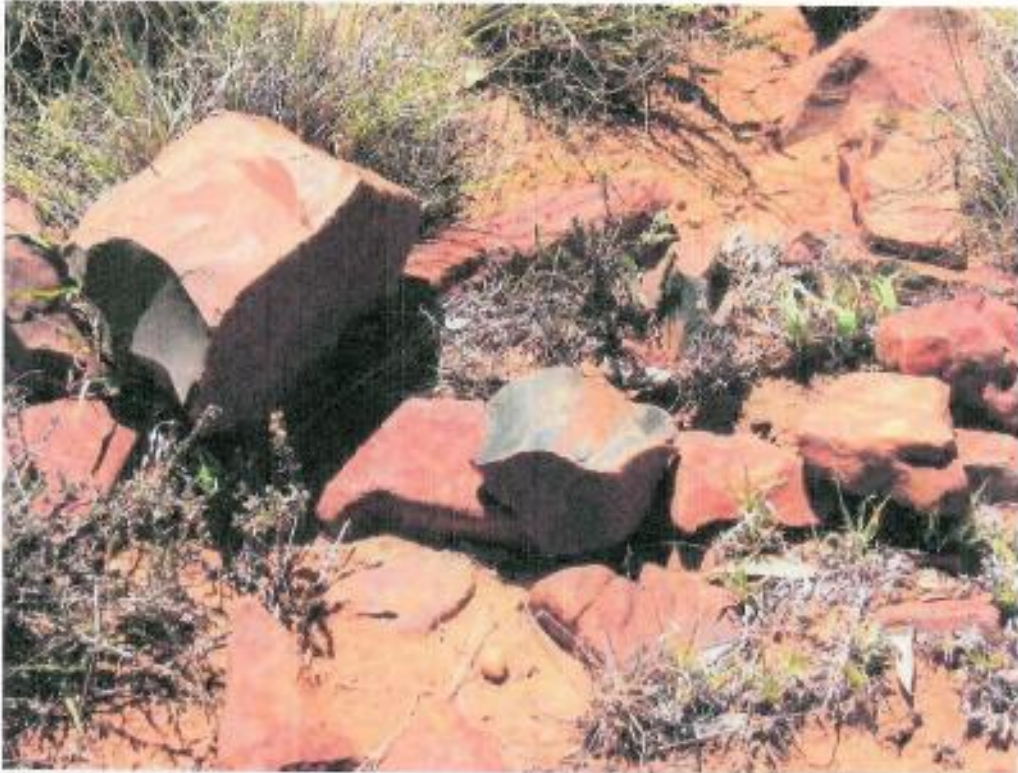
Figure 248: Cores

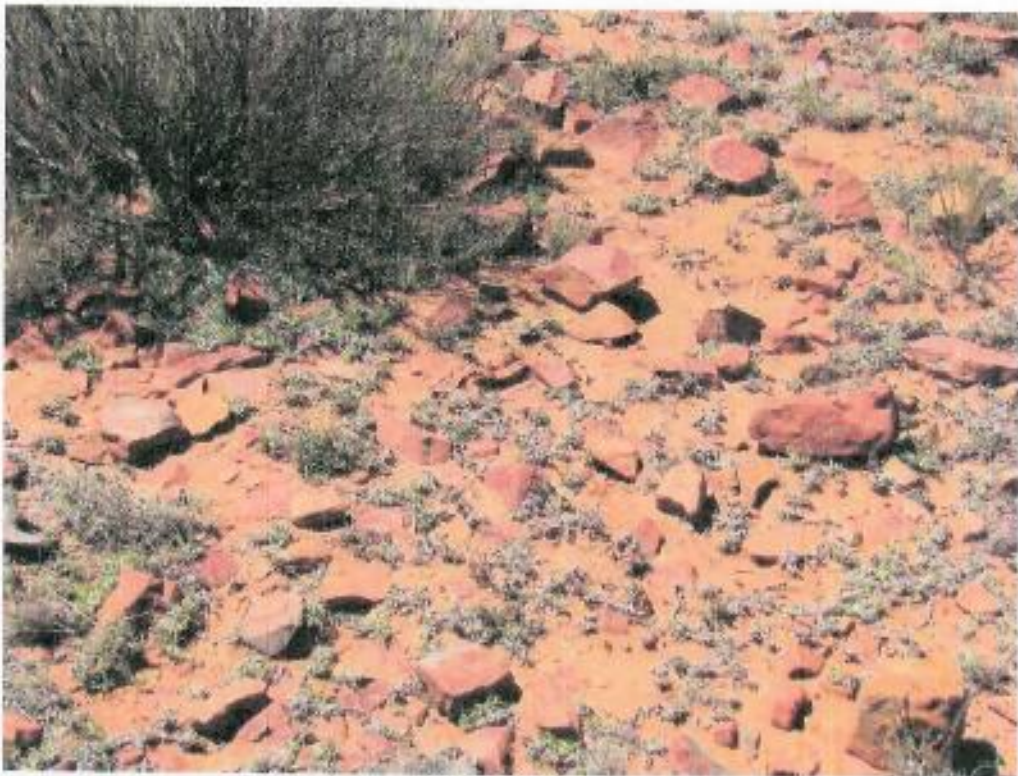
Figure 249: Cores

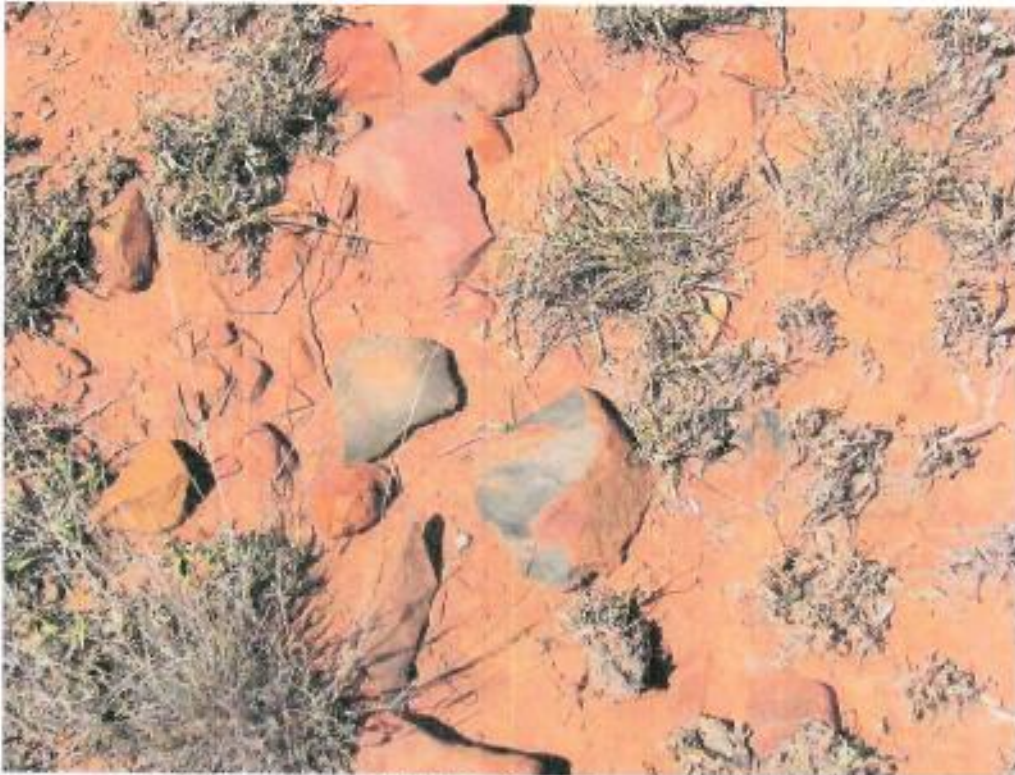
Figure 250: Core and flakes with one showing signs of retouch
