SPECIALIST REPORT

A PHASE 1 ARCHAEOLOGICAL AND HERITAGE IMPACT ASSESSMENT OF THE
STONE WALLED SETTLEMENTS ON TAURUS PLANTATION, BARBERTON
DISTRICT, MPUMALANGA PROVINCE

**REPORT PREPARED FOR
YORK TIMBERS**

APRIL 2015

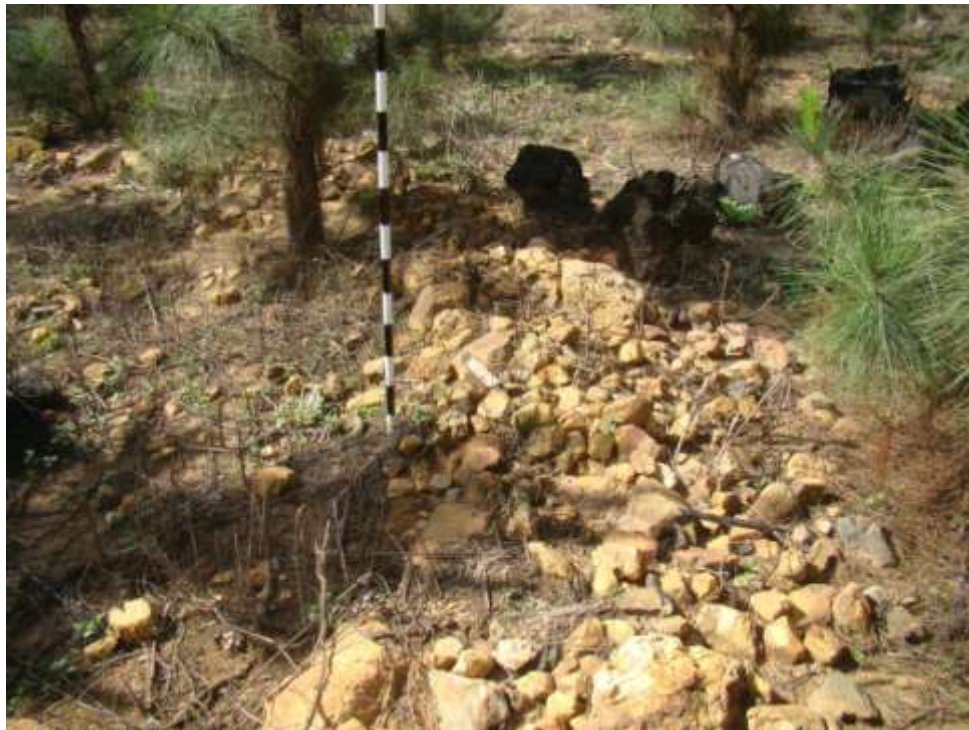
General comments A14: Most of the circular units in A14 have a diameter of approximately 5m (unless otherwise stipulated). They are all situated within the plantation area and severe disturbance has taken place as a result of plantation activities. The height of the walls, vary from almost level to the ground surface, to about 300mm. The original rows of foundation stones are mostly visible, filled in with smaller stones. Damage by cattle has also taken place and the walls are badly run down.

Fig. 33: Visible remains of circular stone wall are observed in Block A 14.

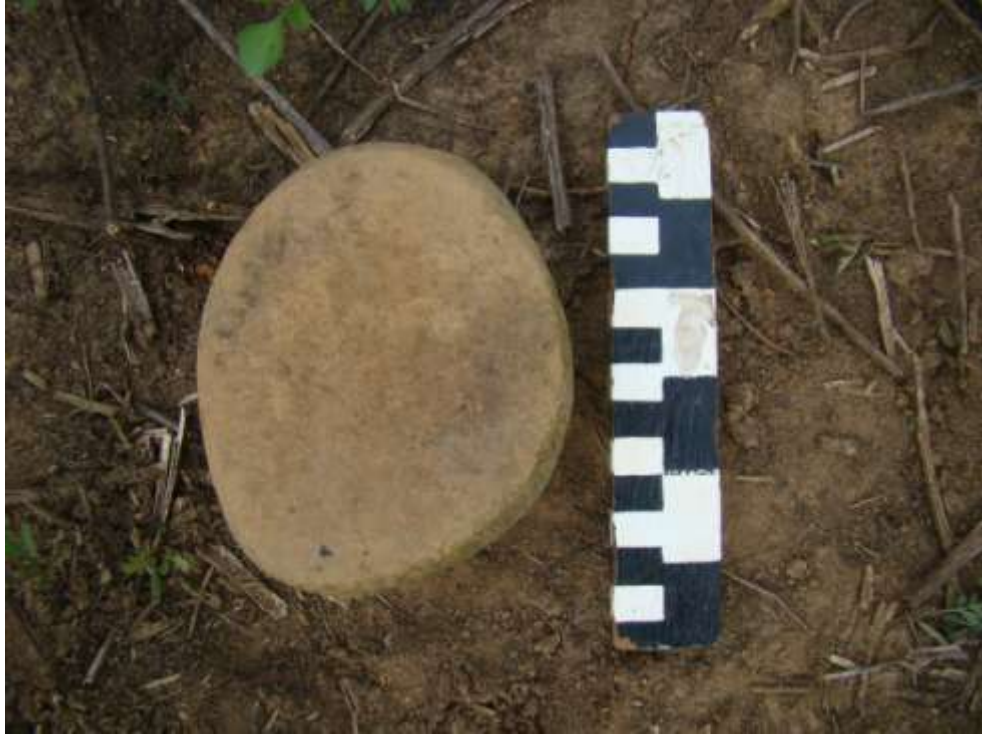
Fig. 36: Upper grinder.

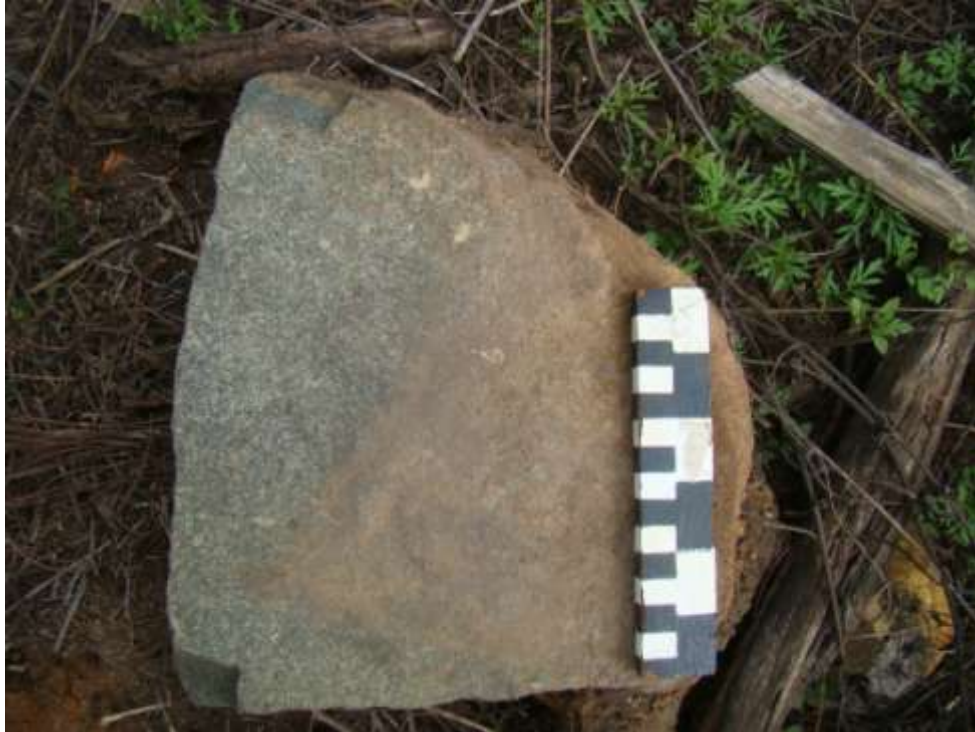
Fig. 38: A broken lower grinder.

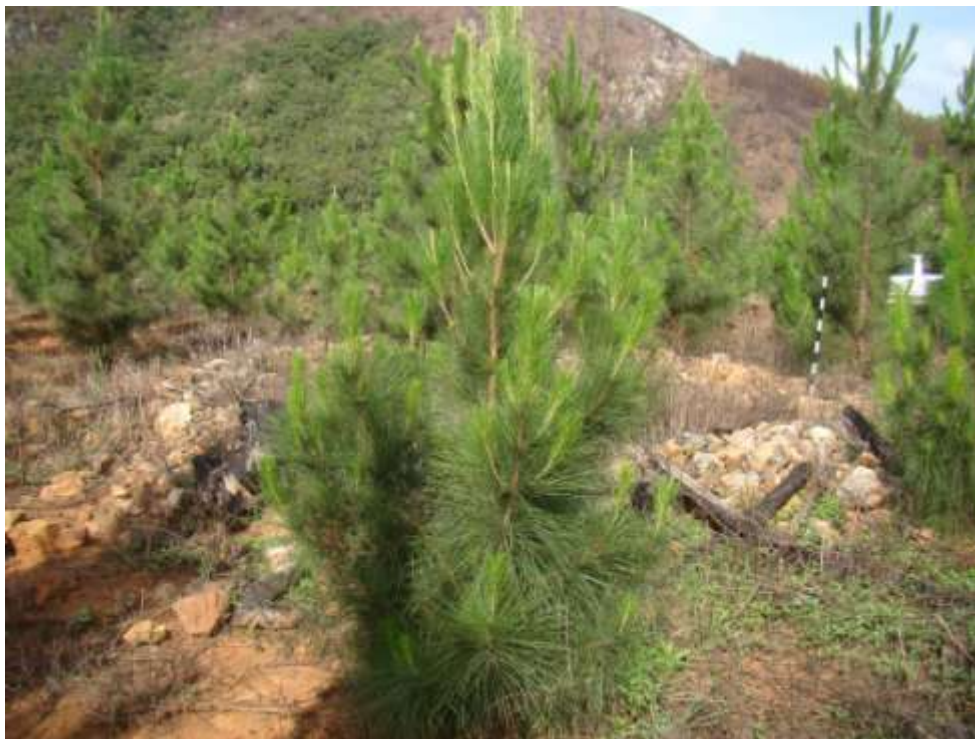
Fig. 39: More units are visible in the plantation.

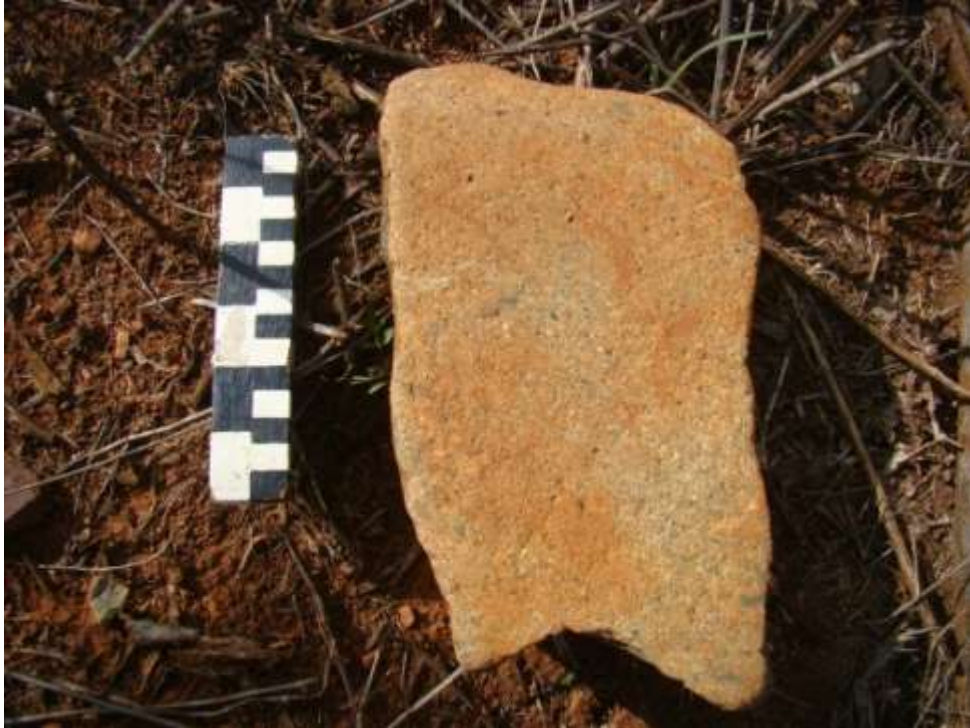
Fig. 40: A broken lower grinder.

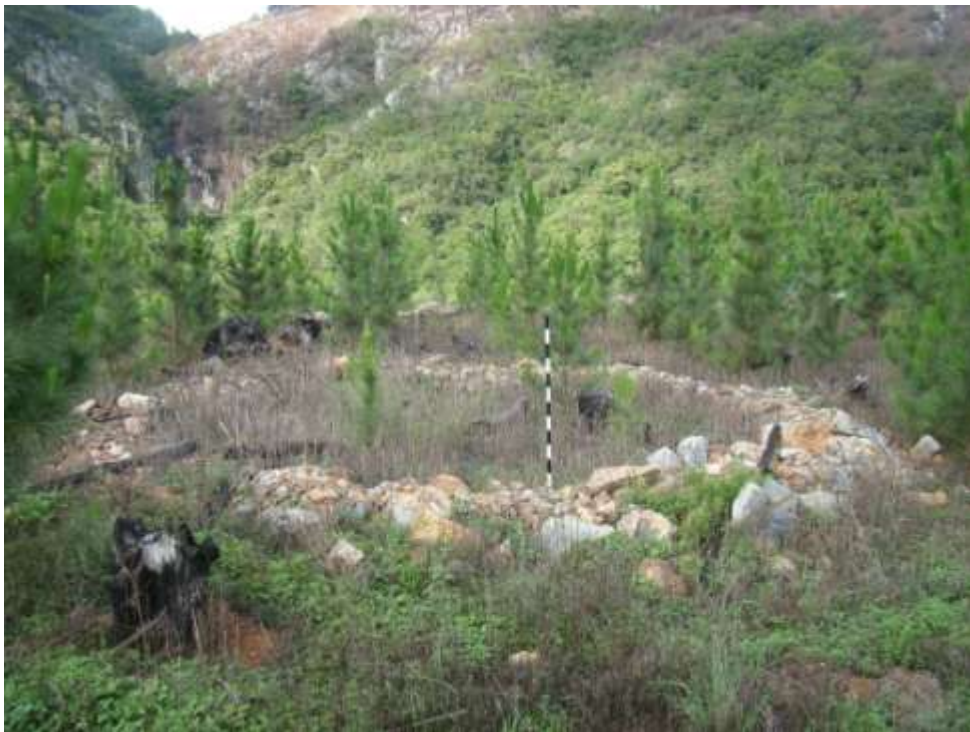
Fig. 41: A circular unit with a distinct wall.

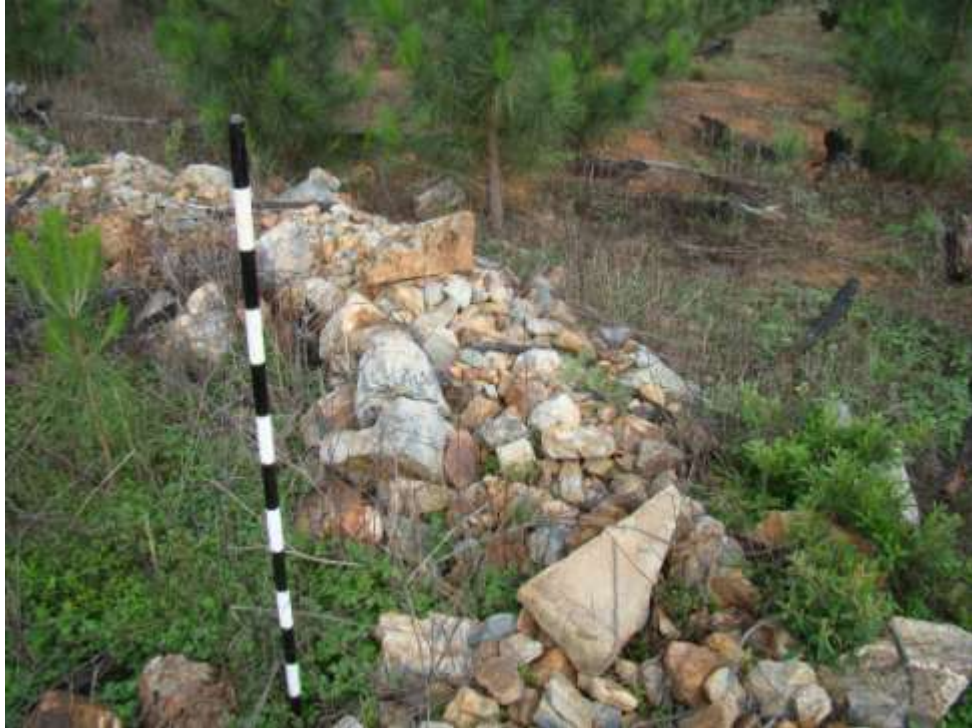
Fig. 42: Detail of the above wall.

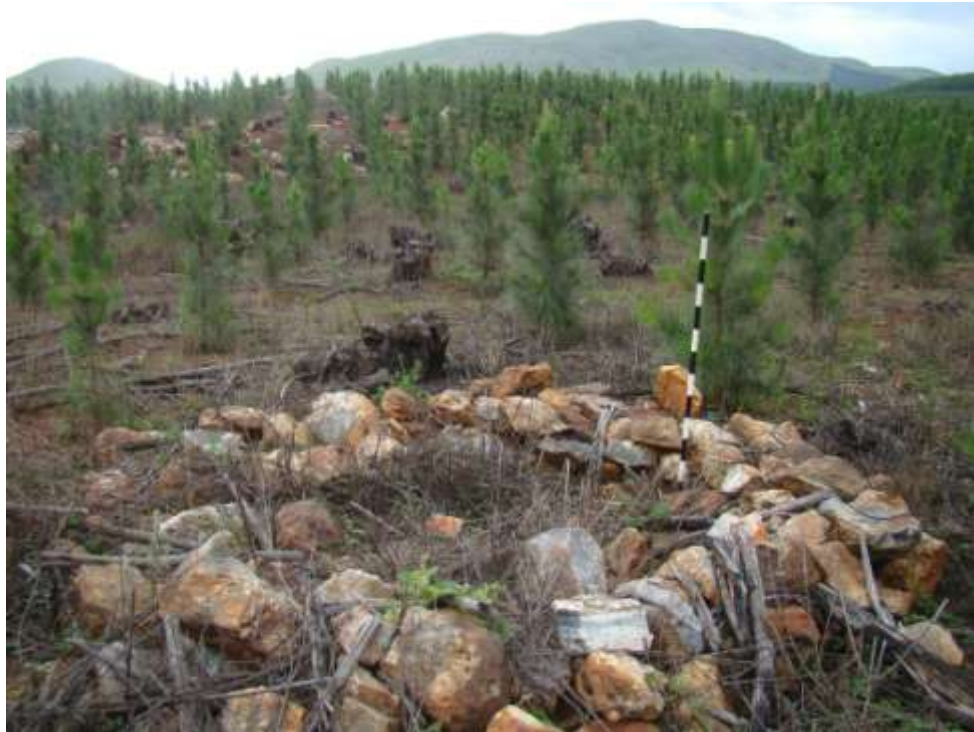
Fig. 50: A small circular unit with a diameter of approximately 2m inside.

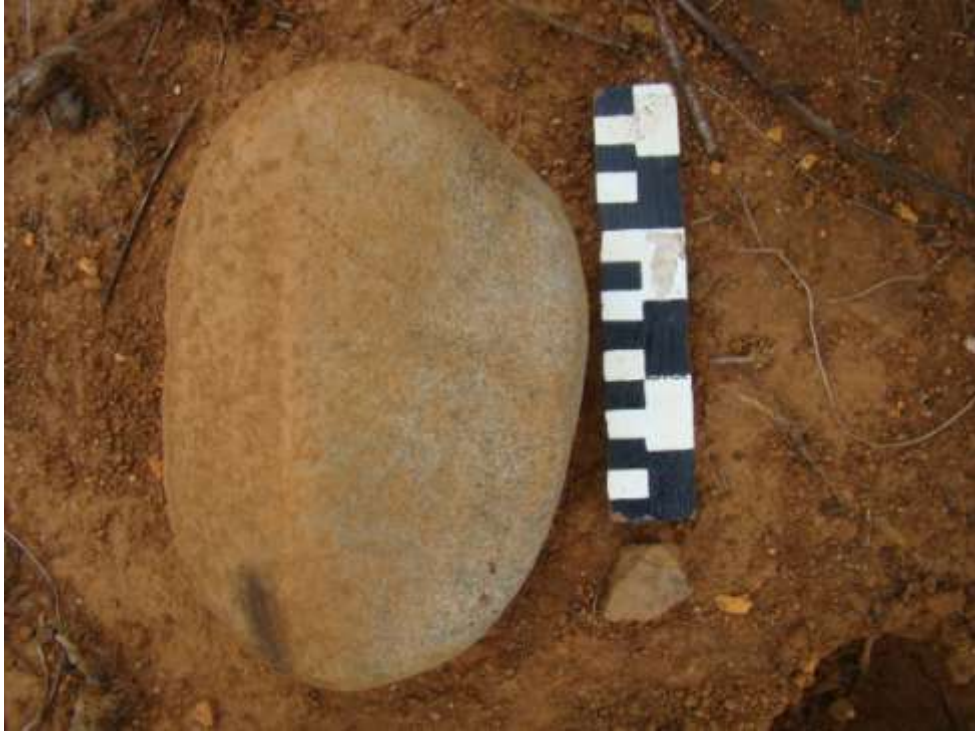
Fig. 52: Upper grinder.

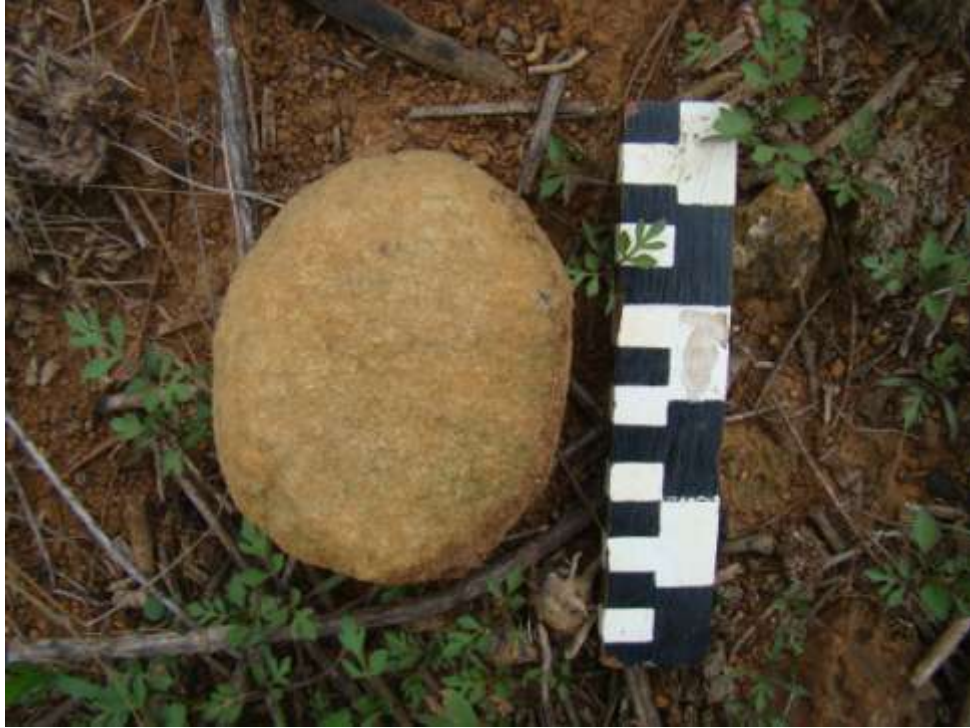
Fig. 54: Upper grinder.

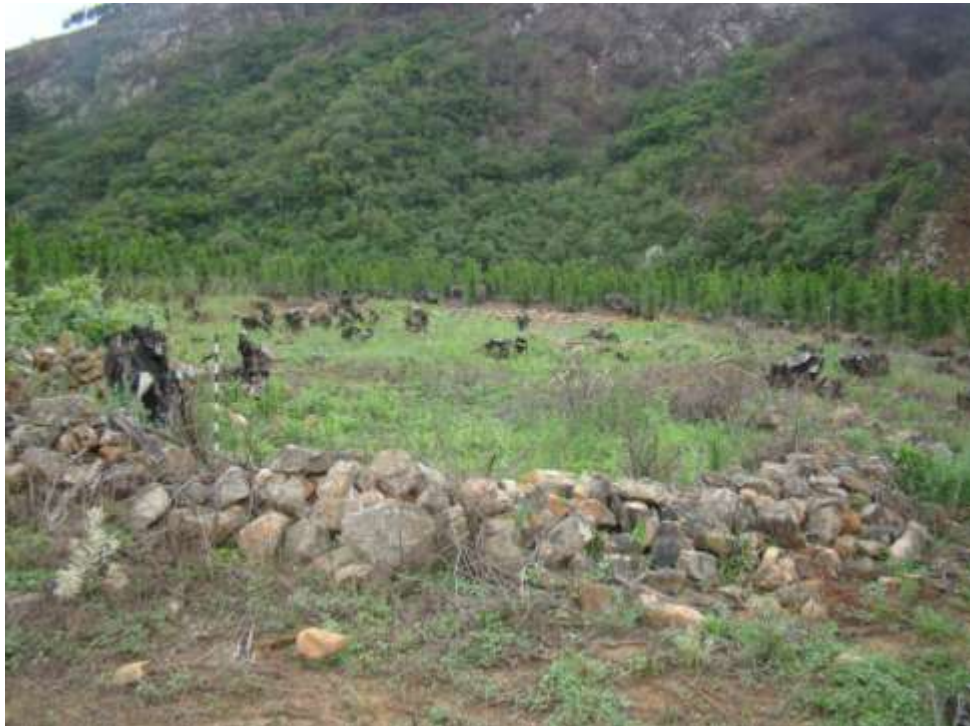
A14 – 10, 11 & 12	Circular stone walls	3 x circular units marked as an ASI. One unit is approximately 30m in diameter. The others are approximately 15m in diameter. There are no pine trees within the units, but the surrounding area is planted. Some of the walls are still approximately 1300mm high, although most are not in a good condition.	Elev: 1270m S25° 54' 37.77" E30° 54' 37.77"
-------------------------	----------------------	--	---

Fig. 55: Three distinct large units are visible in this section.

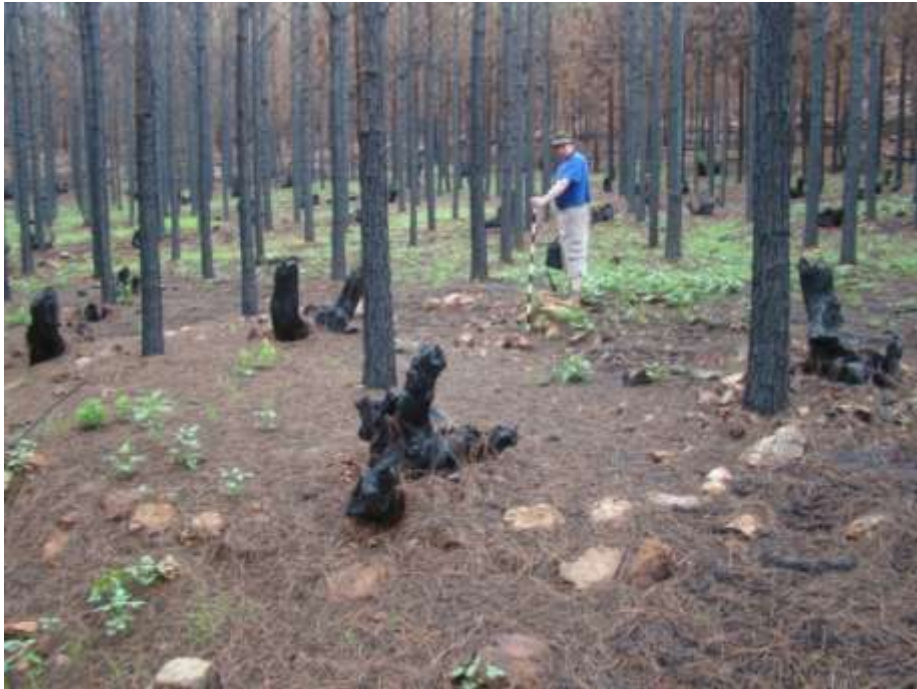
Fig. 64: One of the larger units covered with pine needles.

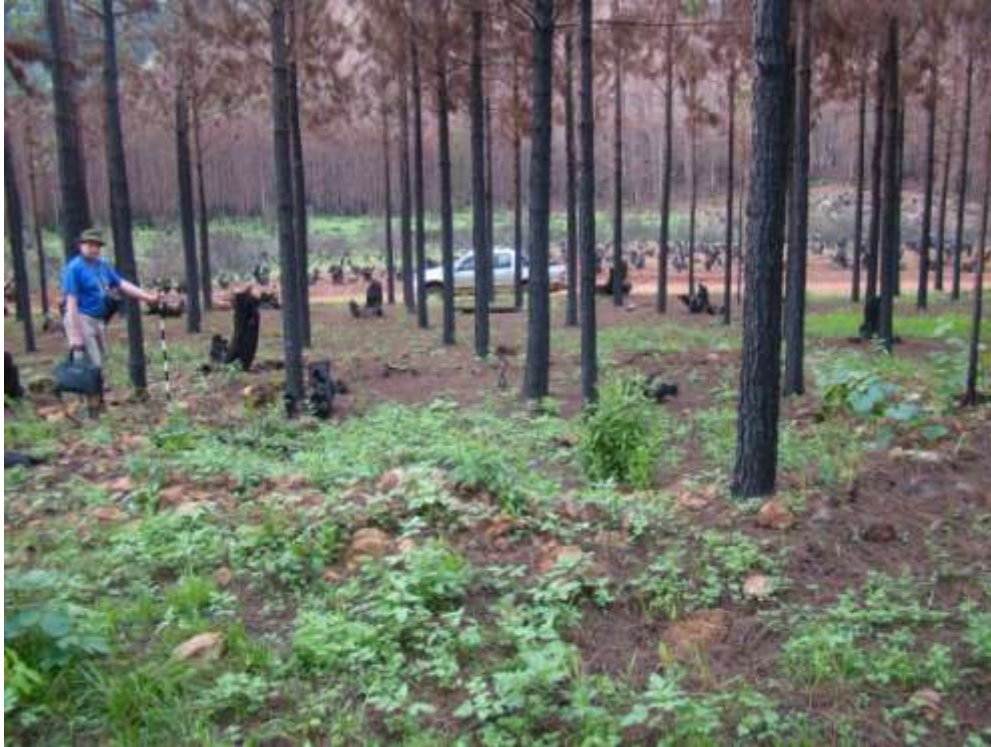
Fig. 65: Most of the circular units in this section are close together.

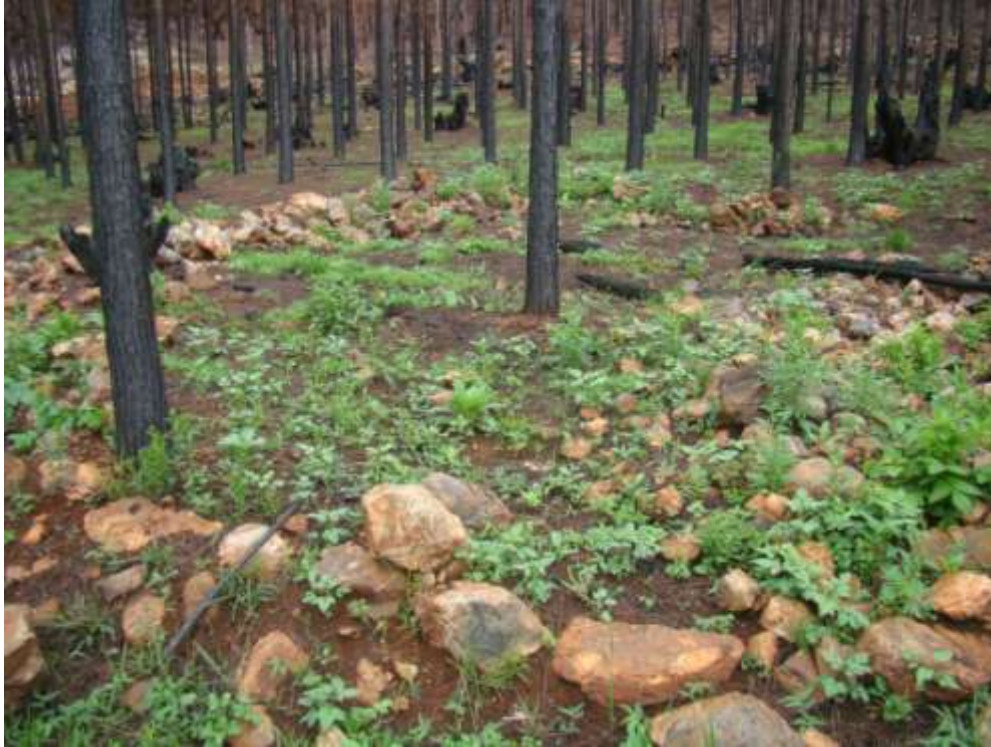
Fig. 67: C01 – 5 A large circular unit.

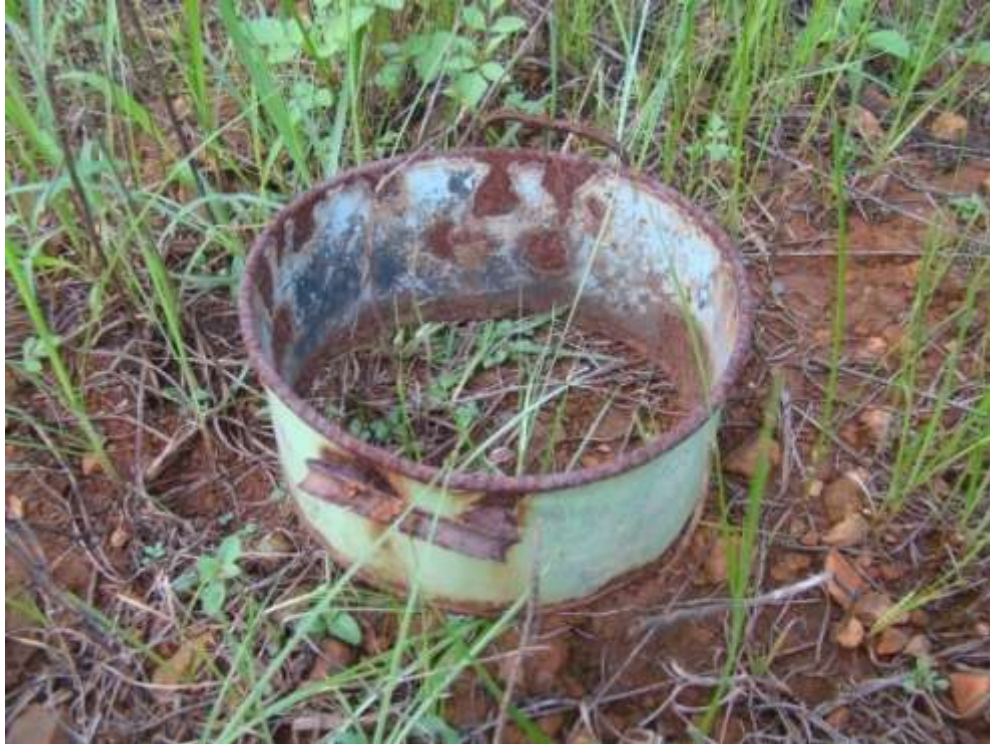
Fig. 72: Recent enamel ware, were observed in this section.

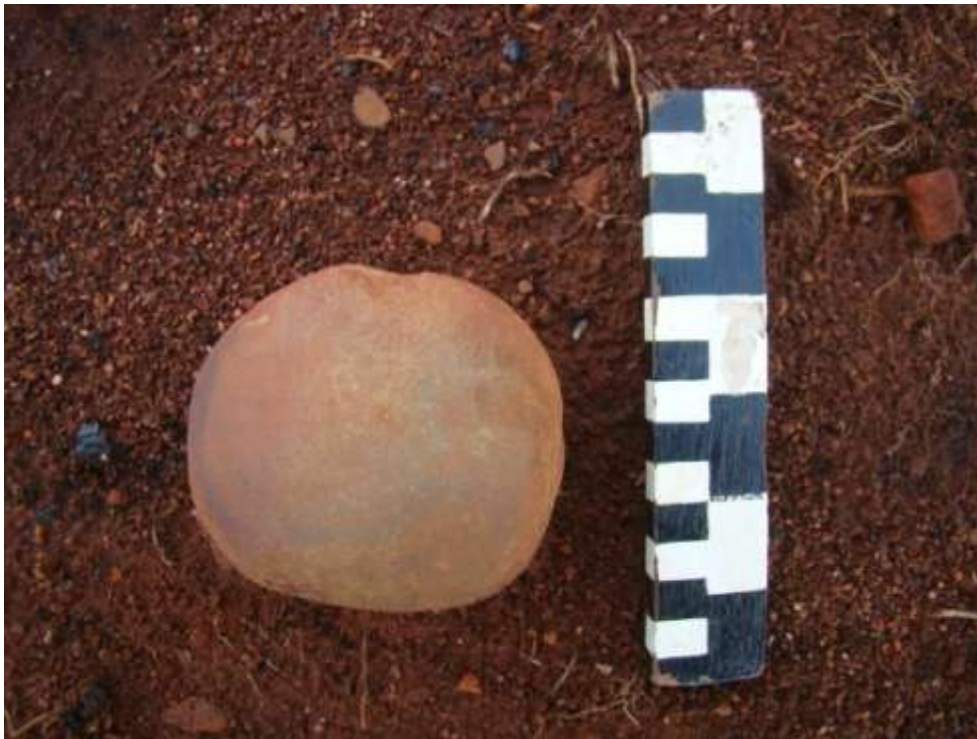
Fig. 75: An upper grinder.

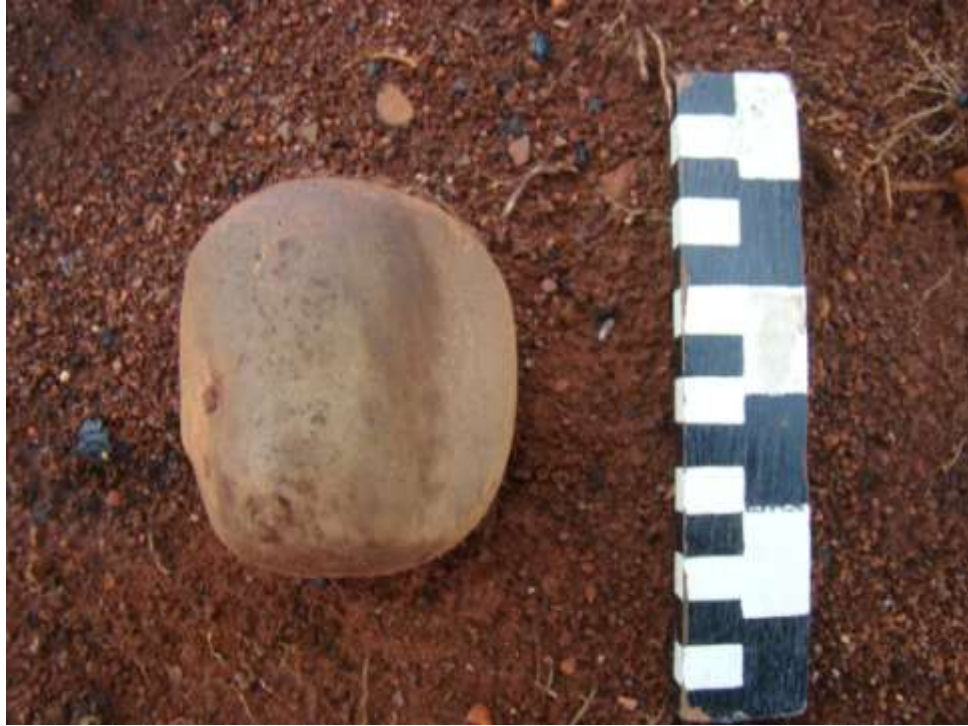
Fig. 76: Upper grinder (worked on three sides).

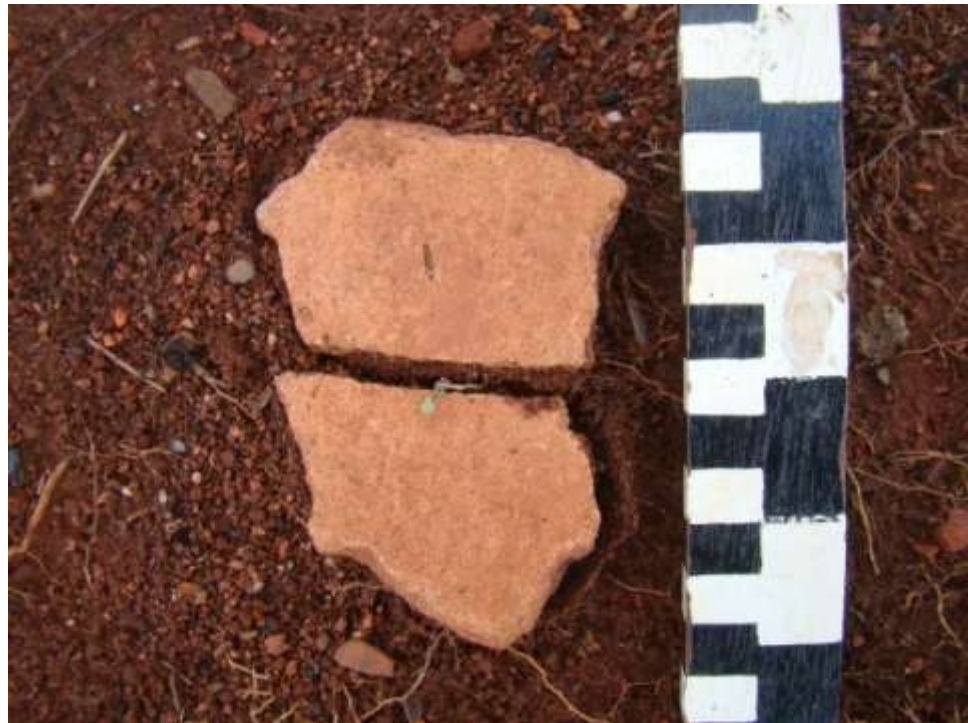
Fig. 77: Fragments of clay potsherds are visible in the entire area.

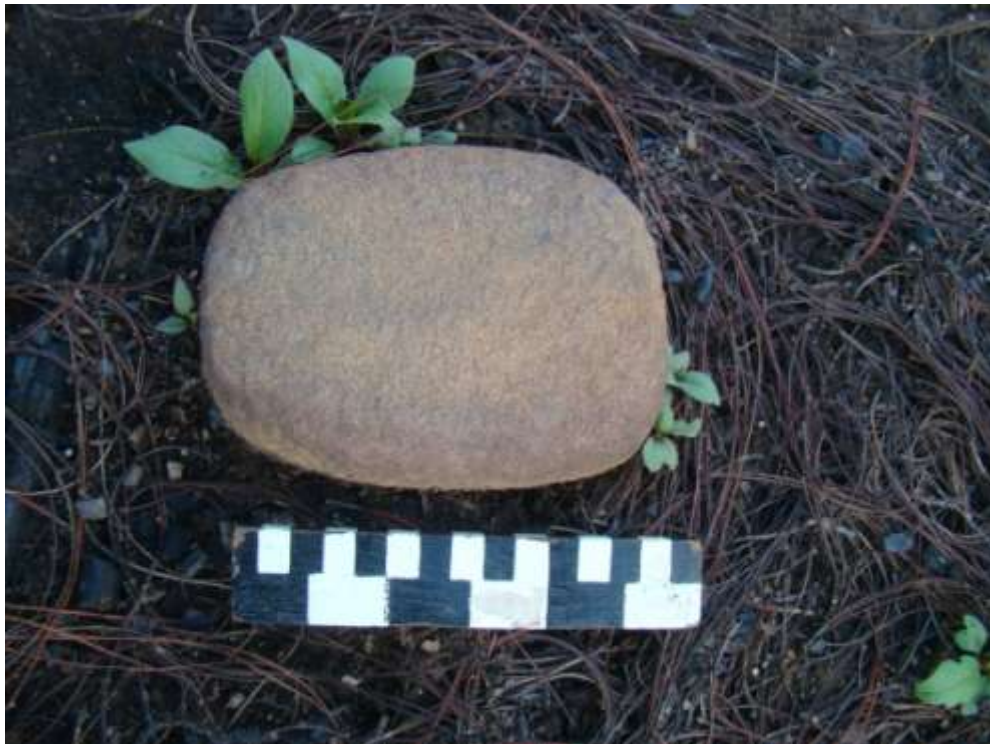
Fig. 82: Upper grinder.

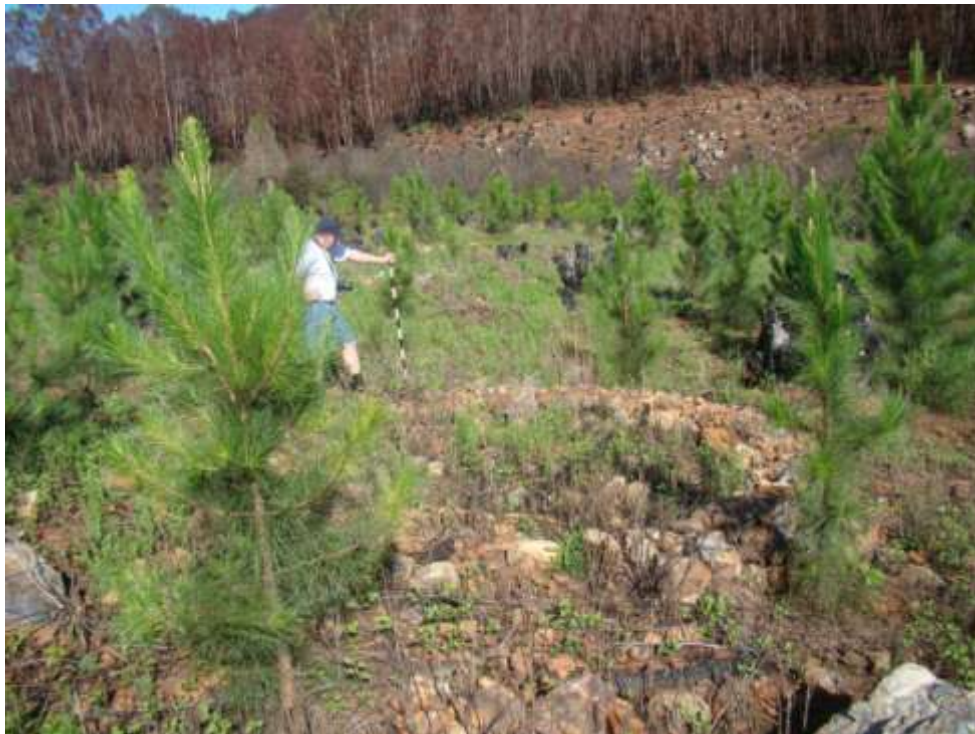
Fig. 96: One of the units in section A21.

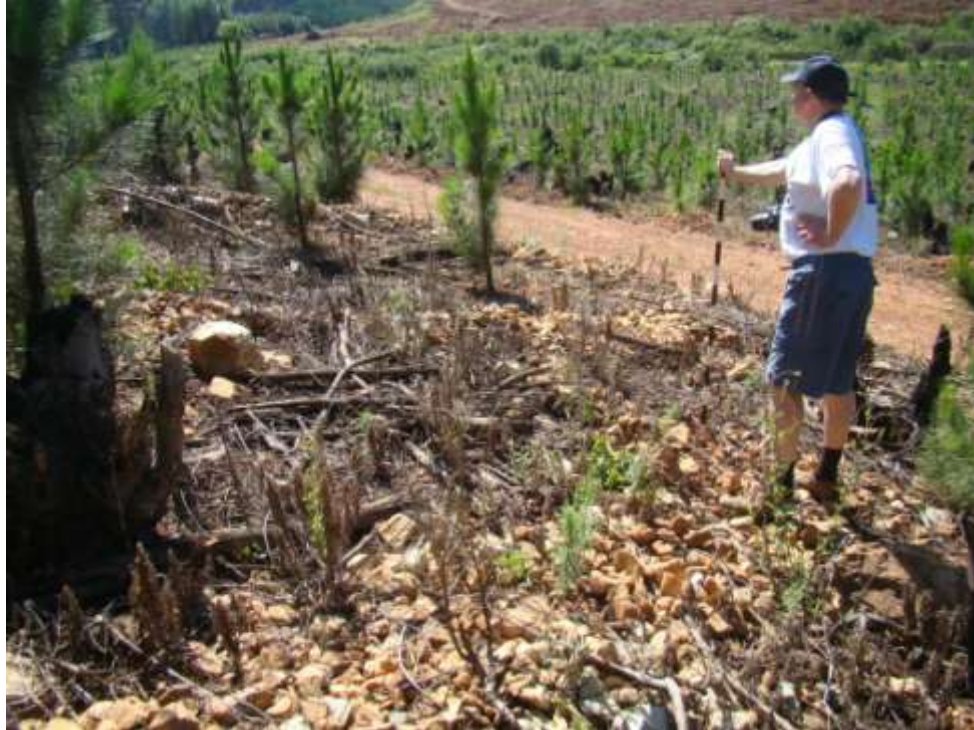
Fig. 103: The section is extensively disturbed by plantation activities.

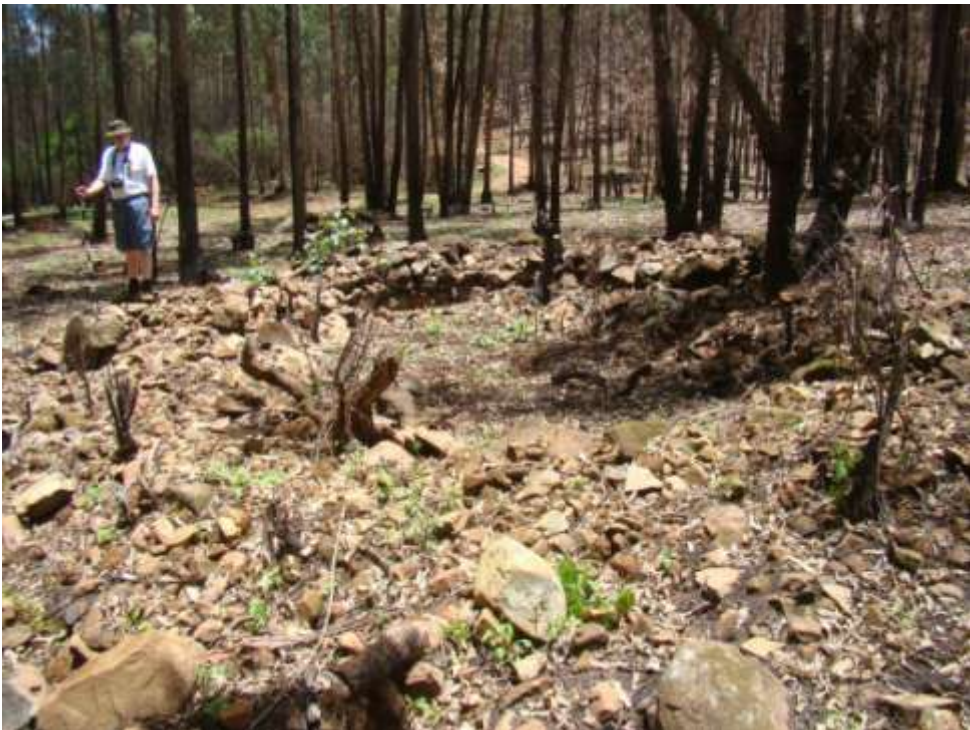
Fig. 125: 2 x circular units connected to each other.

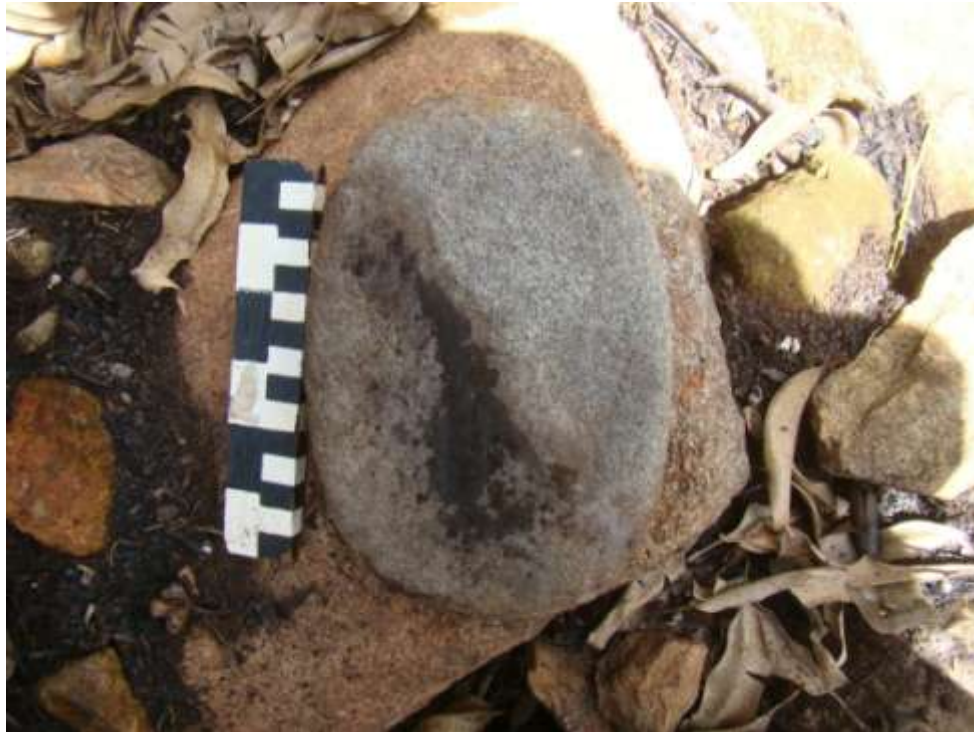
Fig. 126: Upper grinder observed near the unit above.

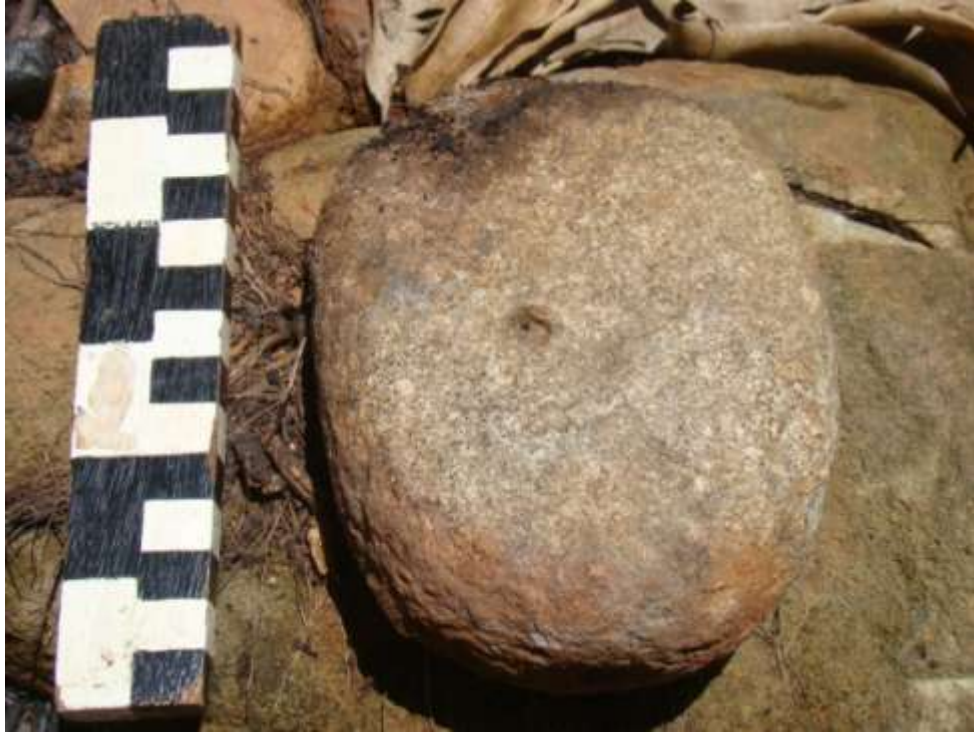
Fig. 128: Upper grinder.

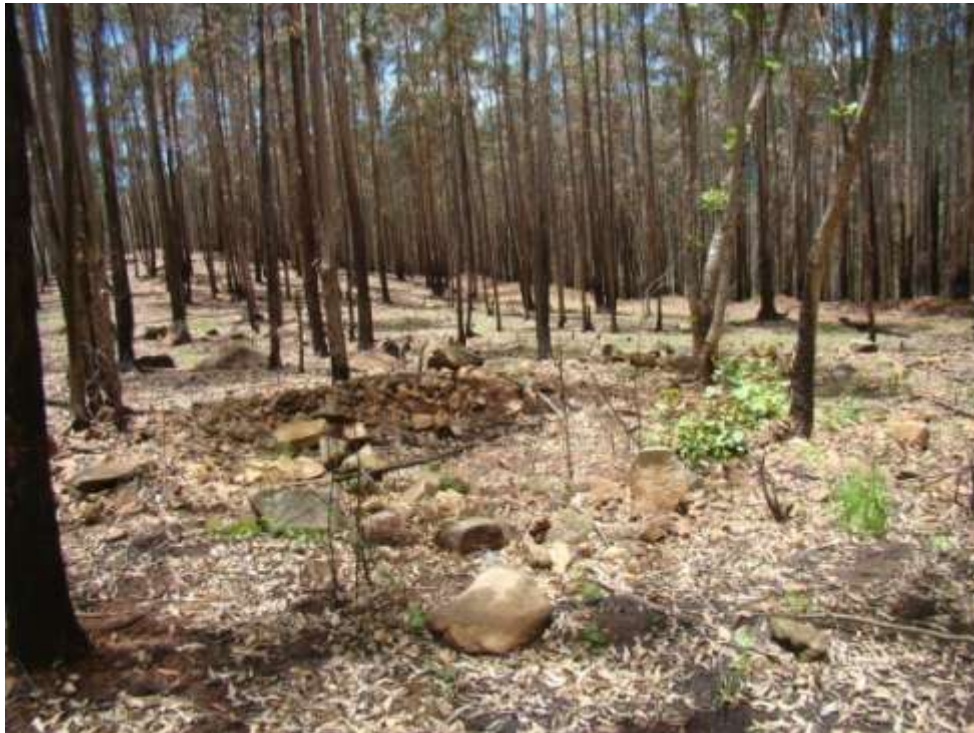
Fig. 129: Another circular unit in block C32

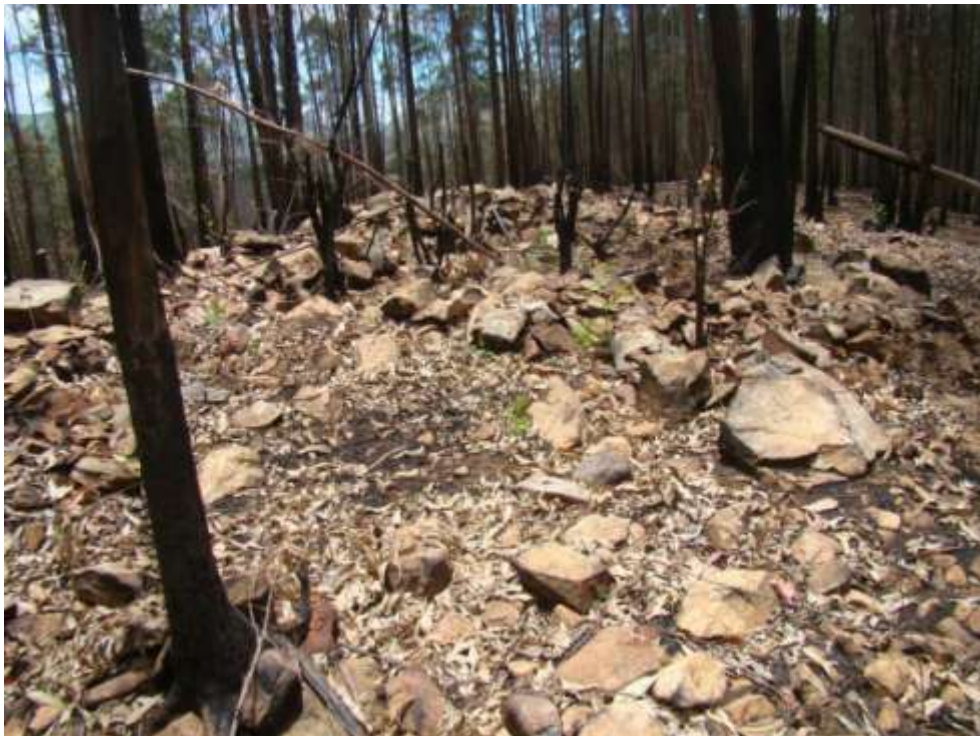
Fig. 131: Four indistinct circular stone walls in the direct vicinity of A25/C32 – 6.

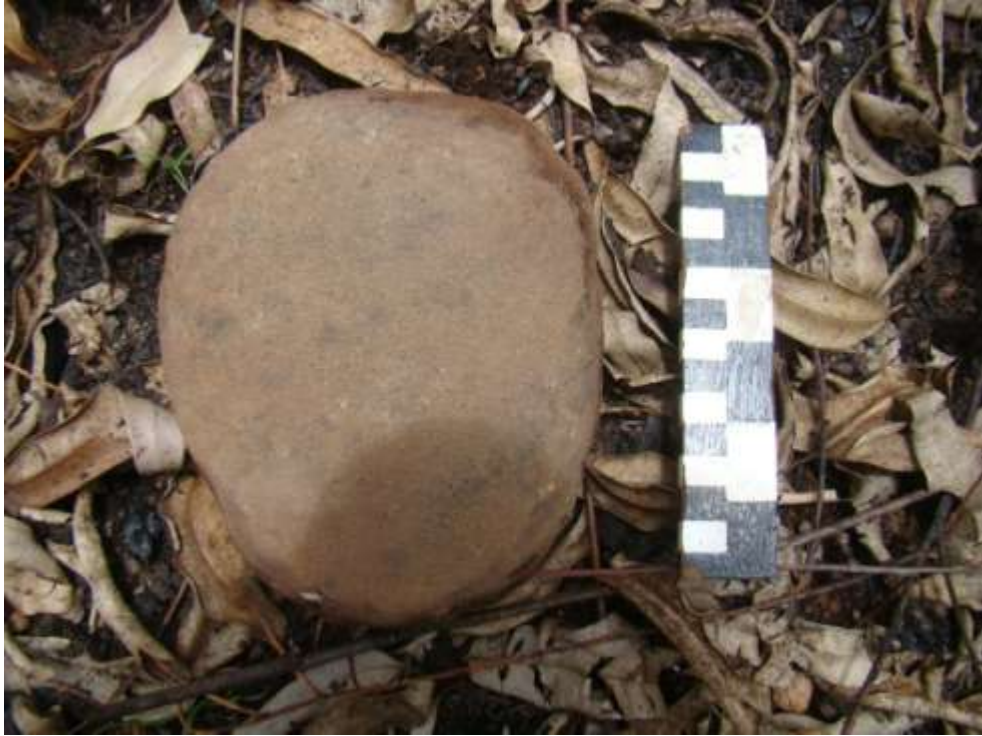
Fig. 132: An upper grinder.

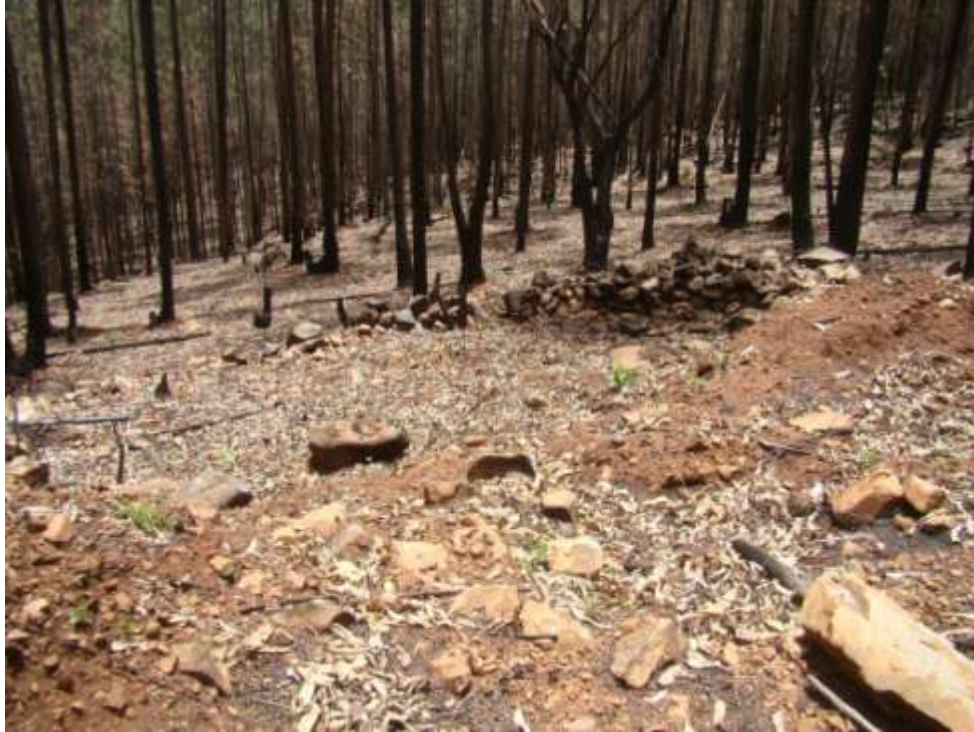
Fig. 134: The same unit as seen from the road.

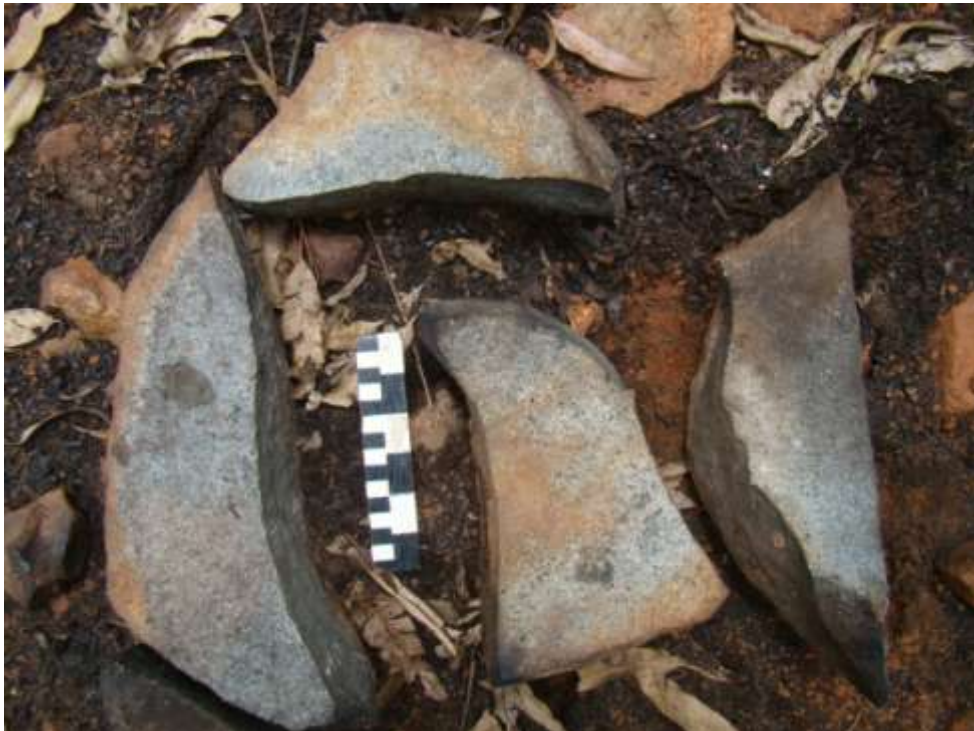
Fig. 135: A broken lower grinder.

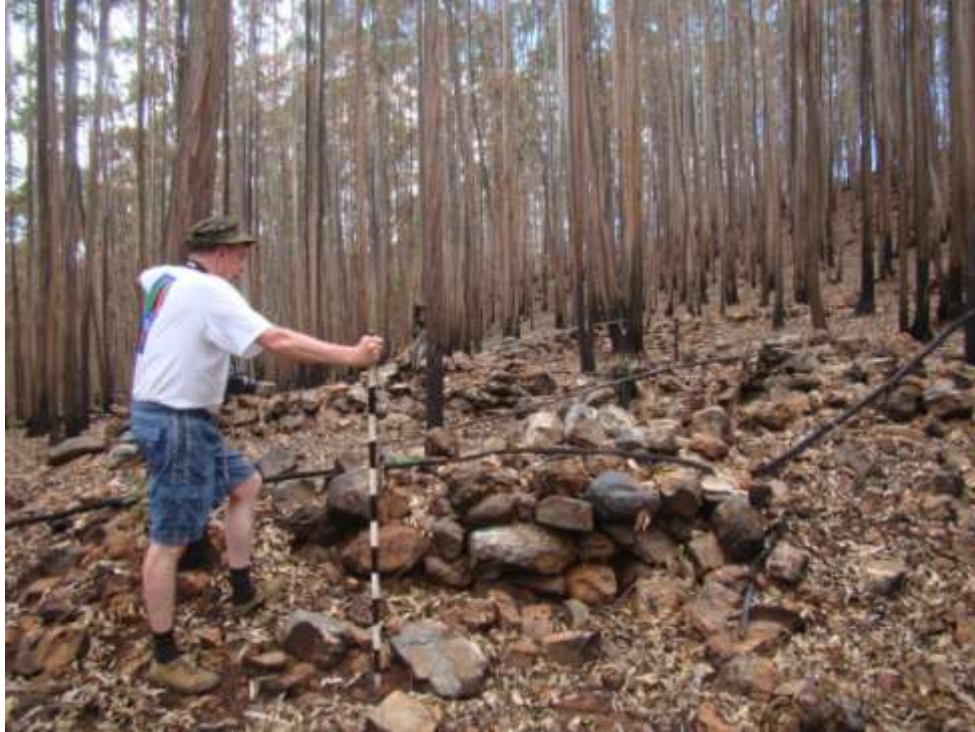
Fig. 146: Circular units were identified.

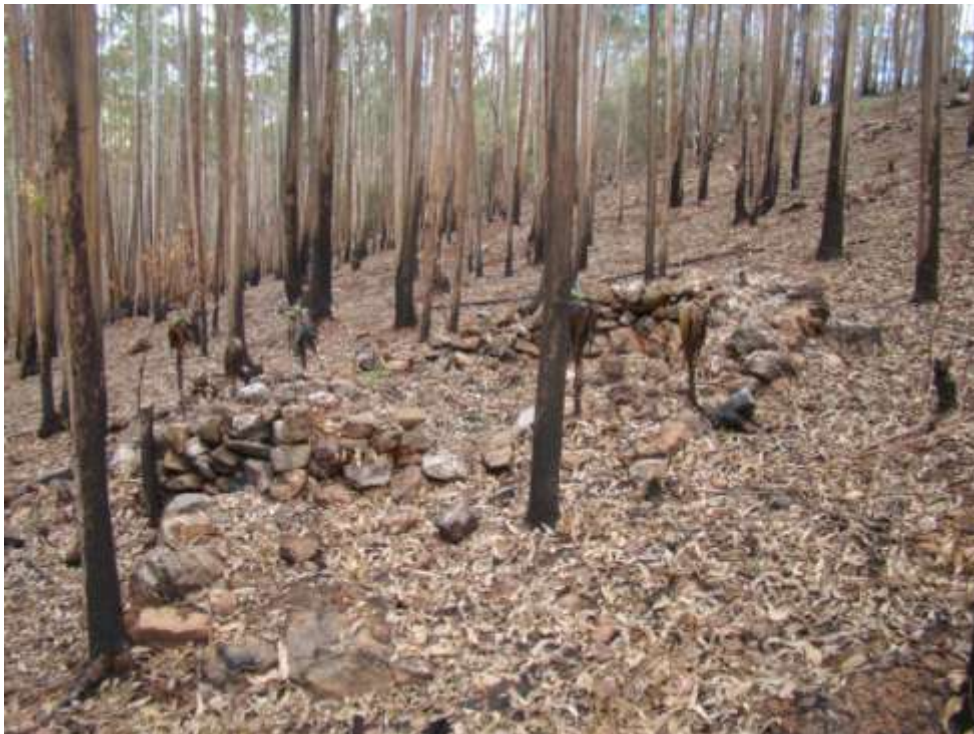
Fig. 149: Another small circular unit towards the east.
